Noncompliance Recall: Front Control Box OTA Software Update

Supersedes 20-051, dated July 29, 2020, to revise the information highlighted in **yellow**.

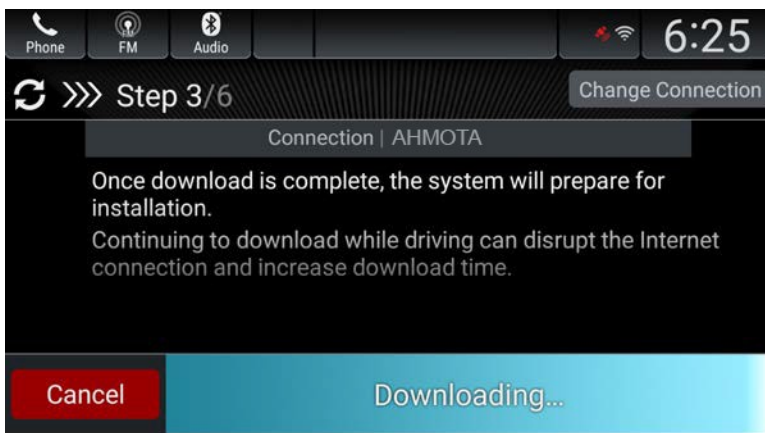
5. Once you have confirmed the vehicle is connected to AHMOTA, and the **Honda SW Version** reads lower than **B.1.3.4**, return to the Home screen. From there, select **System Updates**, then **via Wireless**.

- In some instances, you might not see the following screens on the display.
- If you see **Code 6382**, make sure your dealer AHMOTA network is properly set up.

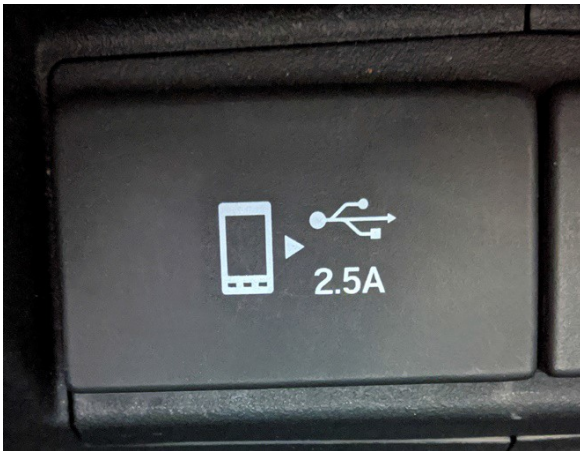
12. Plug the flash drive into the vehicle's USB Data port identified with this symbol.

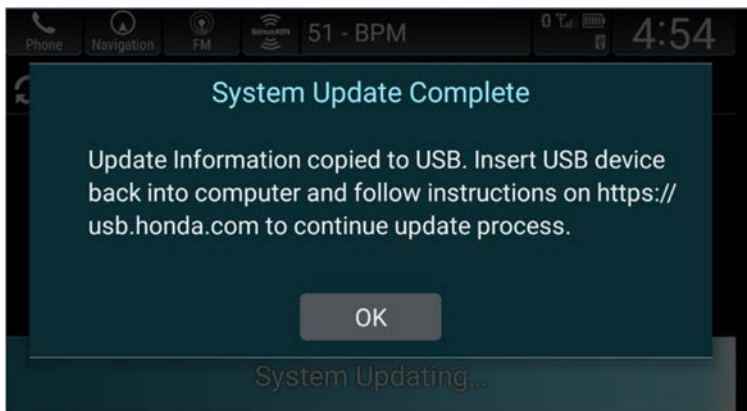
- If the System Update Complete screen is displayed, you will need to manually report the status of the update. Return to your PC and insert the USB drive into your computer. Go to <https://usb.honda.com>. Select **Report Upload**. Navigate to the RB folder on your USB drive and choose the XXXXXREPORT.JSON file.

Under REPAIR PROCEDURE – USB FLASH DRIVE, a note and image were added under step 13.

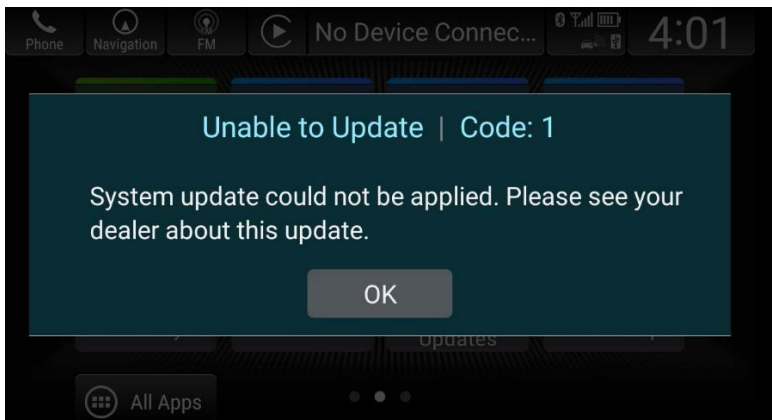
- If you encounter a message **Unable to Update | Code: 1** after seeing the image above, press OK and cycle the ignition.
