Noncompliance Recall: Front Control Box OTA Software Update

AFFECTED VEHICLES

CORRECTIVE ACTION

REPAIR PROCEDURE – OVER THE AIR (OTA) UPDATE

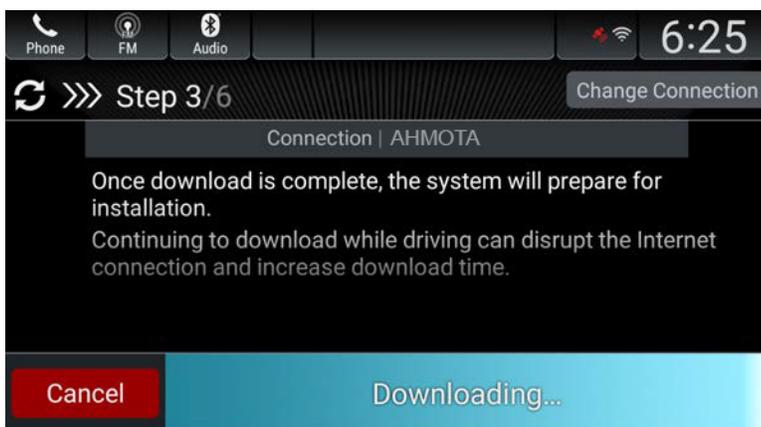
5. Once you have confirmed the vehicle is connected to AHMOTA, and the **Honda SW Version** reads lower than **B.1.3.4**, return to the Home screen. From there, select **System Updates**, then **via Wireless**.

- In some instances, you might not see the following screens on the display.
- If you see **Code 6382**, make sure your dealer AHMOTA network is properly set up.

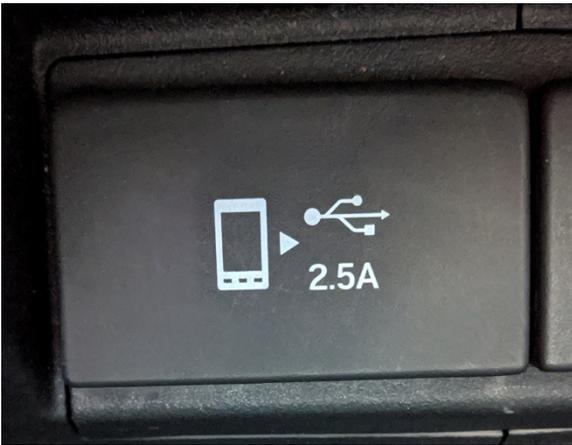
9. Plug the flash drive into the vehicle's USB Data port identified with this symbol.

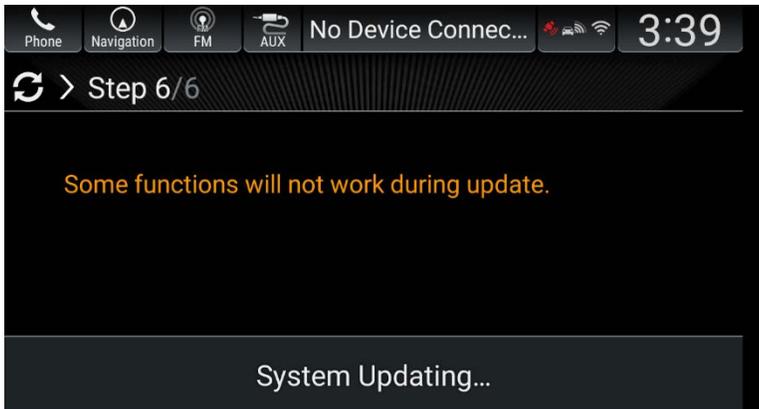
- The system will reboot several times during the installation.
- You may see this screen twice if the vehicle has navigation.
