March 2021
FL859A-AK
NHTSA #20V-485
REVISED BULLETIN

Subject: OptiView Dash Cluster Brightness

Models Affected: Specific Model Year 2015-2019 Freightliner Custom Chassis Corporation XCL, XCM, XCP, XCR, and XCS chassis manufactured October 21, 2014, through May 7, 2019.

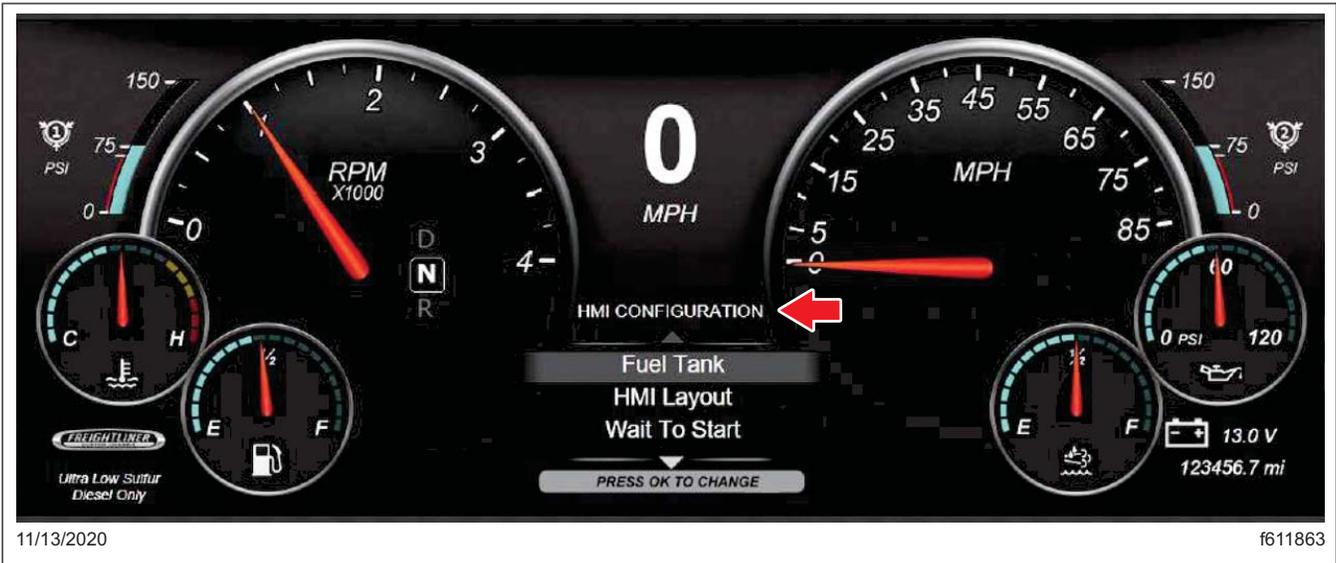
Fig. 13, Configuration Menu

3. This will open the configuration menu. See [Fig. 13](#). Examples of the six HMI Configuration menus are shown in [Fig. 14](#) and [Fig. 15](#).

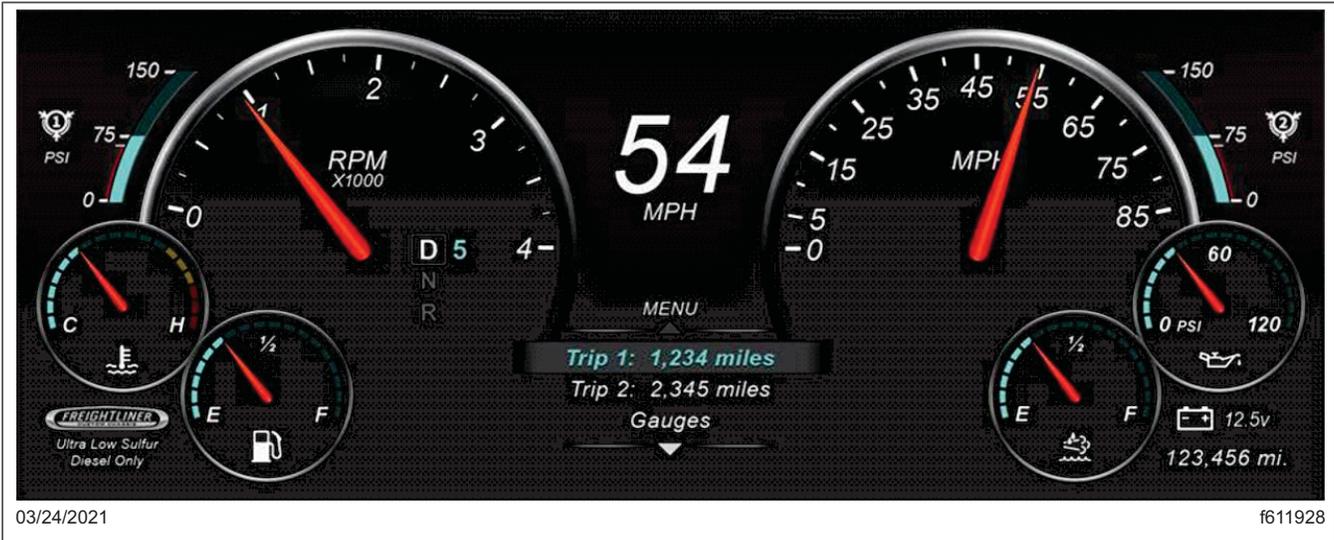
Fig. 20, HMI Configuration, FCC

16. Turn the ignition to ON, and start the engine. Verify the correct HMI Configuration is displaying. See [Fig. 20](#) for an FCC HMI and [Fig. 21](#) for ALT HMI.
