SIB 61 17 20

RECALL 20V-490: HIGH-VOLTAGE BATTERY

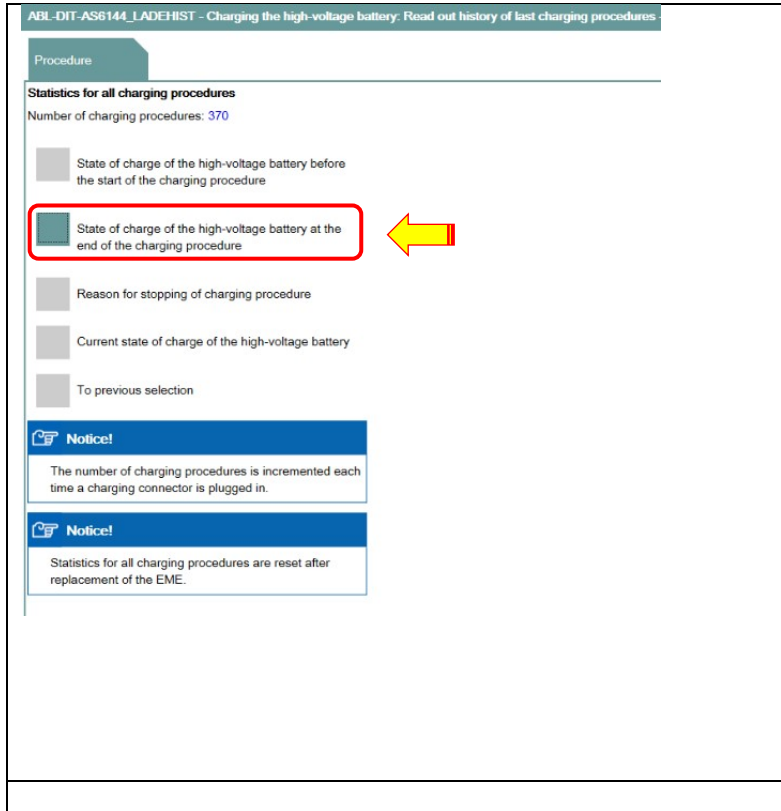
6. Select: "State of Charge of the High Voltage Battery at the end of Charging Procedure" (#2 in example)

ABL-DIT-AS6144_LADEHIST - Charging the high-voltage battery: Read out history of last charging procedures
