# Compliance Recalls

## Code: 91BB & 91BC

**Subject** Rear Camera Software

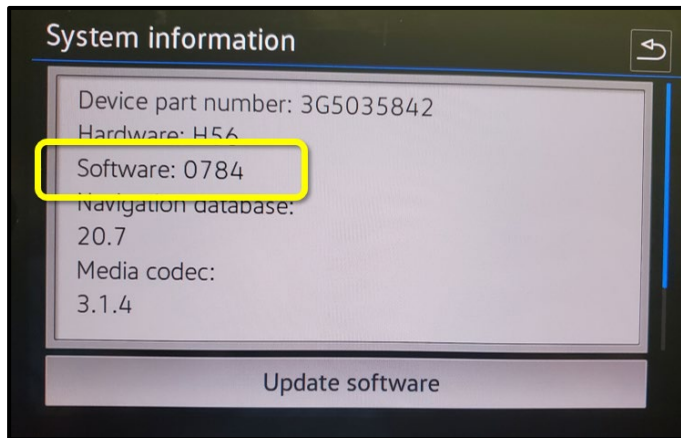
- Check the current software version.
  - Click Menu
  - Settings
  - System Information
- If software version is 0786 or higher:
  - No further work is required.
  - Proceed to Section D.
- If software version is lower than 0786 (typically 0781 or 0784):
  - MIB3 system requires updating.
  - Proceed to the next step.
- Open the hood.
- Open the battery cover.
- Switch the ignition on.
- Apply the parking brake.
- Switch off all consumers (headlights, heated seats, climate control, etc.).
- Attach the GRX3000VAS Tester/Charger (or equivalent) IN POWER SUPPLY MODE to the vehicle battery.
