GROUP
Safety Recall Campaign

SUBJECT: KSDS SOFTWARE LOGIC IMPROVEMENT (SC2001)**

This bulletin provides information related to a software update to the Engine Control Unit (ECU) to install the Knock Sensor Detection System (KSDS) in order to protect the engine from excessive connecting rod bearing damage (refer to applicable model table below).

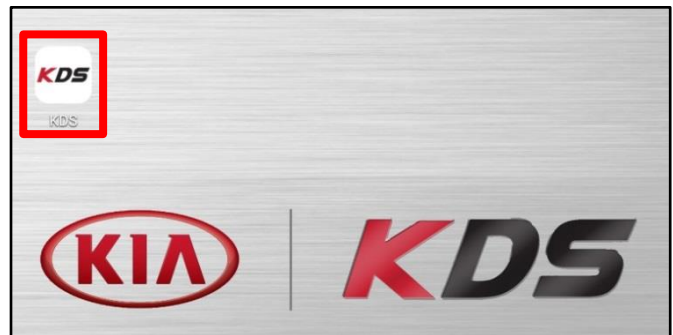
2. With the ignition ON, turn ON the KDS tablet. Select **KDS** from the home screen.

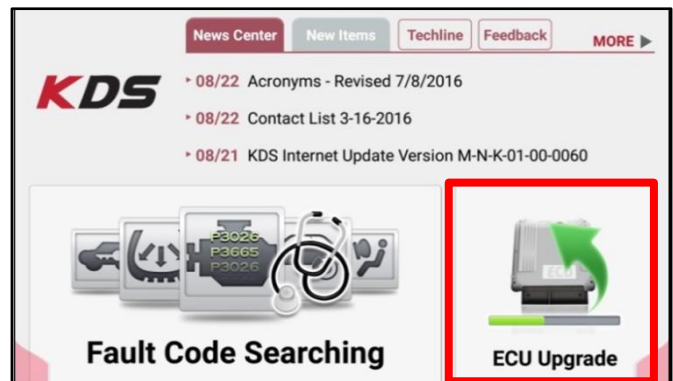
4. Select **ECU Upgrade**.

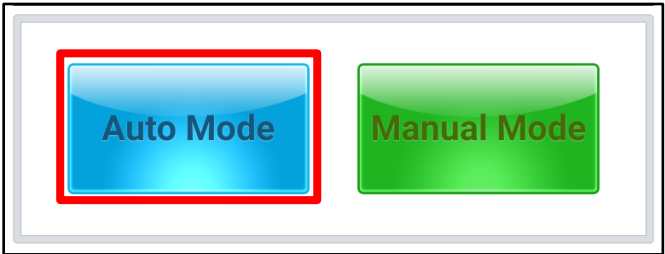
- Select **Auto Mode**.

CAUTION
 Do NOT attempt to perform a Manual Mode upgrade **UNLESS Auto Mode fails**. Always follow the instructions given on the KDS in either Auto or Manual mode.

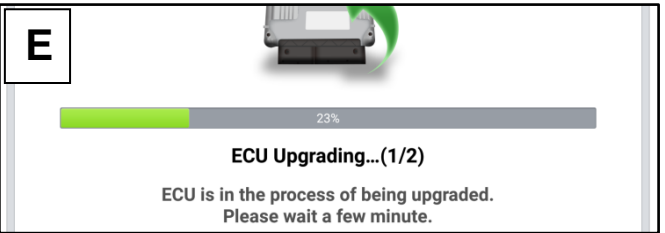
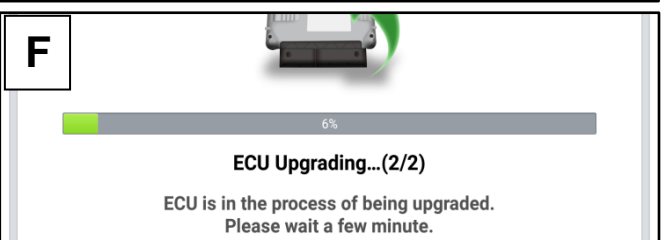
- The ECU upgrade will begin and the progress of the upgrade will appear on the bar graph. Upgrade part (1/2) (E) will download the upgrade event to the VCI-II. Upgrade part (2/2) (F) will upgrade the ECU.

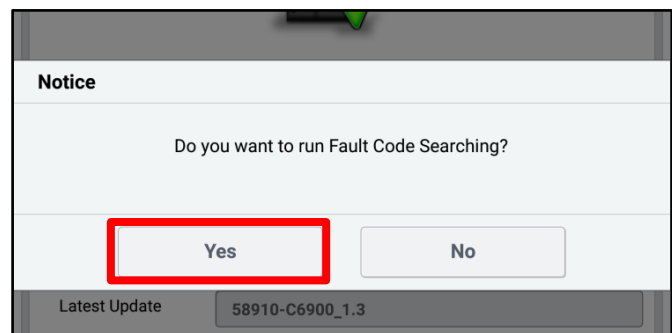
12. When prompted, select **YES** to check for Diagnostic Trouble Codes (DTC) and erase any DTCs stored such as EPS, ESC, and TPMS that may have been set during the upgrade.
