REF #: ICI20-043
Effective: 12/23/20
Release: 12/23/20

SUBJECT: FL870 Pre-Release Repair Notice

Work Instructions

FL870 eB2 Hill Start Assist Update

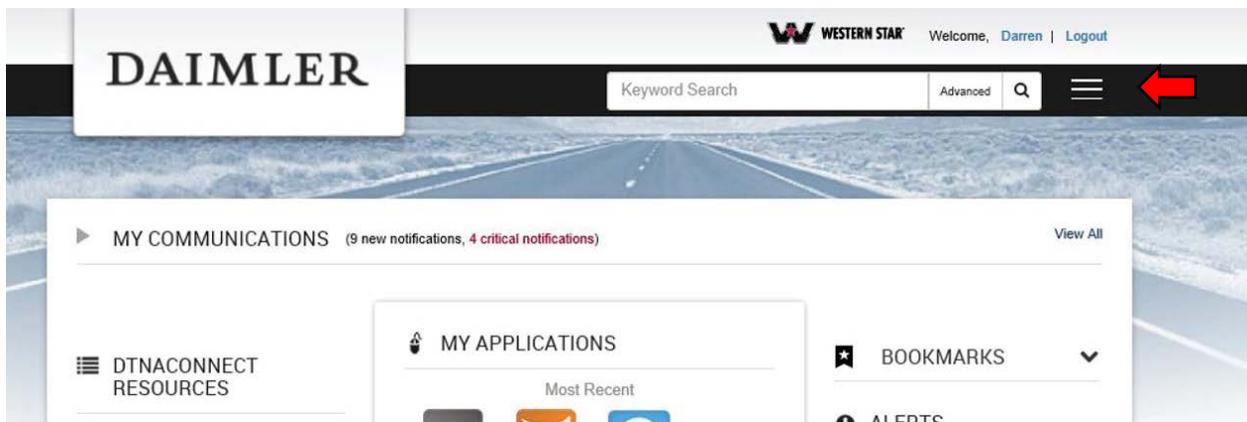
1. Check the base label (Form WAR259) for a completion sticker for FL870 (Form WAR260) indicating this work has been completed. The base label is usually located on the front wall under the dash. If a sticker is present for FL870, no work is needed. If there is no sticker, proceed with the steps below.
2. Park the vehicle on a level surface, shut down the engine, and set the parking brake. Chock the tires.
3. On the laptop, go to DTNAConnect and select the three menu bars in the upper right-hand corner. See [Fig. 1](#).

Fig . 1, DTNAConnect Home Screen

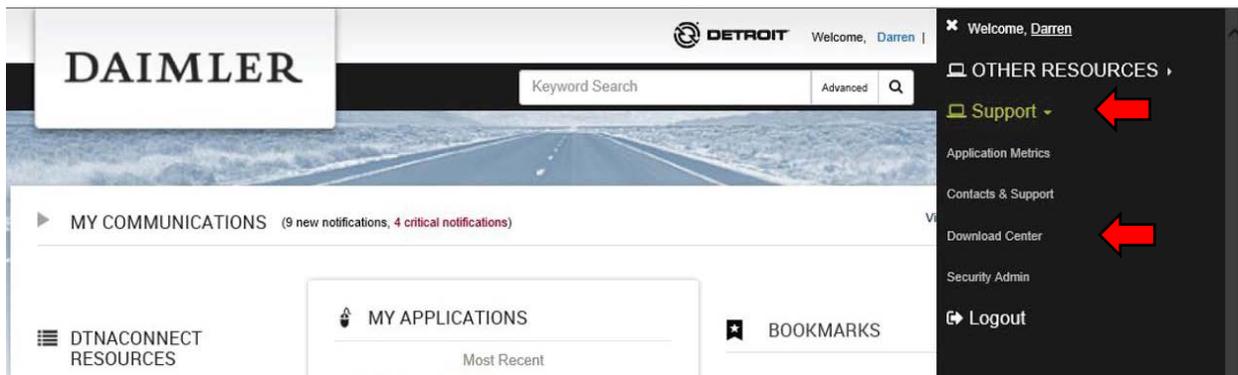
4. Select 'Support,' then select 'Download Center.' See [Fig. 2](#).

Fig. 2, Selecting Support and Download Center Screen

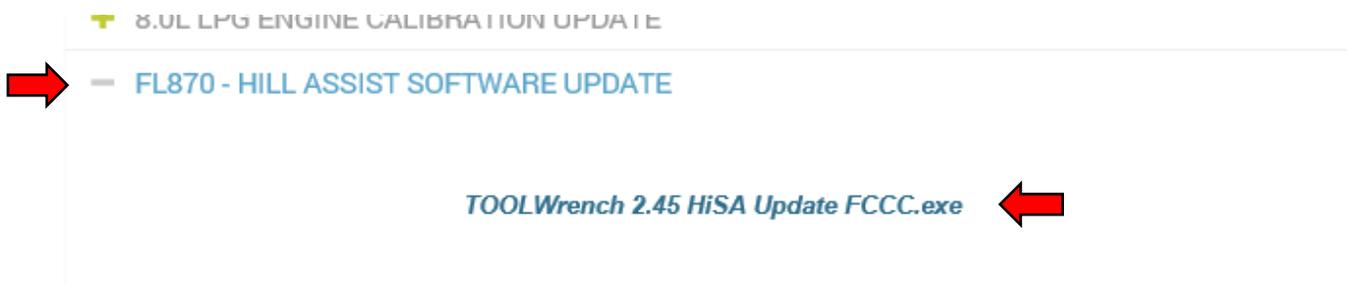
5. Scroll down to the "FL870 Hill Assist Update" and select the "+" symbol, then select the ToolWrench 2.45HiSA Update FCCC.exe link. See [Fig. 3](#).

Fig. 3, Selecting the File Link

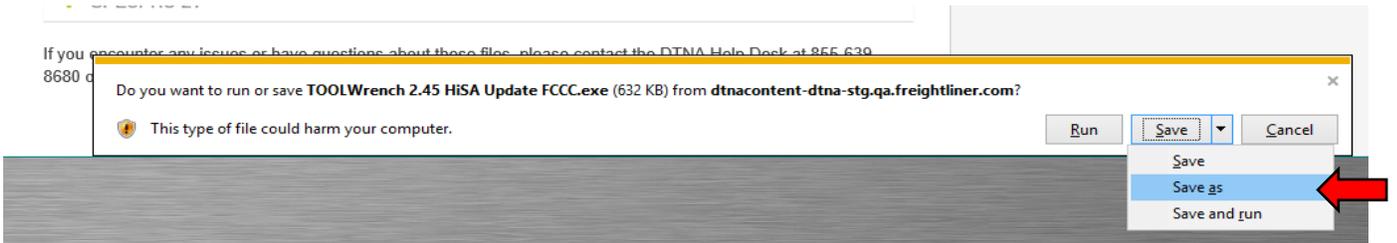
6. Select 'Save As.' See [Fig. 4](#).

Fig. 4, Selecting Save As

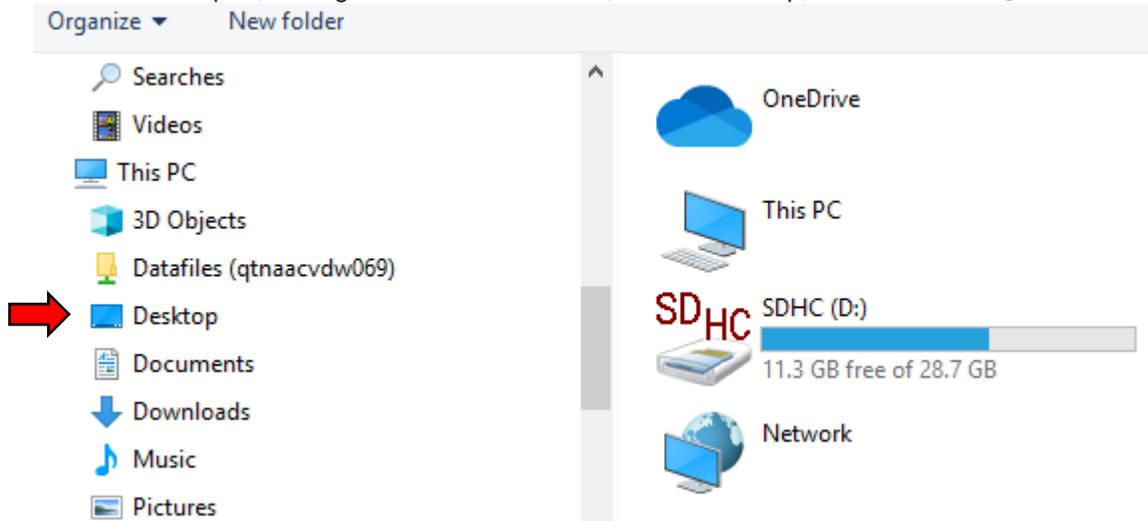
7. A window will open, asking where to save the file; select 'Desktop,' as shown in [Fig. 5](#).

Fig. 5, Saving the File to the Desktop

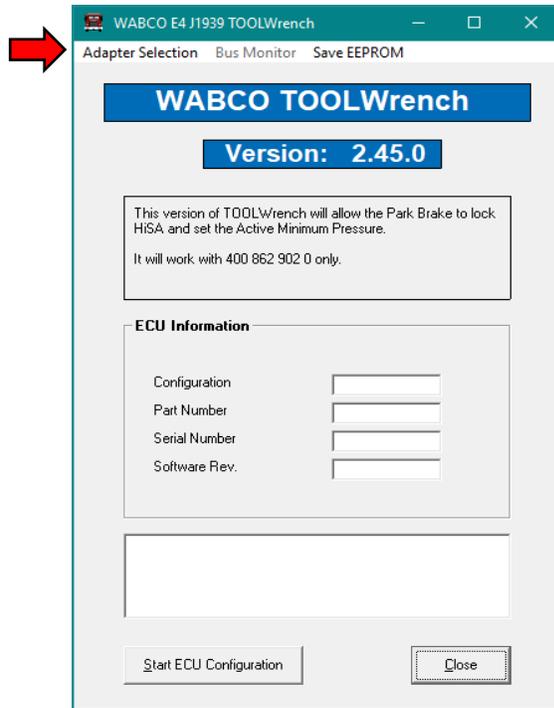
11. Then click Adapter Selection. See Fig. 6.

Fig. 6, Toolwrench Adapter Configuration

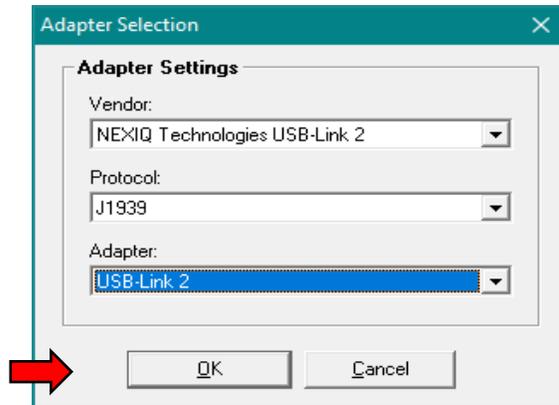
12. Then select the correct options for each menu field, then click ok. See Fig. 7.

Fig. 7, Toolwrench Adapter Settings

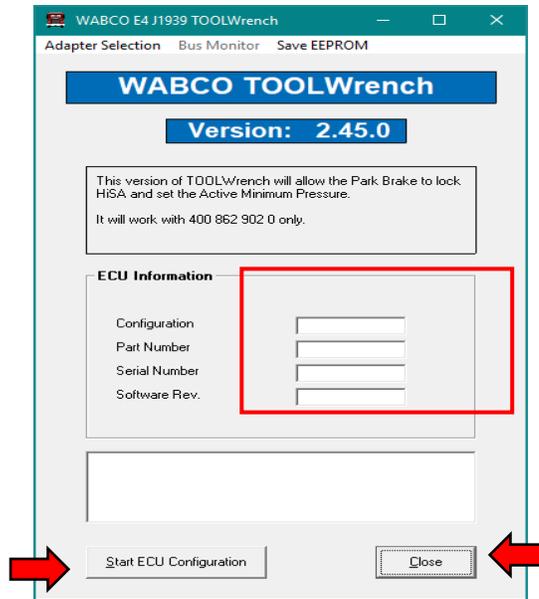
IMPORTANT: Confirm that the ECU Information Fields populate (red box), and that the part number shown is 400 862 902 0. This ToolWrench only works for this part number. See Fig 8.

13. Select Start Configuration. Fig. 8.

Fig. 8, Toolwrench Start ECU Configuration
