VOLUNTARY SAFETY RECALL CAMPAIGN 2013-2015 PATHFINDER; STOP LAMP SWITCH ADJUSTMENT

CAMPAIGN ID #: PC786

APPLIED VEHICLES: 2013-2015 Pathfinder (R52)

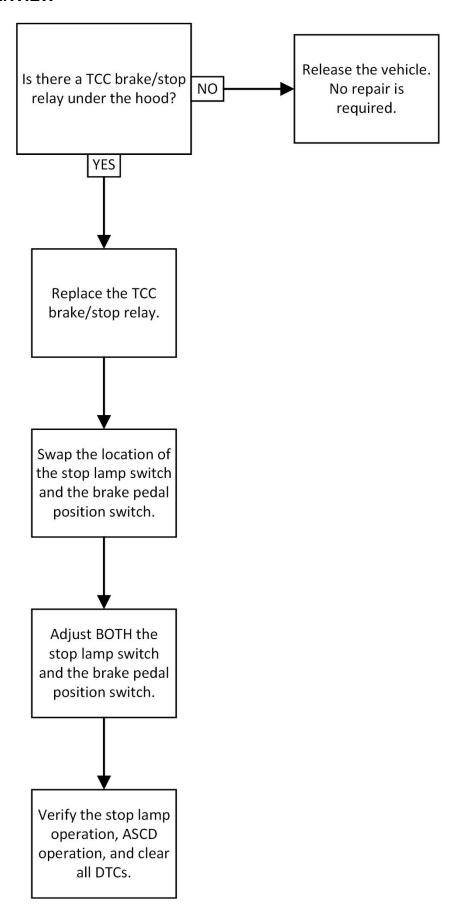
REPAIR OVERVIEW

Nissan is conducting this voluntary safety recall campaign, on certain specific model year 2013-2015 Pathfinder vehicles, to inspect and, if necessary, replace the TCC brake/stop lamp relay and adjust the stop lamp switch. This service will be performed at no charge to the customer for parts or labor.
