Product Safety Recall

N212328790 Front Passenger Airbag Takata Inflator

– Priority Group 9

Correction	Dealers will replace the passenger-side frontal airbag inflator.

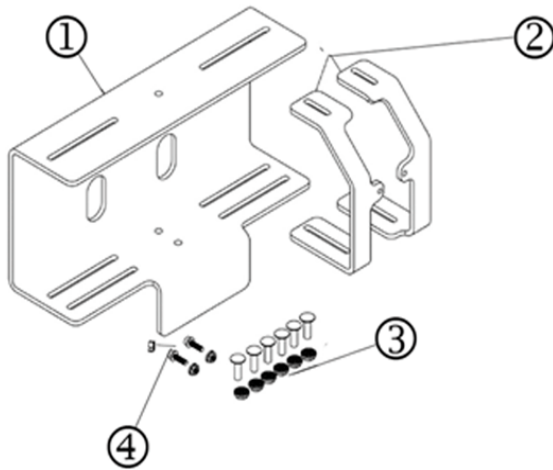
4006668

(1) Mounting Bracket (2) Support Bars (3) Support Bar Hardware (4) Airbag Mounting Hardware.

Dealers must use the airbag mounting bracket, shown below, to replace the front passenger airbag inflator. As of December 31, 2015, all U.S. dealers have been shipped the airbag mounting bracket at no charge through Bosch Automotive Service Solutions. The Bosch tool number is EL-51377. If your dealership does not have the airbag mounting bracket, do not attempt to perform this service procedure and immediately contact **1-800-GM-TOOLS** for assistance. Attempting to replace the front passenger airbag inflator without using the bracket may pose a safety risk for the technician and anyone else in the area.

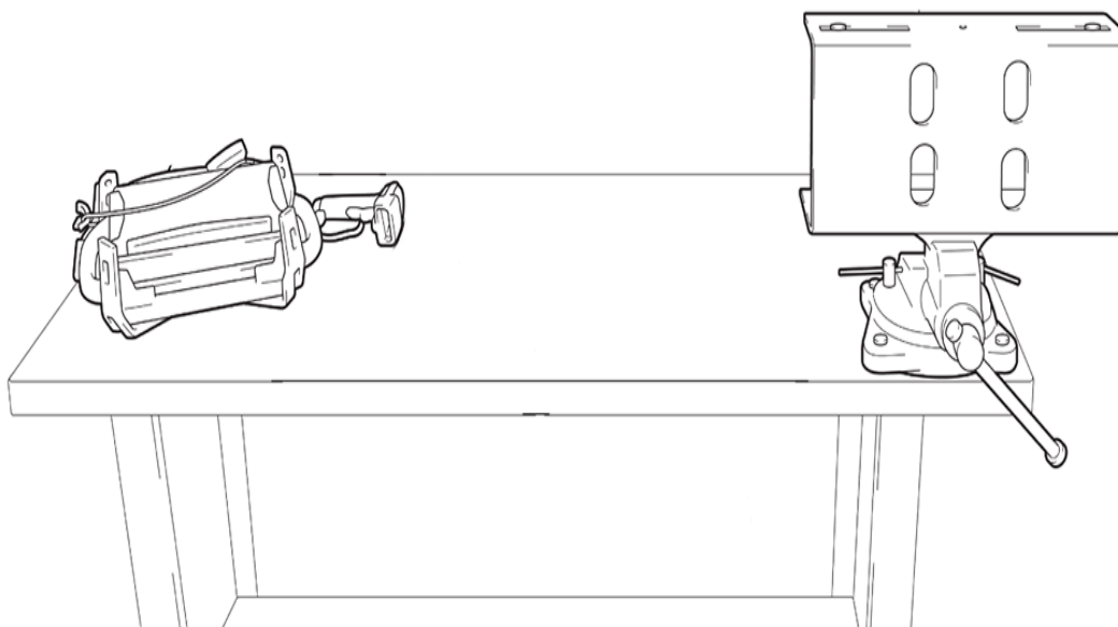
3607819

Danger: To avoid personal injury or death, it is critical to use an airbag module bracket when replacing an inflator module. Carefully read and follow the instructions below:

1. Confirm the bracket assembly is installed securely in the vise.
2. Confirm there are no loose objects or people exposed to the back side of the bracket for safety in the unlikely event of airbag deployment due to improper work procedures. The airbag is NOT being replaced due to an inadvertent deployment concern.
3. Confirm that no objects, tools or people are within 3 feet (1 meter) of the back side of the bracket.
4. Confirm that no objects, tools or people are within 2 feet (0.6 meters) of the sides of the bracket.
5. BEFORE starting work and periodically while working on the airbag module, touch a metallic part of the work bench to discharge static electricity in the body.

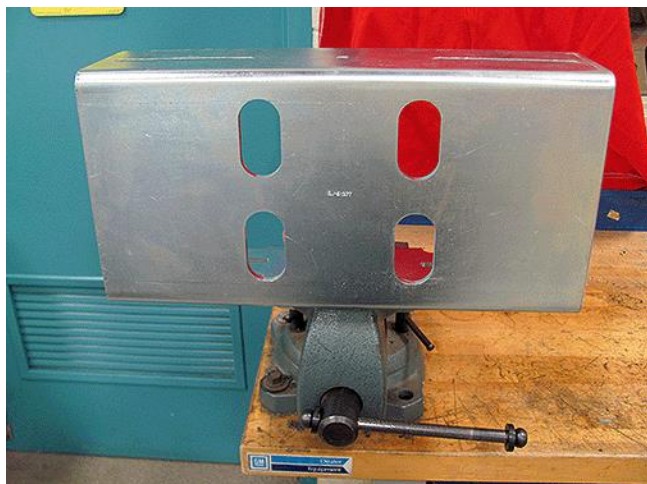
4664047

1. Mount the airbag module bracket securely in a vise.

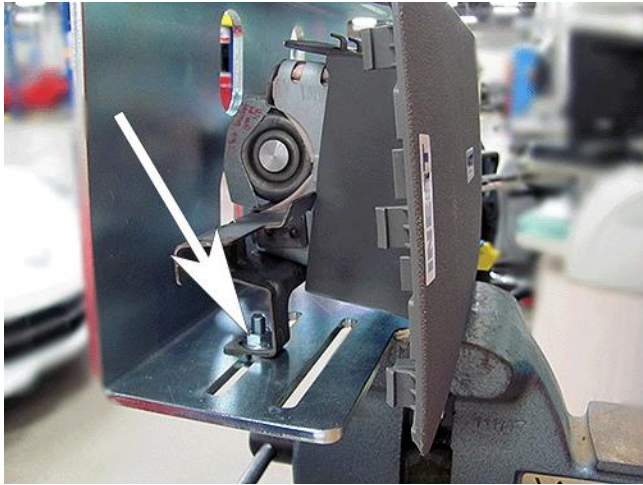
4664048

- Using the hardware kit supplied with the module bracket, loosely mount the airbag assembly to the bracket using two nuts and bolts.

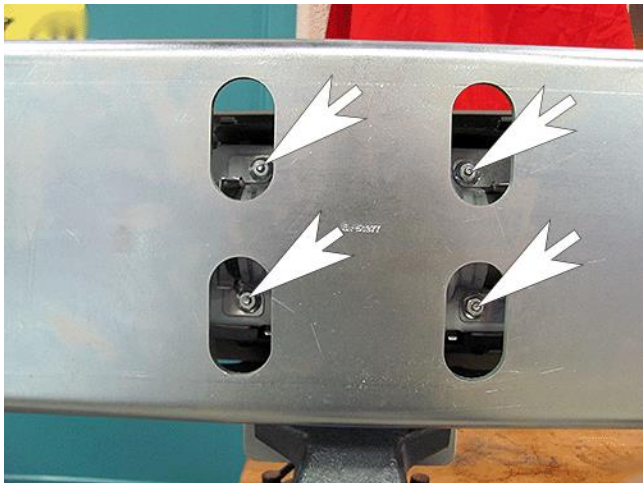
4664049

- Position the airbag assembly so that all four stopper plate nuts can be removed through the access holes.

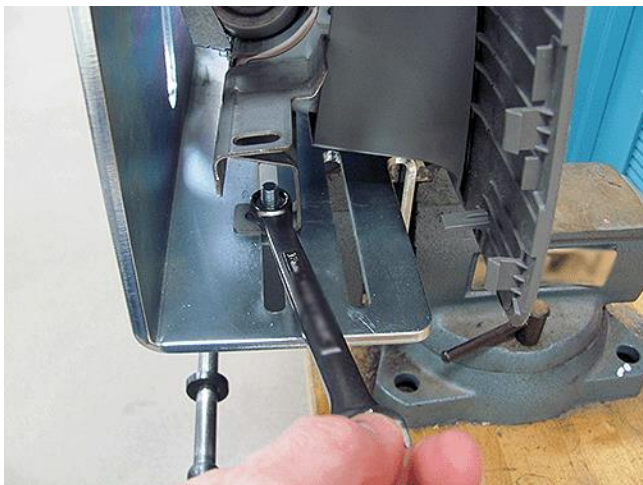
4664050

- Tighten the two fasteners that attach the airbag assembly to the module bracket.
- Confirm the following steps have been completed BEFORE proceeding to the next step:
 - The mounting bracket is secure in the vise.

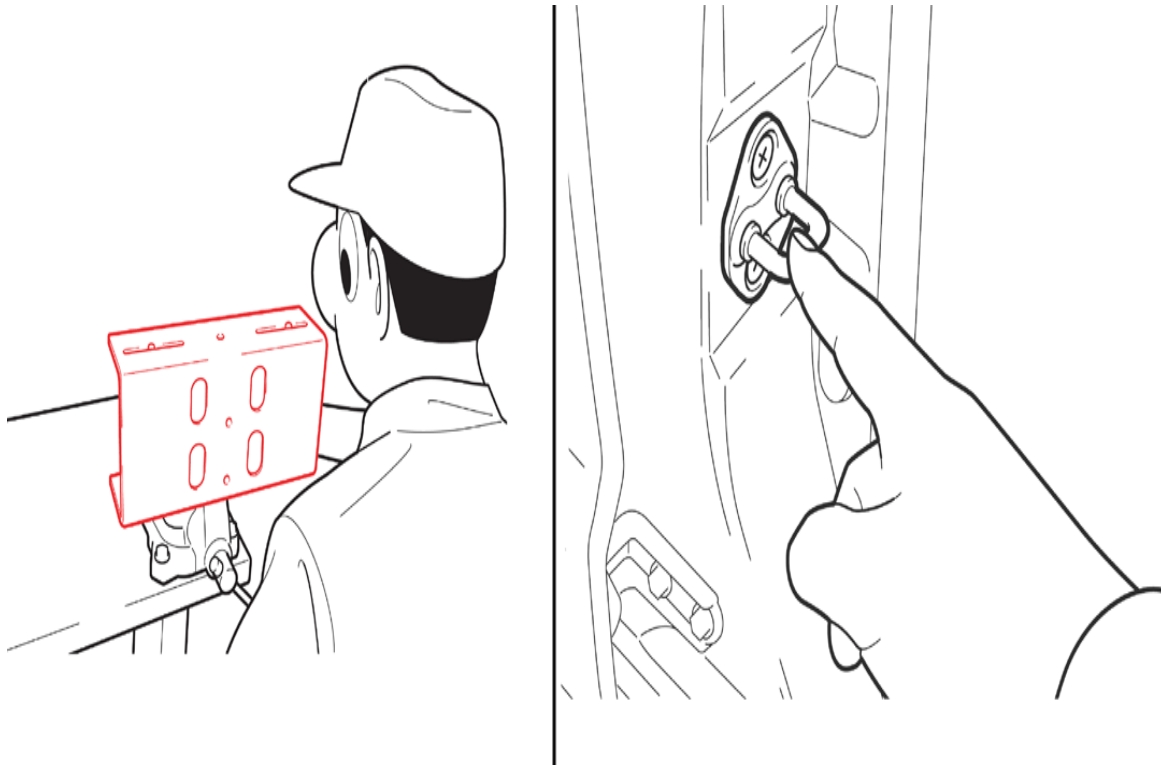
3607909

Danger: To avoid personal injury, *ALWAYS* keep as much of your body as possible in front of the bracket when working on the airbag assembly. Remember to periodically touch a metallic part of the vehicle or work bench to discharge static electricity in the body. **DO NOT** use power tools when performing the inflator removal/reinstallation steps.

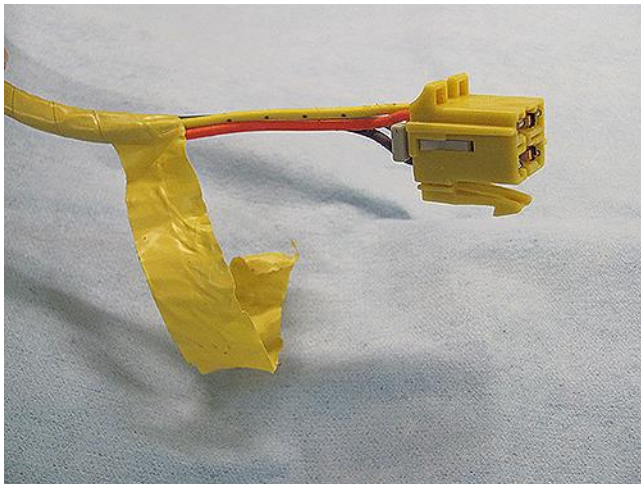
5680363

1. Peel the yellow tape off of the wire harness near the connector. **DO NOT** use a knife or sharp tool to remove the yellow tape.

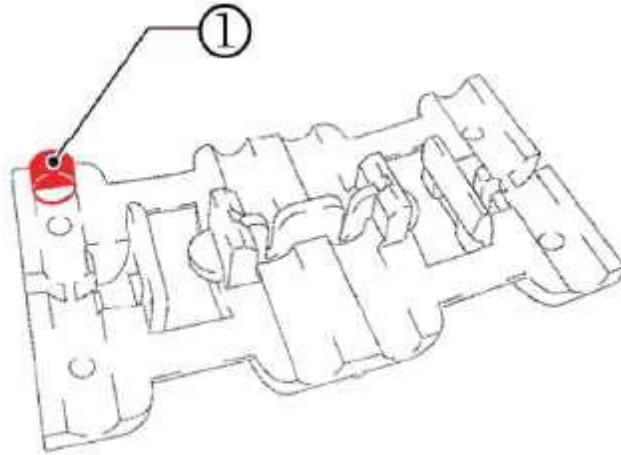
5680722

2. Locate the red plastic “Electro Tap” from the service kit. If required, remove the small tab from the electro tap as shown (1).

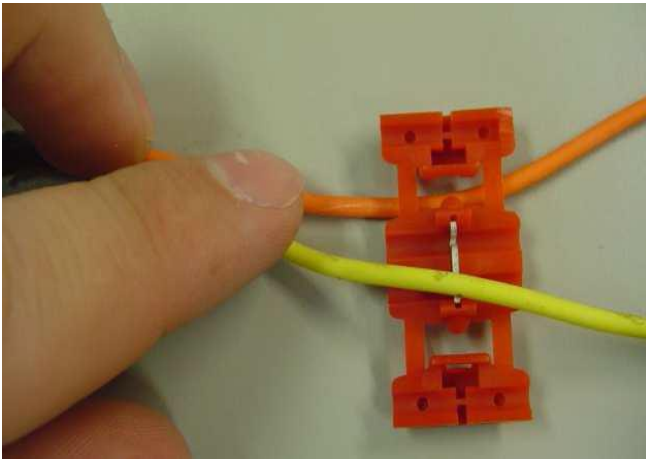
5680660

3. Locate the yellow wire and place it in the electro tap.

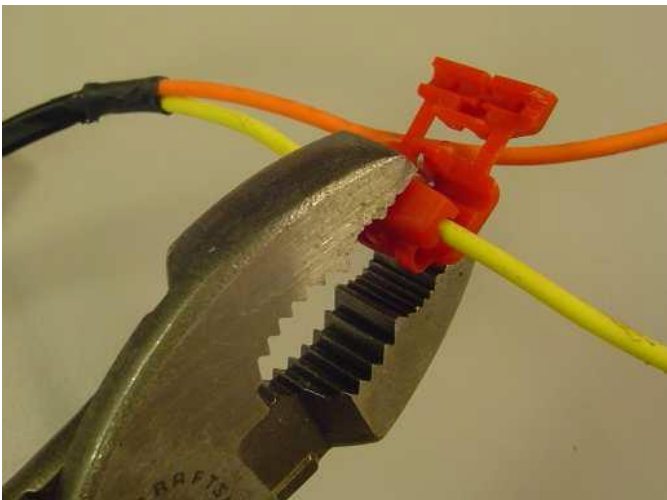
5680663

4. Use pliers to firmly close the electro tap on the **yellow wire** until an audible “click” is heard confirming the installation.

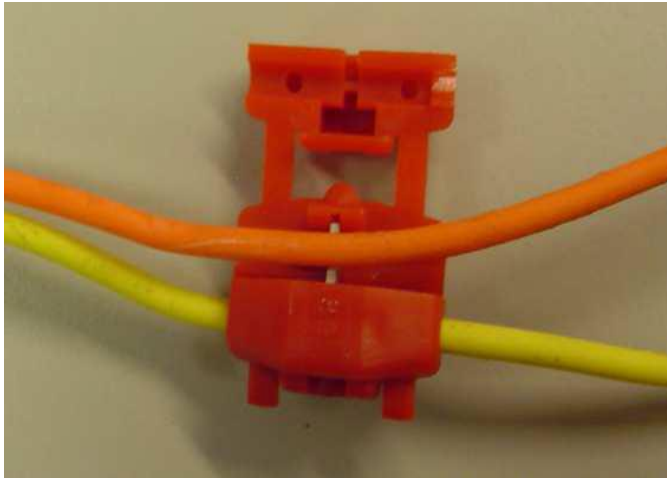
5680664

5. Locate the orange wire and place it in the electro tap.
6. Use pliers to firmly close the electro tap on the **orange wire** until an audible “click” is heard confirming the installation.

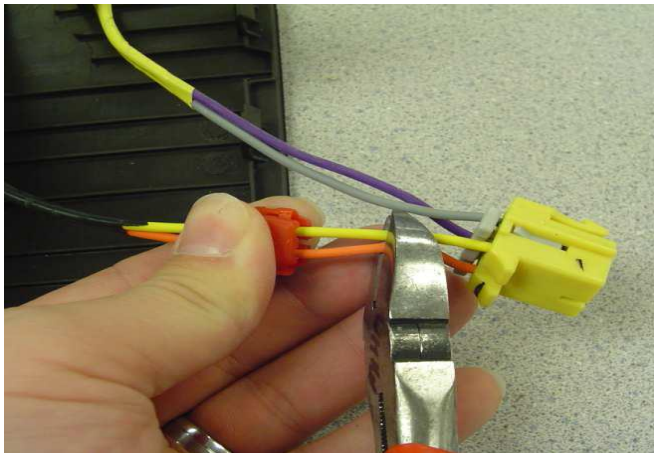
5680666

7. Place wire cutters on the connector side of the electro tap and cut the wires as shown.

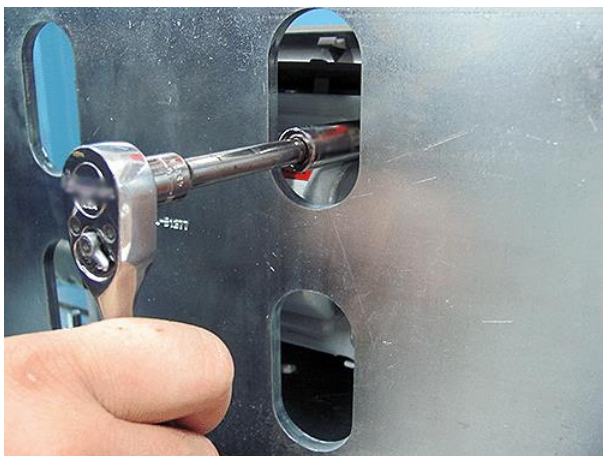
4664052

8. Use the access holes in the bracket to loosen and remove the four self-locking nuts, **do not use power tools to remove the nuts**. Discard the nuts, they will not be reused.

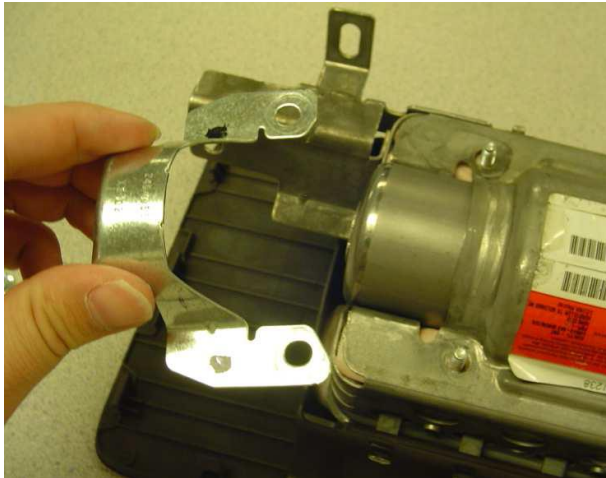
5680667

9. Remove the stopper plate (bracket).

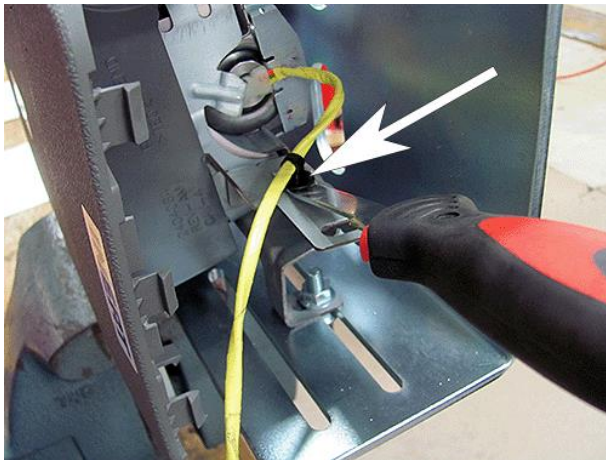
4664053

10. Disengage the wire harness locator from the housing.

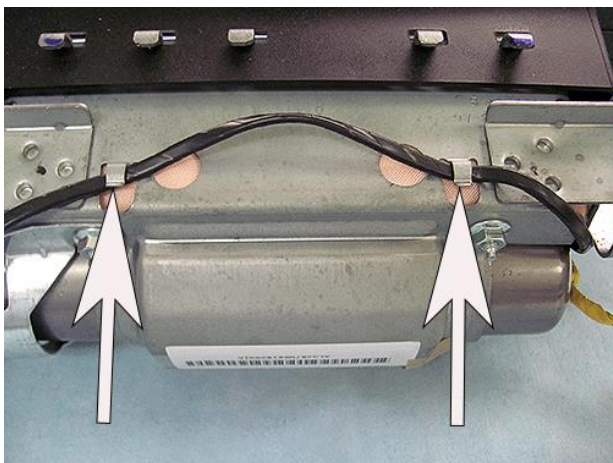
5680364

11. Remove the black taped wire from the housing tabs. The wire harness is now fully disconnected from the housing.

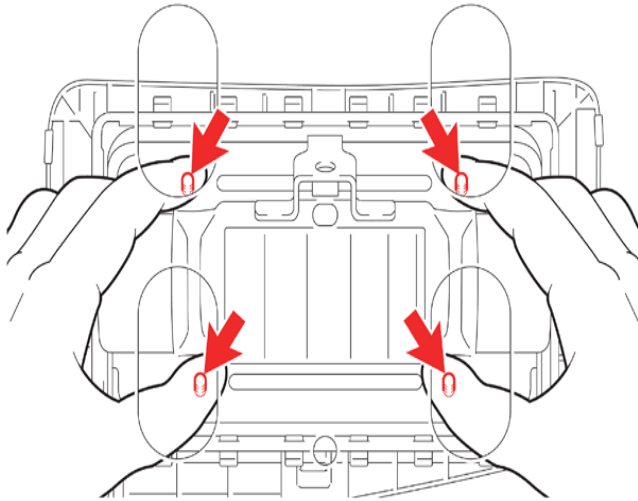
3607857

12. Gently push in the 4 studs to loosen the inflator for removal.

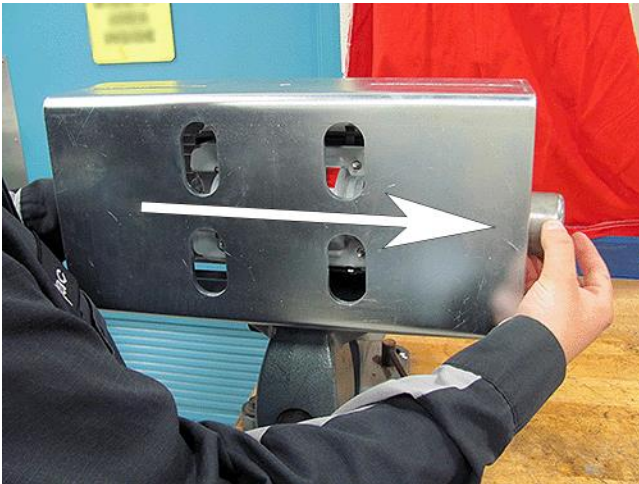
4664060

13. Remove the inflator from the housing, slide the inflator to the right.

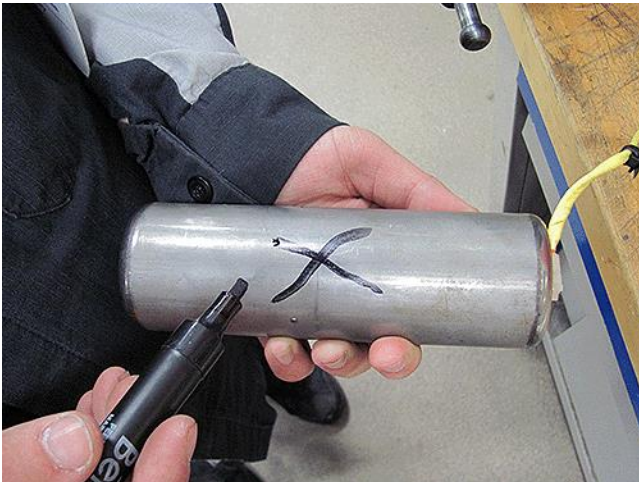
4664063

14. Put a mark on the removed inflator and store it in the provided replacement part box. Refer to the instructions that were included with the new inflator module kit.

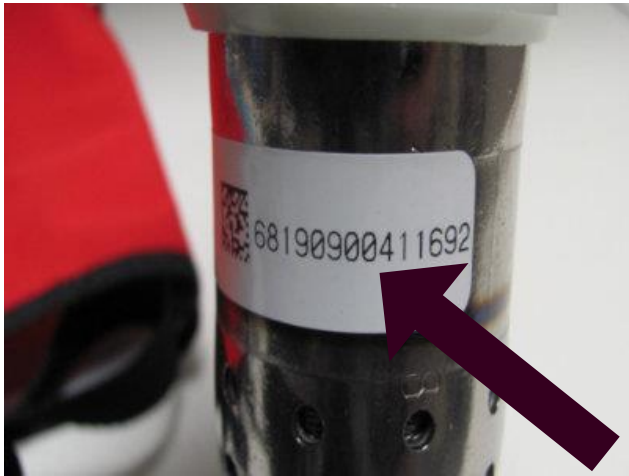
5845761

15. Record the serial number of the new (replacement) inflator from the service kit on the job card.

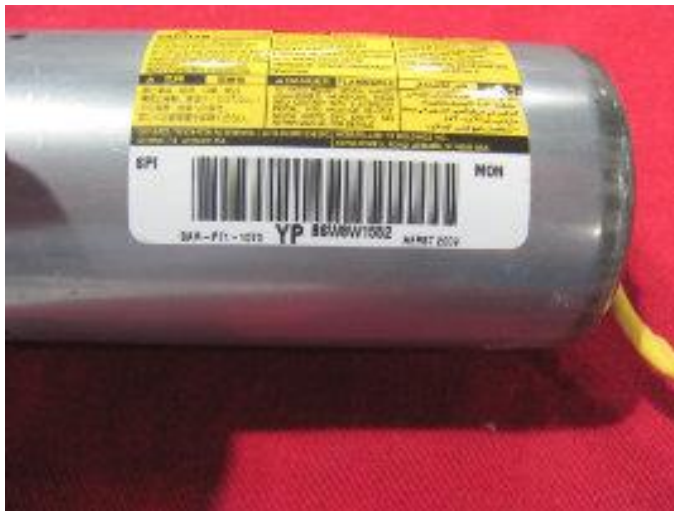
5844318

16. Record the serial number of the used inflator that is being returned on the job card.
17. Inspect the new inflator for the following two conditions:

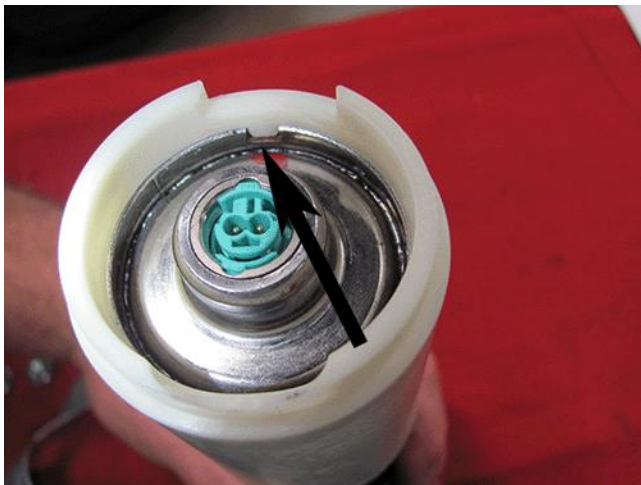
5680402

- Ensure the tab on the white end cap is aligned with the notch in the inflator.

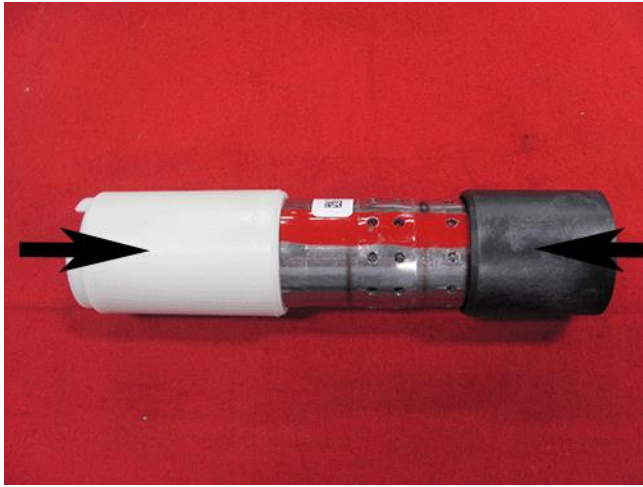
5680403

- Ensure both end caps are fully seated onto the inflator.

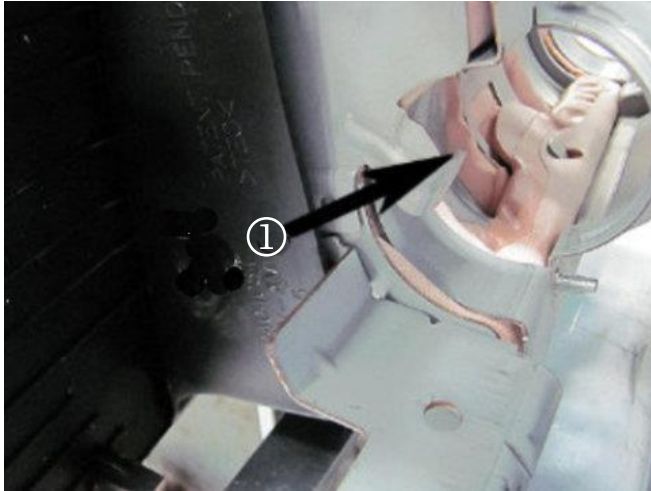
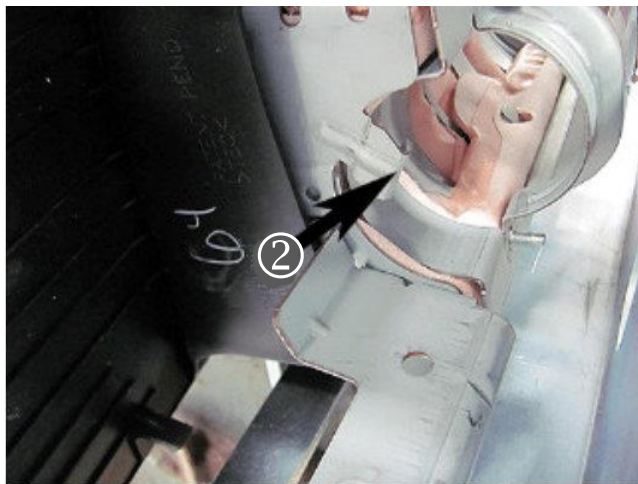
5845806

18. Using a small pair of slip joint pliers, bend the alignment tab on the airbag inward from a 90 Deg. angle (1) to a 45 Deg. angle (2).

Note: Only the small return tab should be bent. Take care to not bend any other portion of the orientation tab.

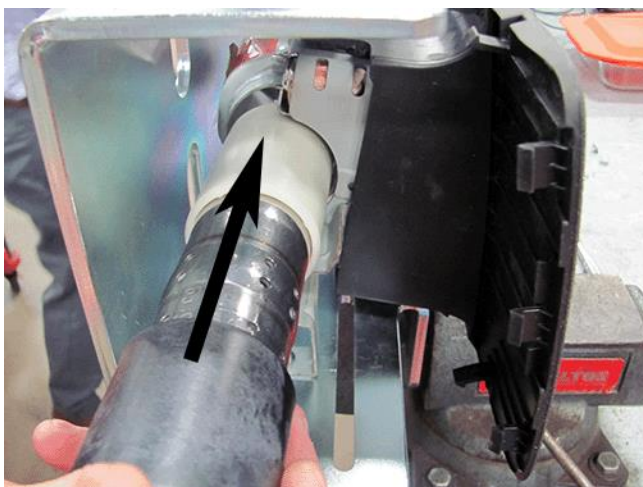
5680409

19. Slide the new inflator into the housing with the white end cap first.

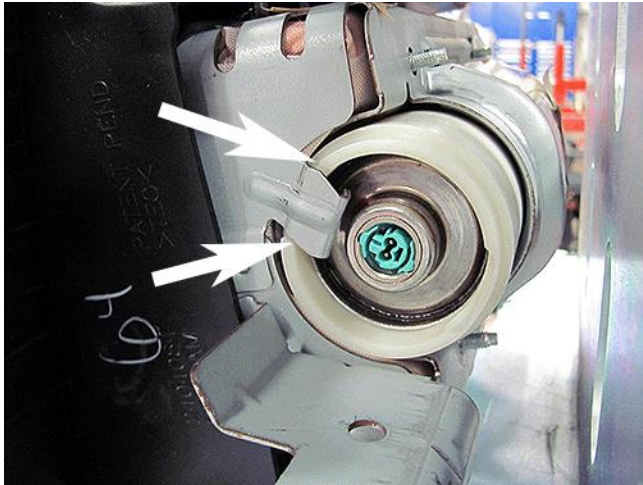
5680411

20. Rotate the inflator until the notch in the white end cap aligns with the alignment tab.

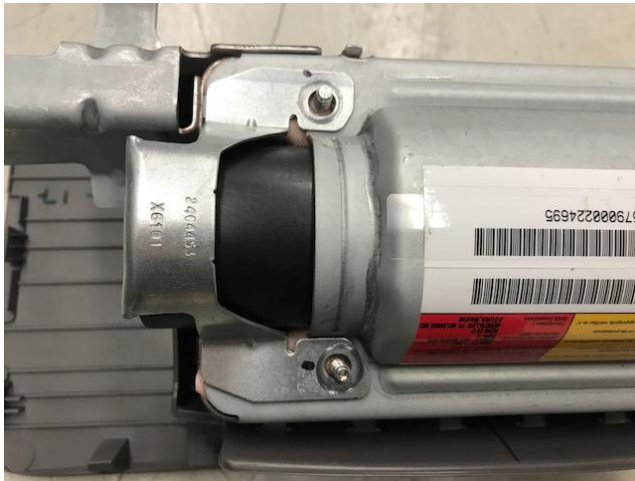
5680668

21. Place the stopper plate onto the studs as shown.

22. Loosely hand start the 4 new nuts on the studs.

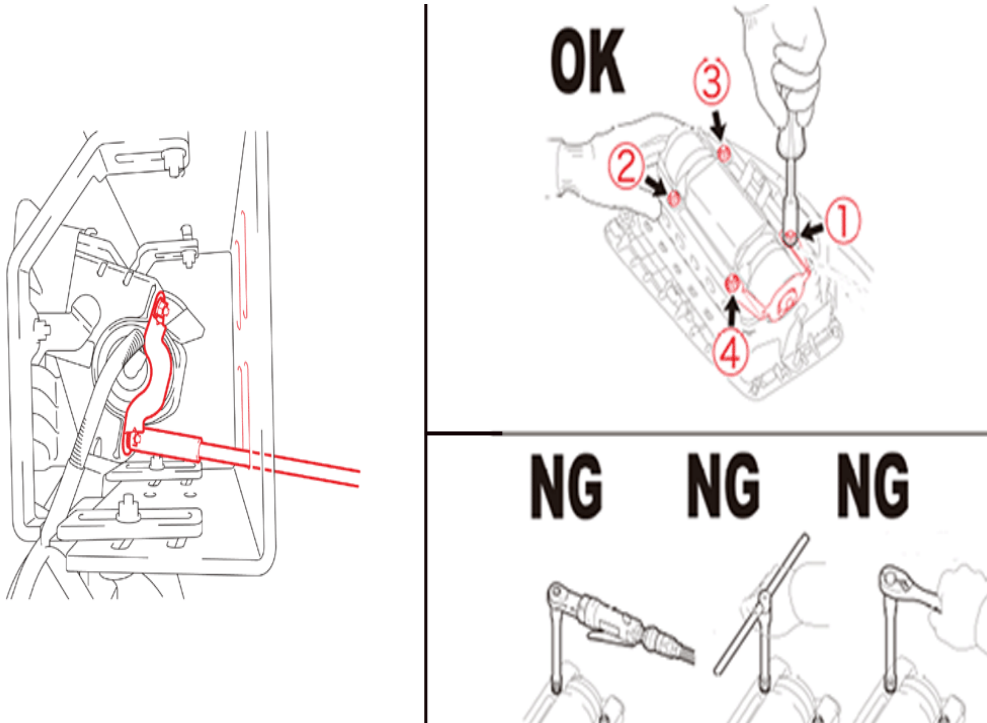
3610416

23. Tighten four (4) *NEW* plate nuts evenly in several increments in the order shown in the illustration using a 10-mm socket driver while pushing on the inflator against the alignment tab.

Note: The inflator should be netted out against the alignment tab prior to tightening the nuts. You will encounter some resistance during tightening because these nuts are self-locking nuts. **Torque Specification: 6.5 Nm (57 in-lb).**

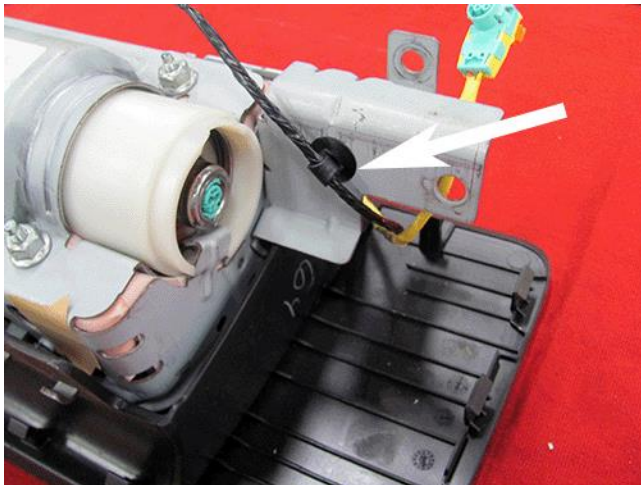
5680514

24. Install the wire harness locator to the housing.

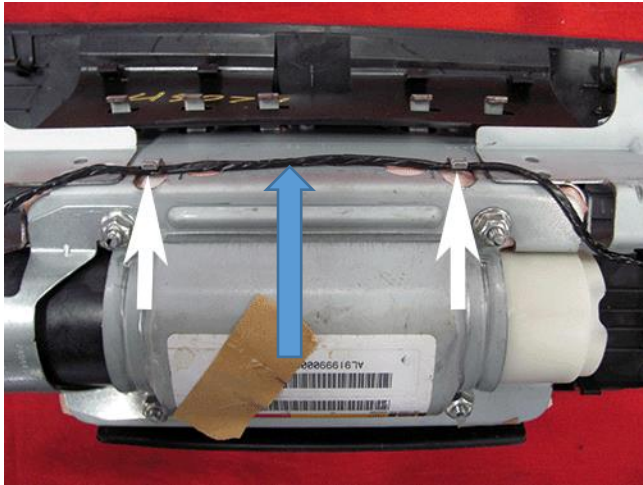
5845760

25. Press the black taped wire into the housing tabs as shown. Tape the wire harness to the metal housing in between the tabs (in the area of the blue arrow).

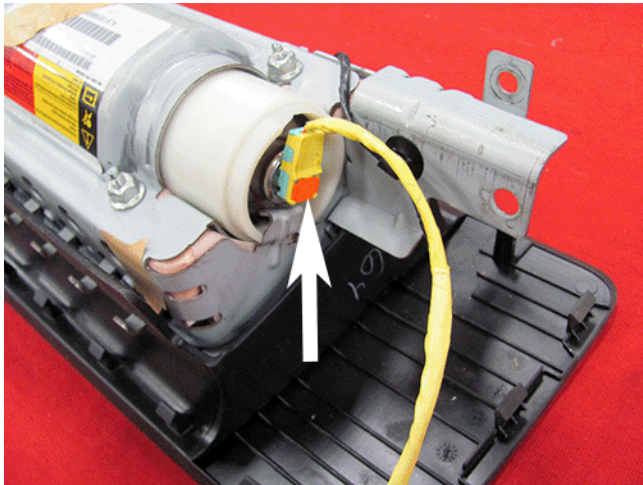
5680520

26. Install the yellow taped wire into the inflator (white cap end). Ensure the CPA is engaged.

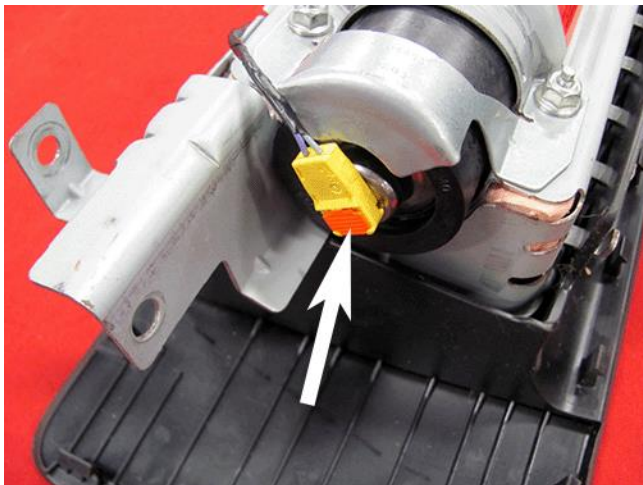
5680522

27. Install the black taped wire into the inflator (black cap end). Ensure the CPA is engaged.

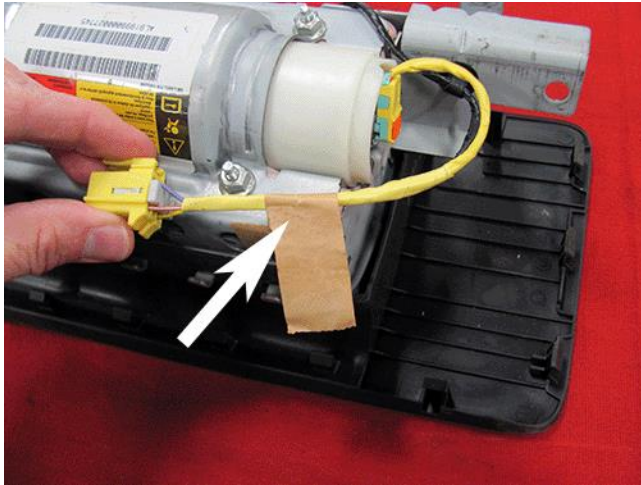
5680523

28. Apply a masking tape strip to the wire harness in the location shown below.

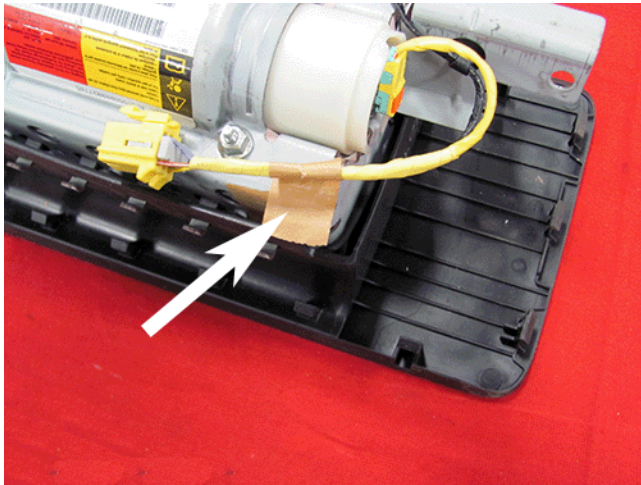
5680525

29. Adhere the tape strip and wire harness to the metal housing as shown.
30. Confirm the wire harness is in the correct orientation after taping.
31. Remove the airbag assembly from the bracket by removing the two bolts and the airbag assembly.
32. Reinstall the instrument panel passenger airbag assembly. Refer to *Airbag Instrument Panel Module Replacement* in SI.

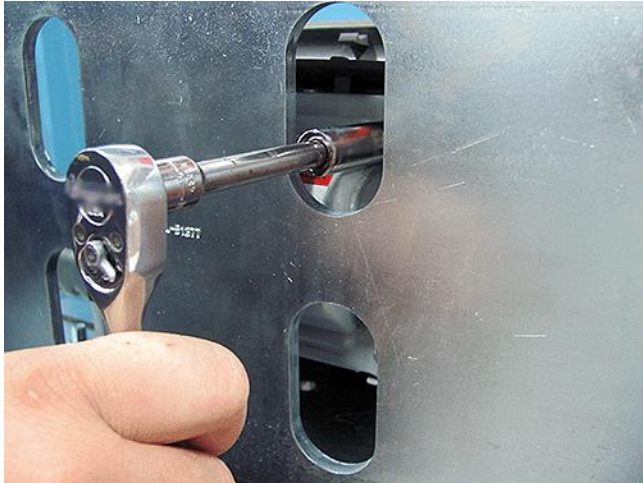
4664052

1. Use the access holes in the bracket to loosen and remove the four self-locking nuts, **do not use power tools to remove the nuts**. Discard the nuts, they will not be reused.

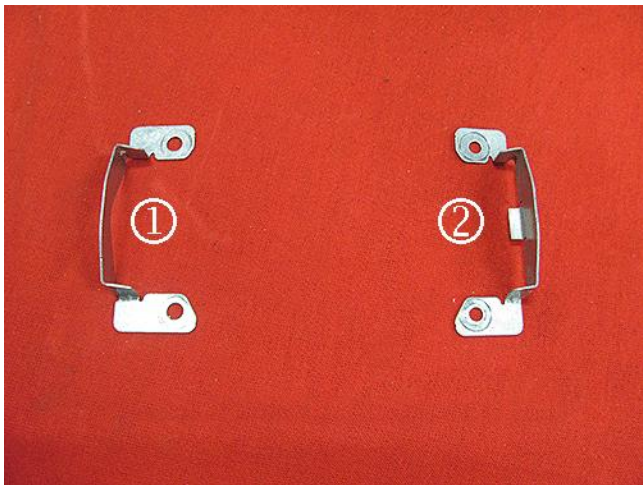
4664065

2. Remove the two stopper plates (1 and 2). Discard the stopper plates, they will not be reused.

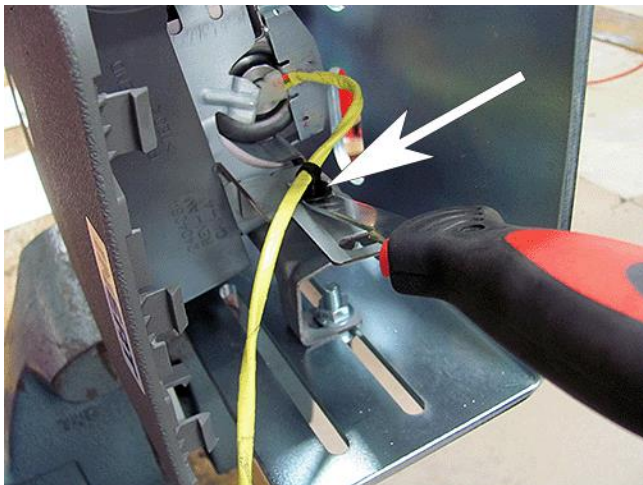
4664053

3. Disengage the wire harness locator from the housing.

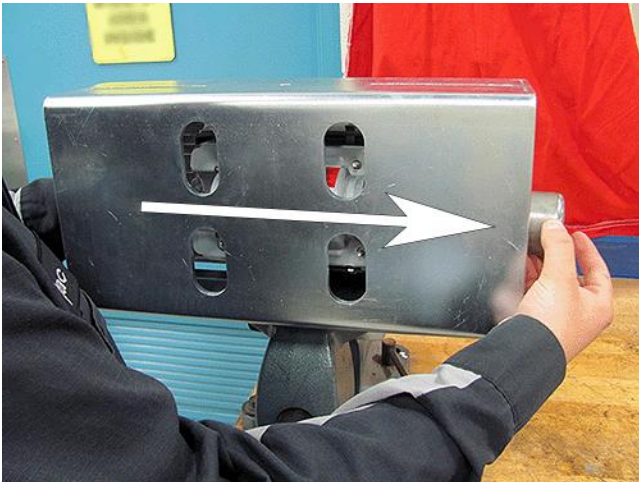
4664060

5. Remove the inflator from the housing, slide the inflator away from the harness side.

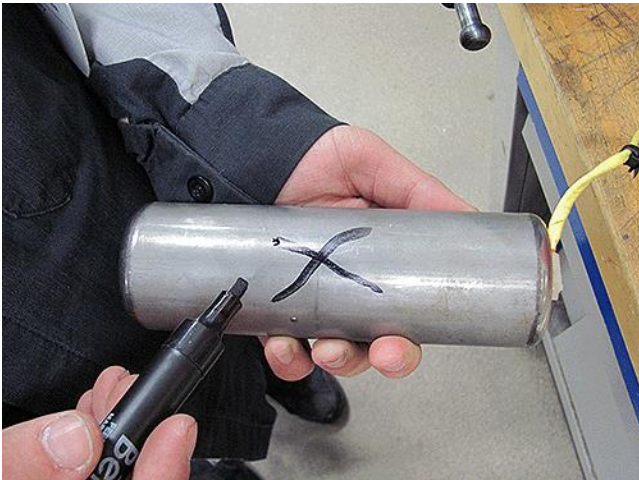
4664063

6. Put a mark on the removed inflator and store it in the replacement part box.

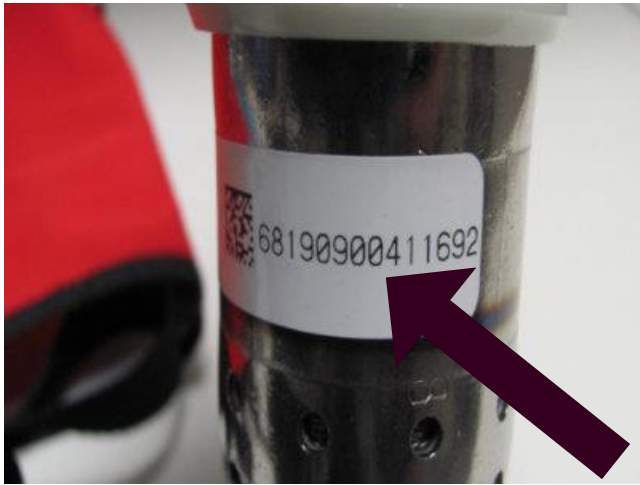
5845761

7. Record the serial number of the new (replacement) inflator from the service kit on the job card.

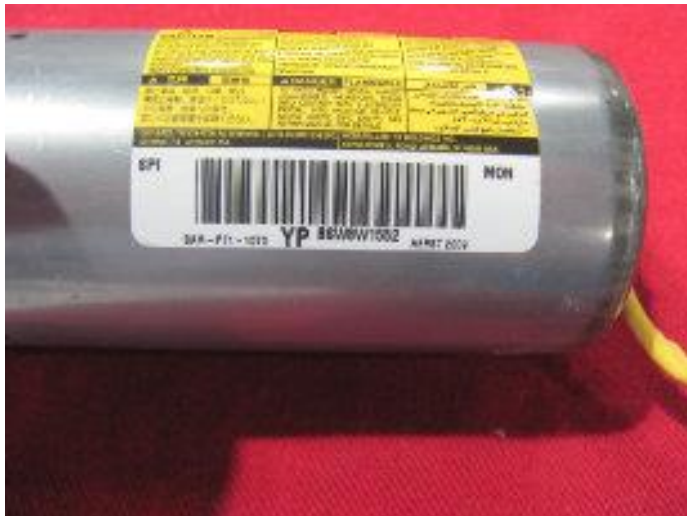
5844318

8. Record the serial number of the used inflator that is being returned on the job card.
9. Inspect the new inflator for the following two conditions:

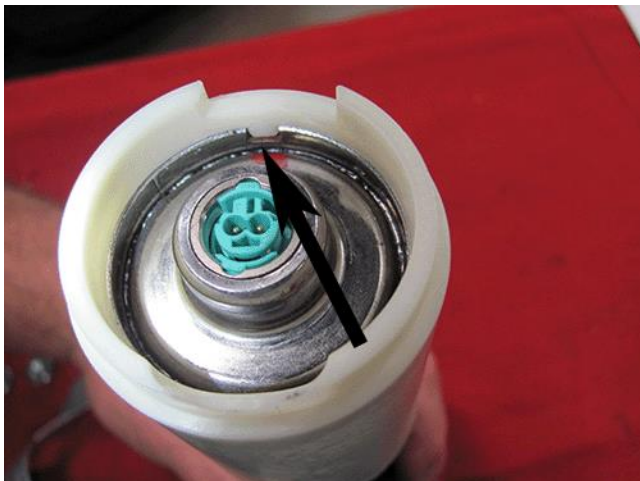
5680402

- Ensure the tab on the white end cap is aligned with the notch in the inflator.

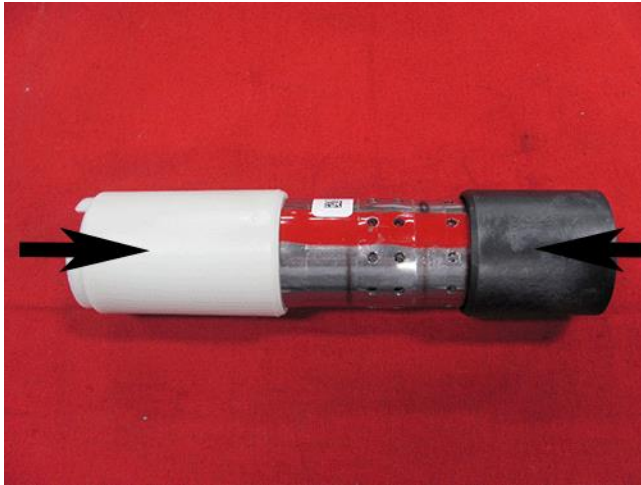
5680403

- Ensure both end caps are fully seated onto the inflator.

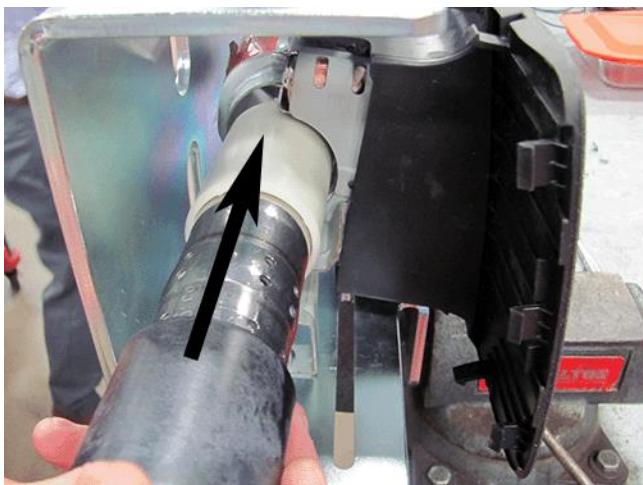
5680409

11. Carefully slide the new inflator into the airbag assembly. Ensure the inflator is installed with the harness (white end cap) end first.

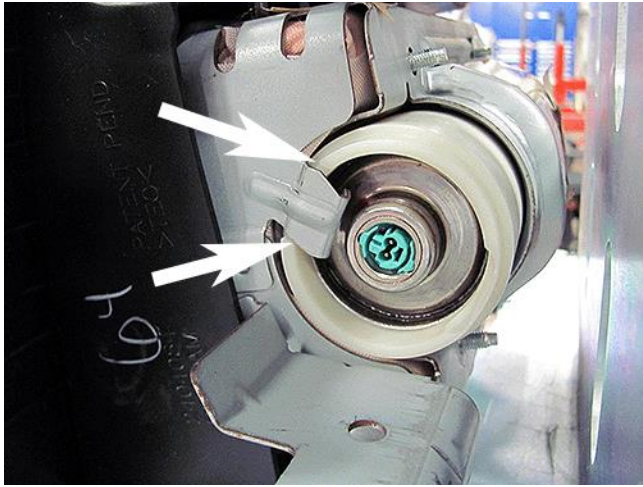
5680411

12. Rotate the inflator until the notch in the white end cap aligns with the alignment tab.

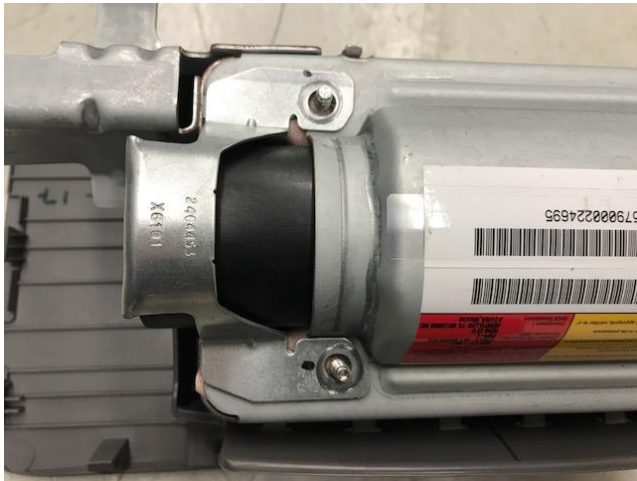
5680668

13. Place the new stopper plate (bracket) onto the studs as shown.

14. Loosely hand start the 4 new nuts onto the studs.

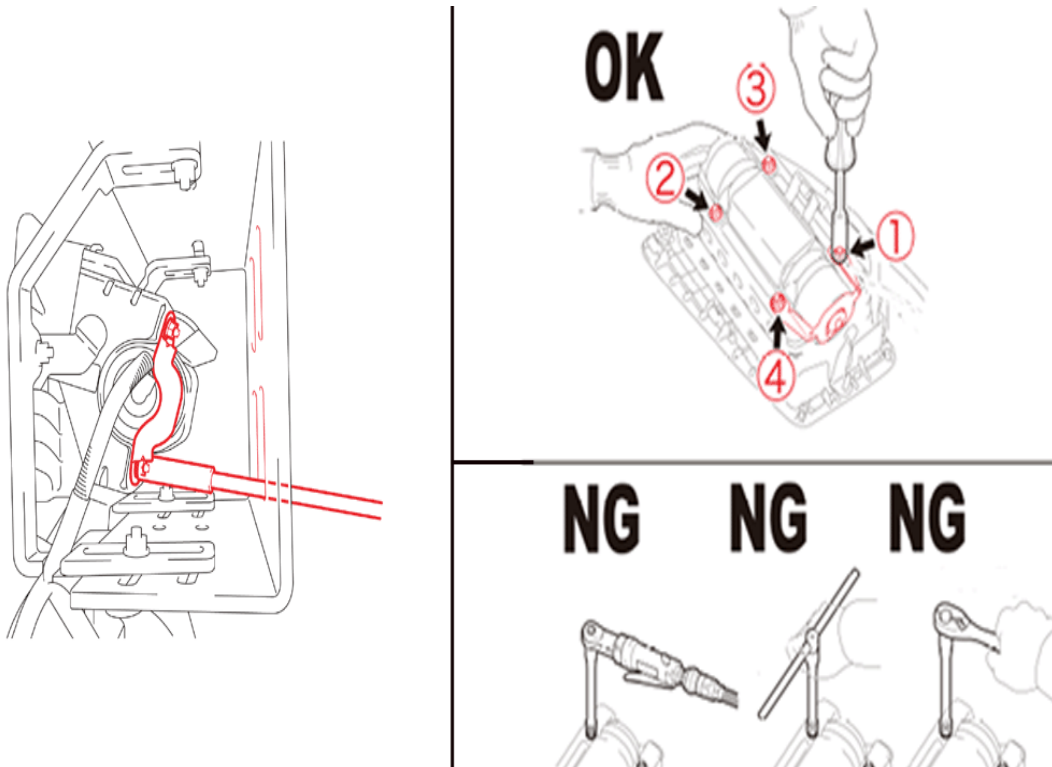
3610416

15. Tighten four (4) **NEW** plate nuts evenly in several increments in the order shown in the illustration using a 10-mm socket driver while pushing the inflator. You will encounter some resistance during tightening because these nuts are self-locking nuts. **Torque Specification: 6.5 Nm (57 in-lb).**

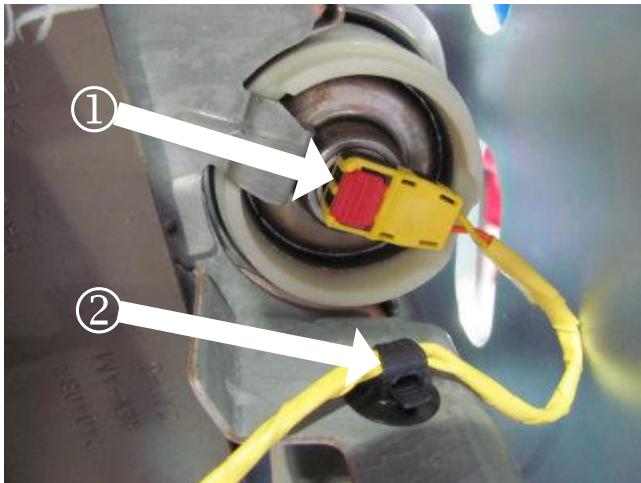
5845807

16. Connect the new yellow wiring harness to the airbag inflator, fully engage the CPA (1).
17. Install the wire harness locator to the housing (2).
18. Remove the airbag assembly from the bracket by removing the two bolts and the airbag assembly.
19. Reinstall the instrument panel passenger airbag assembly. Refer to *Airbag Instrument Panel Module Replacement* in SI.
