REPAIR PROCEDURE
Recall Campaign 4621B

Safety Recall 4621B – 2020-2021 CX-30 Power Liftgate May Partially Lower Unexpectedly

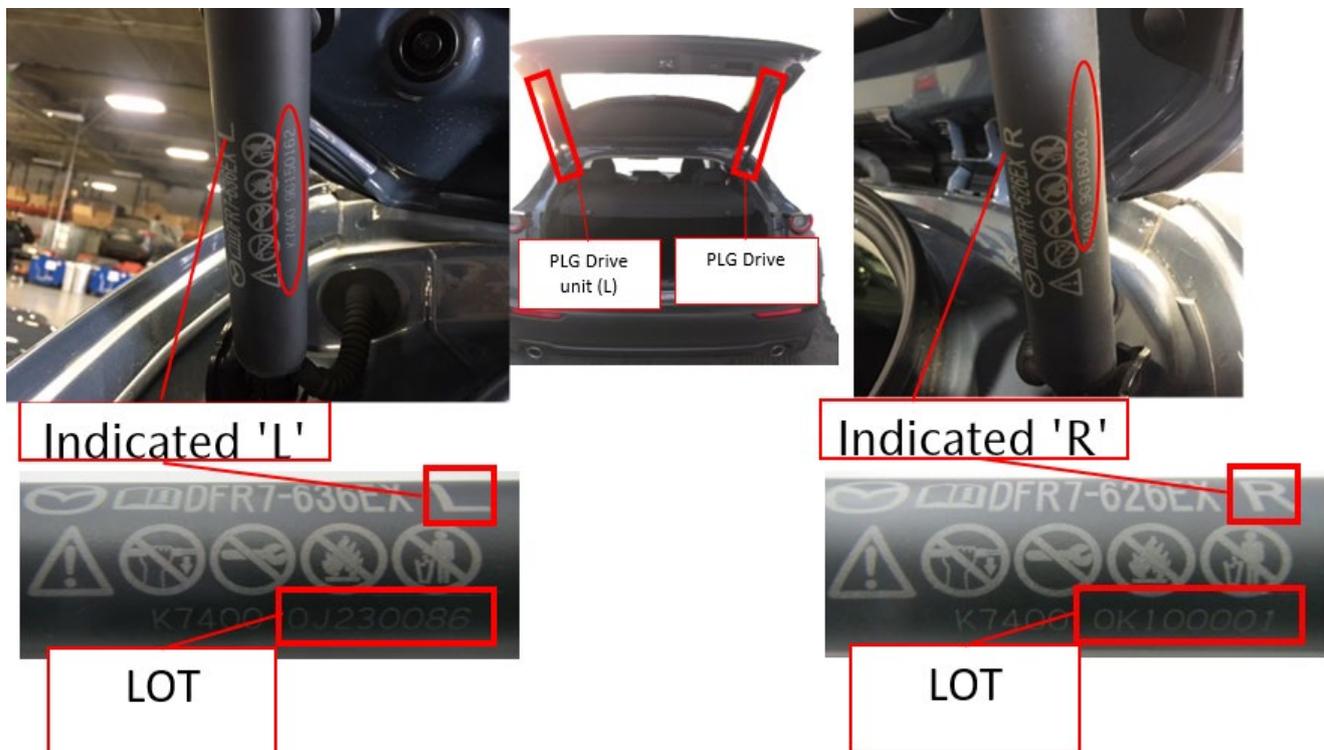
- A. Verify the LOT No. of the PLG drive units**
 - B. Replace the affected PLG drive unit**
1. Open the Liftgate and write down the 8 Digit Lot Number
 2. There is a number (9 or 0 indicates year) followed by a letter (Indicates month) and 6 numbers. Input all 8 digits into the Lot Number calculator or an error will occur. **Note:** If there is no number before the letter, input 9 (2019 production). Example : G050032 →9G050032
 3. If the result is Not Affected replacement is not required. Reprogram power liftgate module with supplied SSPC5/4621B MDRT. This will be 96% of the vehicles.
 4. **IF THE RESULT IS "AFFECTED", STOP AND PARK THE VEHICLE NO FURTHER REPAIRS CAN BE DONE UNTIL PARTS ARE AVAILABLE. CAR CANNOT BE SOLD UNTIL REPAIRED.**

Location	LOT	Result	Location	LOT	Result
	(8-digit half-width input)			(8-digit half-width input)	
L	9f230086	NOT AFFECTED	R	0k100001	NOT AFFECTED

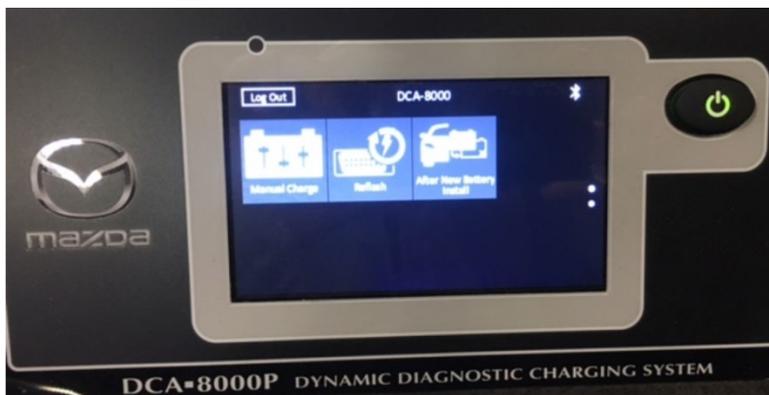
- a. During reprogramming, connect the DCA8000 battery charger using the Reflash mode

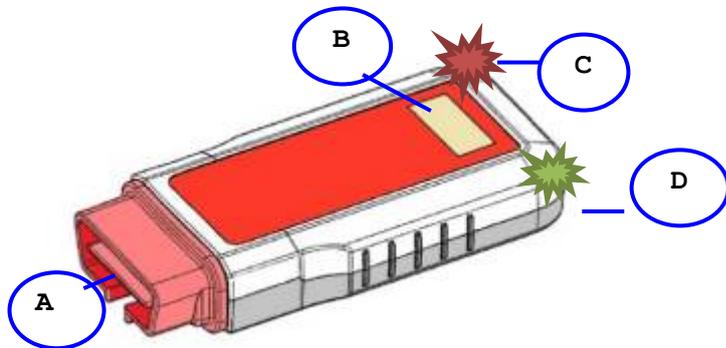
A	OBDII connector
B	Display
C	LED light (Red)
D	LED light (Green or Blue)

LED lights show the configuration status.

*There are two LED types for MDRT.

1. Green & Red (Serial number up to 02217)
2. Blue & Red (Serial number after 02218)

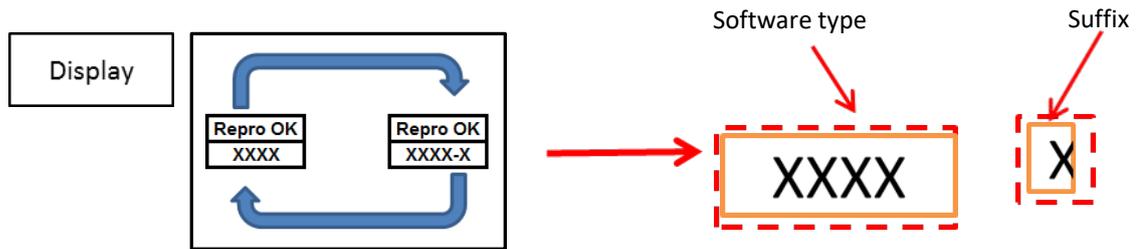
Confirm that the display shows a message after completing reprogramming.

Lower message on the display indicates each of the soft type & suffix

If a suffix becomes higher, Reprogramming is completed.

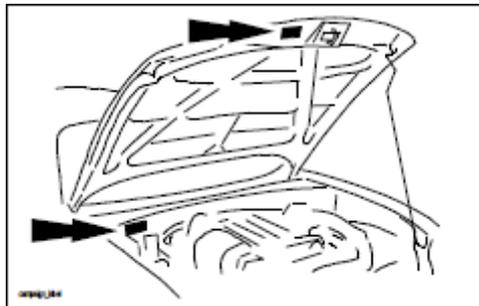
2. Affix it to the hood or bulkhead as shown:
