RECALL 21V287 / 2021-244 REMEDY INSTRUCTIONS

| | Make(s): CATALINA Model(s): BCAT192FQS Model Year(s): 2021 | Repair Code: RC-003-22-00-004053 Allotted Time: .50 HRS. Inspection Code: N/A Allotted Time: N/A |
| | Concern: An incorrect wire gauge was routed from the battery into a 100AMP breaker then to a 1000W Inverter. | Photo(s) Required: YES Prior Authorization Required: YES Part(s) Kit Number: F100265185 Part(s) Return: NO |

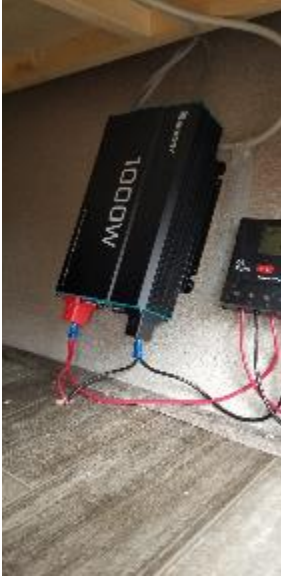
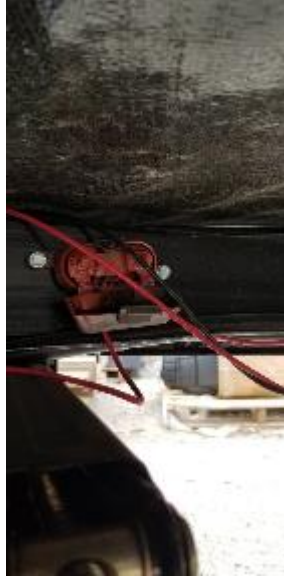
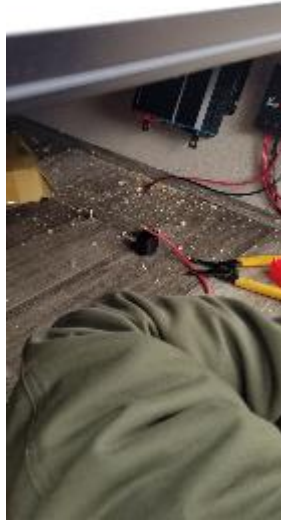
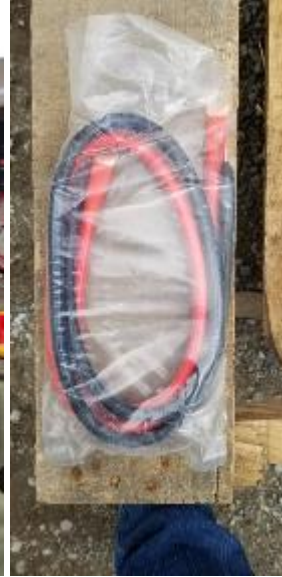
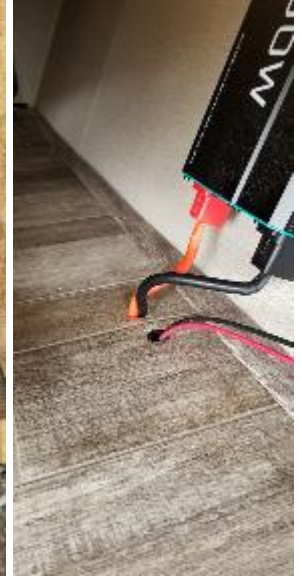
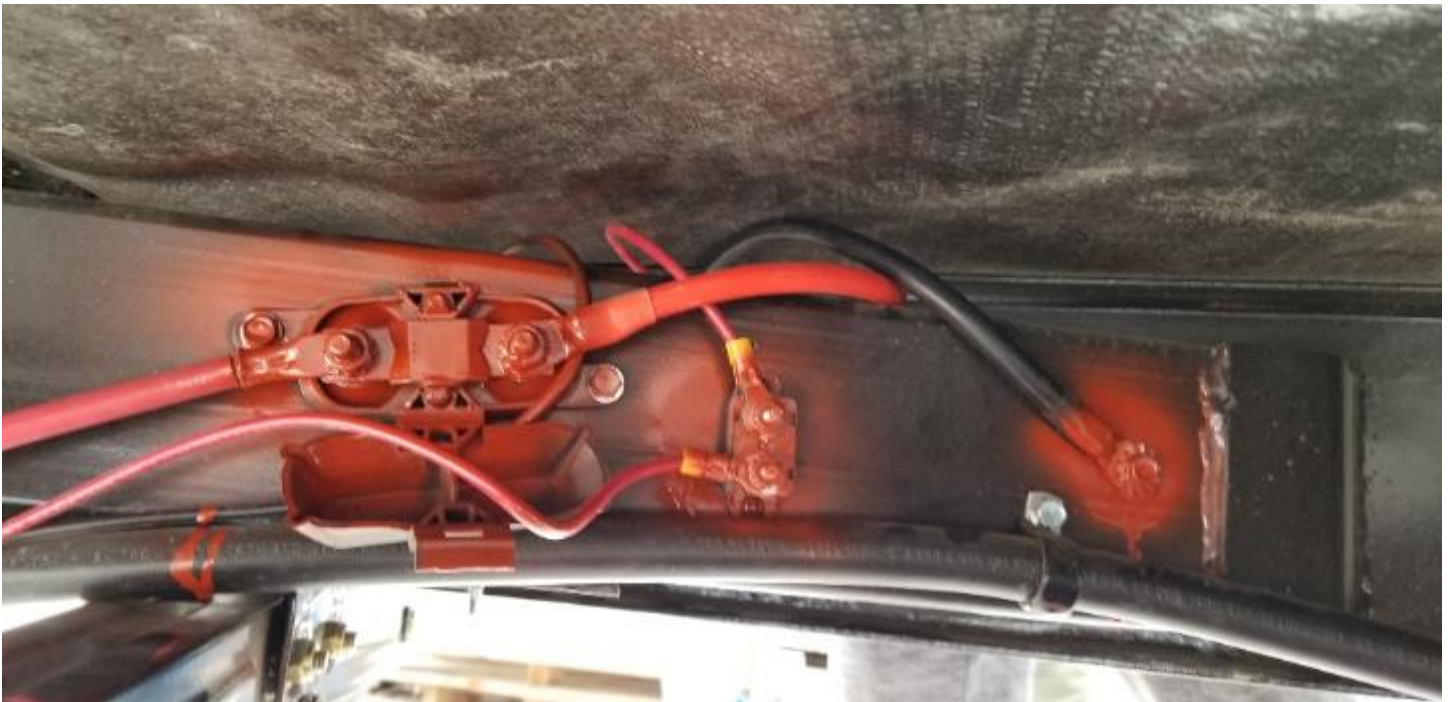
STEP 1: ACCESS THE INVERTER BY OPENING THE FRONT PASSENGER SIDE BAGGAGE DOOR;

STEP 2: LOCATE THE HOLE IN THE FLOOR THE SOLAR PANEL WIRES USE, MEASURE TOWARDS THE CENTER OF THE UNIT 2" AND MAKE A MARK;

STEP 3: ON THE MARK MADE, USE A 3/4" BUTTERFLY BIT AND DRILL A HOLE THROUGH THE FLOOR AND UNDERBELLY;

STEP 4: DISCONNECT THE RED AND BLACK WIRES FROM THE INVERTER AND SOLAR CONTROLLER;

STEP 5: DISCONNECT THE RED WIRE FROM THE 100AMP BREAKER THAT IS FROM THE INVERTER AND DISCARD;

STEP 6: DISCONNECT THE RED WIRE FROM THE 100AMP BREAKER THAT ROUTS TO THE BATTERY AND DISCARD;

STEP 7: DISCONNECT THE BLACK GROUND WIRE FROM THE INVERTER LOCATION ALL THE WAY TO THE BATTERY AND DISCARD;
