GROUP	NUMBER		
RECALL	21-01-054H		
DATE	MODEL		
AUGUST, 2021	ELANTRA (AD) KONA (OS) VELOSTER (JS)

NU 2.0L ATKINSON ENGINE INSPECTION (RECALL 203)

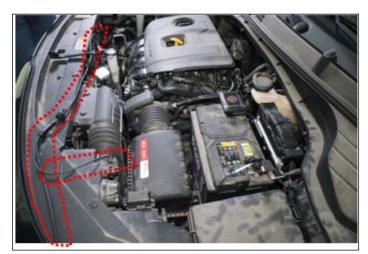
- 1. Prepare the engine vibration inspection tool and GDS-M.
 - Inspect the vehicle in an area where the ambient noise and vibration levels are minimal.
 - Using the last GDS-M software update, the VCI must be updated with the latest firmware also.
- Connect the knock sensor connector (A) of the engine vibration inspection tool to the engine knock sensor (D).
- 3. Connect the ground clamp (B) to the battery '-' terminal.
 - Position the vibration inspection tool harness to avoid interference and vibration from the engine components which may affect the inspection result.
 - > Route the wiring harness around the engine compartment as shown below.

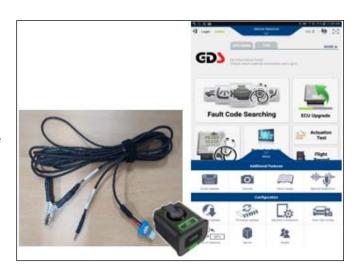
4. Connect the signal jack (C) to the GDS-M stereo input port.

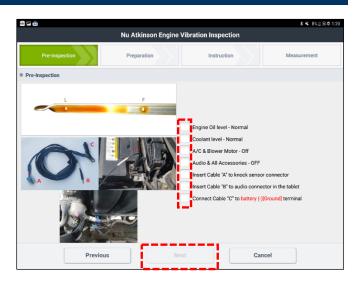
- To obtain accurate inspection results, verify and acknowledge the check items that must be carried out before the inspection test.
 - Check all the precondition items on the list. (The actual monitoring of the Engine Coolant Temperature will be performed at the following screen.)
 - After all the precondition items have been acknowledged with checkboxes, press the 'Next' button to proceed.

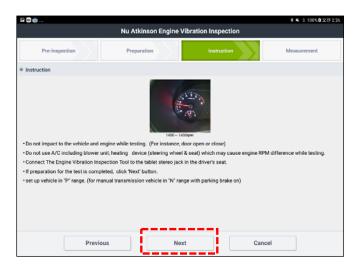
- If all conditions are satisfied, press the "Next" button to proceed.
- 11. After reviewing the vibration inspection process explanation and precautions, press the "Next" button to proceed.

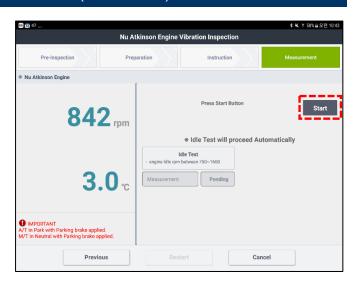
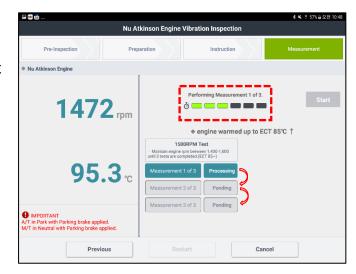
- 13. Press the accelerator pedal to maintain an engine rpm target of 1500±100 rpm.
 - Maintain a steady engine speed between 1400-1600 rpm for five seconds.

- When the engine speed is within the target rpm range, the green status bars will continue to illuminate for each measurement cycle.
- ➤ Repeat the 1500±100 rpm engine speed test to complete the 3 measurement cycles.

- 12. In this screen, the program will perform an internal diagnosis after the "Start" button is pressed while the engine is at **idle speed** and the KS signal is acquired for five seconds.
 - A brief warm up of the engine (by slightly raising the engine speed several times) may be required if the coolant temperature is not warm enough to be tested.

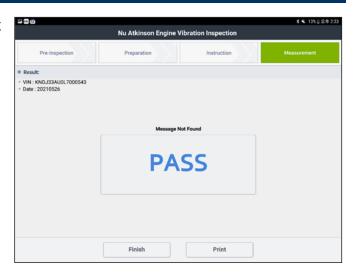
- 14. When the inspection test is completed, the result will be displayed. Save a screenshot of the results screen for records.
 - If the test result is PASS, the measured engine vibration level is determined to be normal. The engine inspection is complete.

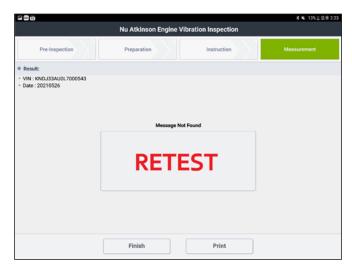
- ➢ If the test result is NO PASS, the measured engine vibration level is determined to be abnormal.
 - The PA and Engine Diagnosis Worksheet will be automatically created and saved in DRAFT.
 - 2) Complete the information in the Engine Diagnosis Worksheet and apply the Service Manager's signature before submitting the PA.
 - 3) Place the customer in a SRC and await further direction on the remedy.
- If the test result is RETEST, there is an error detected in measuring the vibration value. Check the inspection tool connections and perform the inspection test again.

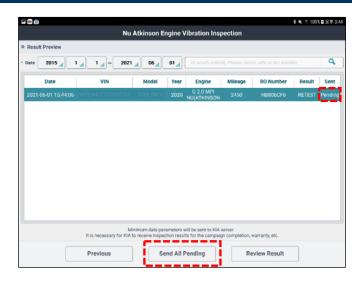
- 15. When the inspection is completed, the inspection results are automatically sent to the server.
 - KS measured value, inspection time, dealer code, VIN, vehicle information, mileage, and sensor recording file will be sent.
 - Be sure to check the status in the Results Preview screen and select "Send All Pending" if the test results have not been sent from the tablet to the server.

The basic inspection history and the results sent to the server are available to review through by selecting the "Review Result" button from the Results Preview screen.
