Product Safety Recall

N212338110 Airbag Light May Not Indicate Malfunction

Release Date: June 2021

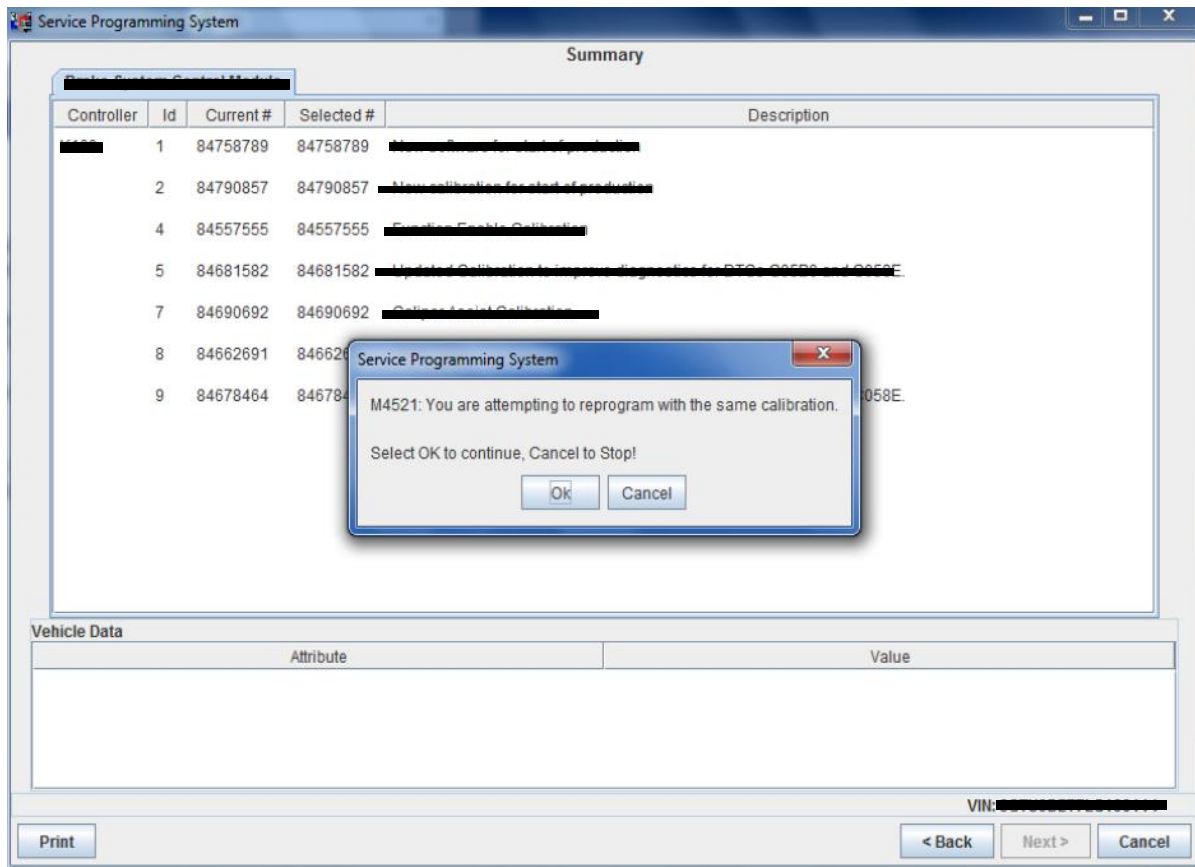
5431207

Important: Techline Connect and TIS2WEB screens shown above.

Important: If the same calibration/software warning is noted on the TLC or SPS Summary screen, select OK and follow screen instructions. After a successful programming event, the WCC is located in the Service Programming System dialogue box of the SPS Summary screen. No further action is required. Refer to the Warranty section of the bulletin.

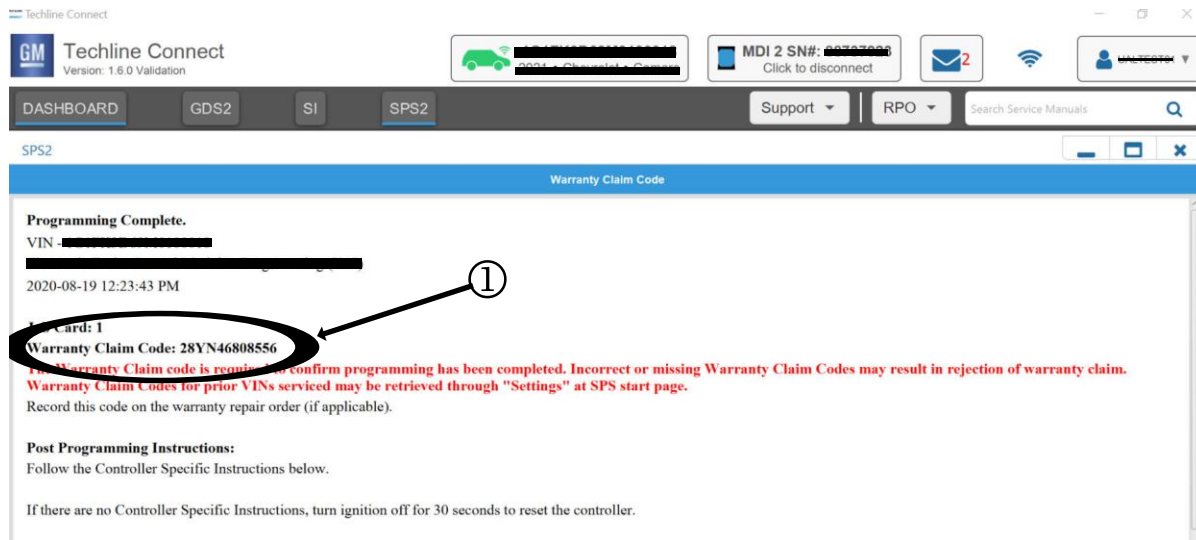
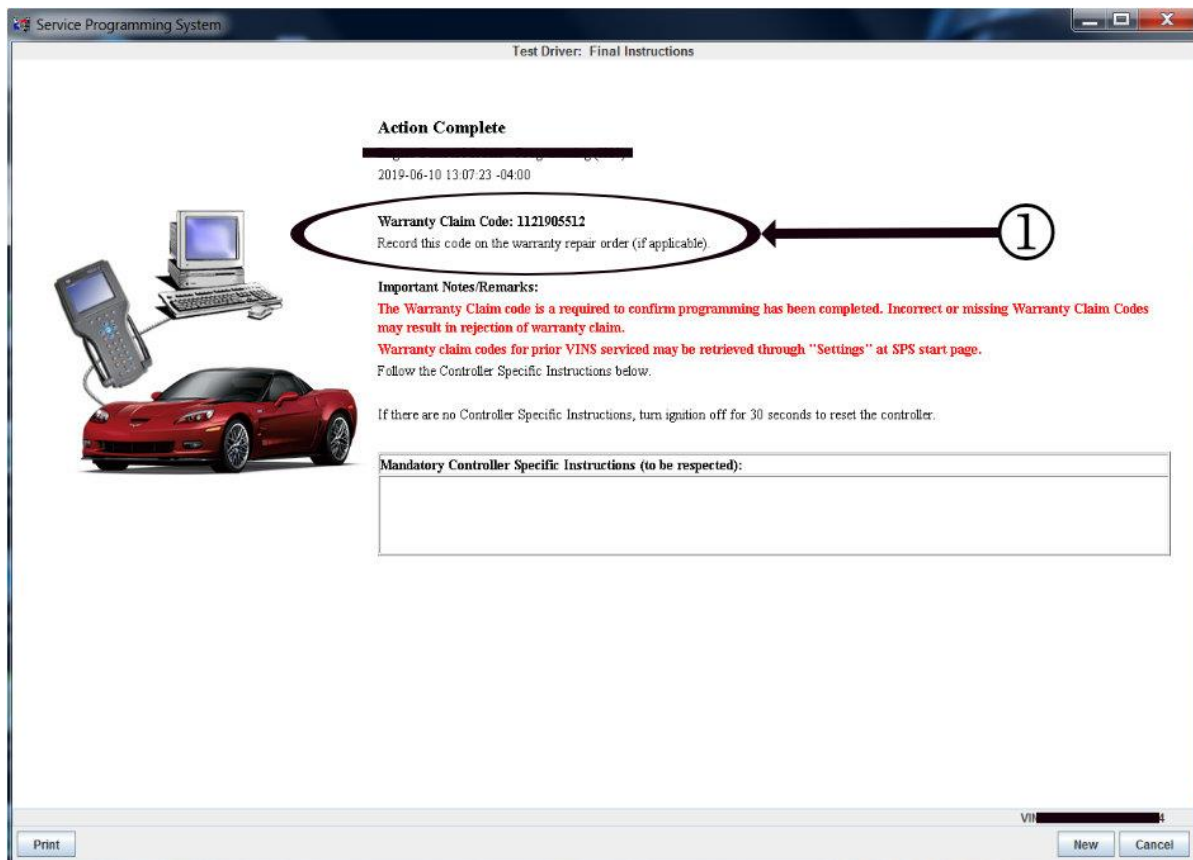
Note: The screenshots above are an example of module programming and may not be indicative of the specific module that is being programmed. Module selection and VIN information have been blacked out.
