AMB5 - Re-Programming Power Electronics (Stop Delivery/Recall Campaign)

Model Line: **Taycan (Y1A)**

Concerns: **Power electronics and engine electronics (DME)**

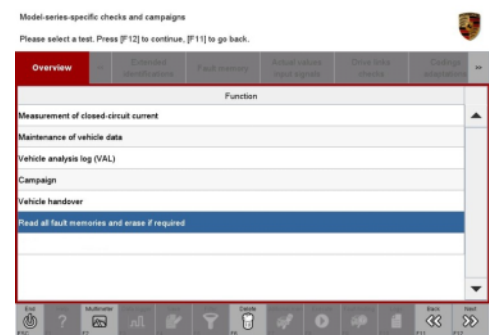
Erasing fault memories

11.4 Press •F8" to delete fault memory entries.

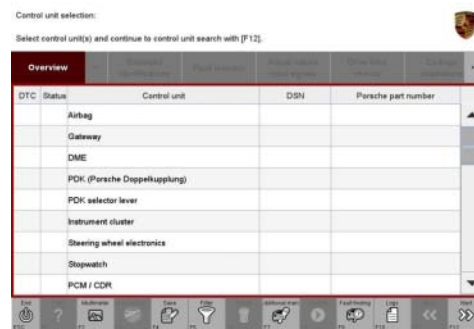
Control unit selection

- Plug the PIWIS Tester diagnostic connector into the diagnostic socket again and restore communication with the vehicle.
 - Read out the fault memory again and delete any fault memory entries that are stored.
- 11.6 Once you have erased the fault memories, select the **'Overview'** menu to return to control unit selection ⇒ *Control unit selection*.

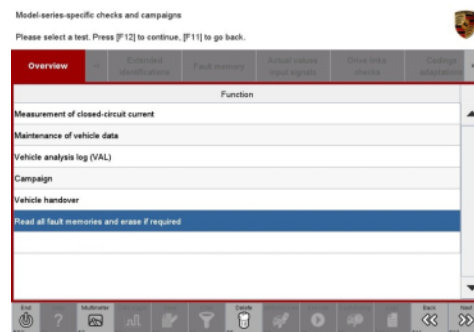
Erasing fault memories

2.4 Press •F8“ to delete fault memory entries.

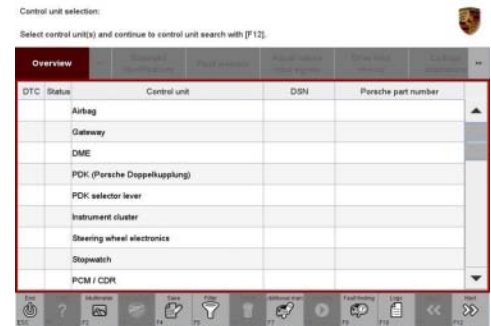
Control unit selection

2.6 Once you have erased the fault memories, select the **'Overview'** menu to return to the control unit selection screen ⇒ *Control unit selection*.
