**AMB5 - Re-Programming Power Electronics (Stop Delivery/Recall Campaign)**

Model Year: **2021**

Model Line: **Taycan (Y1A)**  
**Taycan Cross Turismo (Y1B)**

Concerns: **Power electronics and engine electronics (DME)**

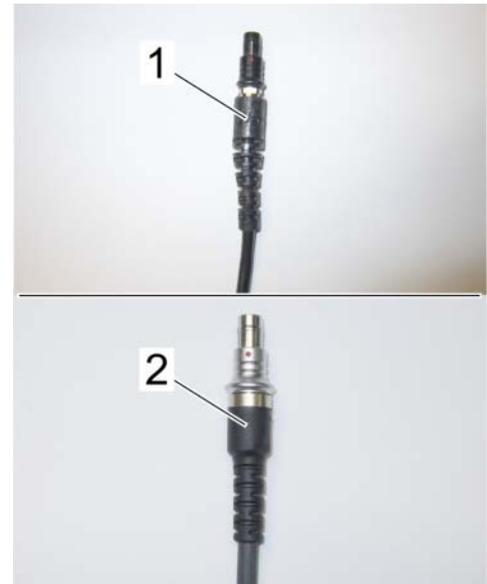
*PIWIS Tester data cable*

Use the **new** PIWIS Tester data cable to carry out the campaign. The difference between the old ⇒ *PIWIS Tester data cable -1-* and new ⇒ *PIWIS Tester data cable -2-* data cable is shown in the illustration.

If the connection between the vehicle and PIWIS Tester is interrupted, check the data cable for the PIWIS Tester for signs of damage. If the data cable is damaged, it **must** be **replaced**. To do this, follow the instructions in the PPN for "Returning faulty USB cable caps" (PPN portal > Dr Ing. h.c. Porsche AG > Aftersales > Workshop > PIWIS > Documents).

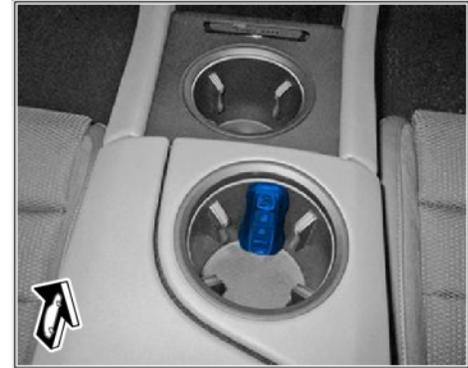
*Emergency start tray*

- 2 Position the **driver's key** with the back facing forward upright between the holding struts in the rear cupholder (**emergency start tray**) to guarantee a permanent radio link between the vehicle and remote control ⇒ *Emergency start tray*.
- 3 Connect **9900 - PIWIS Tester 3** to the vehicle communication module (VCI) via the **USB cable**. Then, connect the communication module to the vehicle and switch on the PIWIS Tester.  
**Operate the PIWIS Tester via the power supply unit** due to the long programming time.

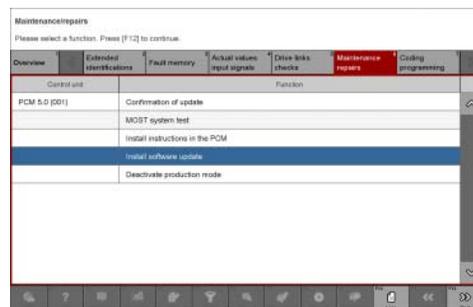
*Installing PCM 6.0 software update*

- 9.7 Once the PCM central computer control unit has been found and is displayed in the 'Overview', select the '**Maintenance/repairs**' menu.
- 9.8 Select the '**Install software update**' function and press •F12" ('Next') to perform the software update ⇒ *Installing PCM 6.0 software update*.

Once the update has started, the PCM is restarted in the Update menu and the individual components are then updated.

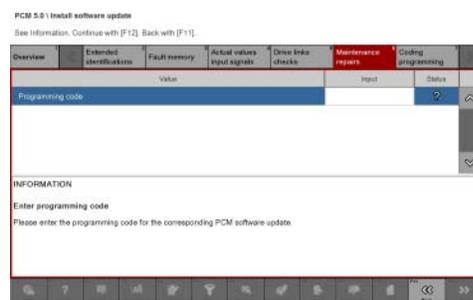
- 9.11 Enter the programming code **K4M4S** in the relevant column ⇒ *Entering PCM 6.0 programming code* and press •F12" ('Next') to confirm ⇒ *Entering PCM 6.0 programming code*.

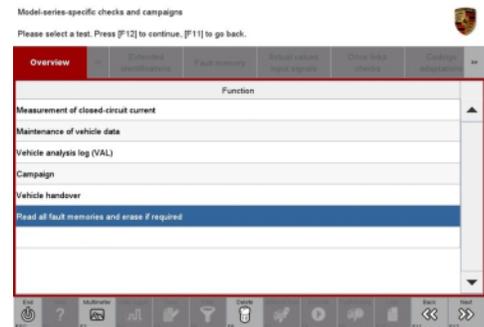
*Erasing fault memories*

- End operational readiness (switch off ignition).
- Disconnect the PIWIS Tester diagnostic connector from the diagnostic socket.
- Lock the vehicle using the driver's key and remove the driver's key from the proximity of the vehicle (approx. 10 meter/ 32.8 ft).
- Unlock the vehicle again after waiting for at least 15 minutes.
- Restore operational readiness (switch on ignition).
- Plug the PIWIS Tester diagnostic connector into the diagnostic socket again and restore communication with the vehicle.
- Read out the fault memory again and delete any fault memory entries that are stored.

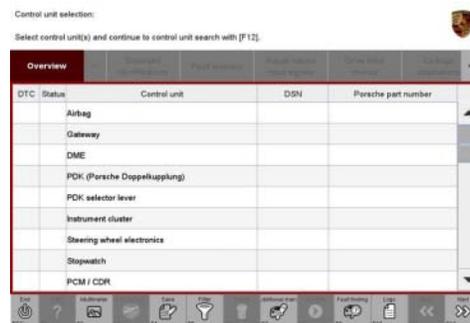
*Control unit selection*

5.6 Once you have erased the fault memories, select the **'Overview'** menu to return to the control unit selection screen ⇒ *Control unit selection*.

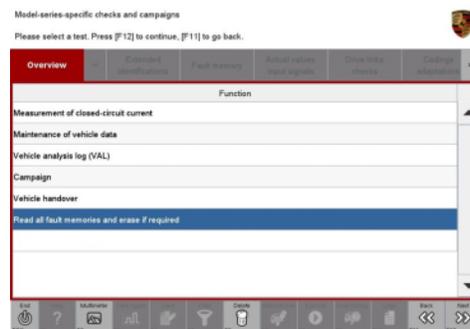
*Erasing fault memories*

4.4 Press **•F8** to delete fault memory entries.

- End operational readiness (switch off ignition).
- Disconnect the PIWIS Tester diagnostic connector from the diagnostic socket.
- Lock the vehicle using the driver's key and remove the driver's key from the proximity of the vehicle (approx. 10 meter/ 32.8 ft).
- Unlock the vehicle again after waiting for at least 15 minutes.
- Restore operational readiness (switch on ignition).
- Plug the PIWIS Tester diagnostic connector into the diagnostic socket again and restore communication with the vehicle.
- Read out the fault memory again and delete any fault memory entries that are stored.

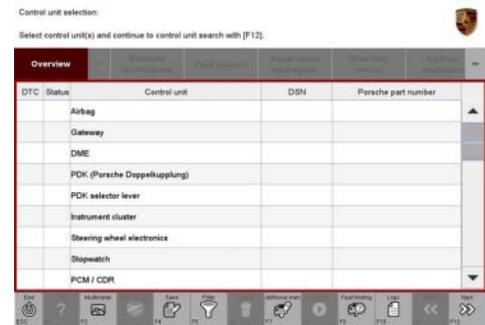
Control unit selection

- 4.6 Once you have erased the fault memories, select the **'Overview'** menu to return to the control unit selection screen ⇒ *Control unit selection*.
- 5 Create vehicle analysis log (VAL) using the PIWIS Tester.  
Mark the vehicle analysis log you have just created with the attribute **"Final VAL"** and after carrying out the campaign, return it using the PIWIS Tester.
- 6 Attach the working log to the PQIS line.
- 6.1 Select the PCCS button under **Applications** in the PIWIS Tester.
- 6.2 Log in using the PIWIS Tester and complete the relevant process in the PCCS.
- 6.3 Select File Upload in the PIWIS Tester.
- 6.4 Select **Pdf Prints** in the selection menu.
