September 2021
FL896A
NHTSA #21V-547 (School Bus)

Subject: FCCC Bendix Intellipark Software Update

Models Affected: Specific Model Year 2021 to 2022 Freightliner Custom Chassis B2 school bus chassis (Thomas Built Buses C2 and C2e Saf-T-Liner) manufactured November 27, 2019, through May 27, 2021, and equipped with a Bendix Intellipark System.

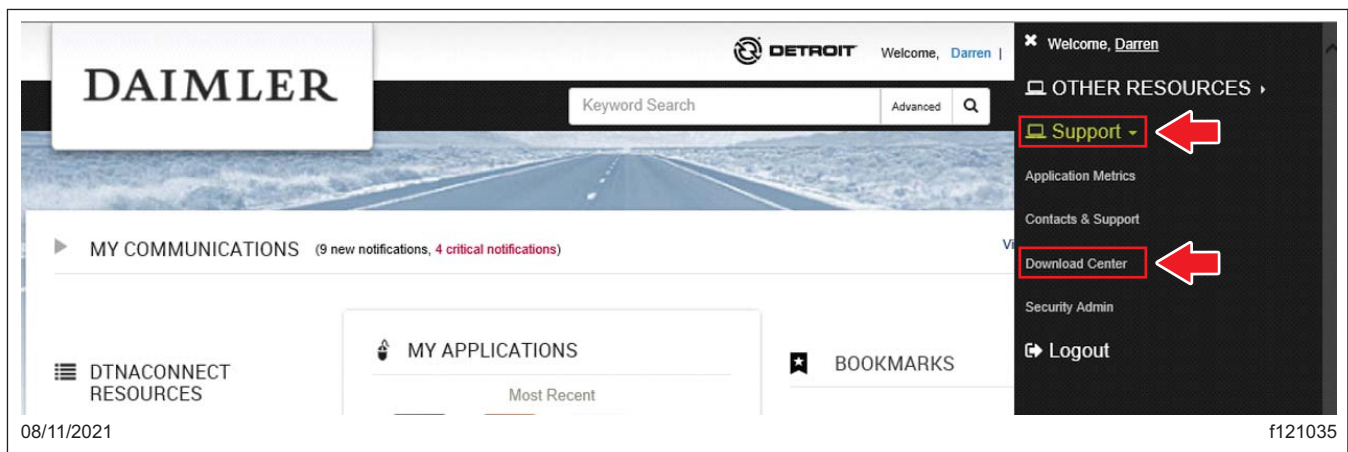
Fig. 2, Link to Download Center

3. Select 'Support,' then select 'Download Center.' See [Fig. 2](#).

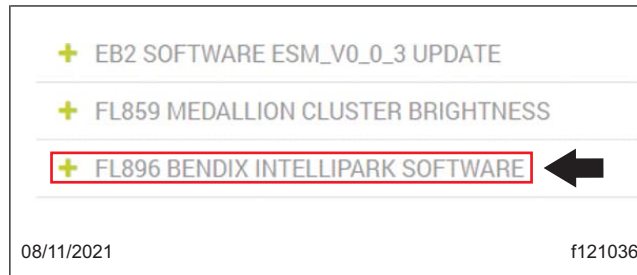
Fig. 3, FL896 Bendix Intellipark Software Container

4. Scroll down to the 'FL896 Bendix Intellipark Software,' then select '+' symbol. See [Fig. 3](#). Select the 'FL896 Update Files' link, then save the zip file.

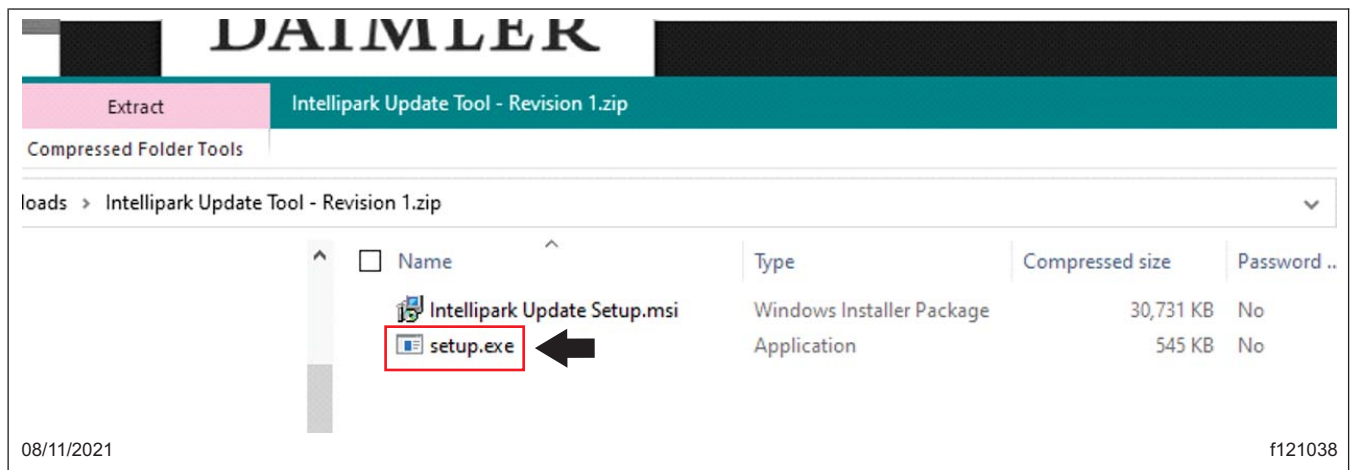
Fig. 4, Bendix Intellipark Update Setup File

- Administrative rights may be required to perform this operation. Contact the local system administrator for assistance.
 - Allow the systems default location for installation of the application.
6. In the extracted folder, run the 'Setup.exe.' file to install the Bendix Intellipark Update Tool. See [Fig. 4](#).

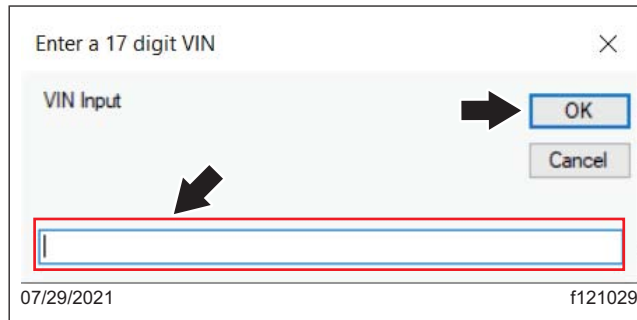
Fig. 11, VIN Input Window

7. If the vehicle identification (VIN) is not detected automatically, a window will appear requesting to enter the VIN. Enter the VIN, then select 'OK.' See Fig. 11.

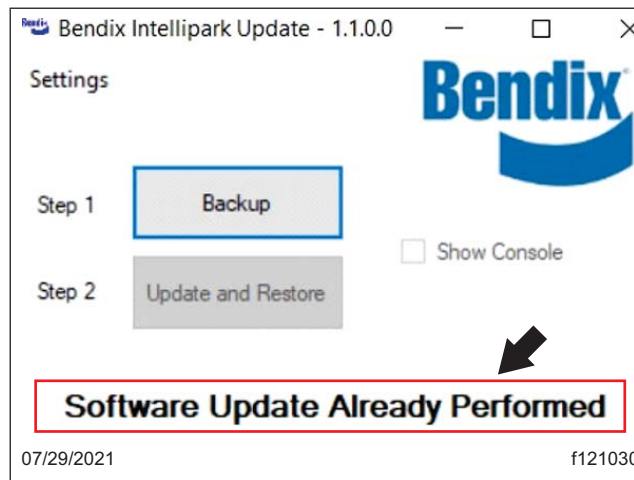
Fig. 12, Message Displayed if Software Update was Already Performed

8. If the DECU is already updated, the message 'Software Update Already Performed' will be displayed. See Fig. 12. No further work is required. Go to step 12.

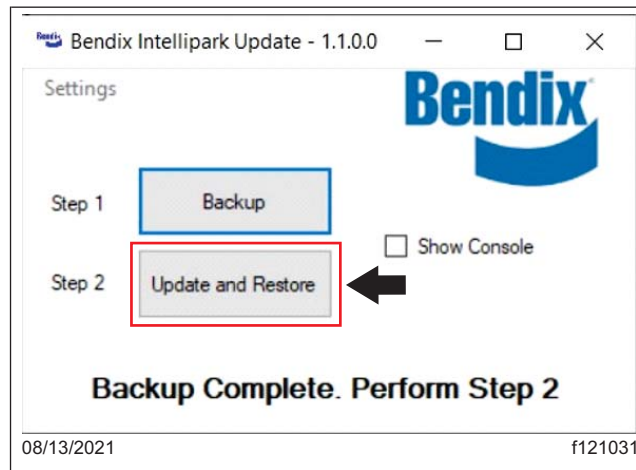
Fig. 13, Selecting Update and Restore

- If the Intellipark system installed in the vehicle is not compatible with this update, the message 'Software Version Not Applicable' will be displayed. Go to step 12.
- If neither of the conditions from steps 8 and 9 exist, select 'Update and Restore.' See [Fig. 13](#).

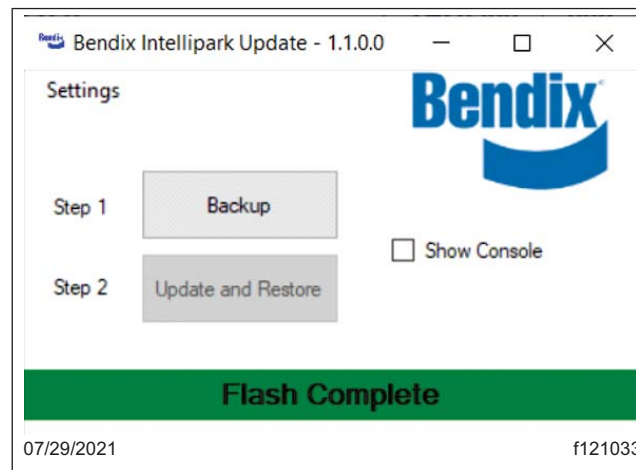
Fig. 14, Flash Complete Message Displayed

- Once the update is complete, the message 'Flash Complete' will be displayed. The laptop can be now disconnected from the vehicle. See [Fig. 14](#).
