**TECHNICAL INSTRUCTIONS**  
**SAFETY RECALL 21TA04**  
**POTENTIAL INCREASED BRAKING DISTANCE**  
**CERTAIN 2020 - 2021 MODEL YEAR SUPRA VEHICLES**

## I. OPERATION FLOW CHART

## V. OVERVIEW OF WORK PROCEDURE (REPROGRAMMING USING ISTA)

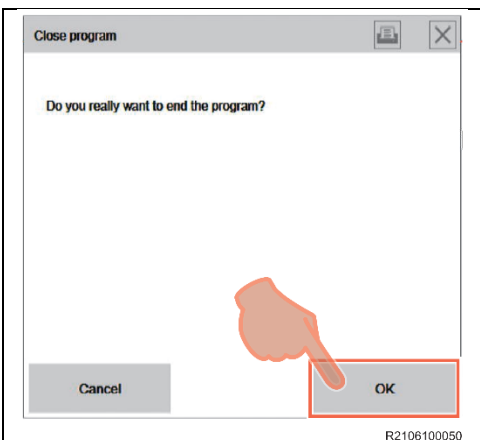
Flashing Animation	There is a warning message; a response is required. Click the icon, and then follow the on-screen instructions to carry out the work.

6. Click “OK” when the “Close program” dialog box appears.

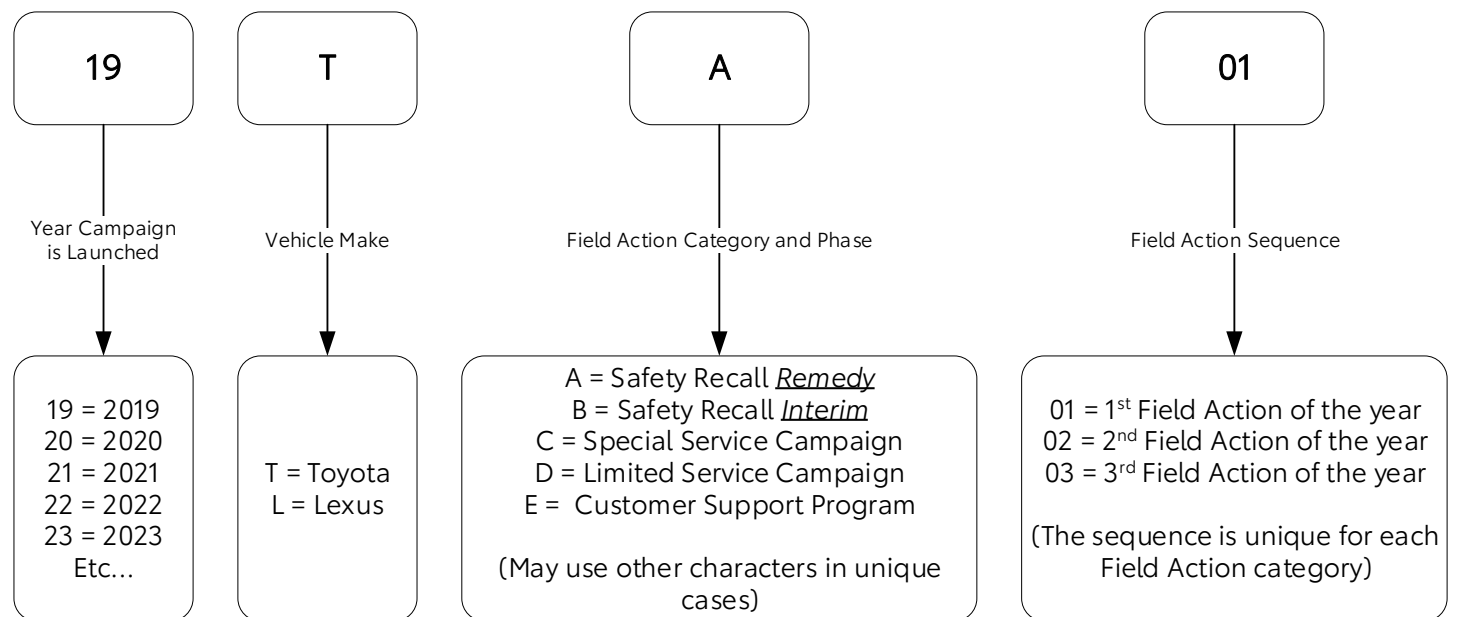
# 19TA01

19TA01 = Launched in 2019, Toyota, Safety Recall Remedy Phase, 1<sup>st</sup> Safety Recall Launched in 2019  
20TC02 = Launched in 2020, Special Service Campaign, 2<sup>nd</sup> Special Service Campaign Launched in 2020  
21TE05 = Launched in 2021, Customer Support Program, 5<sup>th</sup> Customer Support Program Launched in 2021
