TECHNICAL INSTRUCTIONS

SAFETY RECALL 21TA04

POTENTIAL INCREASED BRAKING DISTANCE

CERTAIN 2020 - 2021 MODEL YEAR SUPRA VEHICLES

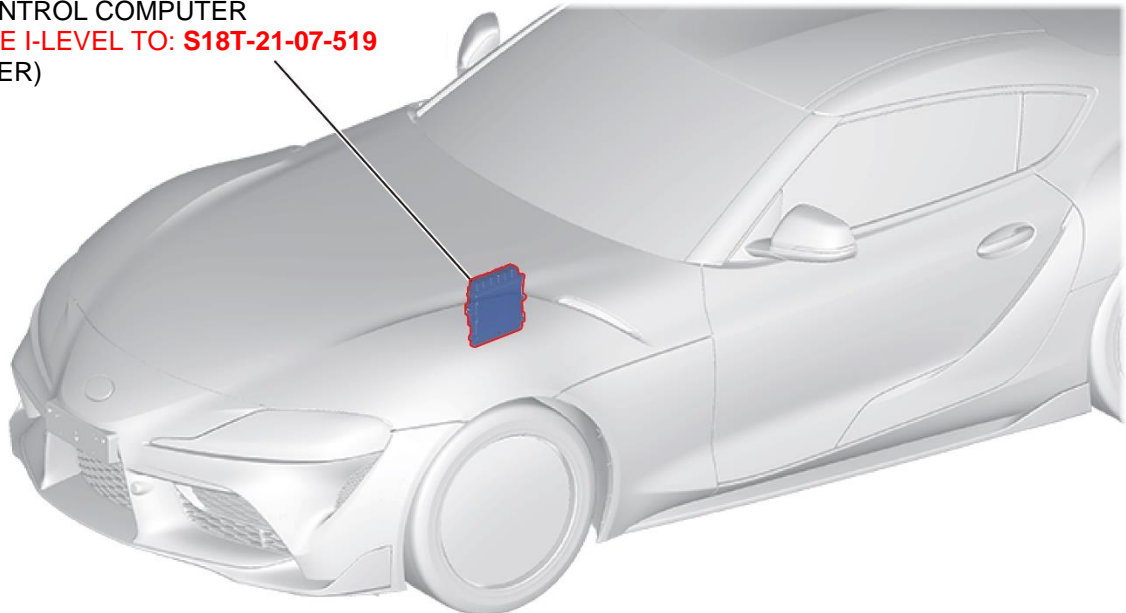
R2107060005a

VII. COMPONENTS

ENGINE CONTROL COMPUTER
UPDATE THE I-LEVEL TO: **S18T-21-07-519**
(OR GREATER)

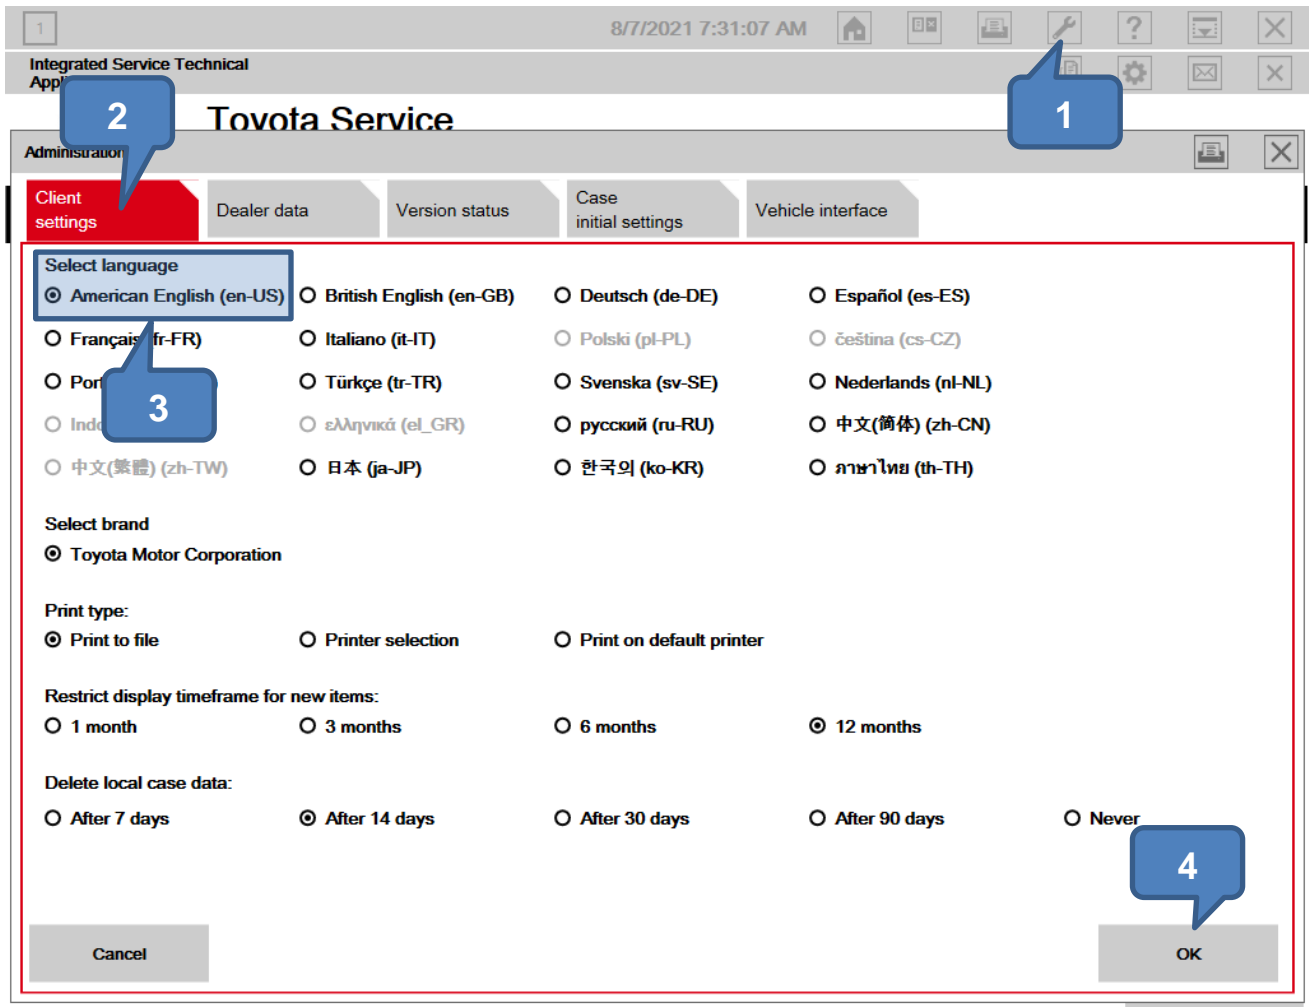
5. Click on the Configuration Button as indicated in the illustration.
6. Click on the Client settings tab as indicated in the illustration.
7. Select “American English”
8. Click “OK”

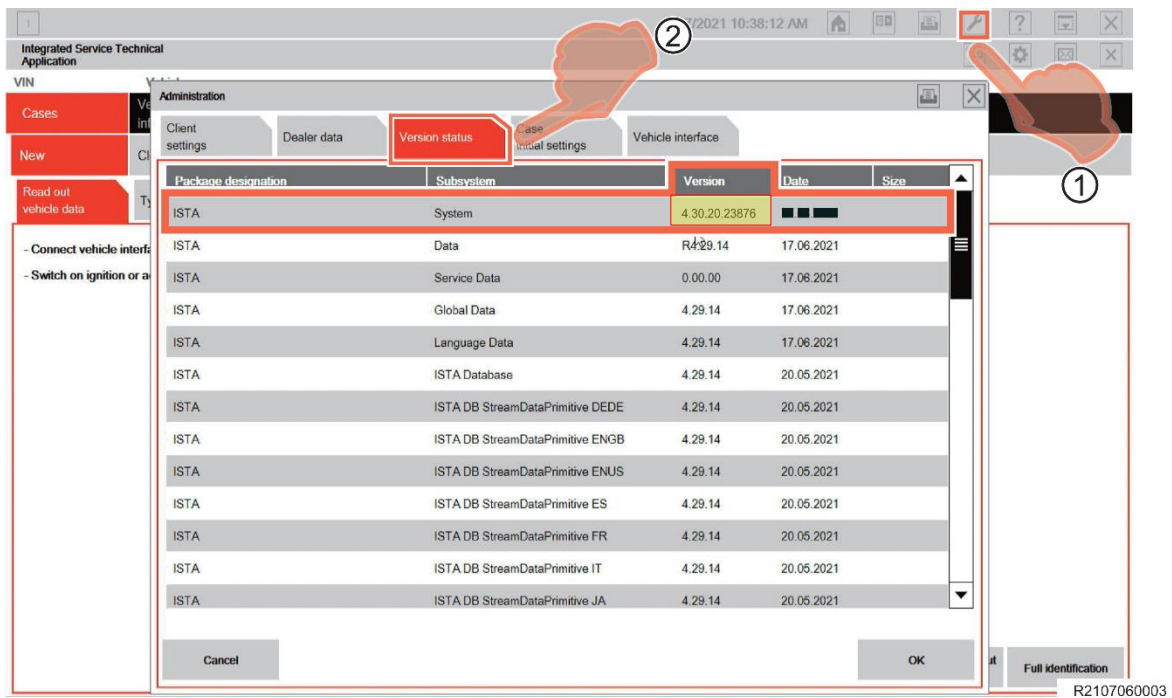
4. Click on the Configuration Button as indicated in the illustration.
5. Click on the Version status tab as indicated in the illustration.
6. Compare the installed version to the minimum required version: **4.30.20.23876**. If the version is less than version **4.30.20.23876**, install the latest version.

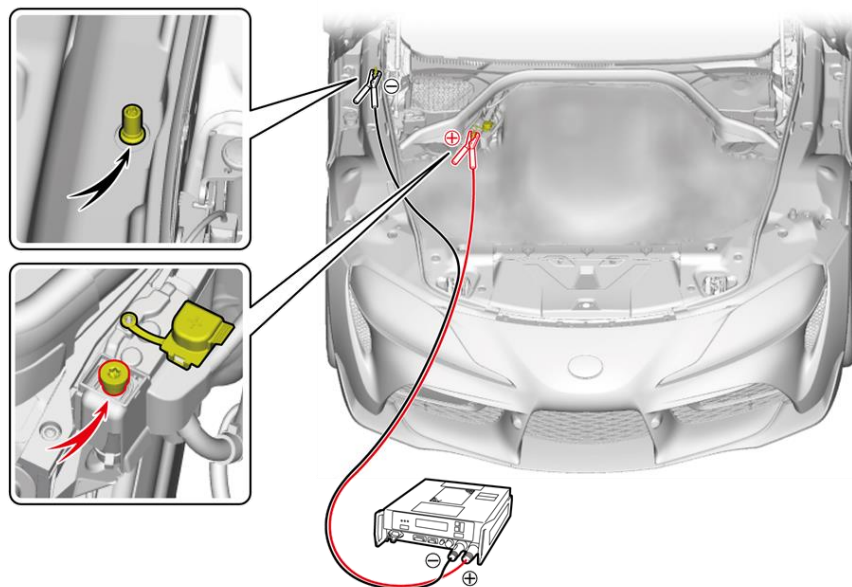
Connect Battery Charger

1. Connect the specified battery charger at the locations in the illustration.

Battery Charger	Mode	Voltage	Battery Type
DCA-8000	Power Supply Mode	13.5-14.6	AGM

- Make sure that the battery charger is off before connecting it.
- Make sure you respect the correct polarity when connecting the battery charger cables like displayed in the illustration below.

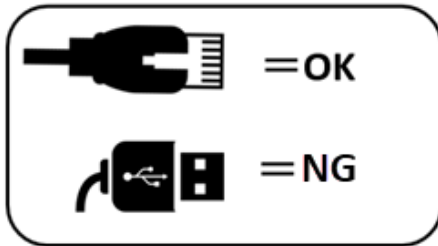
NOTICE: It is an absolute necessity that the vehicle is connected to the Techstream ADVi via the Toyota Supra Diagnostic Cable which has a LAN ethernet connection.

In order to maintain successful communication between the Techstream ADVi and the vehicle, the Toyota Supra Diagnostic cable must be used. Other interfaces that connect to the Techstream ADVi via USB are not allowed. Attempting to use such other devices may cause permanent ECU damage due to the slower communication speed.

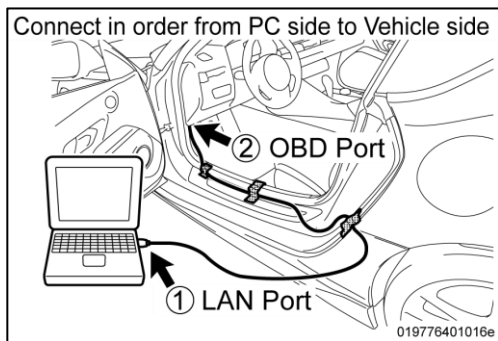
A. CONNECT THE CABLE (connection sequence):

1. Always connect the Supra diagnostic cable **first** to your PC LAN port (1) and only after that to the OBD port of the vehicle (2).

If this order of operations is not respected, possible vehicle communication issues may occur when using Toyota ISTA software.

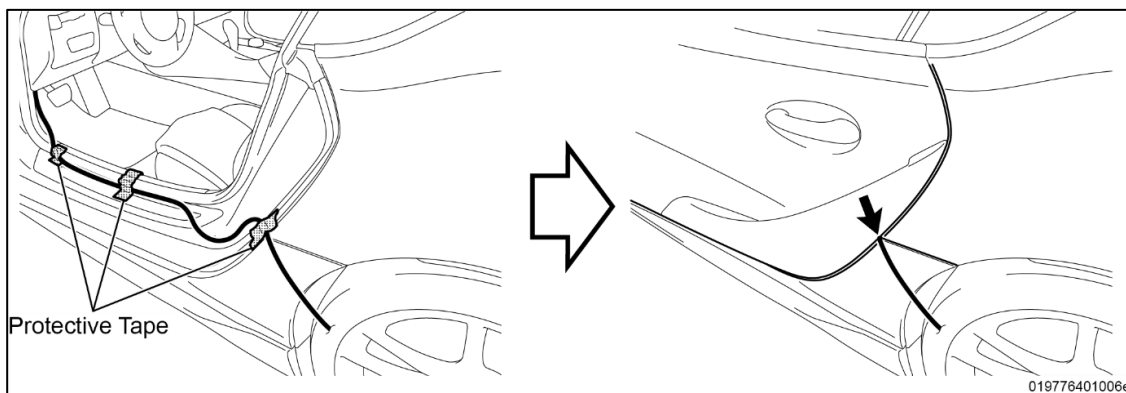
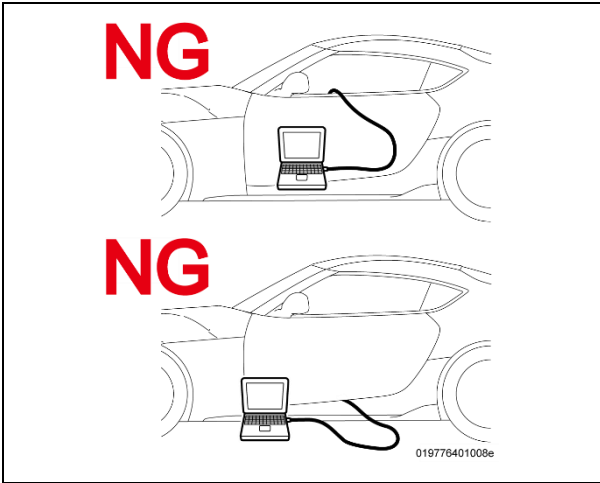
B. POSITION THE CABLE

1. Position the SUPRA diagnostic cable out of the vehicle as shown in the illustration. Otherwise the SUPRA diagnostic cable may be pinched, communication disconnected, and ECU's permanently damaged.
2. The Toyota Supra Diagnostic cable should always be passed through the position shown in the figure below. If it passes through any other position it is possible that the cable will be damaged.
3. Using the gap between the rear fender and the side garnish, pull the Supra Diagnostic cable to the outside of the vehicle. Please use protective tape for fixation and protection of the cable.

- **DO NOT** attempt to pass the ISTA diagnostic cable through the window opening. The window glass may move during reprogramming or initialization.
- Ensure the cable is out of the path of the front Driver's seat. During initialization the driver's seat moves and could damage cable or disconnect the OBDII connector during movement.
- Additionally, **DO NOT** attempt to pass the ISTA diagnostic cable through any other position of the door opening as it may cause damage to the cable.

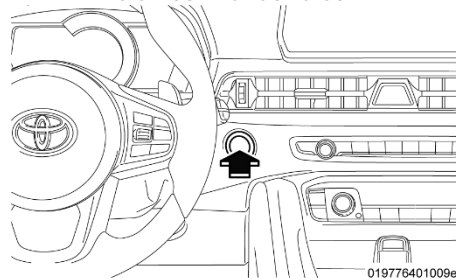
019776401009e

Pressing the Start Button
3 times in under 0.8s

1. PAD mode can be activated by pressing the start button 3 times in under 0.8 seconds (very fast, foot off the brake pedal) or by directly connecting the Toyota ISTA software and initiating the vehicle connection.

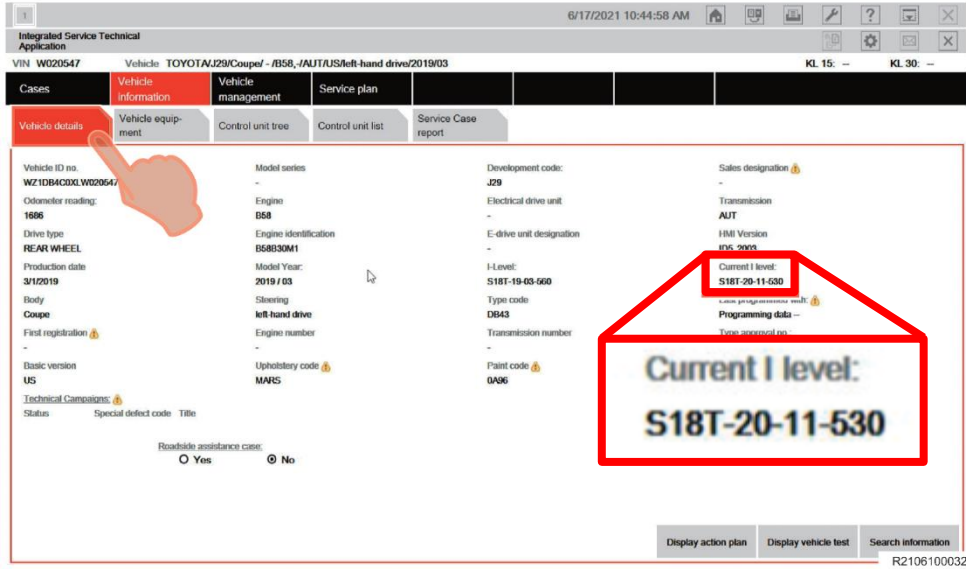
1. Select "Vehicle details".
2. The "Vehicle details" screen appears. Check the displayed "Current I level:", and then refer to the table below to determine if the vehicle requires reprogramming.

3. Confirm if the vehicle requires reprogramming based upon the "Current I-Level" of the vehicle. Use the decoder below.

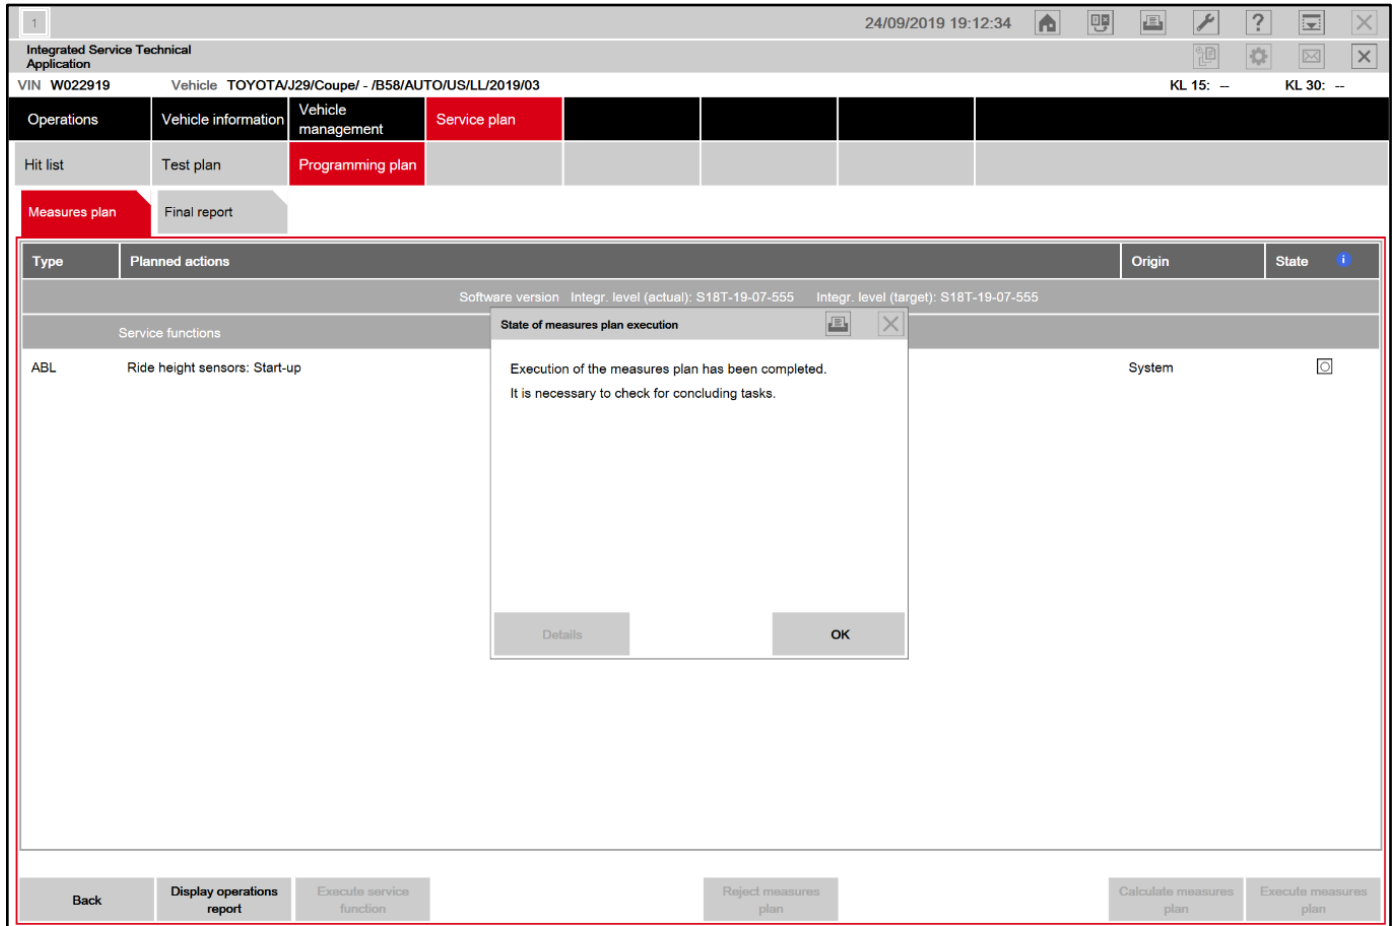
If ride height is required, you will need to insert the ride height for both the front and rear wheels. This will require you to measure this height in millimeters. The repair manual procedure can be found in this location:

[Vehicle Exterior > LIGHTING \(EXT\) > HEIGHT CONTROL SENSOR > INSTALLATION](#)
5. ADJUST HEIGHT CONTROL SENSOR (DOC ID: RM10000001JCL5)

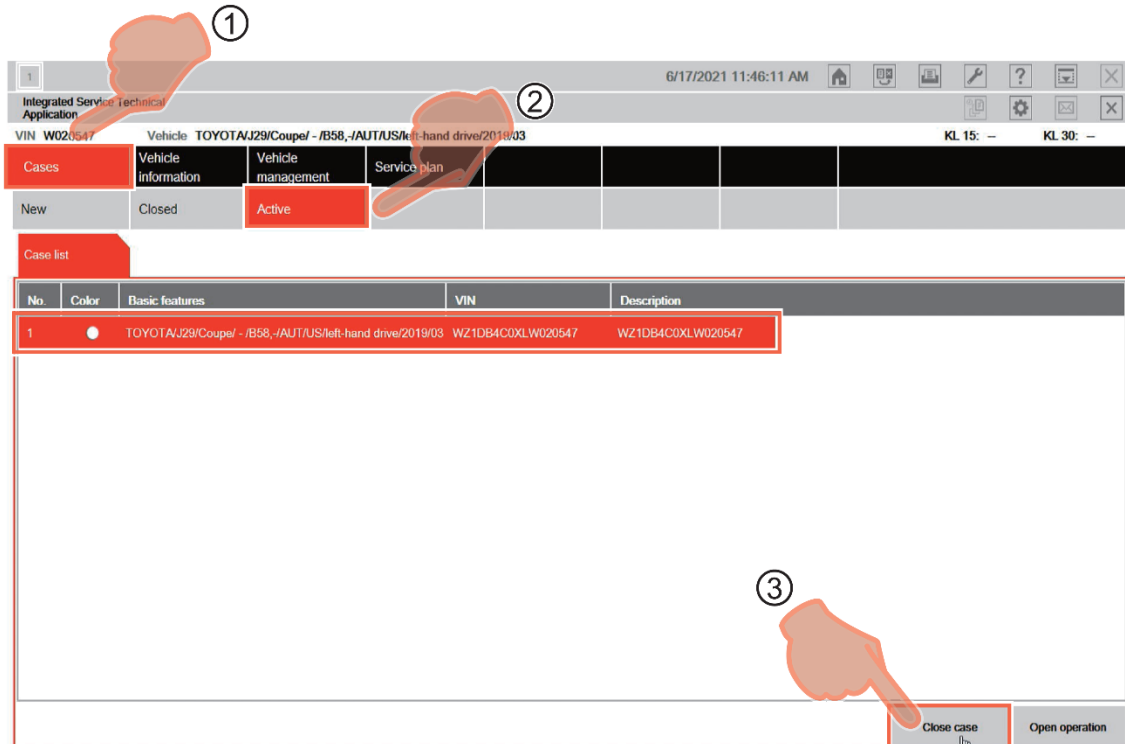
R2106100047

1. Select "Cases" -> "Active" to display the "Case list".
2. Confirm the vehicle information is correct, and then click "Close case".
