<b>HYUNDAI</b> <b>Technical Service Bulletin</b>	GROUP <b>RECALL</b>	NUMBER <b>21-01-071H</b>
	DATE <b>NOVEMBER, 2021</b>	MODEL(S) <b>SONATA (LFA) SONATA HYBRID (LF HEV) SONATA PLUG-IN (LF PHEV)</b>
<b>SUBJECT:</b> SMART JUNCTION BOX (SJB) – TURN SIGNAL CONTROL LOGIC UPDATE (RECALL 210)

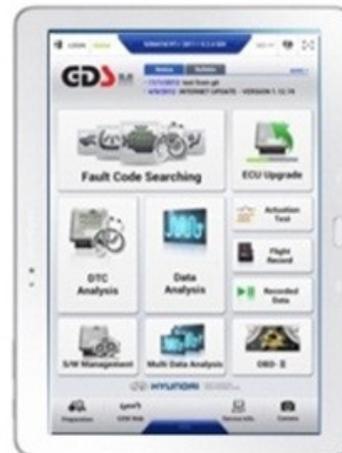
ECU upgrade function on GDS-Mobile is basically operating in wireless communication and Wi-Fi direct. Also, it's possible to be performing via USB cable between Tablet PC and VCI-II.

Tablet PC

VCI-II

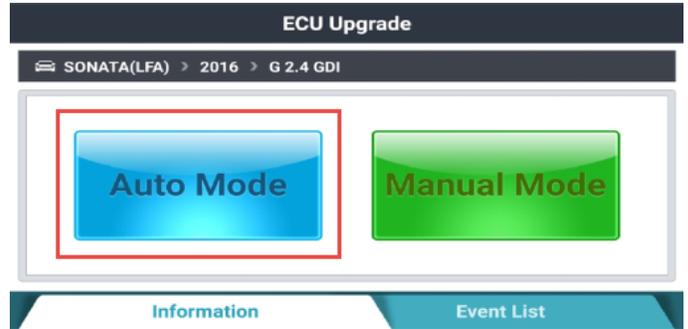
- 1. Select ECU Upgrade on the initial screen after entering the vehicle information.

Select Auto Mode.

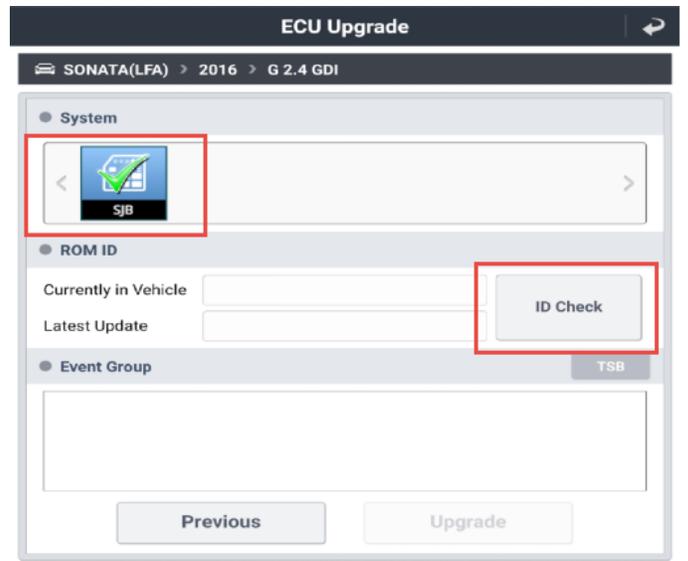
- 2. Click on SJB system and click on ID Check.

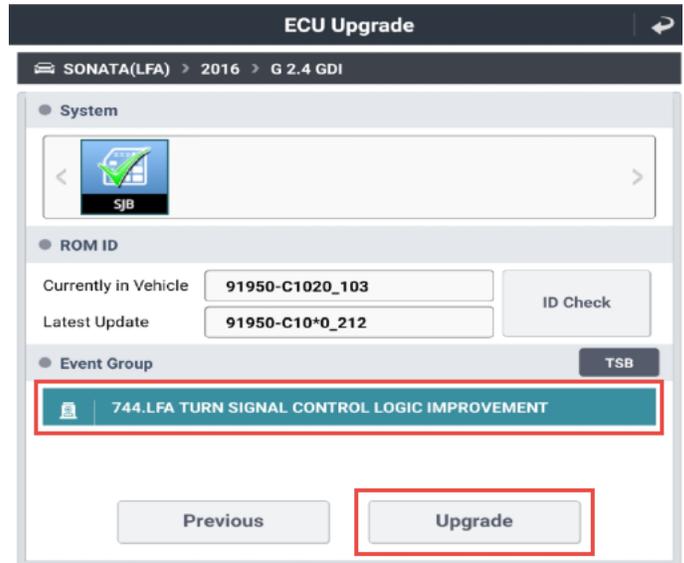
- 3. The GDS-Mobile will read the current ROM ID in vehicle and check the newest upgrade event.

Select the upgrade event.

Choose between:

- 744 for LFA Turn Signal Control Logic Improvement
- 745 For LF HEV / PHEV Turn Signal Control Logic Improvement

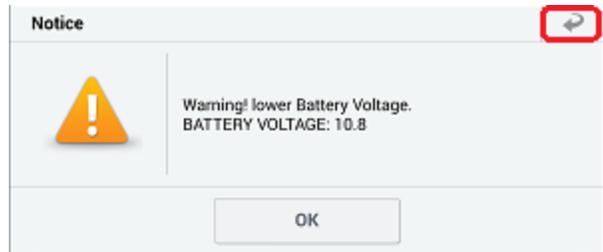
- 4. The vehicle battery voltage is checked to make sure it is at least 12 volts to ensure reliable upgrade results. Click OK if the results indicate voltage is OK.

**If battery voltage is below 12 voltages as below, click BACK and then run the engine to ensure an adequate battery charge state for reliable upgrade results.**

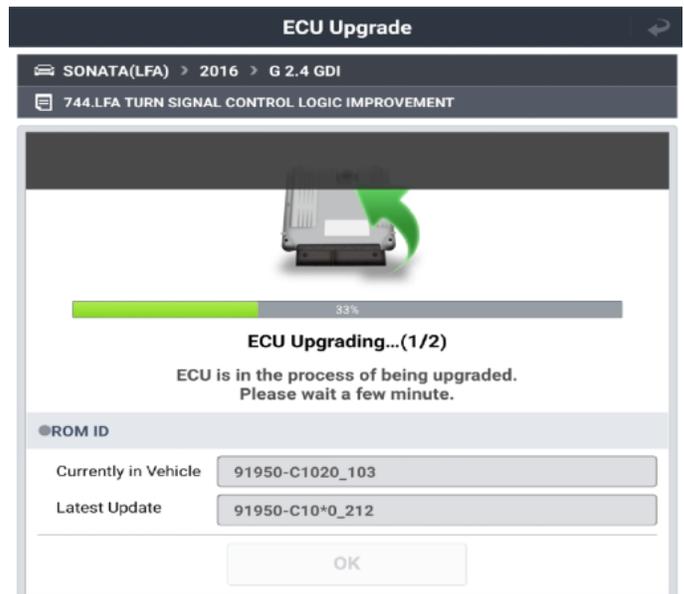
- 5. Upgrade (1/2) will begin, and the progress of the upgrade will appear on the bar graph. Upgrade (1/2) will occur until 100% is reached on the bar graph.

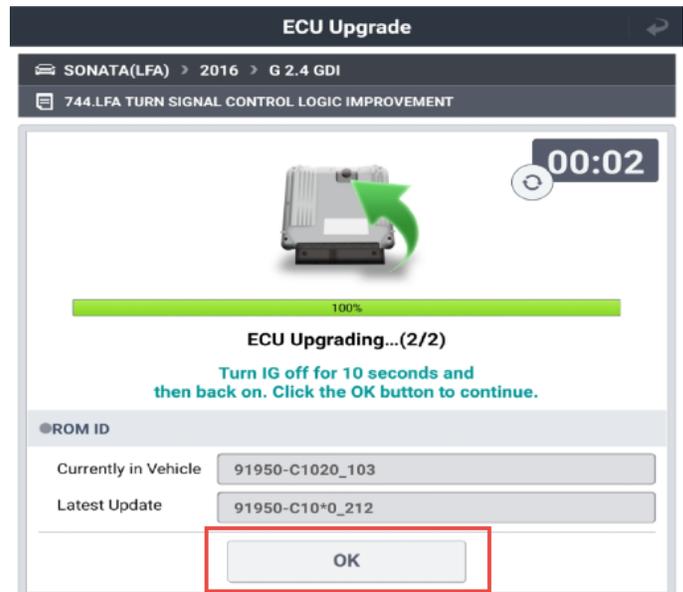
6. Upgrade (2/2) will begin, and the progress of the upgrade will appear in the bar graph.

Upgrade (2/2) will occur until 100% is reached on the bar graph.

After progress bar reaches 100%, turn the ignition key off for 10 seconds. Turn the key back to the on position, and then click OK to continue according to information displayed on the screen.

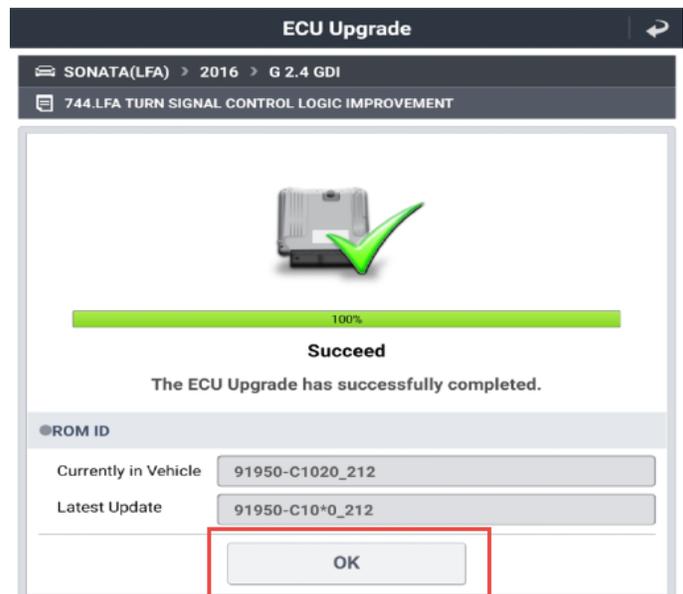
7. Click OK on the final screen, which indicates upgrade is complete.

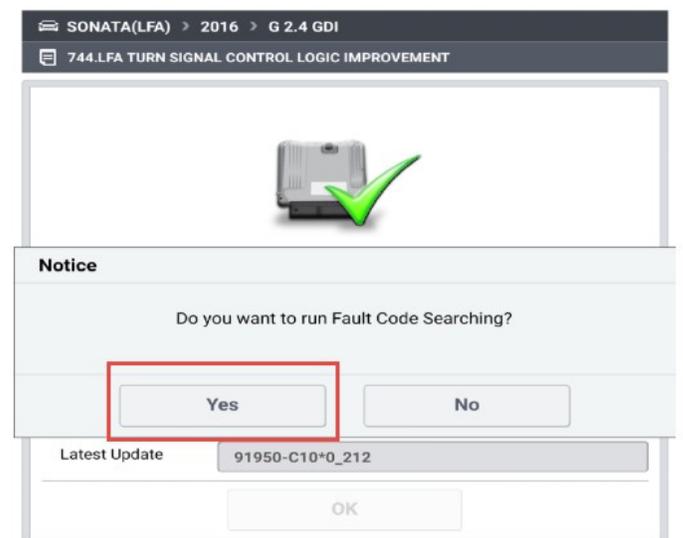
8. Check if any incidental Diagnostic Trouble Codes (DTC) have been created by the upgrade and clear the DTC(s) present.

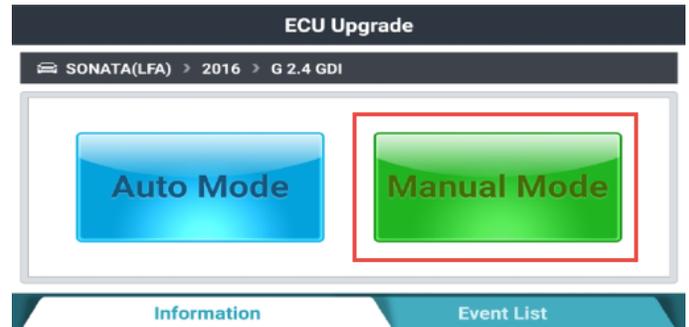
- The manual upgrade should be performed only when the automatic upgrade fails.
  - If automatic upgrade fails, turn the ignition key off for about 10 seconds, place it back in the on position to reset the control unit before performing manual upgrade.
1. Within the upgrade screen, select Manual Mode, then select upgrade event.

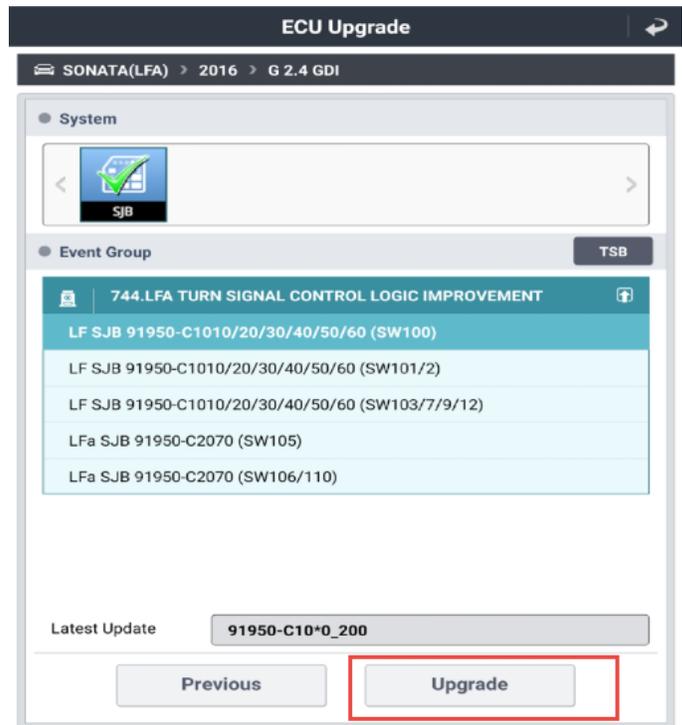
2. Select the control unit part number with reference to the above ROM ID Information Table (Page 2) and click Upgrade.

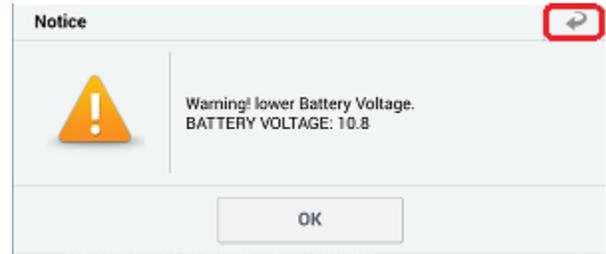
- The vehicle battery voltage is checked to make sure it is at least 12 volts to ensure reliable upgrade results. Click OK if the results indicate voltage is OK.

**If battery voltage is below 12 volts, click BACK and then run the engine to ensure an adequate battery charge state for reliable upgrade results.**

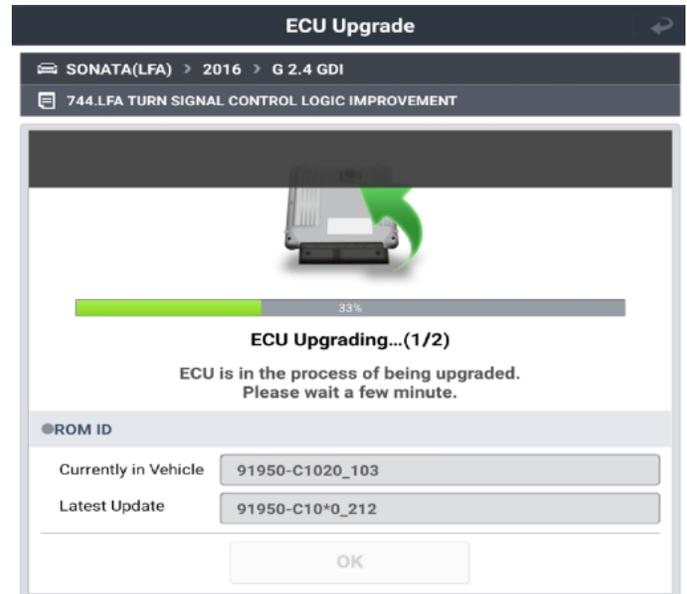
- Upgrade (1/2) will begin, and the progress of the upgrade will appear on the bar graph. Upgrade (1/2) will occur until 100% is reached on the bar graph.

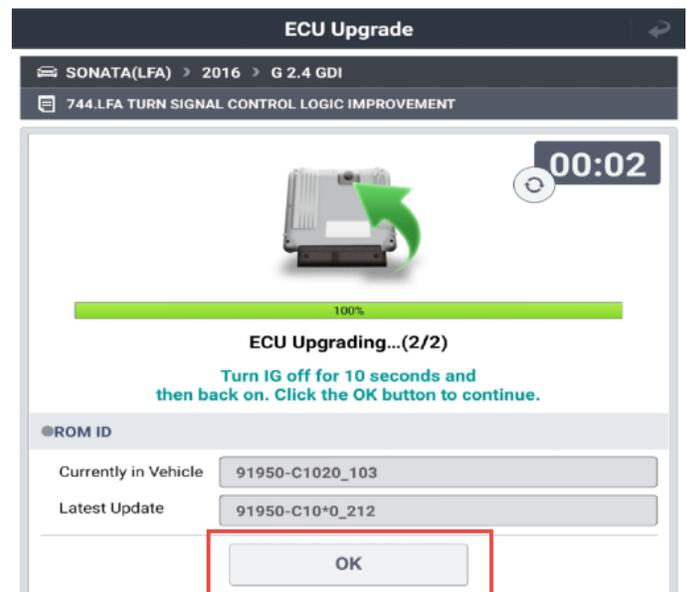
- Upgrade (2/2) will begin, and the progress of the upgrade will appear in the bar graph. Upgrade (2/2) will occur until 100% is reached on the bar graph.

After progress bar reaches 100%, turn the ignition key off for 10 seconds. Turn the key back to the on position, and then click OK to continue according to information displayed on the screen.

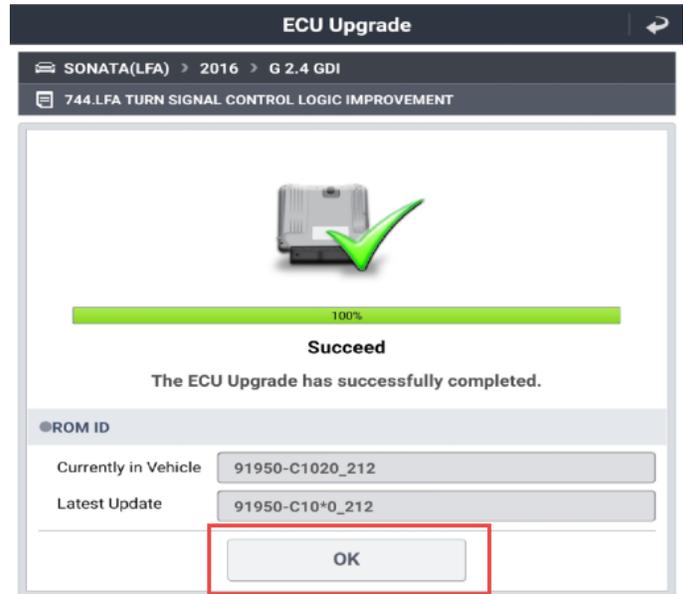
7. Click OK on the final screen, which indicates upgrade is complete.

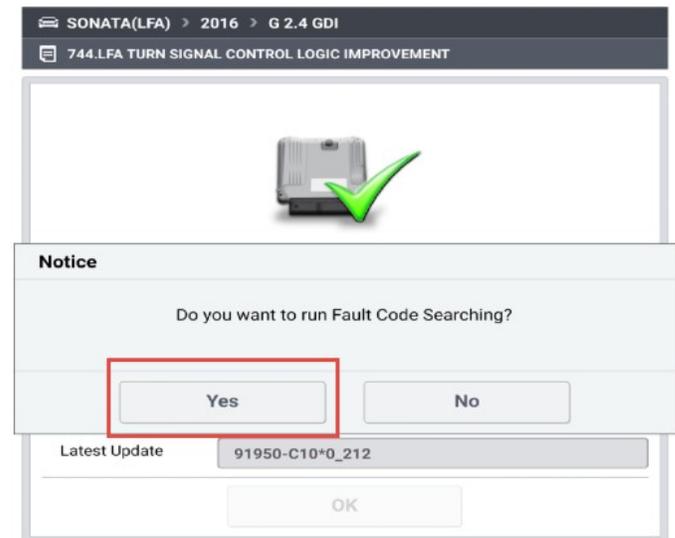
8. Check if any incidental Diagnostic Trouble Codes (DTC) have been created by the upgrade and clear the DTC(s) present.
