GROUP	MODEL
Safety Recall Campaign	2017-2018MY Optima (JF P/HEV) w/Nu 2.0L GDI HEV
NUMBER	DATE
SC218 (Rev 2, 02/10/2022)	November 2021

ENGINE INSPECTION/REPLACEMENT AND KSDS S/W INSTALLATION (SC218)

This bulletin provides information to perform the Bearing Clearing Test (BCT) and, if necessary, replace the engine, and to update the Engine Control Unit (ECU) to install the Knock Sensor Detection System (KSDS) software on 2017-2018MY Optima (JF P/HEV) equipped with Nu 2.0L GDI ULEV/SULEV engine, produced from June 27, 2016 through April 27, 2018. Follow the flowchart on page 2 to perform the BCT and install the KSDS software. In some cases, engine long block replacement may be required if the BCT results in a “No Pass” or “Unable to Perform” (ex. seized engine).

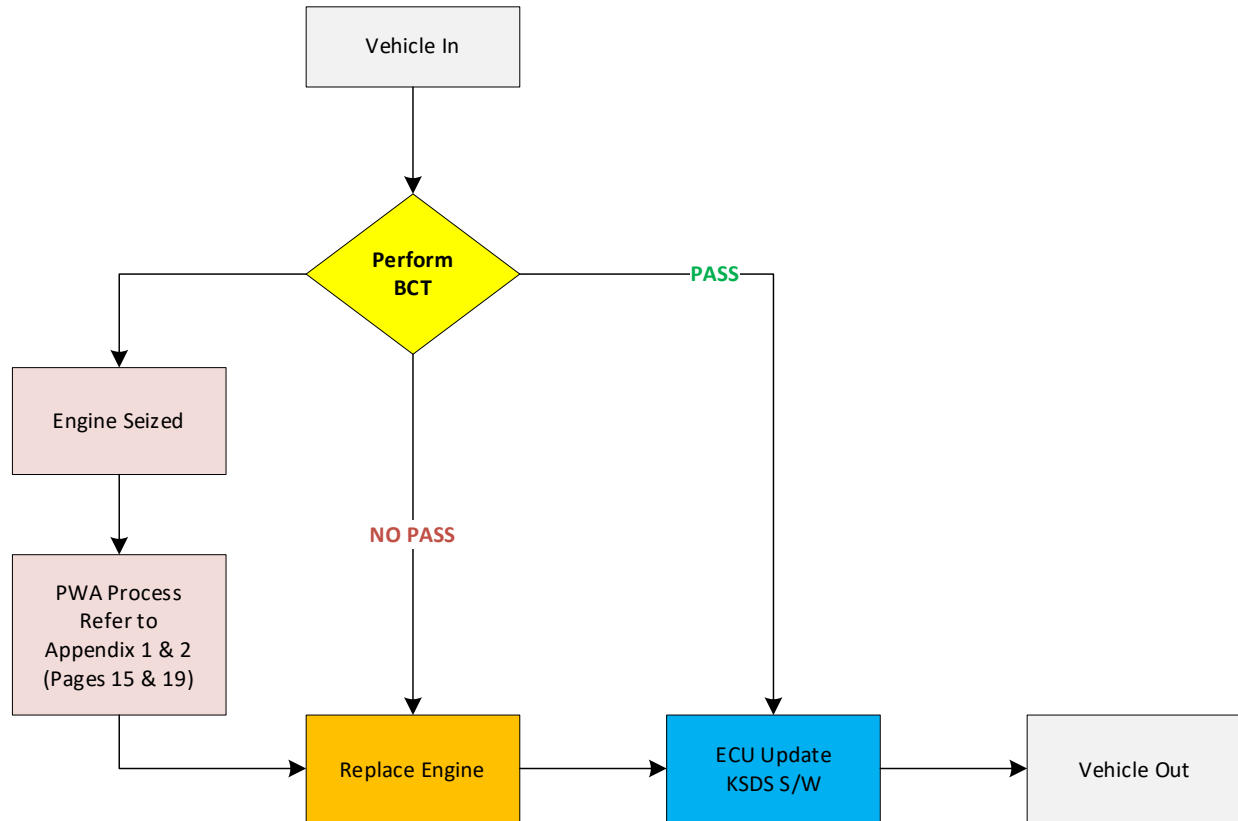
Flowchart:

Follow the flowchart below and refer to SST067 for BCT procedure. Be sure to apply the ECU Update (KSDS Software) after BCT or engine replacement.

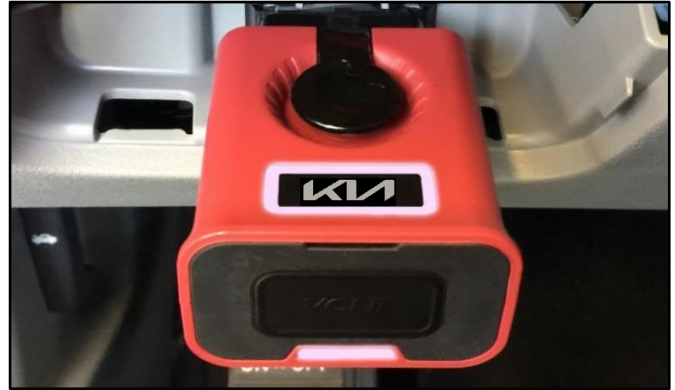
1. Connect the VCI-II to the OBD-II connector, located under the driver's side of the instrument panel.

The ECU upgrade function on KDS operates wirelessly. It is not necessary to perform the upgrade via USB cable.

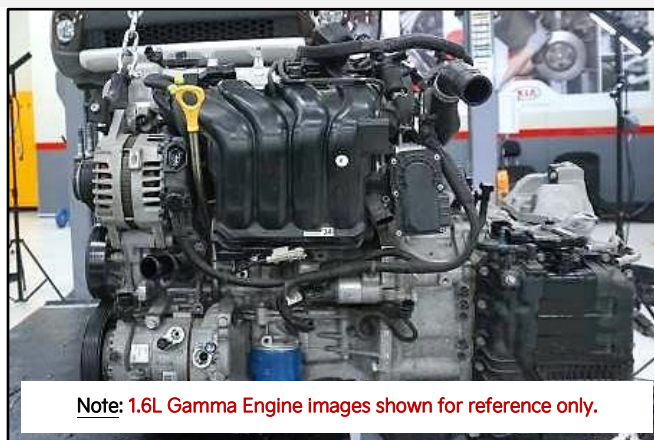
1. Replace the engine assembly by referring to the "Engine Mechanical System → Engine And Transmission (Transaxle) Assembly → Sub & Long Engine Assembly → Repair procedures" chapter in the applicable Shop Manual on KGIS.

Note: 1.6L Gamma Engine images shown for reference only.

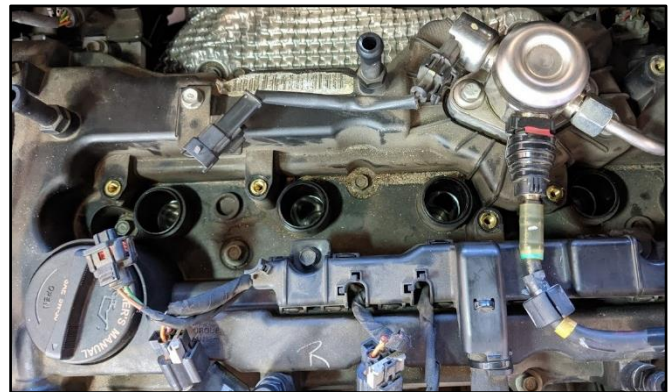
3. Show the empty spark plug holes from the engine.

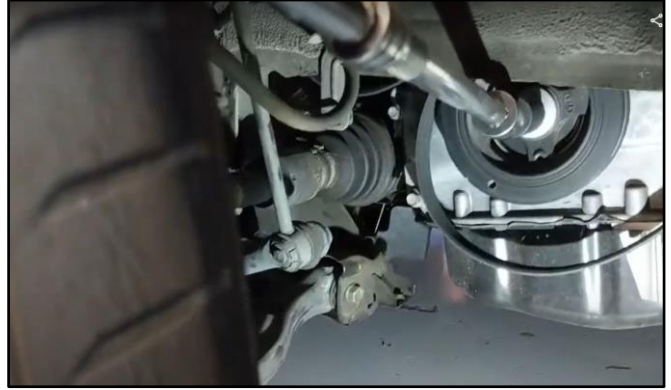
4. Show the removed drive belt and attached torque wrench to crank bolt.

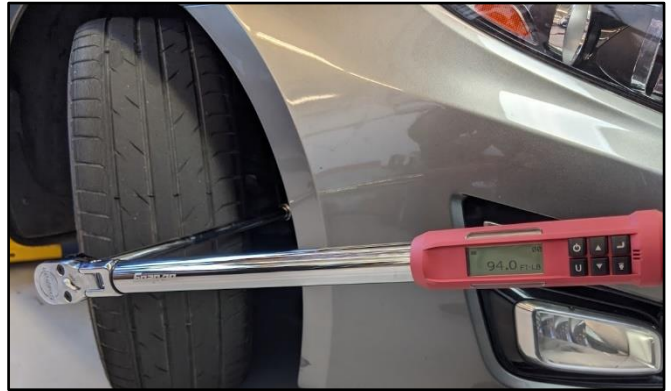
5. Show the engine being cranked and torque specification exceeding 94 lb.ft. torque.
