## **TECHNICAL INSTRUCTIONS**

### **SAFETY RECALL 21TA08**

#### **SECOND-ROW OUTBOARD SEAT BELT COULD TEAR IN A CRASH**

#### **CERTAIN 2022 MODEL YEAR SIENNA VEHICLES CONVERTED FOR WHEELCHAIR ACCESSIBILITY BY VANTAGE MOBILITY INTERNATIONAL (VMI)**

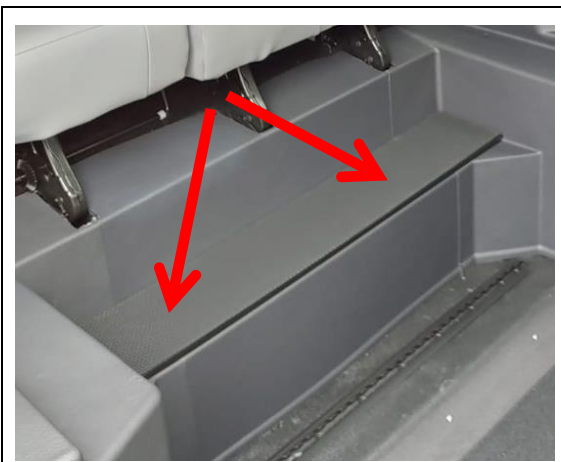
- a) If MicroSpike rubber is installed on the 3rd-row footrest, peel back the covering to expose the six bolts.

*Note: This will destroy the adhesive backing and a new cover will need to be installed. Refer to VMI P/N FN1628.*

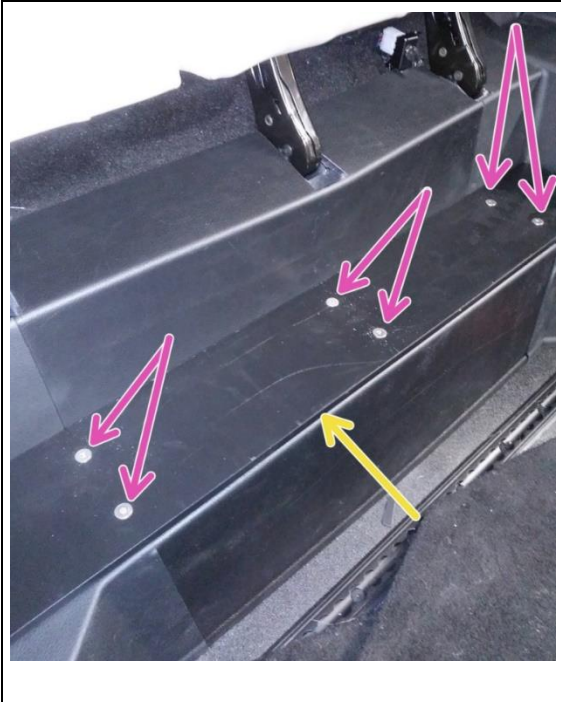
- b) Remove the six flathead bolts from the footrest.
- c) Remove the footrest bar.

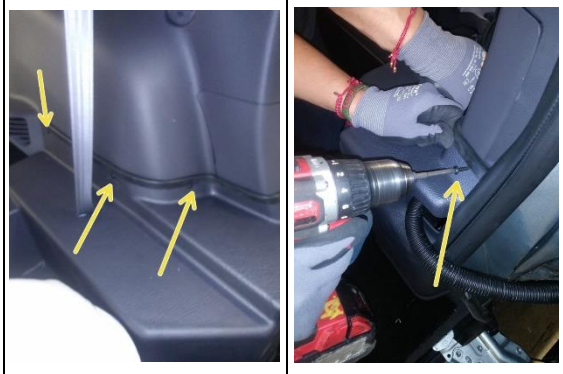
g) Remove the four screws connecting each C-Corner VMI plastic to the Toyota-factory installed quarter-panels.

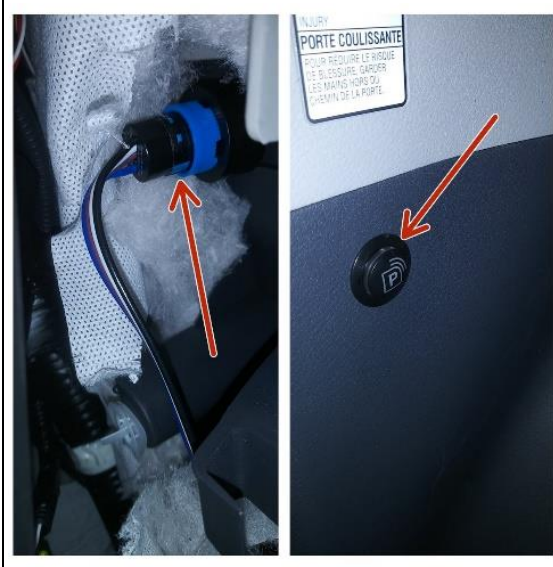
- l) Remove the Toyota factory quarter trim front panel assembly RH (refer to TIS repair manual).
- m) If the ParkSmart option is installed in the front of the RH quarter panel, disconnect its wires (VMI Conversion, picture to the left).

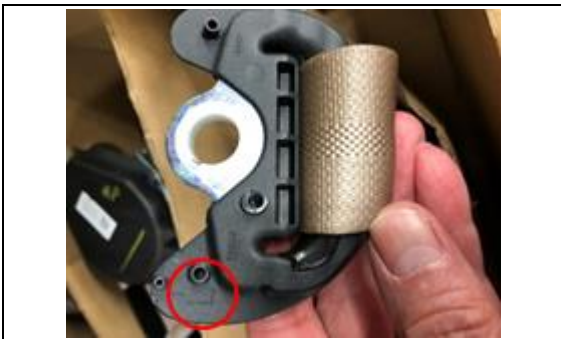
1. CONFIRM THE “L” OR “R” MARK ON **NEW** SEAT BELT

**STOP** DO NOT install seat belt on incorrect side

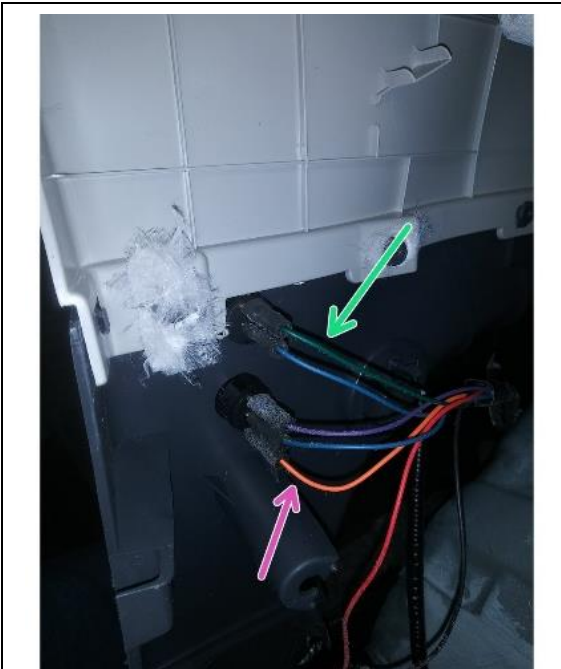
- g) Connect the wires for Ramp (pink arrow) and *Sure Deploy* (green arrow) switches in the LH quarter panel trim as shown (VMI conversion, picture to the left).
- h) Install the Toyota factory quarter trim front panel assembly LH (refer to TIS repair manual).

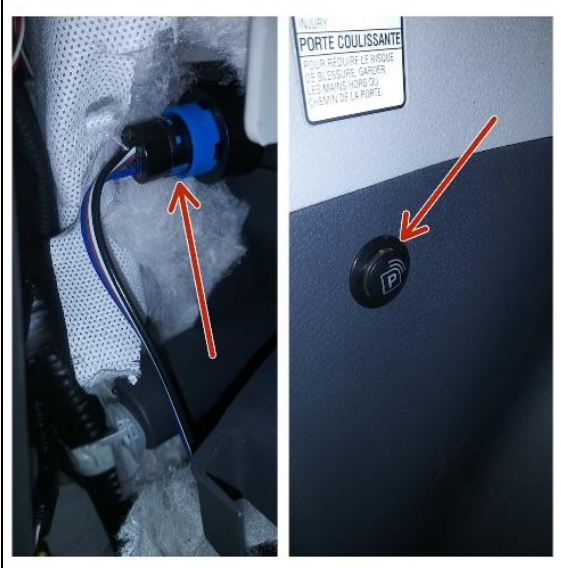
- i) Reconnect the ParkSmart button wires if vehicle is equipped with this option (VMI conversion, picture to the left).
- j) Install the Toyota factory quarter trim front panel assembly RH (refer to TIS repair manual).

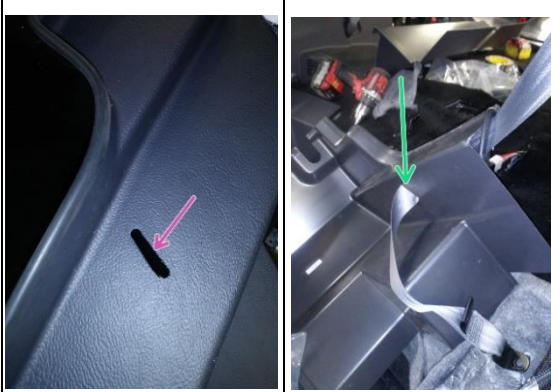
- p) Thread the seatbelt through the slot in the VMI C-corner plastic (VMI conversion, picture to the left).

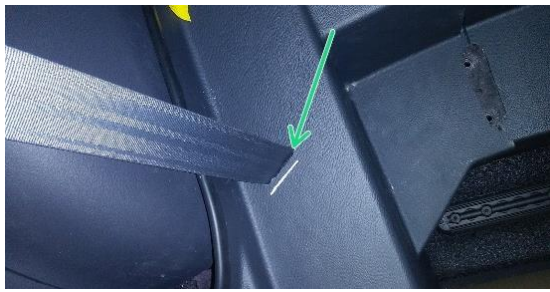
- q) Align the lower seatbelt bracket at the approximate angle matching the slots in the VMI C-corner plastics (VMI conversion, picture to the left).

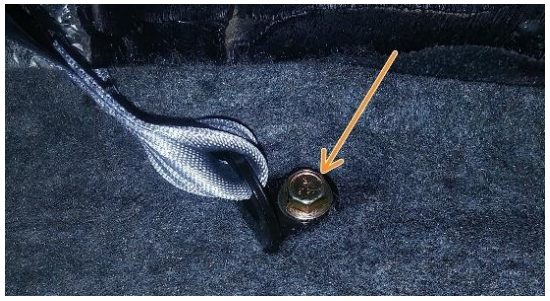
- r) Install floor anchor bolt (VMI conversion, picture to the left).

**Torque:**

**42 Nm (428 kgf cm, 31 ft lbs)**

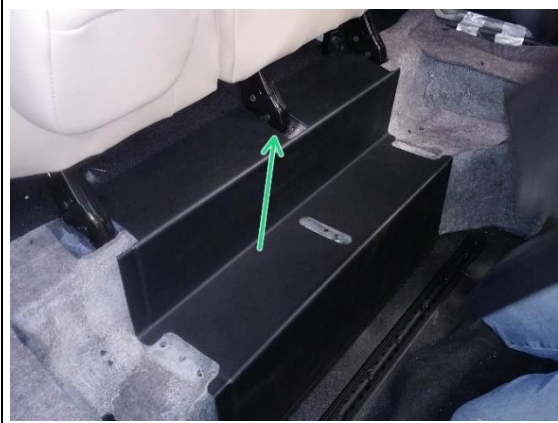
- a) Position the C-Pillar Middle Trim, MP9515 so it fits between the rear bench dog bone mounting points.

NOTE: Rear bench is not installed at this point.

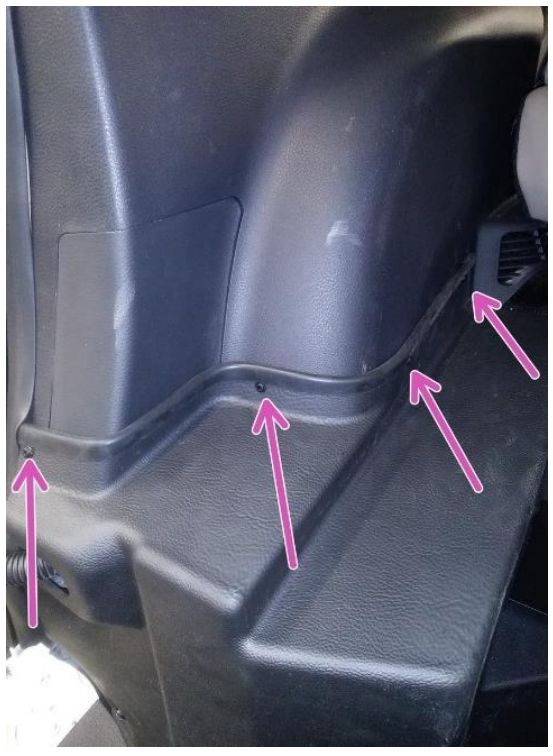
- c) Reinstall the 4X Self Tap Screws into the LH C-pillar plastic using the existing holes.

NOTE: Ensure the middle C-plastic is sitting flat with no bulges and is behind the corner plastics.

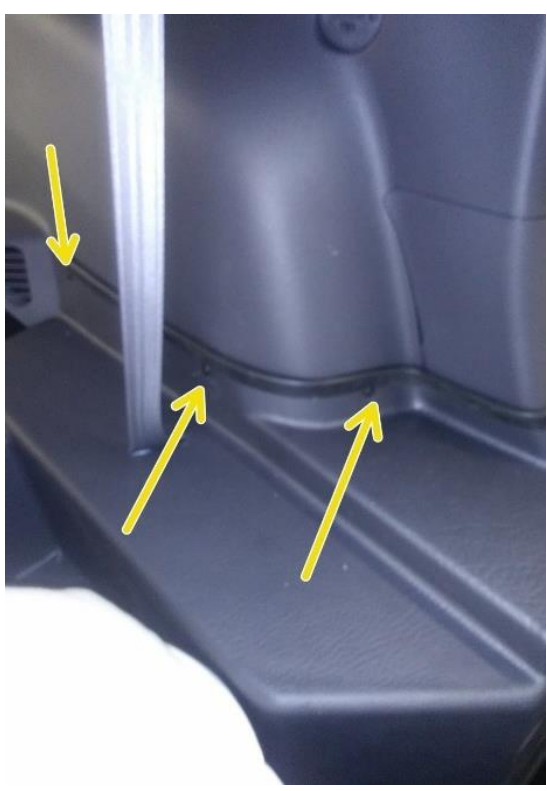
d) Reinstall the 4X Self Tap Screws into the RH C-pillar plastic using the existing holes.

NOTE: Ensure the middle C-plastic is sitting flat with no bulges and is behind the corner plastics.

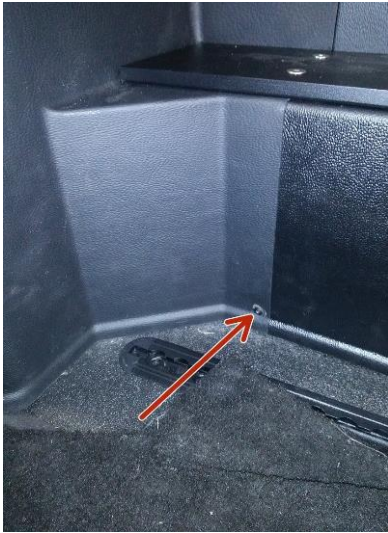
e) Reinstall the lower screw joining the middle C-plastic to the corner plastics (LH)

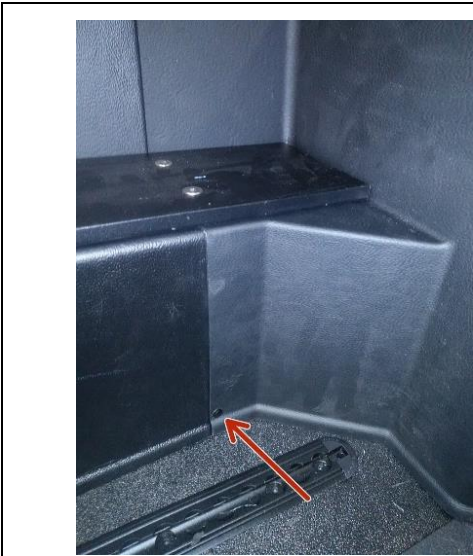
f) Reinstall the lower screw joining the middle C-plastic to the corner plastics (RH)

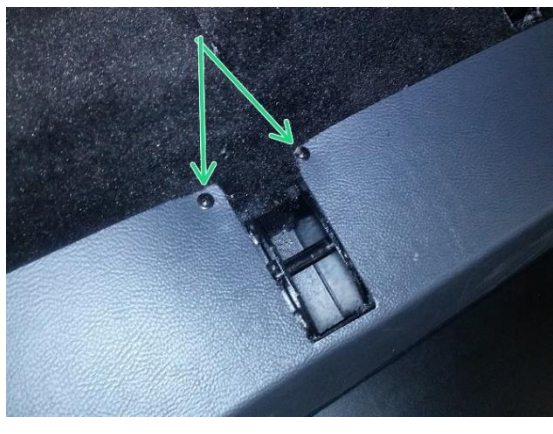
g) Reinstall the upper two screws on either side of the middle bench seat dog bone.

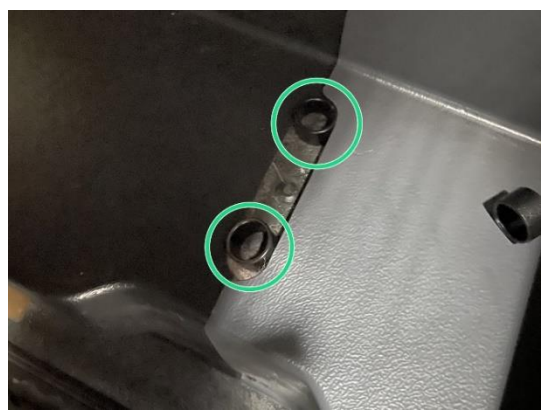
h) Insert the six footrest spacers into the slots in the C-plastics. Align them with the threaded holes in the frame.

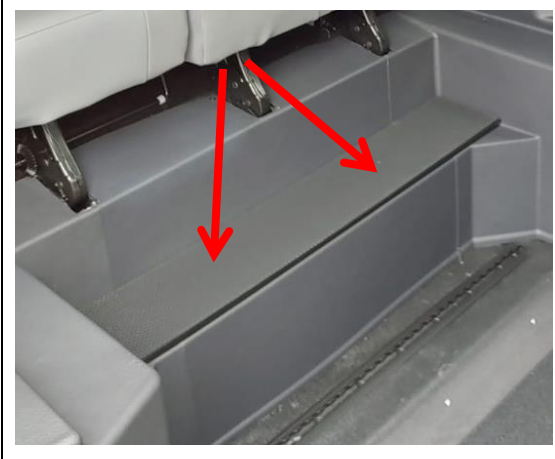
- k) Install a **new** Footrest Microspike FN1628 strip on top of the footrest bar, being careful to align all corners.

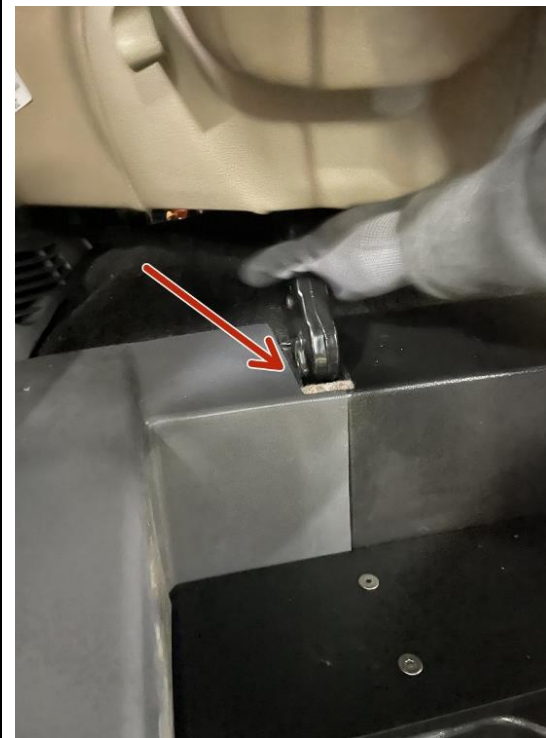
a) Install the front legs of the 3<sup>rd</sup> row bench seat in their dog bones.

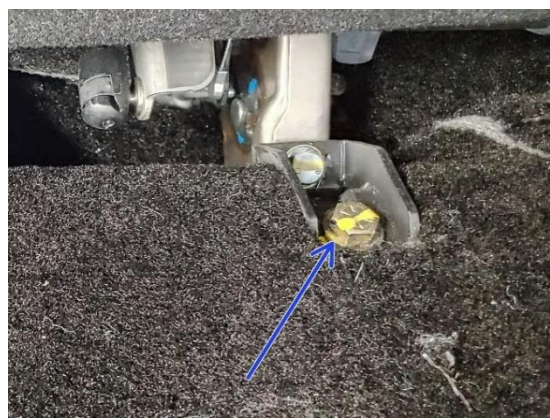
c) Reinstall washer and bolt for rear bench brackets

**Torque:**  
**42 Nm (428 kgf cm, 31 ft lbs)**

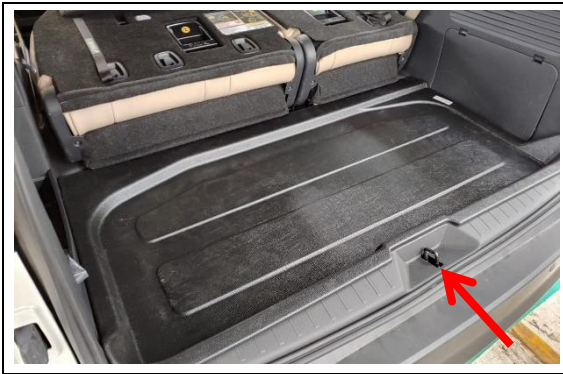
- d) Place the rear cargo cover behind bench and ensure the handle insert locks into place within the cutout in the rear hatch scuff plate.

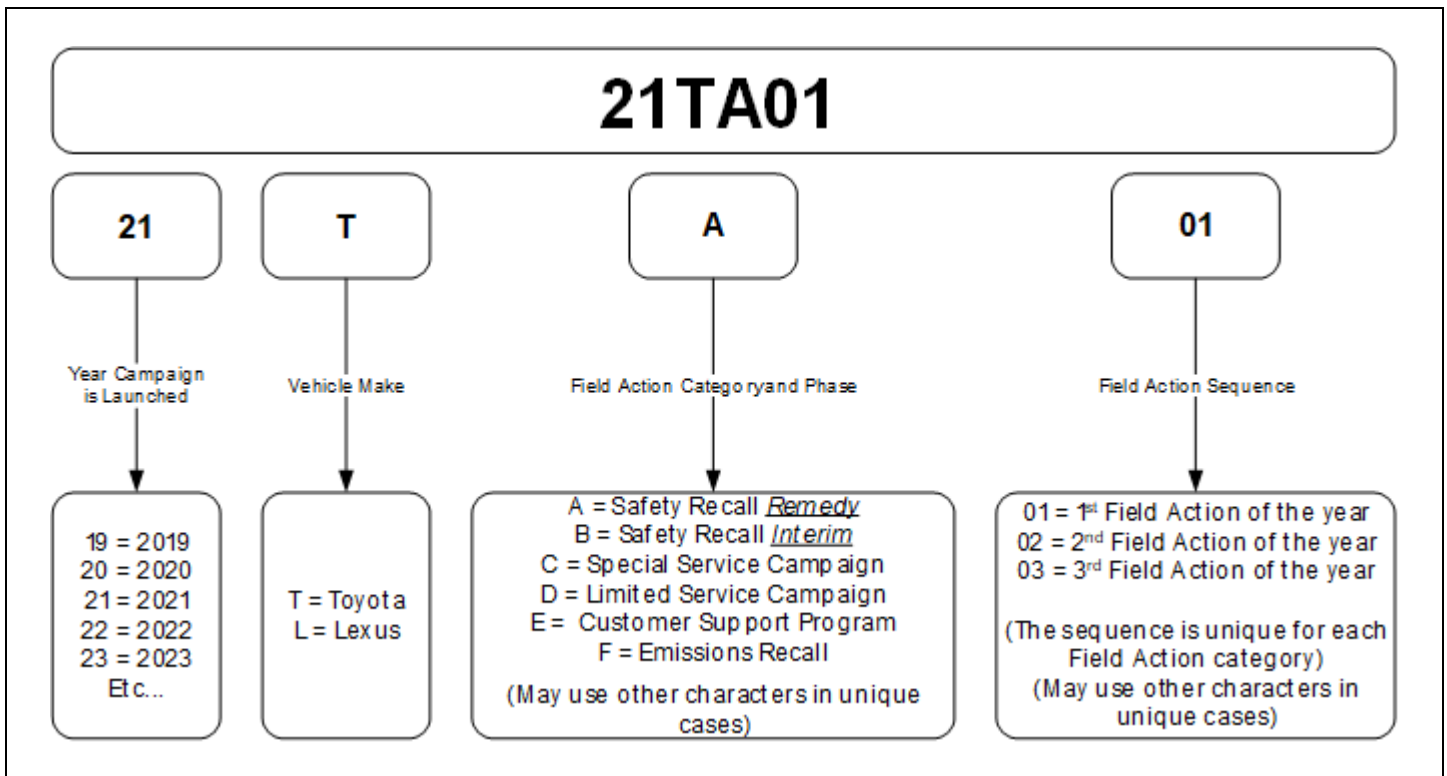
# Campaign Designation / Phase Decoder

**Examples:**

19TA01 = Launched in 2019, Toyota, Safety Recall Remedy Phase, 1st Safety Recall Launched in 2019
