GROUP	MODEL
FMVSS Noncompliance Recall Campaign	2020MY Cadenza (YG) w/Technology Trim
NUMBER	DATE
SC225	March 2022

REAR POWER WINDOW OPERATION LOGIC IMPROVEMENT (SC225)

This bulletin provides the procedure to update the software logic for the rear power window operation in the Driver Door Module (DDM) system on certain 2020MY Cadenza (YG) vehicles, produced from April 1, 2020 through October 15, 2020, equipped with the "Technology" Trim Package. The logic that deactivates rear power window operation after the ignition is turned 'OFF' and a front door is opened was not applied to the subject vehicles. As a result, the rear power windows can be operated by the driver's power window main switch even after the ignition has been turned 'OFF' and a front door is opened. Due to this condition, the subject vehicles do not comply with the operating requirements of Federal Motor Vehicle Safety Standard (FMVSS) 118, "Power-Operated Window Systems". The ability to operate the rear power windows after the ignition switch is turned 'OFF' and a front door is opened increases the risk of injury due to accidental or unintentional operation. Follow the procedure outlined in this publication to app

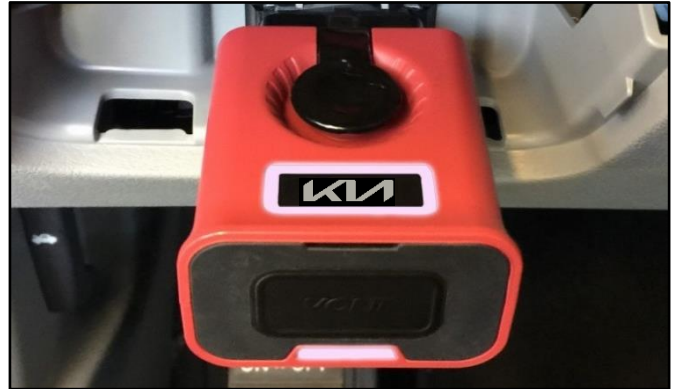
2. With the ignition ON, turn ON the KDS tablet. Select 'KDS' from the home screen.

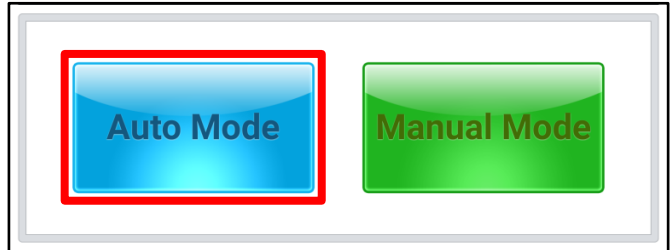
- Select the DDM (D) system under the System selection menu. Confirm that the latest update is available.

Select Upgrade Event #600 and select Upgrade to continue.

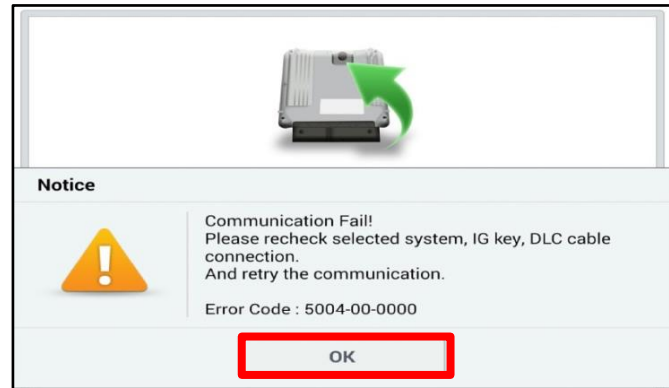
10. When instructed on the KDS, turn the ignition OFF for ten (10) seconds then back on. Select 'OK' to continue.

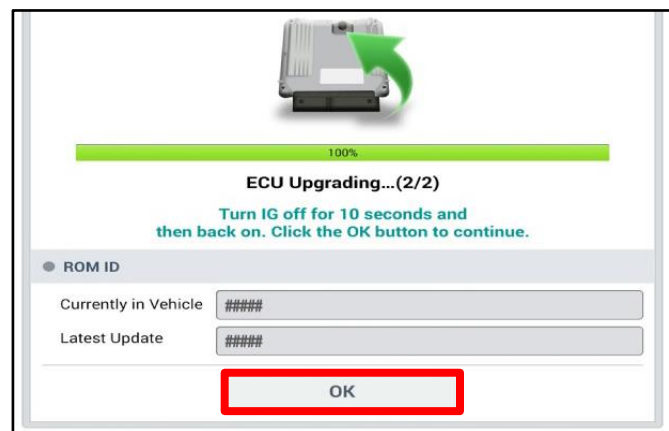
11. Once the upgrade is complete, select 'OK' to finalize the procedure.

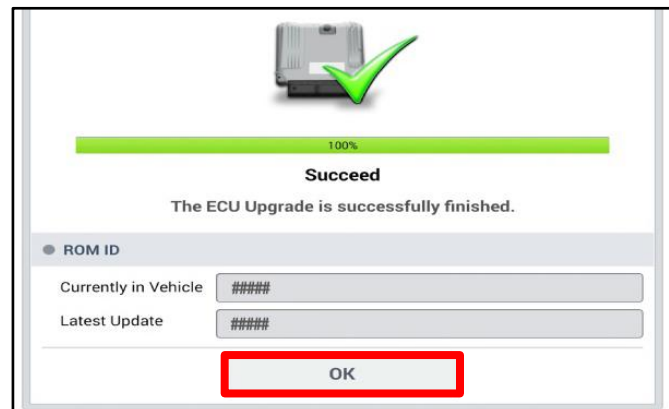
12. When prompted, select 'YES' to check for Diagnostic Trouble Codes (DTC) and erase any DTCs stored such as EPS, ESC, and TPMS that may have been set during the upgrade.
