Technical Service Bulletin

RECALL 22-01-049H

SUBJECT: IONIQ 5 SHIFT BY WIRE CONTROL UNIT (SCU) UPDATE

Description: This bulletin provides information related to the SCU (Shifter Control Unit) software update for IONIQ 5(NE1) vehicles. This SCU update addresses a condition with the electronic parking pawl actuator control. A voltage fluctuation may occur with the vehicle off and in the Park (P) position, which could impact the command signal from the SCU to the parking actuator, resulting in momentary disengagement of the parking pawl and potential vehicle rollaway.

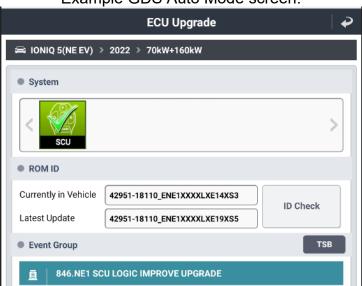
Event#	Description
846	NE1 SCU LOGIC IMPROVE UPGRADE

Example GDS Auto Mode screen:
