**TECHNICAL INSTRUCTIONS
FOR
SAFTY (NONCOMPLIANCE) RECALL 22LA04**

Electronic Parking Brake (EPB) May Not Engage or Disengage Properly

**Certain 2022 Model Year NX 250
Certain 2022 Model Year NX 350**

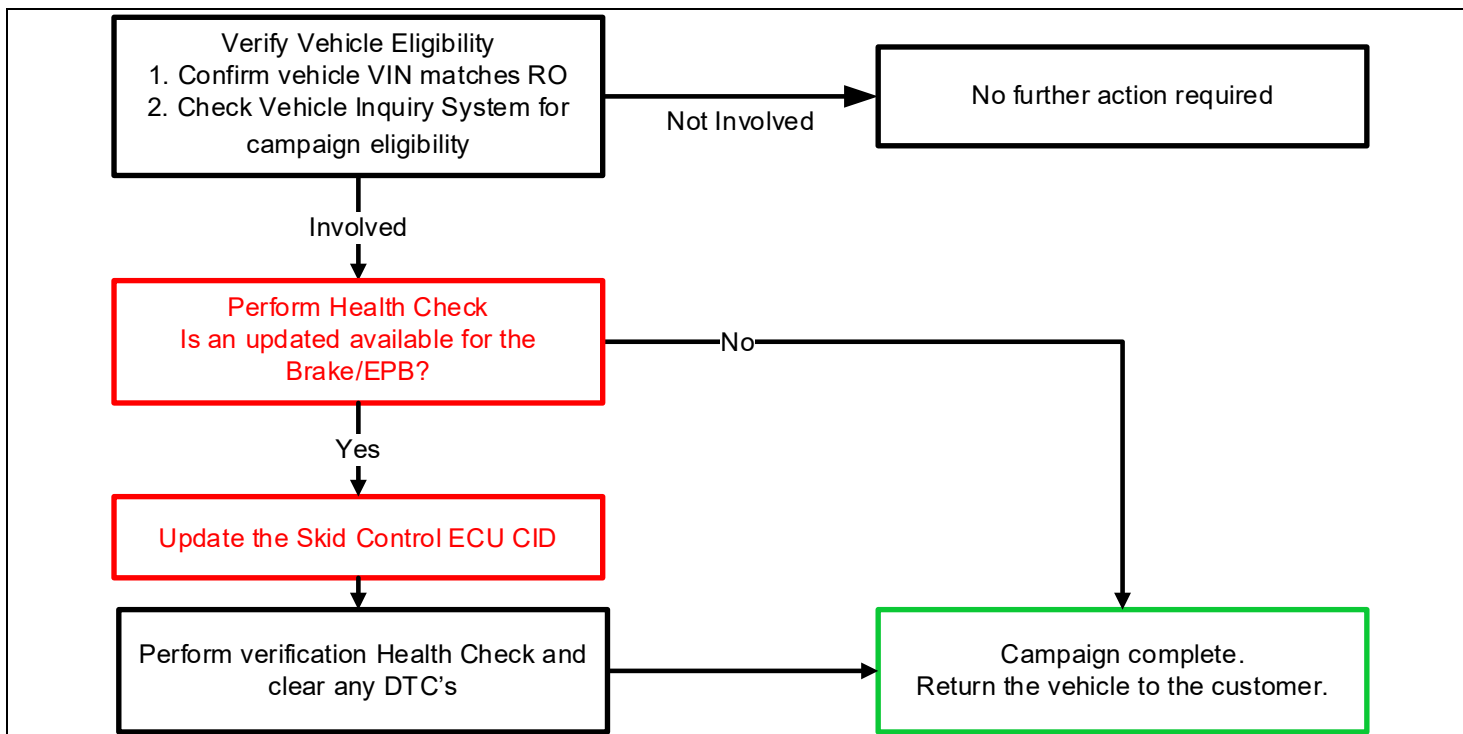
I. OPERATION FLOW CHART

The flow chart is for reference only. **DO NOT** use it in place of the full technical instructions. Follow **ALL** steps as outlined in the full technical instructions to confirm the campaign is completed correctly.

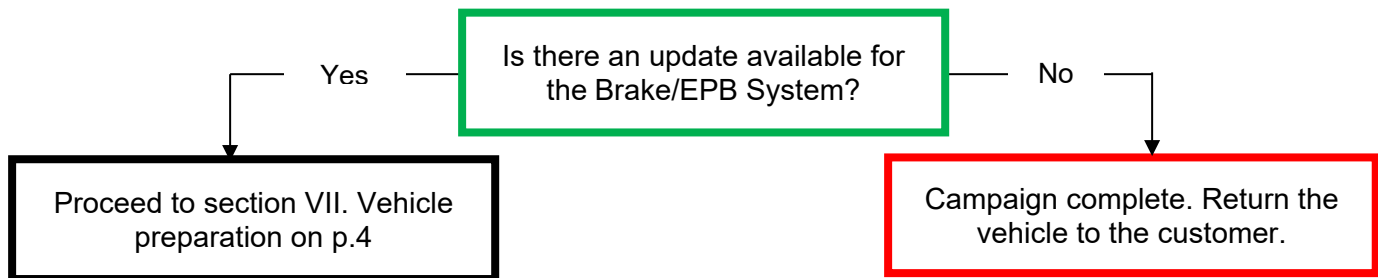
2. CHECK CURRENT CALIBRATION

- Locate the Update column for the Brake/EPB System in the Stored Data tab for this vehicle.
- Determine the status of an available update; indicated by a YES or NO.

If the CID's indicate 'Yes', proceed with the update procedure.

System	RoB	Calibration	Update	Configure
Brake/EPB	●	*****	Yes	No
Power Window Drive	●	8A270F602100	No	No
Tire Pressure Monitor	●	897AF0201100	No	No
Circumference Monitoring Camera Control Module	●	8679F7816001	No	No
Front Recognition Camera	●	8679F7824011	No	No
Front Radar Sensor	●	8679F7816021	No	No
Clearance Warning	●	8646F7805400	No	No
	●	8821F7801100	No	No
	●	8934F7817040	No	No

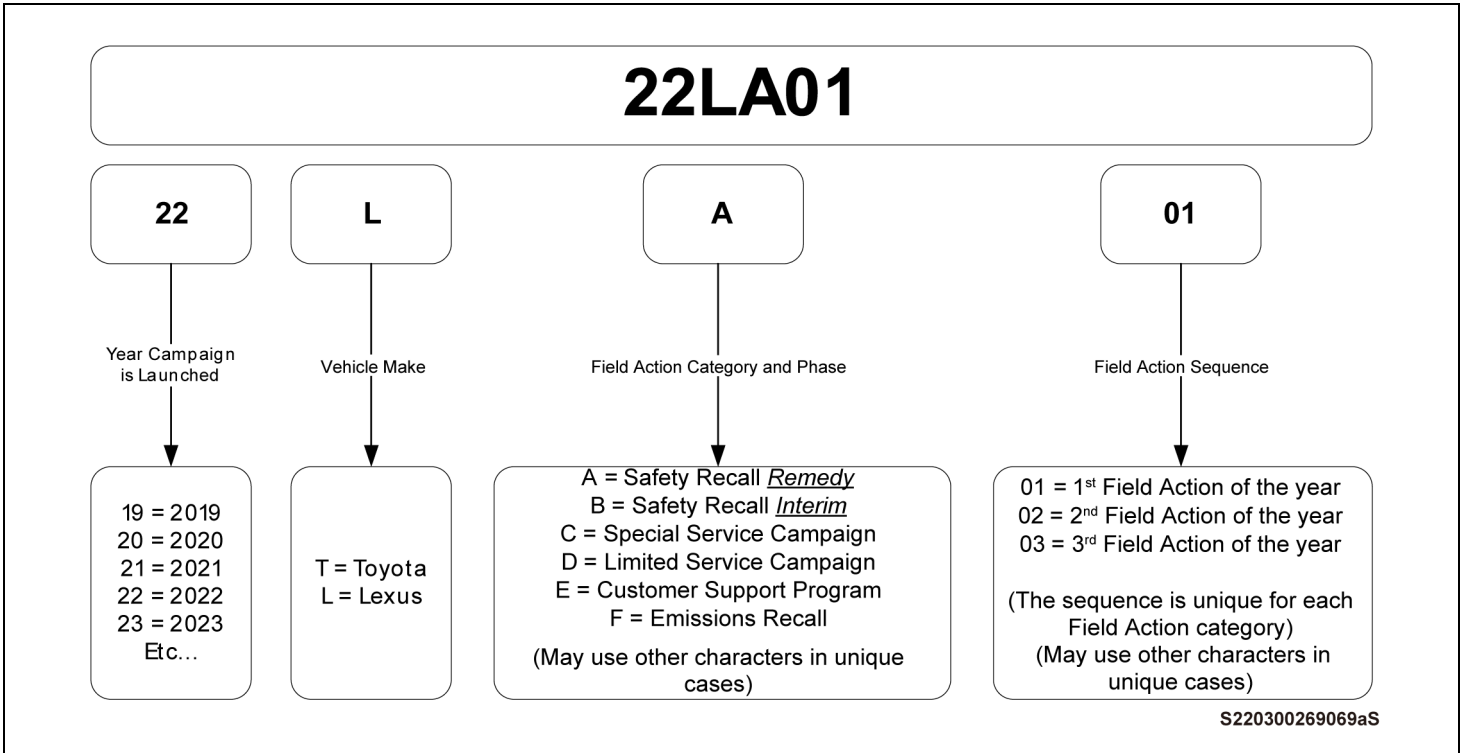
A. CAMPAIGN DESIGNATION DECODER

Examples:

19TA01 = Launched in 2019, Toyota, Safety Recall Remedy Phase, 1st Safety Recall Launched in 2019
