Compliance Recall

Code: 91EG

Subject Rearview Camera Software

Release Date January 10, 2023

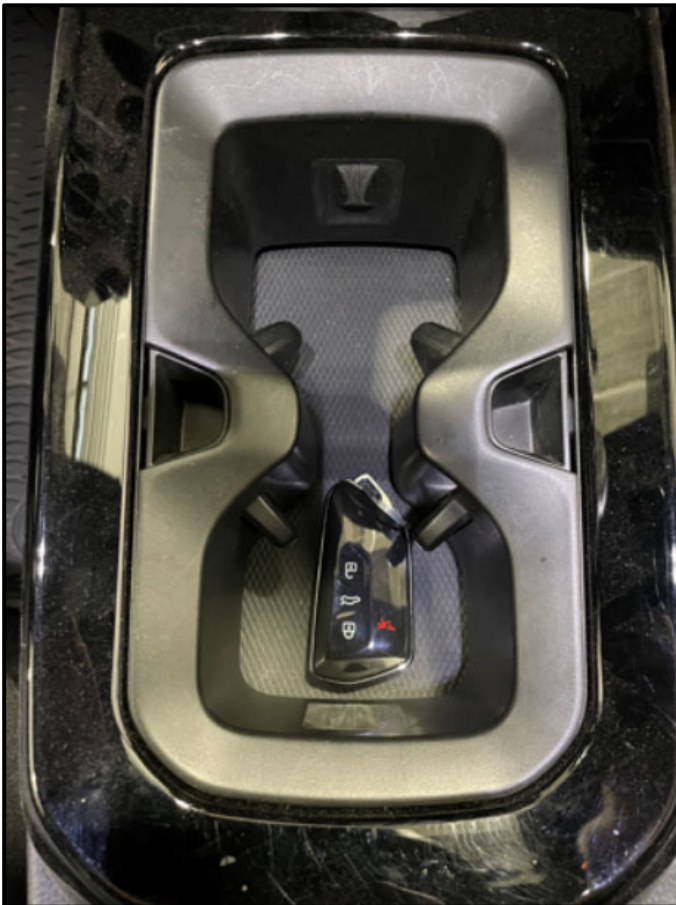
- Place the vehicle key over the reader coil in the center console cupholder.
- Any additional keys must be a minimum of 20 meters away from the vehicle.

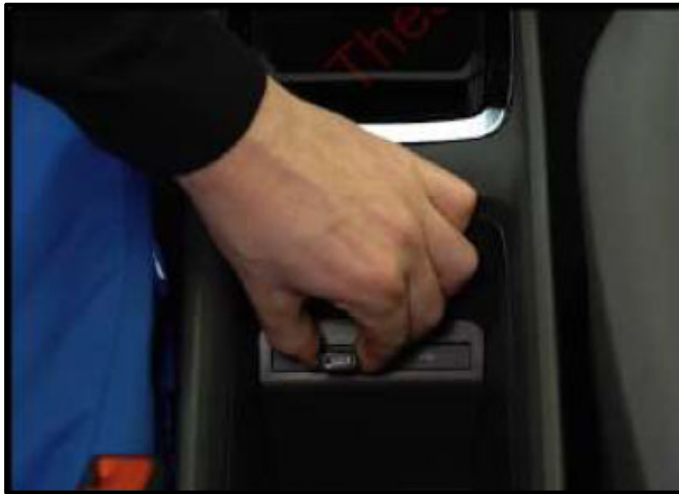
- Insert the USB drive into one of the USB ports.
- Turn the ignition ON.

The radio display may display “No playable content” when the ignition is turned on. This is normal. DO NOT remove the USB drive from the USB port.

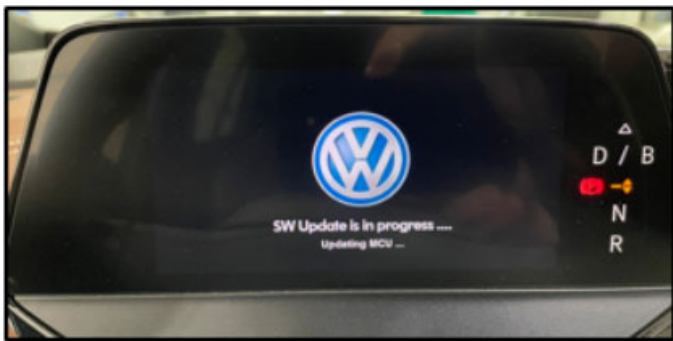
- The update will start on its own after about two minutes.
- During the update, the instrument cluster display will change multiple times.
