Compliance Recall Code: 45J6

TPMS Software

November 09, 2022

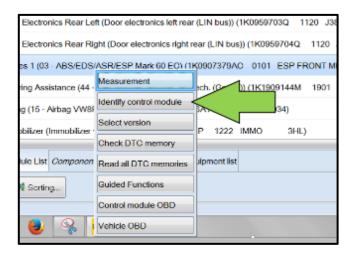
- It is <u>IMPERATIVE</u> that <u>ALL</u> of the ignition cycle on/off delay requests are fulfilled in their entirety during this flash process <arrow 1>.
- Failing to wait for the ignition on/off timing cycle to complete (progress bar and countdown timer <arrow 2>) before cycling the ignition on/off MAY damage a control module.
- Damage to control modules as a result of failing to wait the specified time displayed by the progress bar and countdown timer
 <arrow 2> are <u>NOT</u> covered under this action.
- After the software update is completed and before sending the GFF Log Online:
 - Select the "Control Module" tab.
 - Scroll down and right click on the module that was updated (0003).
 - Select "Identify Control Module" <arrow>.
