# Product Safety Recall

## N232396501 ABS Module and Frontview Camera Module Reprogramming

Release Date: August 2023

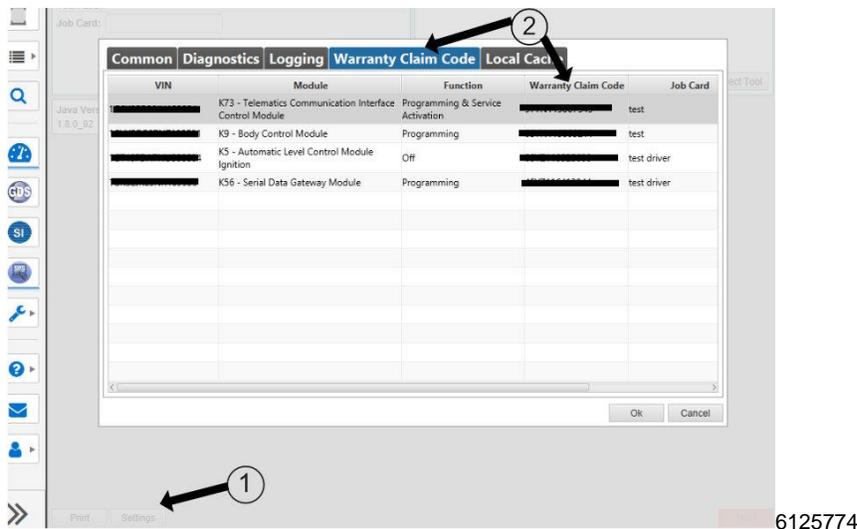
1. Open TLC on the computer used to program the vehicle.
2. Select and start SPS2.
3. Select Settings (1).
4. Select the Warranty Claim Code tab (2).

The VIN, Warranty Claim Code and Date/Time will be listed on a roster of recent programming events. If the code is retrievable, dealers should resubmit the transaction making sure to include the code in the SPS Warranty Claim Code field.

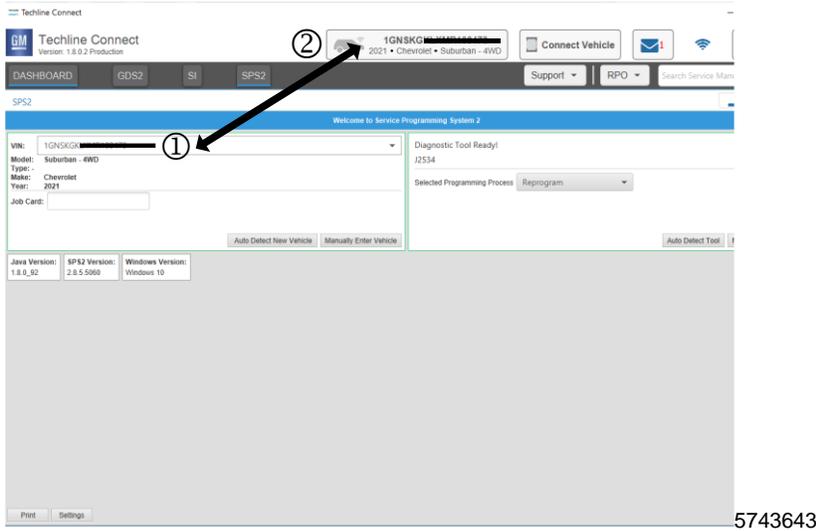
**Caution:** Be sure the VIN selected in the drop-down menu (1) is the same as the vehicle connected (2) before beginning programming.

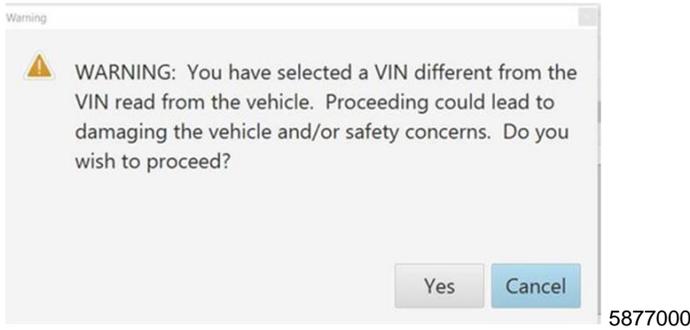
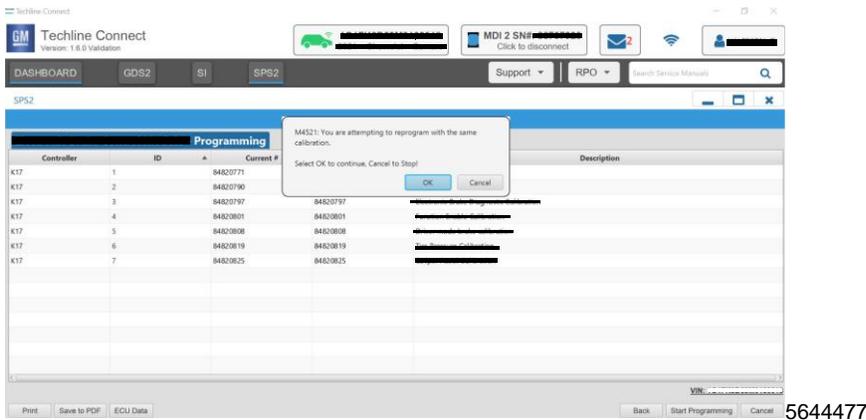
**Important:** If the vehicle VIN DOES NOT match, the message below will be shown.

**Important:** Techline Connect screens shown above.

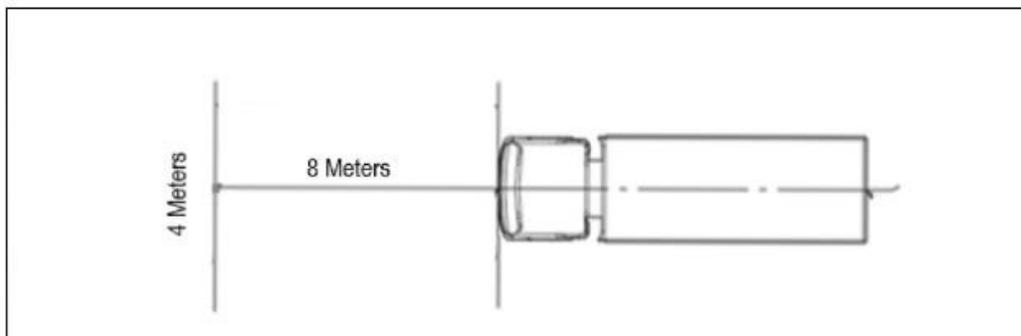
6283437

1. Ensure the Vehicle is not loaded. Position the vehicle on a flat, even, hard, and level surface. Ensure that there is at least 8.0 Meters (26.5 feet) of flat, even, hard, and level surface directly in front of the vehicle. This area must be clear of all objects (shop equipment, poles, other vehicles, etc.) at least 2 meters (6.5 feet) from each side of the centerline of the front of the vehicle. Ensure the parking brake is set.
2. Ensure that the windshield is clean, and the wheels are straight ahead.

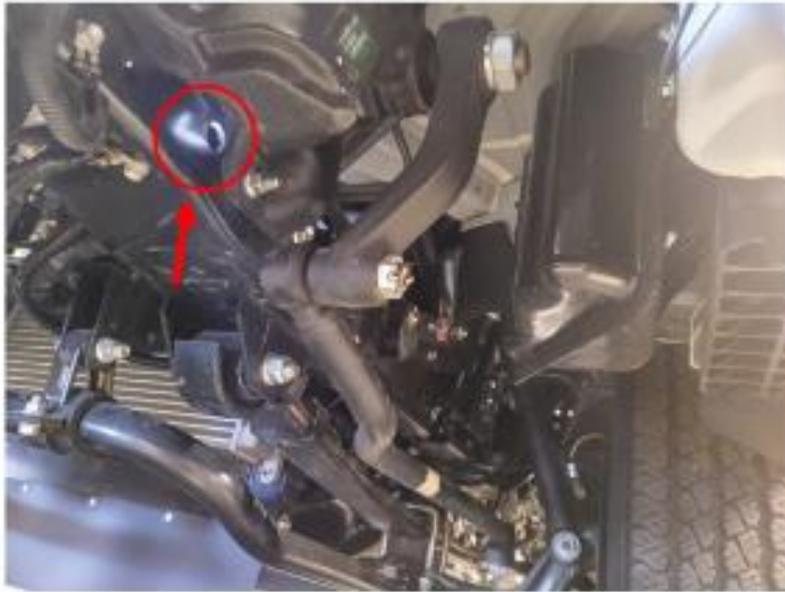
6283438

4. Locate the hole behind the steering gear on the Left-Front of the frame.
5. Pass one of the Plumb Bob (Special Tool GE-53292) strings through the hole from the outside of the frame.

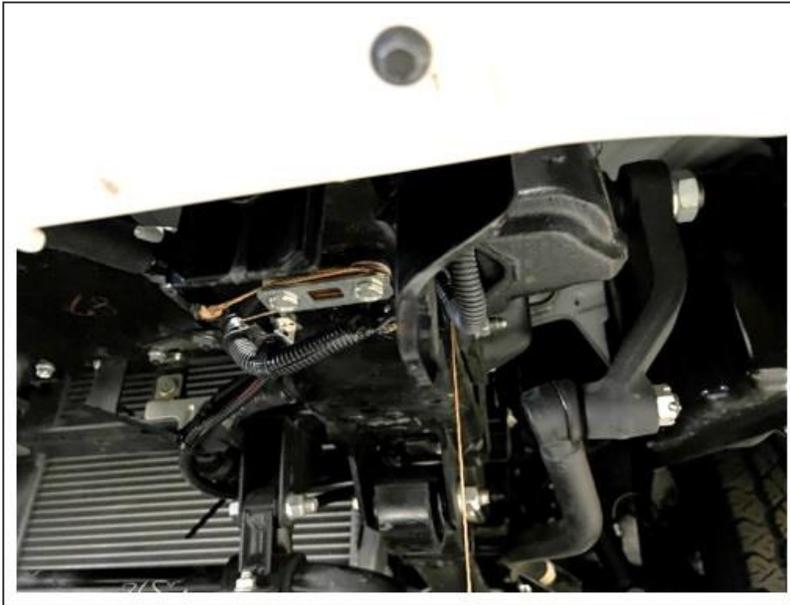
6283439

6. Pull the Plumb Bob string through until the point of the weight is barely above the floor. Tie off the string by looping it around the bolts as shown.

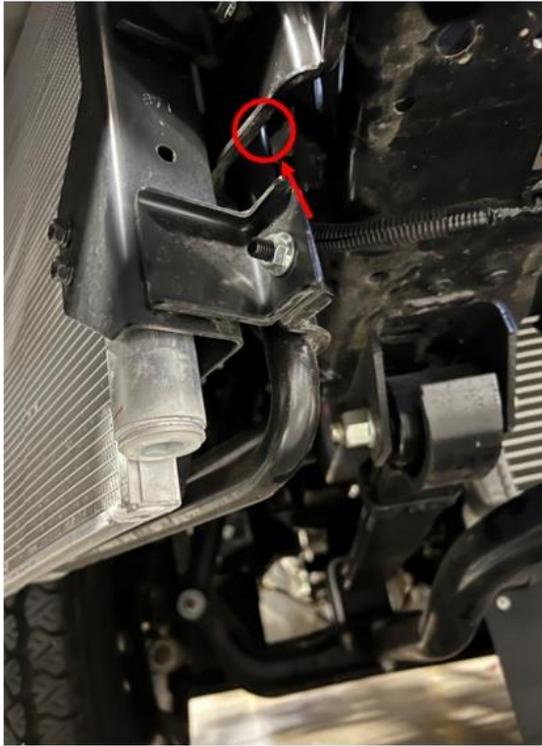
6283440

7. Locate the matching hole on the passenger side of the frame, which is behind the air conditioning condenser assembly.
8. Pass the string of the other Plumb Bob (Special Tool GE-53292) through the hole from the outside of the frame.

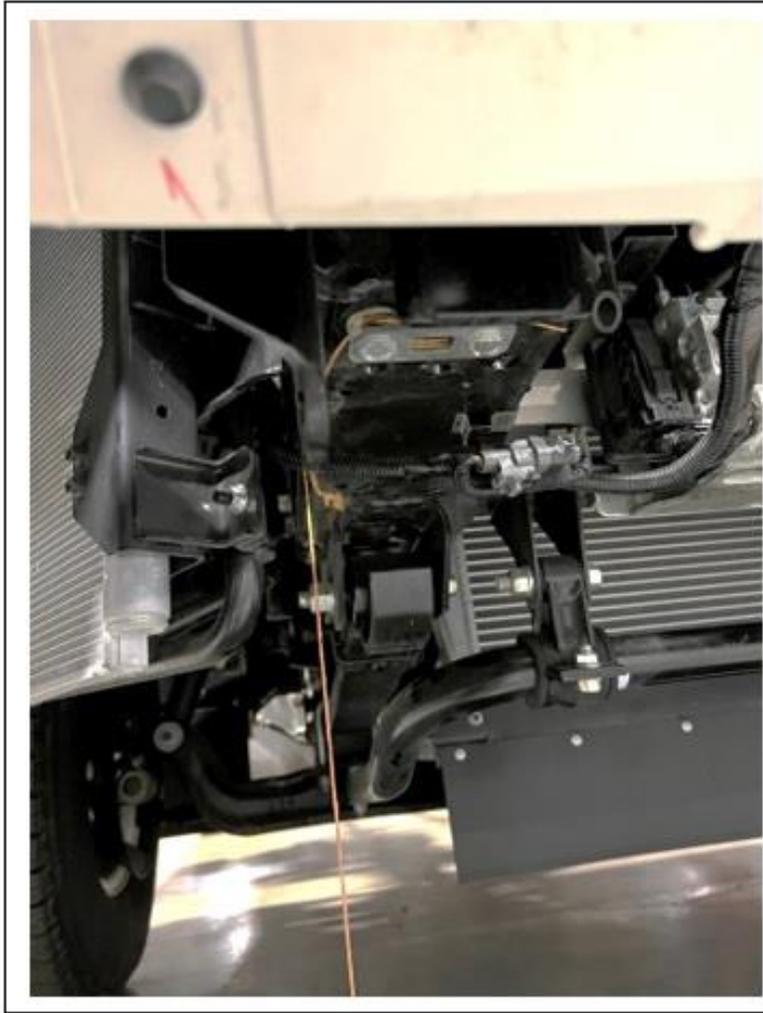
6283442

9. Pull the Plumb Bob string through until the point of the weight is barely above the floor. Tie off the string by looping it around the bolts as shown.

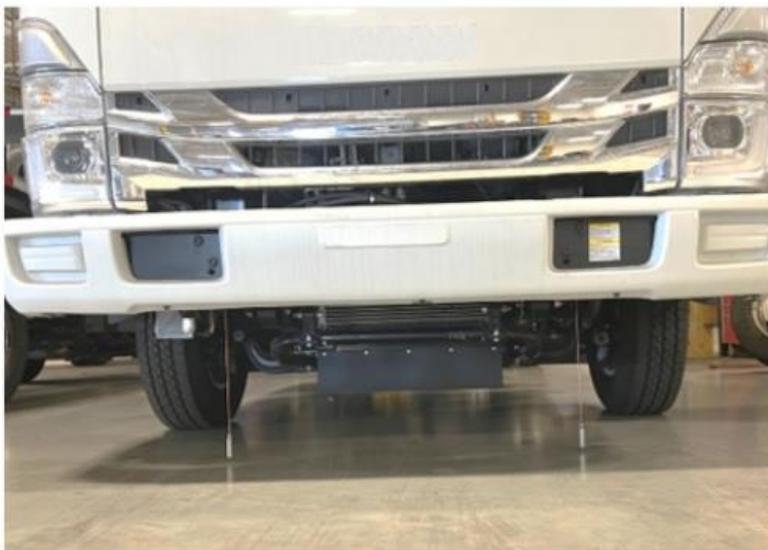
6283443

10. Refer to the picture above for an illustration of both Plumb Bobs correctly in place.

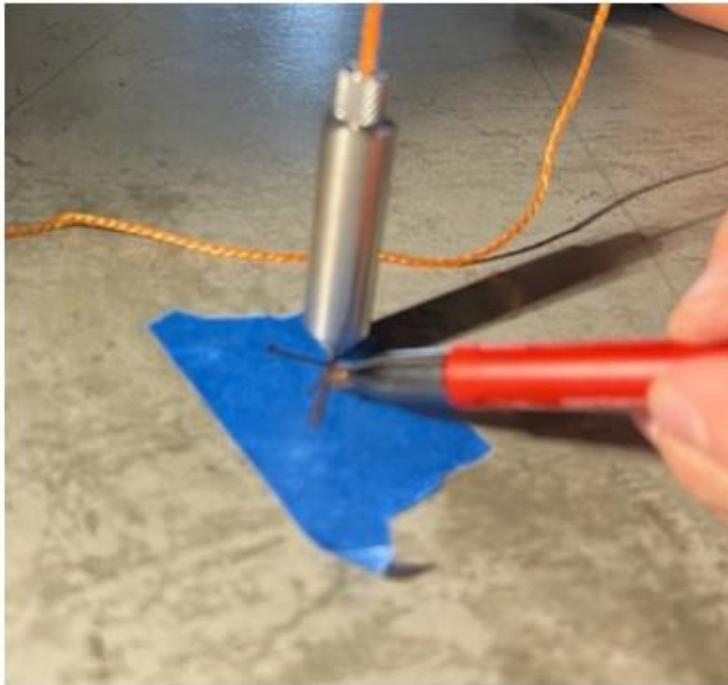
6283444

11. Place masking tape underneath each Plumb Bob weight point. When each of the Plumb Bob weights is still, mark each piece of masking tape with an X directly under the points as shown.

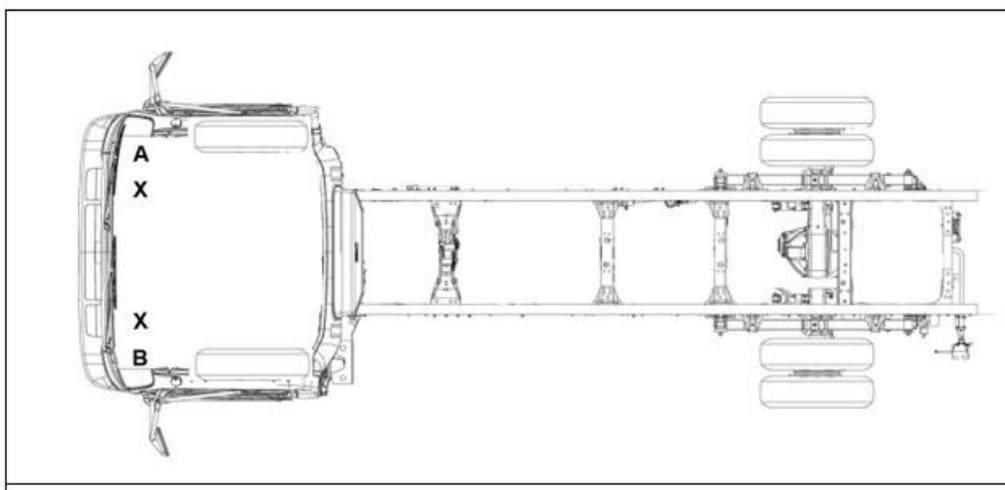
12. When completed there should be 2 Xs under the vehicle as shown labeled A and B.

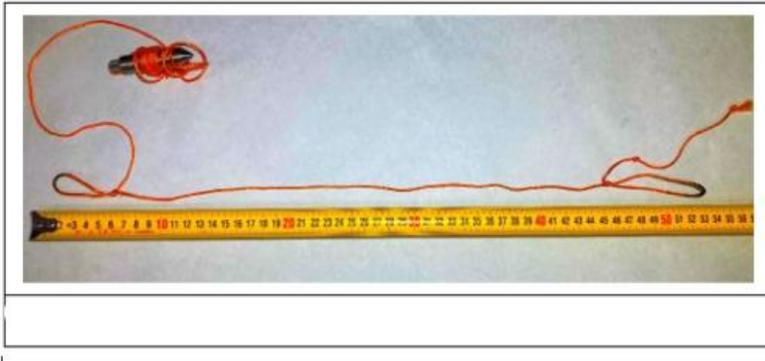
6283446

14. If not already completed per the special tool instructions, make two overhand loops in one of the Plumb Bob strings as shown. The overall length from loop to loop when stretched taut should be approximately 54cm.

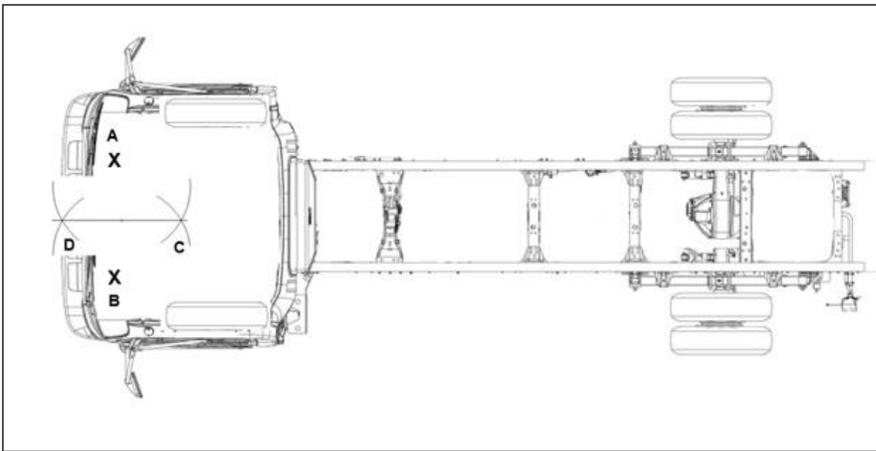
6283447

**NOTE:** When performing Steps 15 – 20, refer to the picture above.

15. Using the Plumb Bob weight point, hold one of the loops steadily on Point (A) made on the passenger's side of the vehicle. Place the capped marker pen into the other loop and put the string taut. Pull the taut string towards to the rear-center of the vehicle to make an estimation of where the masking tape should be for marking the floor and put down a piece of masking tape.

**Important:** When performing Steps 15 – 20, it is critical that the looped string be held taut. Also, the exact position of the loops on the marker pen and the Plumb Bob point must be kept the same for each Step. Finally, both the Plumb Bob point and the marker pen should be kept completely straight up while performing each Step.

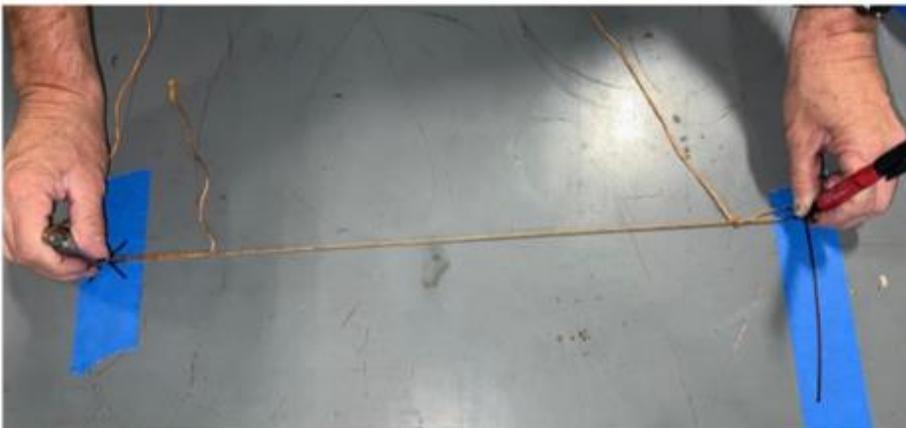
6283448

16. Perform Step 15 again, but with the marker pen uncapped, to create about a 3-inch arc on the masking tape at Point (C).
17. Perform Steps 15 and 16 towards the front-center of the vehicle to create a marked arc on the floor at Point (D).

18. Place the point of the Plumb Bob weight into one loop with the point lightly pressed down directly on the center of Point (B) made on the driver's side of the vehicle. Place the capped marker pen into the other loop and pull the string taut. Pull the taut string towards to the rear center of the vehicle to determine if more masking tape is needed on the floor. Lay down more masking tape as necessary.

19. Perform Step 18 again, but with the marker pen uncapped, to create about crossed arc at Point (C) on the floor.
20. Perform Steps 18 and 19 towards the front-center of the vehicle to create a crossed arc at Point (D) on the floor.

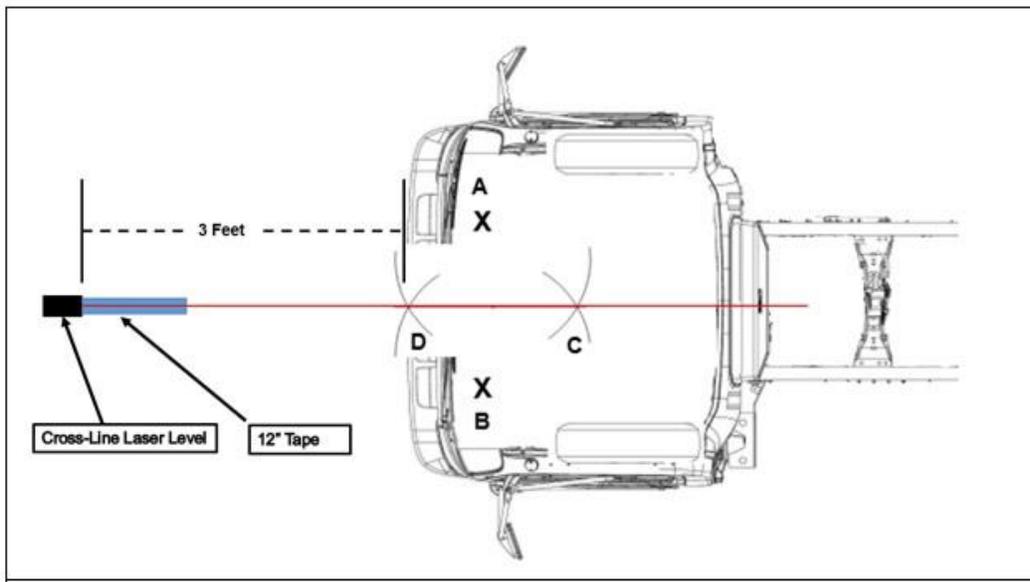
6283449

**NOTE:** When performing Steps 21 – 22, refer to the picture above.

22. With the Cross-Line Laser Level still in place, put down a 12-inch piece of masking tape lengthwise under the laser beam directly in front of the Cross-Line Laser Level. Trace the laser beam line onto the piece of masking tape with a marker pen. This is the Center of the Vehicle reference mark.

21. From about three feet in front of the vehicle use the Cross-Line Laser Level (Special Tool J-53325) to establish the centerline of the vehicle by placing the tool on the floor, turning it on, and aiming the beam directly through the intersection of both points C and D.

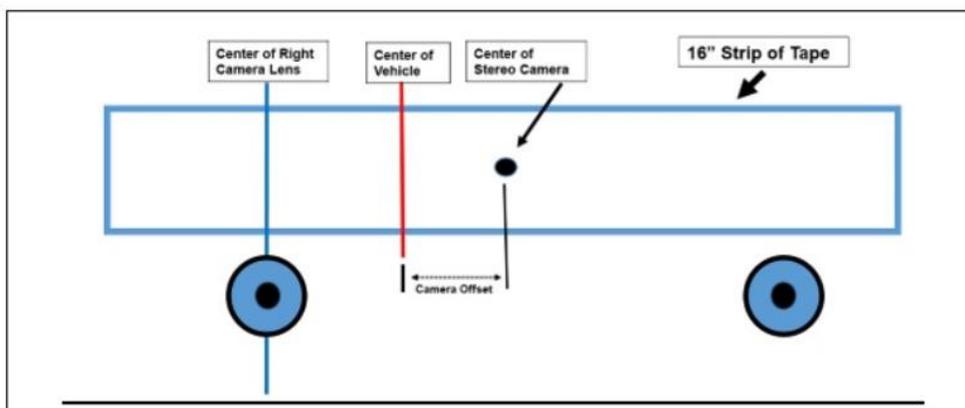
6283451

**NOTE:** For Steps 23 – 29, refer to picture above as a reference.

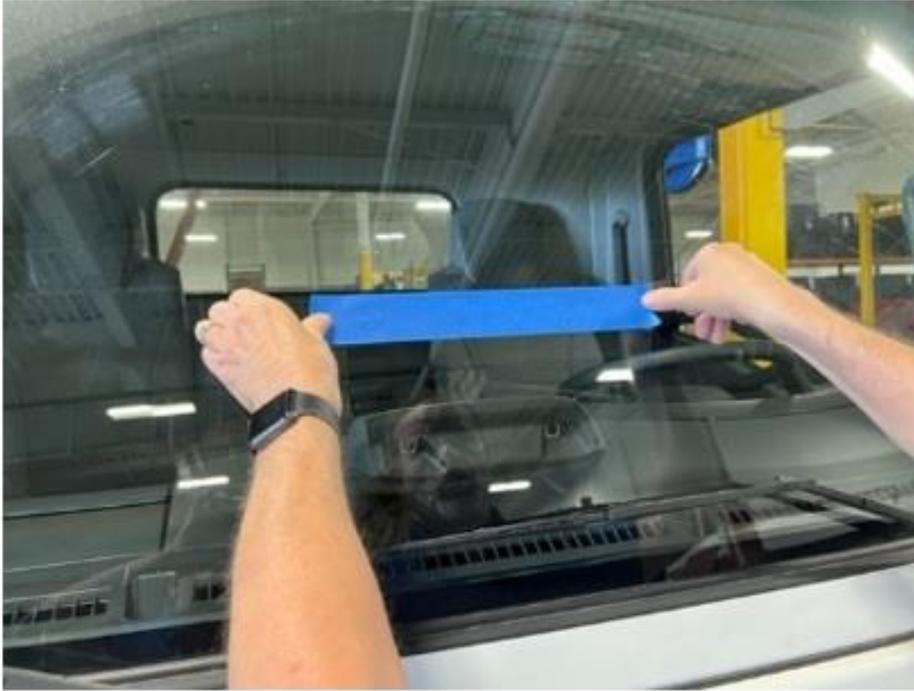
6283452

23. With the Cross-Line Laser Level still in place, lay an approximately 16" strip of masking tape horizontally on the windshield about 4 inches above the front view camera.

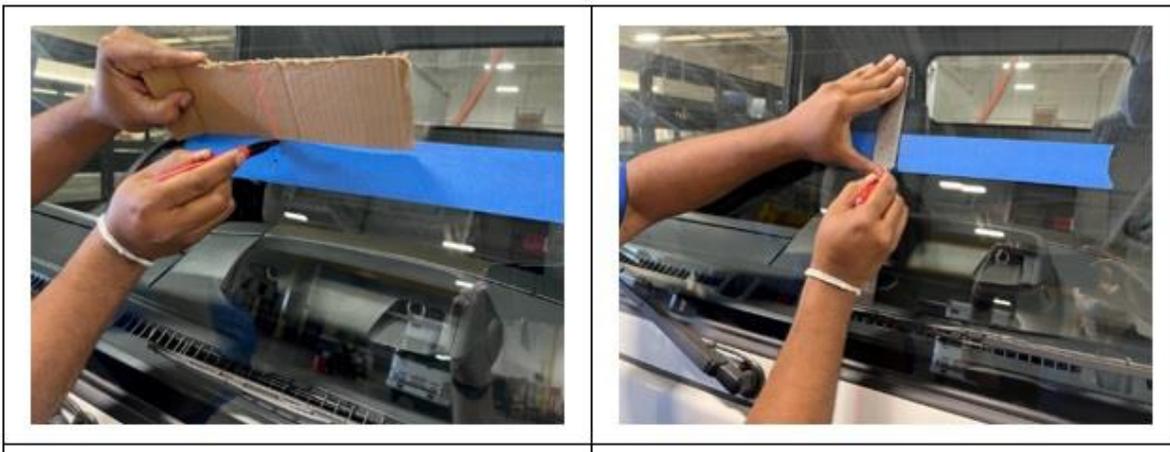
6283453

24. Use a piece of cardboard angled above the masking tape to reflect the laser beam as shown. Use the laser light to mark the center of the vehicle on the masking tape with two dots above each other. Use a ruler to connect the dots into a straight line with a ball point pen. Label this line as the centerline of the truck (C.T.).
25. Use the mount for the Cross-Line Laser Level to attach it to the end of the Target Stand (Special Tool GE-53291) as shown. Which way the laser will have to be mounted depends on how high the Front View Camera is mounted on the vehicle you are servicing.

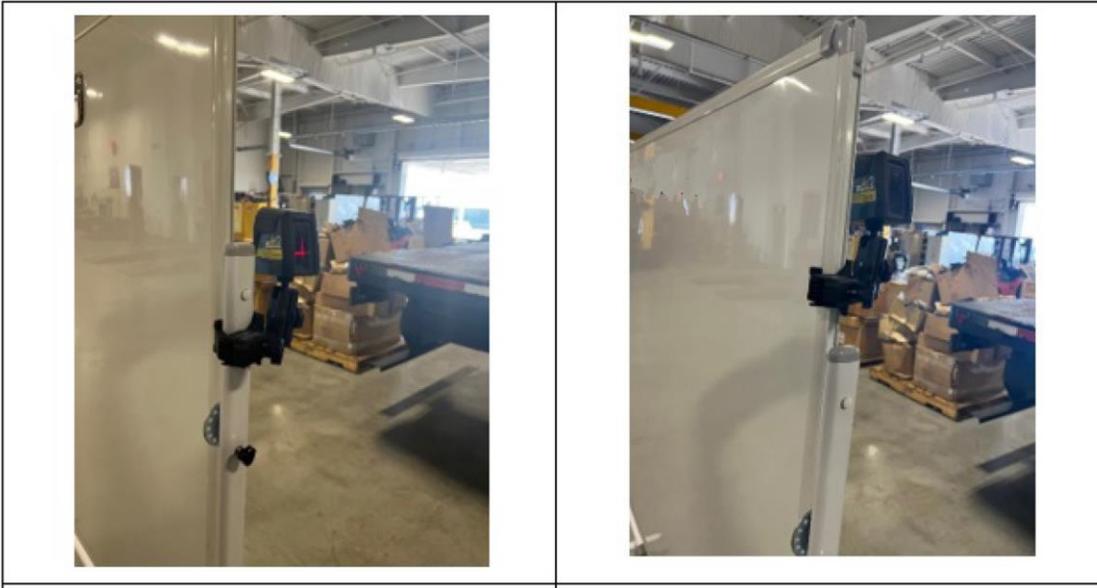
6283456

**Note:** Adjust the Cross-Line Laser Level height as close as possible to the center of the left (passenger) Front View Camera lens. If the laser beams flash at any point during Steps 26 and 27, the Cross-Line Laser Level **MUST** be adjusted so that the angle and height of the horizontal laser beam is more level with the Front View Camera lens.

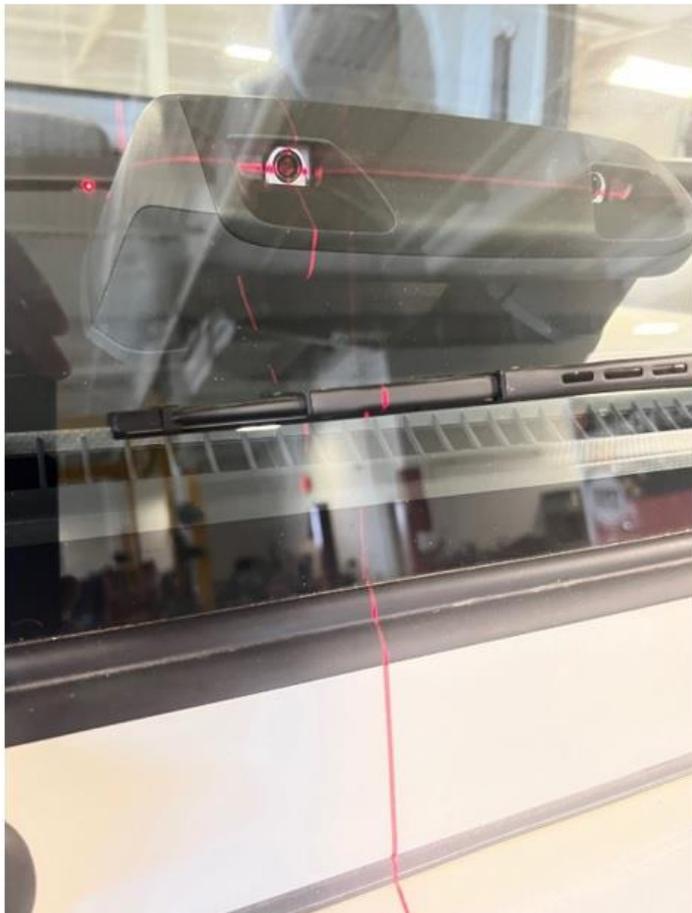
6283458

26. Point the Cross-Line Laser Level at the passenger side Front View Camera lens and adjust the laser until the passenger side lens is bisected vertically and horizontally.

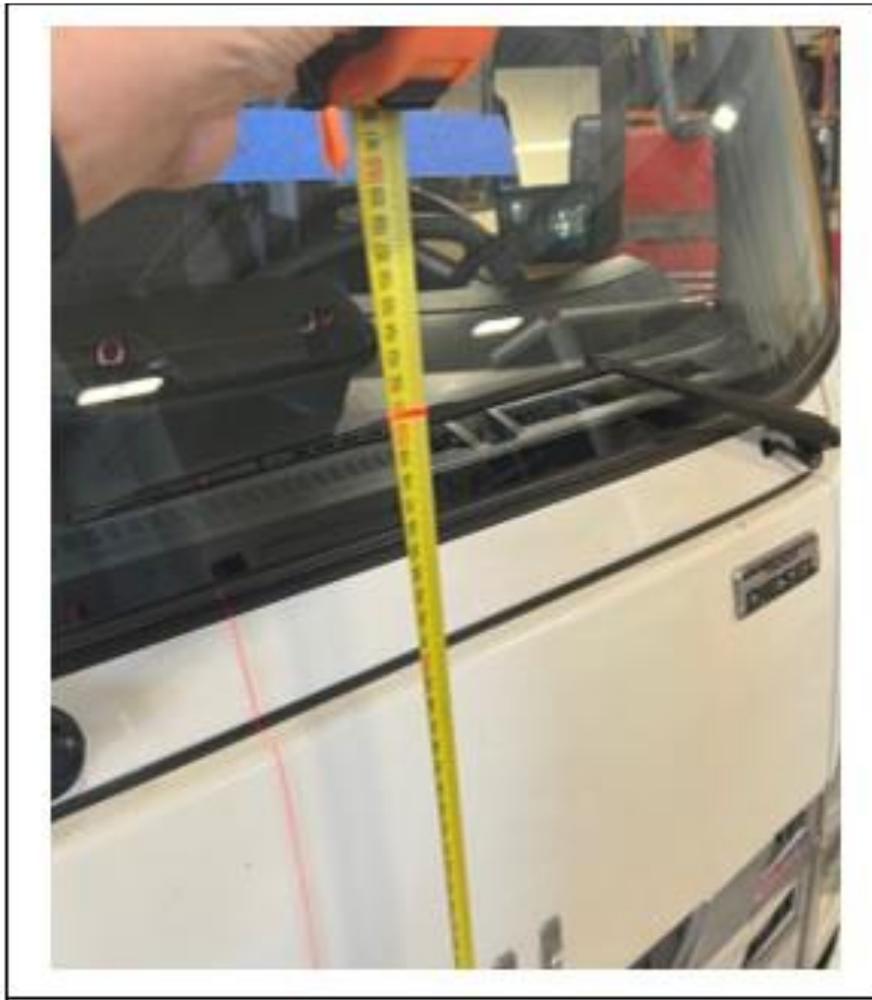
6283459

30. Ensure that the Cross-Line Laser Level is still bisecting the passenger side Front View Camera Lens as shown. Adjust the laser as necessary.

31. Place the end of a tape measure on the floor. Extend the tape measure straight upwards. Record where the horizontal laser beam crosses the tape measure and write it down for later use. This is the height of the camera.

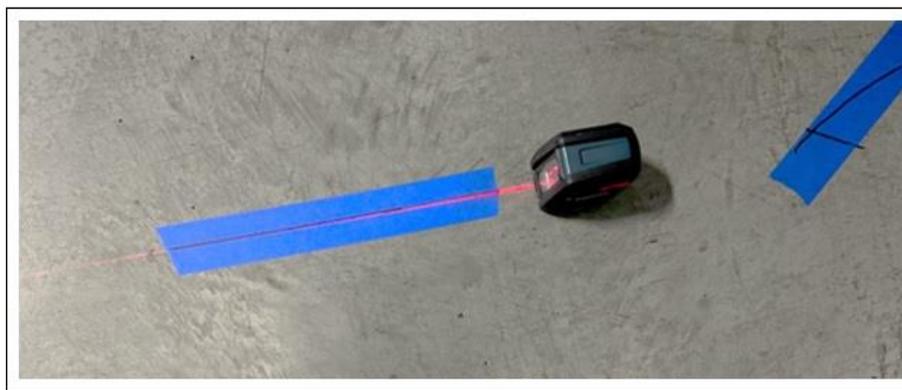
6283460

32. Remove the Cross-Line Laser Level from the Target Stand and the mount. Place the Cross-Line Laser Level on the floor and turn it on facing forward from the front of the vehicle. Align the laser beam with the Vehicle Centerline reference mark made on the floor in Step 22.

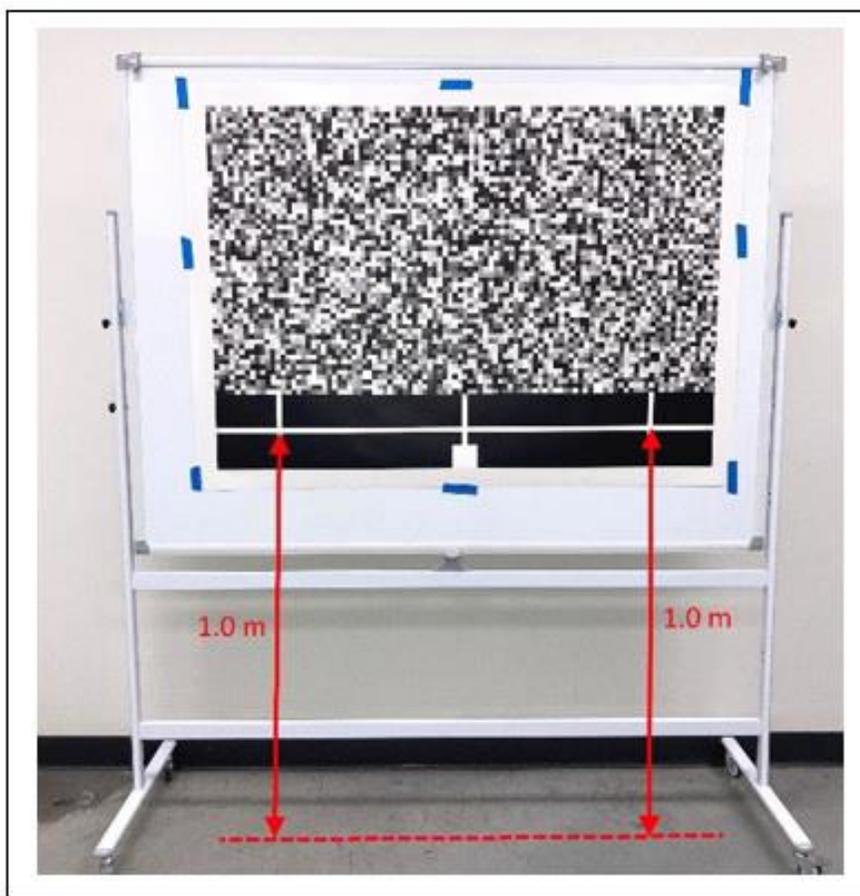
6283461

33. If not already completed per the special tool instructions, attach the Stereo Camera Target (Special Tool GE-53206) to the Target Stand (Special Tool GE-53291). Refer to the picture above and adjust the height of the target so that both ends of the target position line are 1,000mm (1m) above the floor.

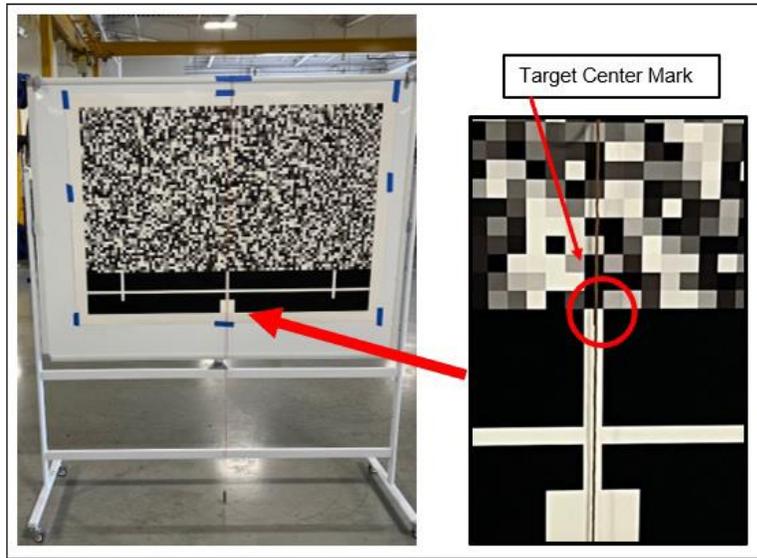
6283462

34. Tape the Plumb Bob string without the loops to the top of the Target Stand. The Plumb Bob string must pass directly through the center of the Target (over the small center mark) as shown above. The Plumb Bob weight point should barely be off the floor.

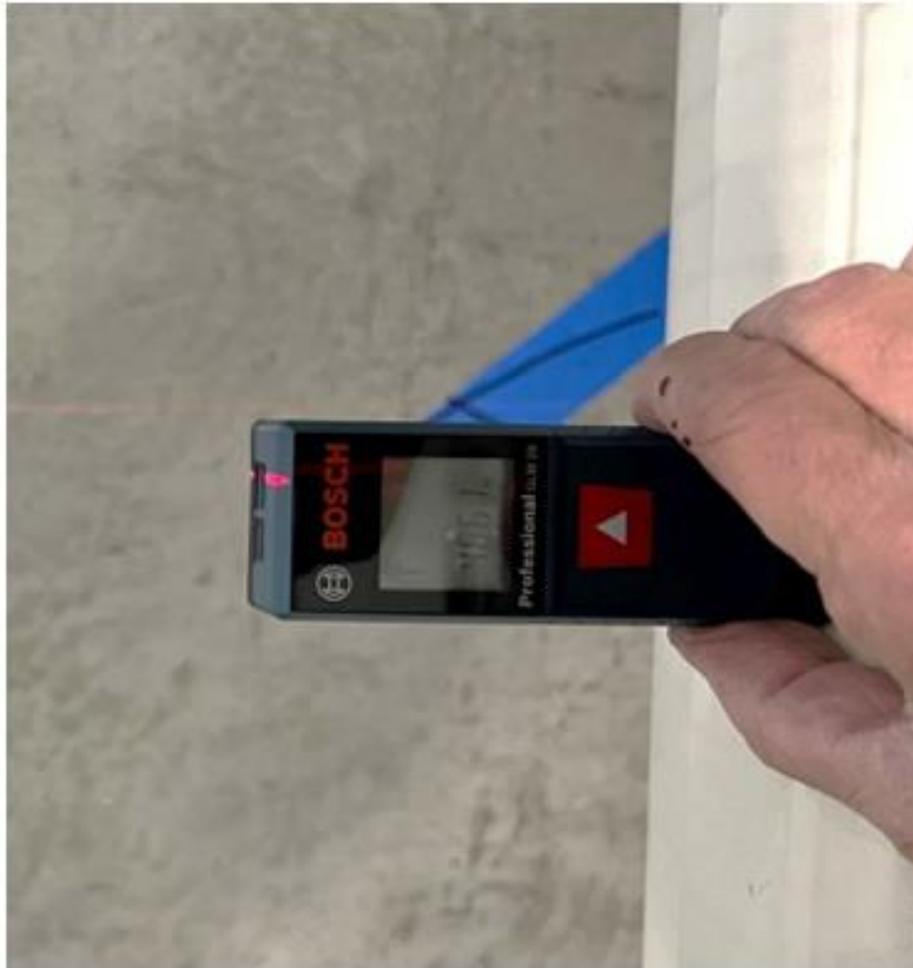
6283463

35. Turn on the Laser Measuring Tool (Special Tool J-53207) and place it against the center of the vehicle's front bumper cover facing forward. See picture above.

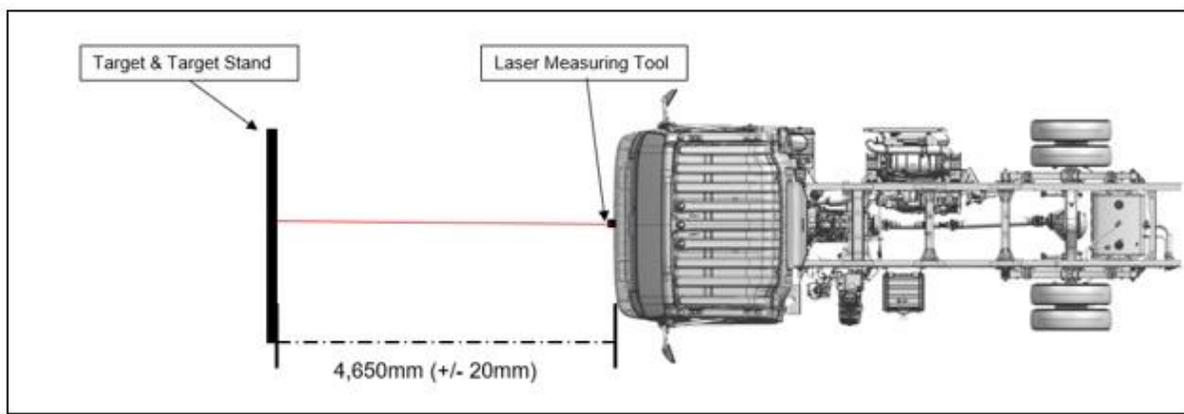
6283465

36. Using the Laser Measuring Tool, place the center of the Target 4,650 mm (+/- 20 mm) from the center of the front bumper cover.
37. Adjust the Target until the Cross-Line Laser Level beam is directly over the Plumb Bob string and the small center mark shown.

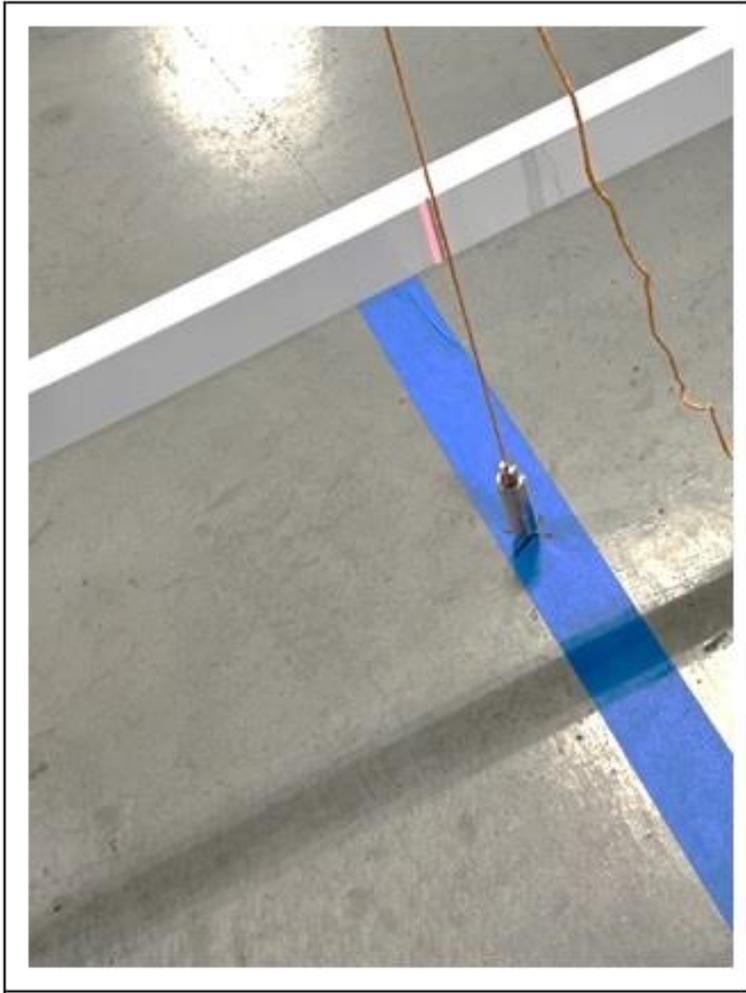
6283466

38. Ensure that the middle of the target is still 4,650 mm (+/- 20 mm) from the vehicle's front bumper cover. Adjust the target as necessary. Apply about a 2-foot length of masking tape to the floor centered under the Plumb Bob point, running lengthwise with the laser beam. Mark the masking tape with an X directly underneath the point of the Plumb Bob weight.

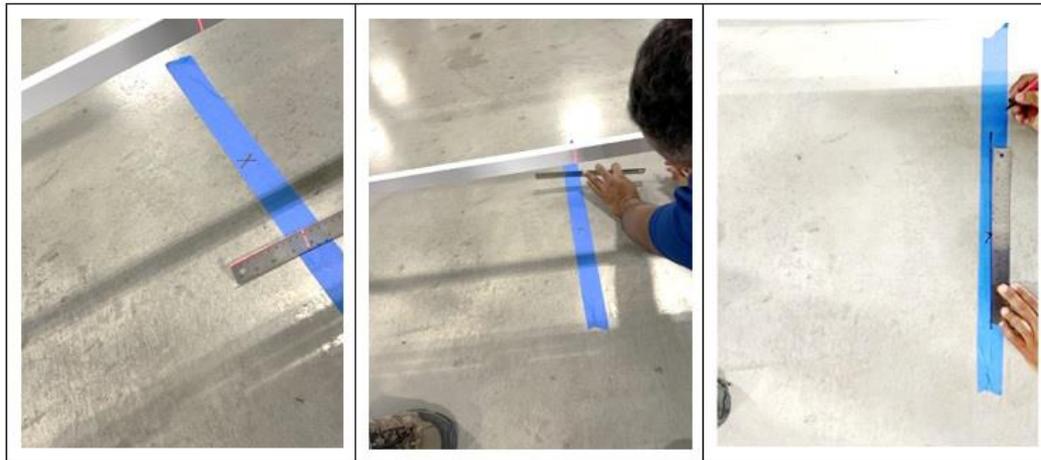
6283467

39. Use a ruler or piece of cardboard tilted an angle to see the laser beam on the masking tape. (See Figure 29.) Establish two different points of the laser beam about 1 foot apart on the lengthwise masking tape with a dot from the marker pen. Connect the two dots with a straight edge and mark a line.

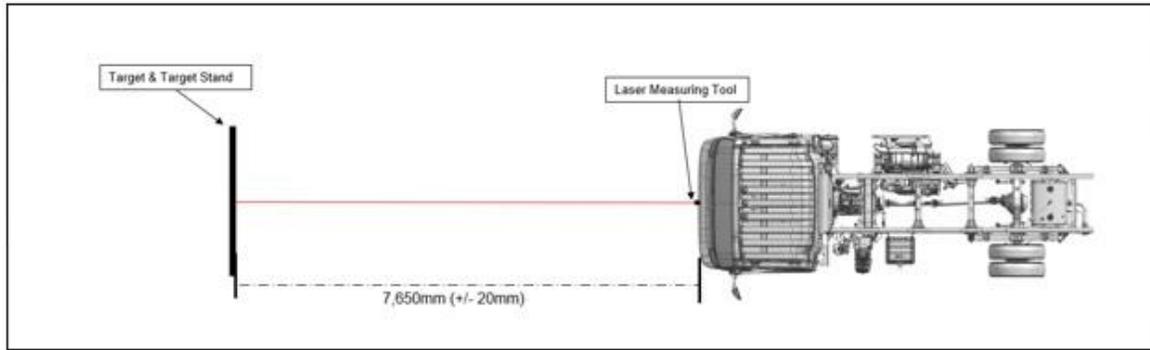
6283468

40. Using the Laser Measuring Tool, place the center of the Target 7,650 mm (+/- 20 mm) from the center of the front bumper cover.
41. Adjust the Target until the Cross-Line Laser Level beam is directly over the Plumb Bob string and the small center mark shown.

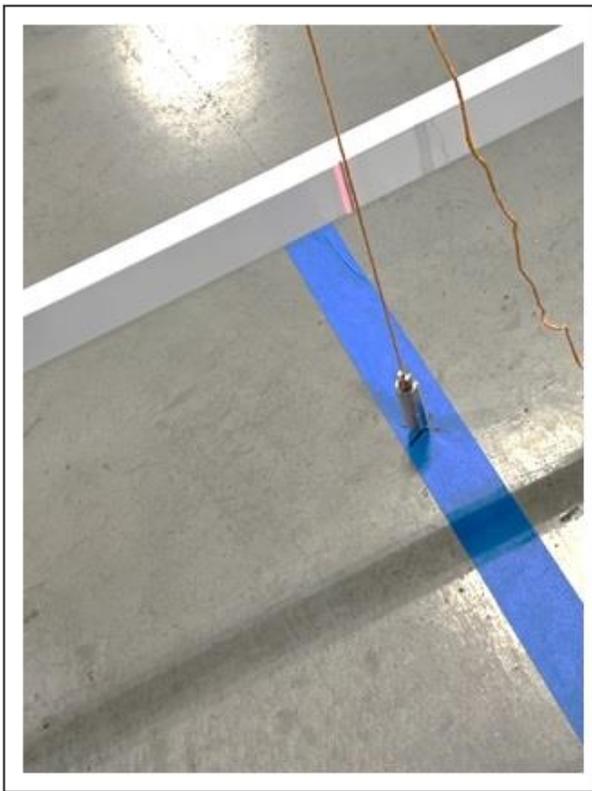
6283466

42. Ensure that the middle of the target is still 7,650 mm (+/- 20 mm) from the vehicle's front bumper cover. Adjust the target as necessary. Apply about a 2-foot length of masking tape to the floor centered under the Plumb Bob point, running lengthwise with the laser beam. Mark the masking tape with an X directly underneath the point of the Plumb Bob weight.

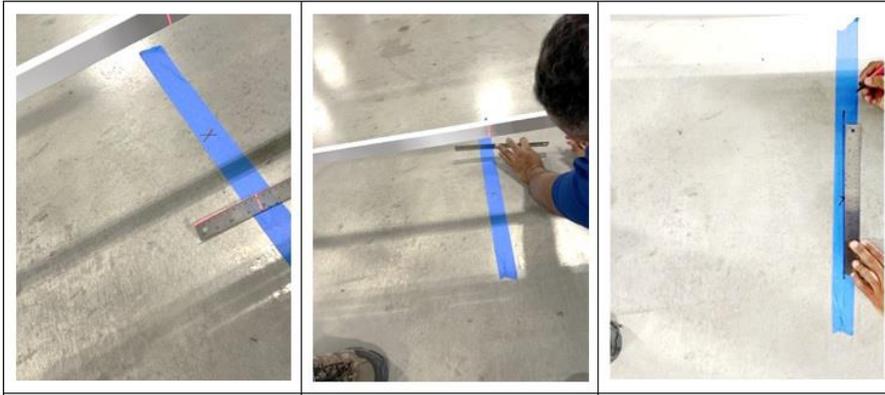
6283467

43. Use a ruler or a piece of cardboard tilted an angle to see the laser beam on the masking tape. Establish two different points of the laser beam about 1 foot apart on the lengthwise masking tape with a dot from the marker pen. Connect the two dots with a straight edge and mark a line.
44. Move aside the Target.

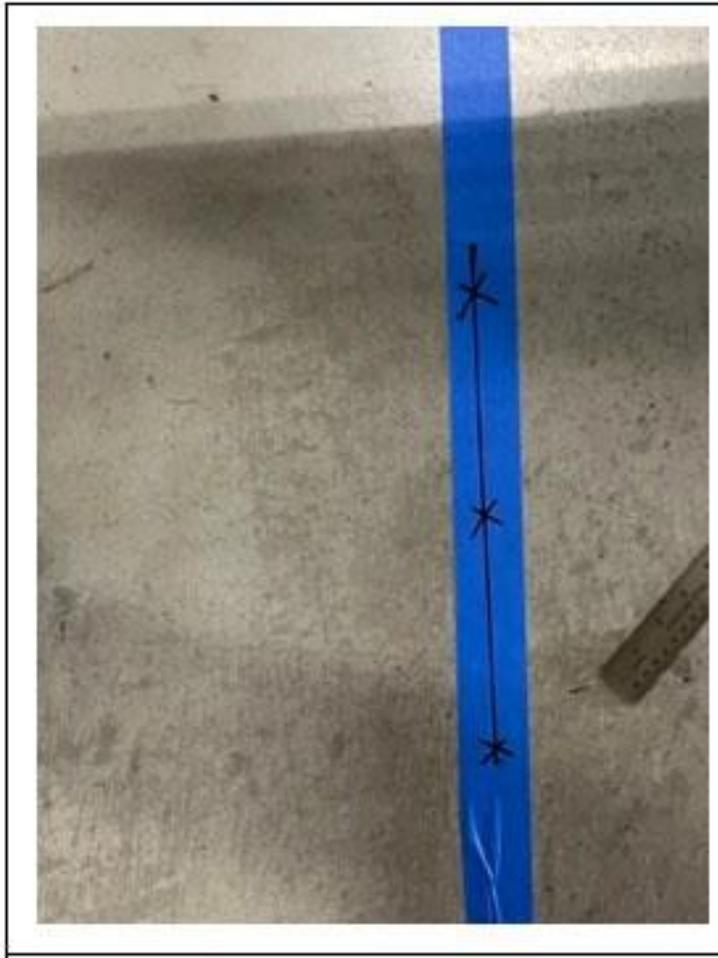
6283470

45. Use the ruler to mark a spot 6 inches in either direction from the center Plumb Bob X on the line made on the floor in Step 42.

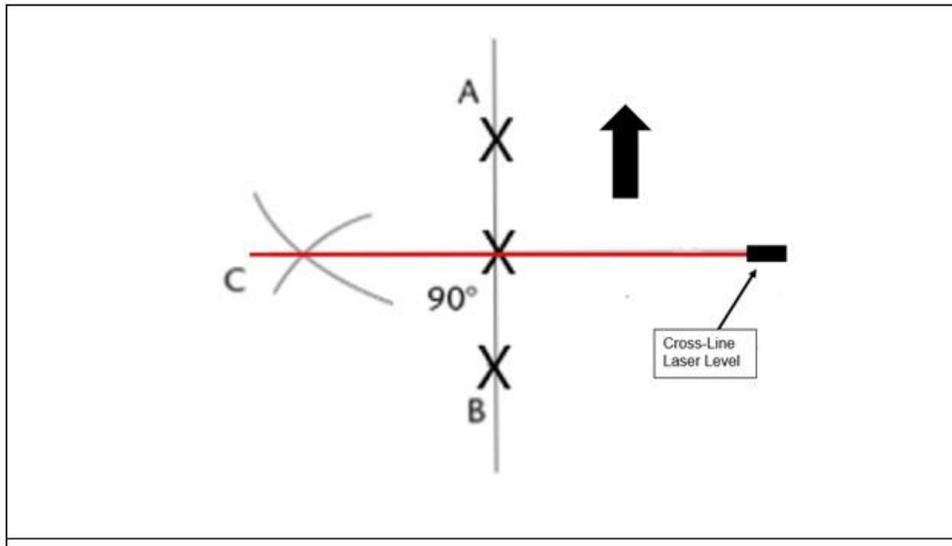
6283471

**NOTE:** When performing Steps 46 – 48, refer to the picture above.

**Important:** When performing Steps 46 – 48, it is critical that the looped string be held taut. Also, the exact position of the loops on the marker pen and the Plumb Bob point must be kept the same for each Step. Finally, both the Plumb Bob point and the marker pen should be kept completely straight up while performing each Step.

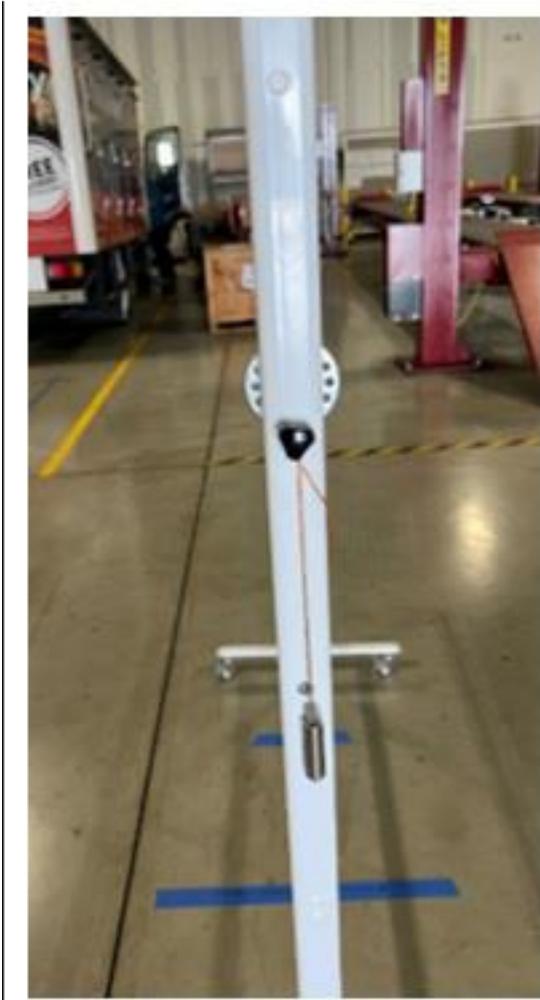
6283472

52. Lift the Plumb Bob over the back of the Target and coil the string to keep the Plumb Bob Assembly from appearing anywhere in the Target as shown.

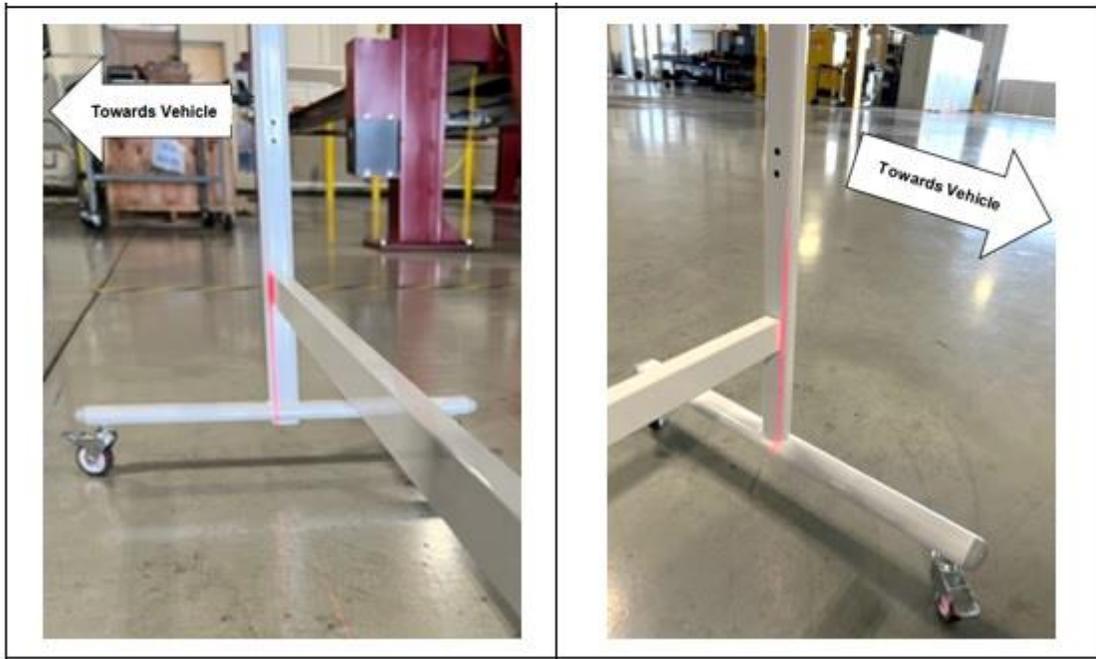
6283474

53. Move the Cross-Line Laser Level tool beam through the 90° marks from right to left as shown in Figure 40. Align the Target Stand with the laser beam as shown in Figure 42 and lock the casters of the Stand on that side. Move the Cross-Line Laser Level 180° (from left to right as shown.) Adjust the frame of the Target Stand as shown and lock the casters on that side.
