Safety Recall

Code: 97ZZ

Subject High Voltage (HV) Battery Management Control Module Software

Release Date May 09, 2023

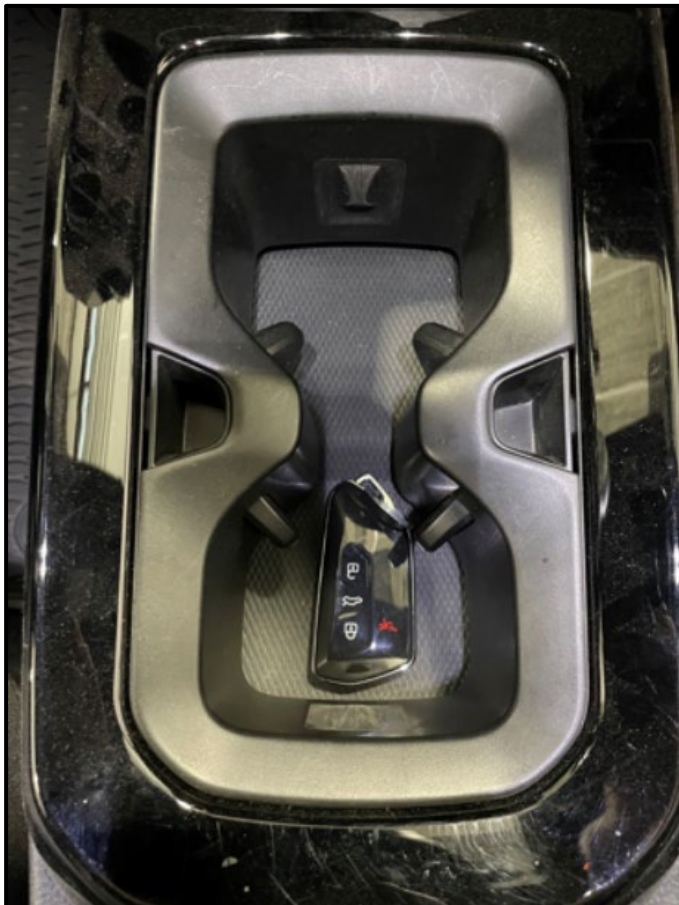
- Place the vehicle key over the reader coil in the center console cup holder.
- Any additional keys must be a minimum of 20 meters away from the vehicle.

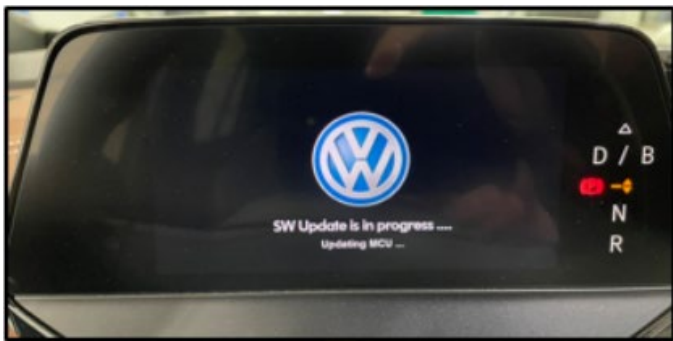
- The update will start on its own after about two minutes.
- During the update, the instrument cluster display will change multiple times.

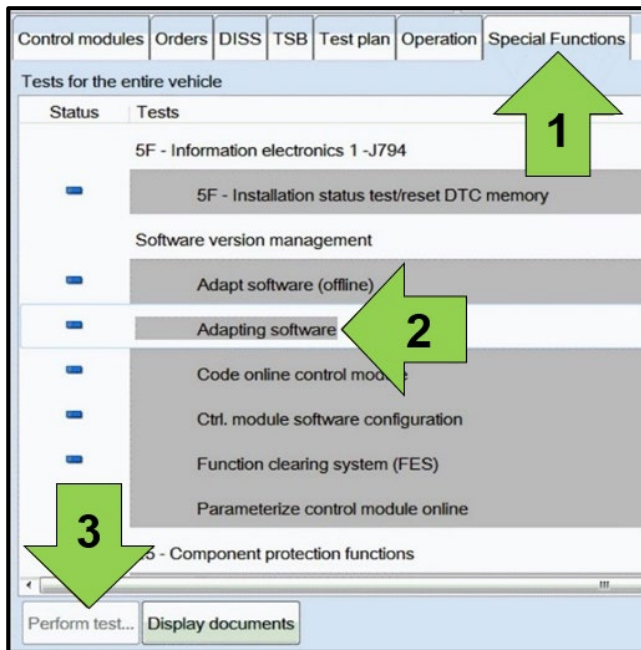
- Once the GFF scan is complete, select “Special functions” <arrow 1>, then “Adapting software” <arrow 2>, then select “Perform test” <arrow 3>.

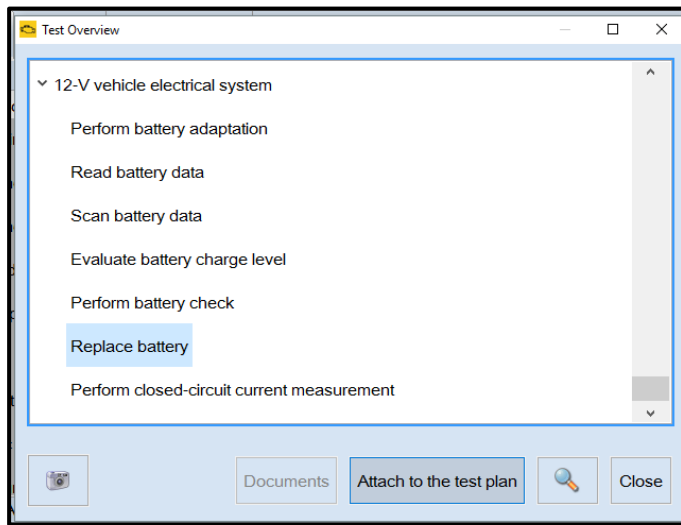
Step 6 – Perform Replace 12V Battery Test Plan

- Perform “**Replace battery**” test plan.
- Follow the on-screen prompts.
- Pay close attention to all steps outlined in the test plan and follow them exactly as described.
- Do not end the diagnostic session.

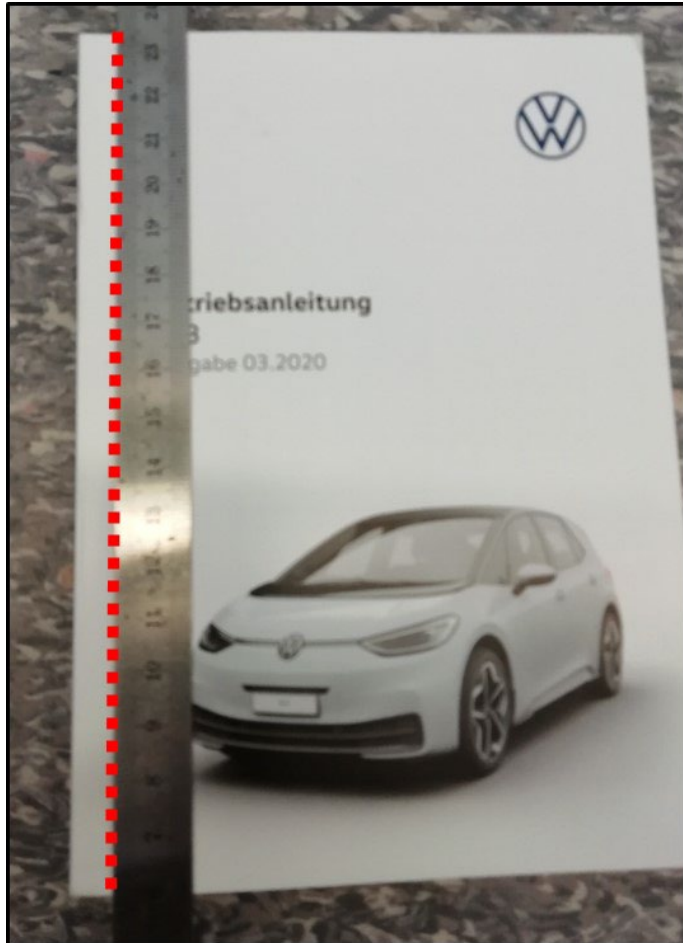
- On the first page (inside) of the owner's manual enclosed in the vehicle there is the vehicle data sticker and information on PDI and date of delivery/registration.
- To ensure this information is not lost to the customer, cut out the first page of the owner's manual with a sharp knife, as shown in the illustration <red dotted line>.
- We recommend the use of a steel ruler or another suitable implement to guide the knife and ensure a straight cutting line.
- Include the cut-out page in the new owner’s manual.
