Safety Recall

Code: 97ZZ

High Voltage (HV) Battery Management Control Module Software

Update software for the HV battery management control unit and the pulse inverter control unit.

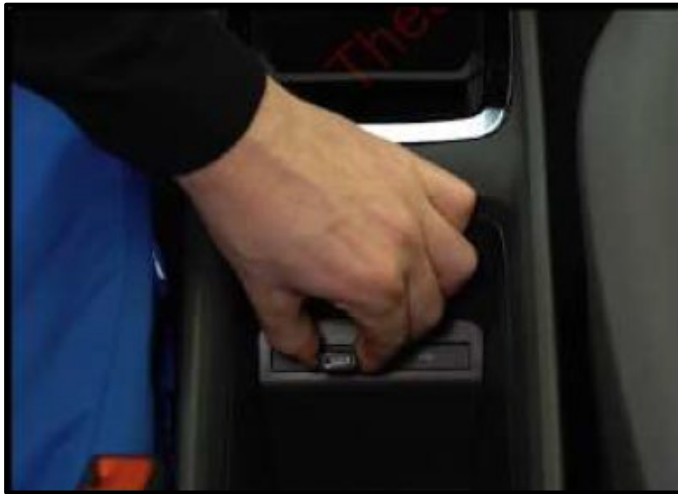
- Insert the USB drive into one of the USB ports.
- Turn the ignition ON.

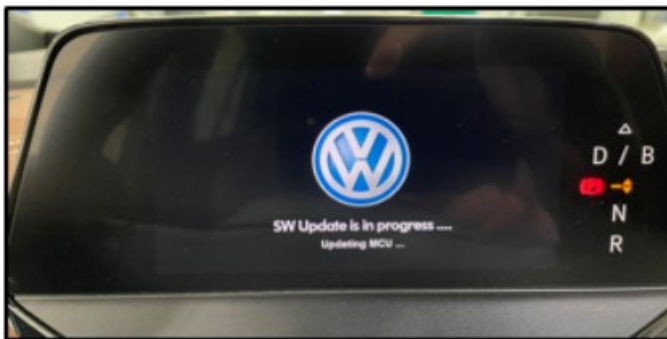
- The update will start on its own after about two minutes.
- During the update, the instrument cluster display will change multiple times.

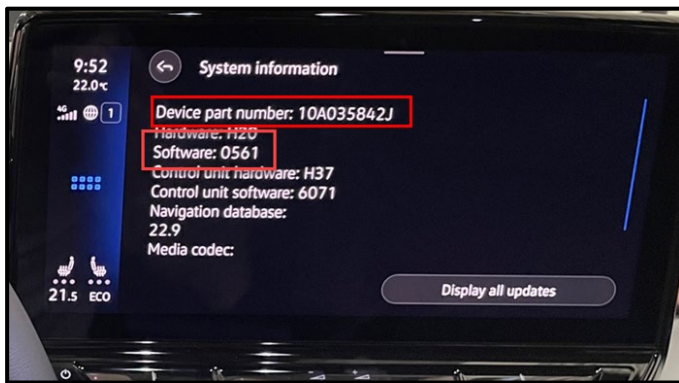
- Check SW version on infotainment display.

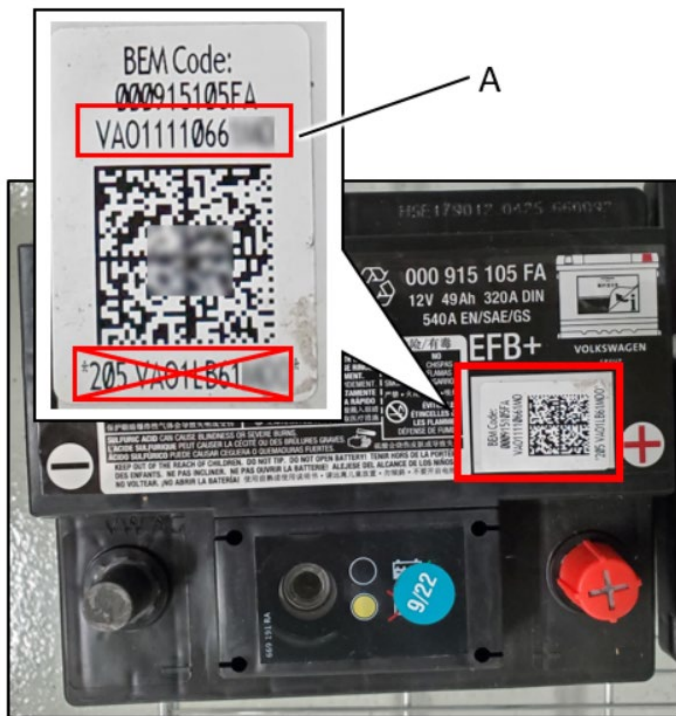
- When installing the 12V battery, record the following from both the NEW and the OLD 12V batteries:
 - Serial number <A>
 - Battery capacity
 - Battery manufacturer
- This will be required later when performing the 12V battery replacement test plan.

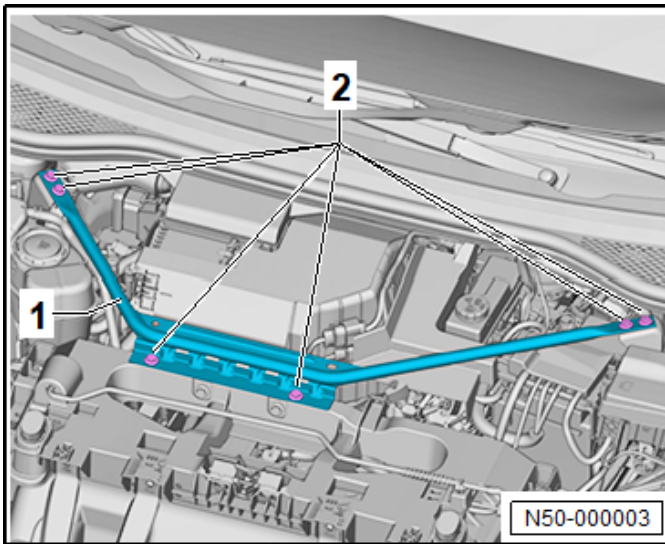
- Remove the bolts <2>.
- Remove the impact member <1>.

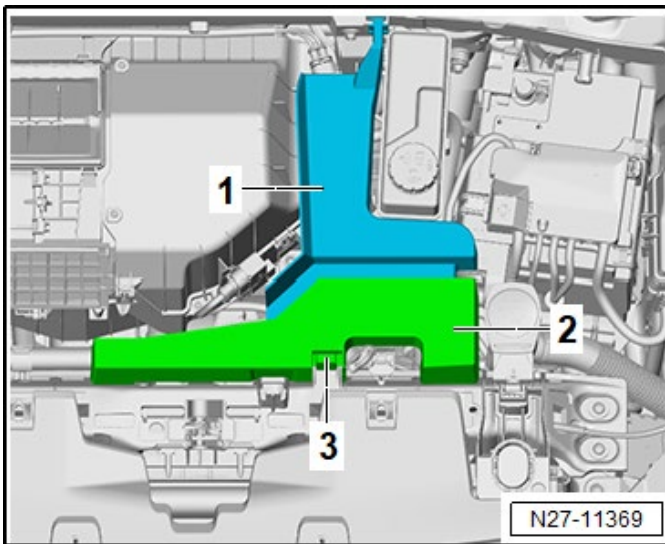
- Release the hook <3>.
- Remove the high-voltage connection cover <2>.

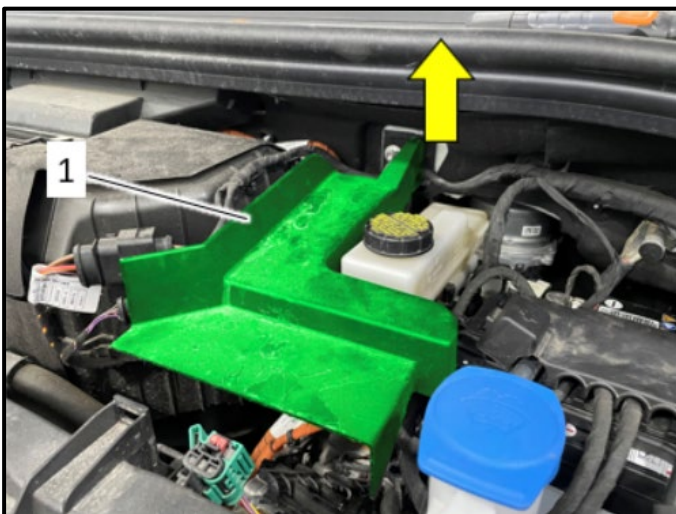
- When removing the high-voltage connection cover <1> the cover has to be lifted up at the connection to the firewall in the <direction of arrow>.

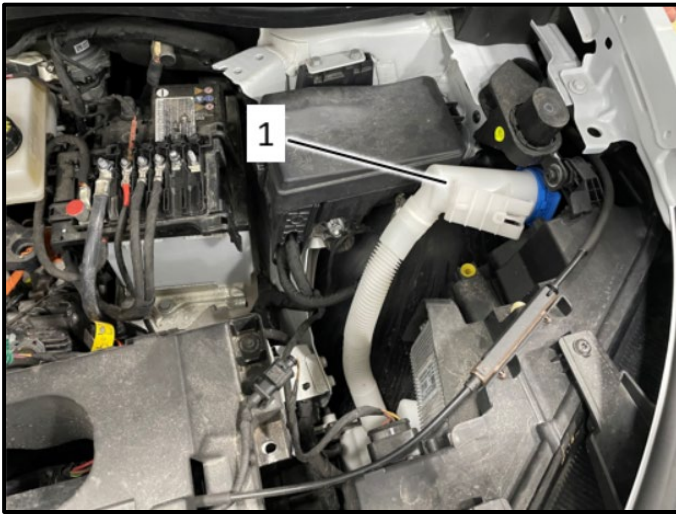
- The washer fluid filler neck will have to be unclipped and moved to the side.

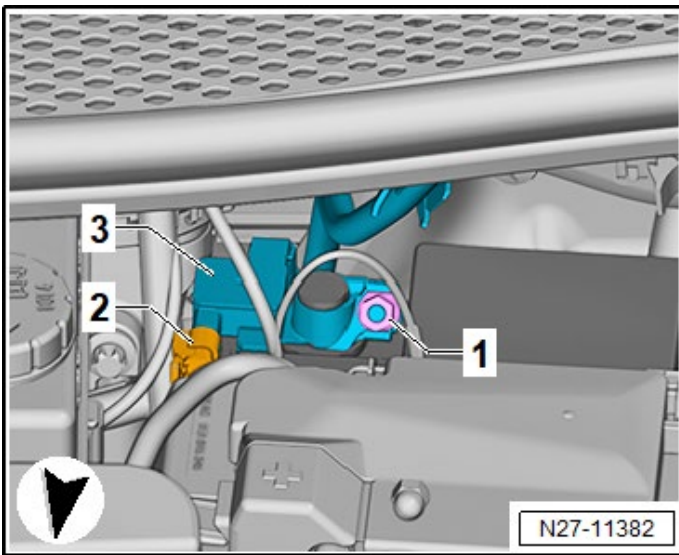
- Open the negative terminal cover above the battery monitoring control module <3>.
- Loosen the nut <1> several turns and remove the battery monitoring control module <3> from the battery negative terminal.
- Disconnect the connector <2> from the Battery Monitoring Control Module -J367-.
- Wait 1 minute.
- Check the voltage of the 12V vehicle electrical system using a commercially available voltmeter.
- The voltage must be 0V.

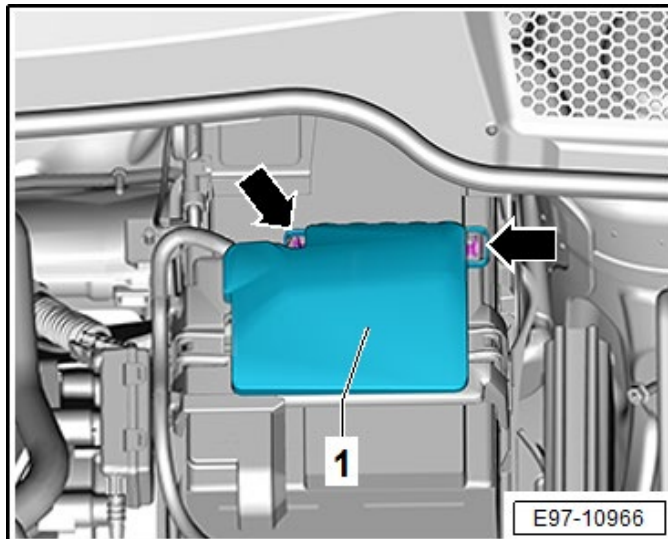
- Release the hooks <arrows>.
- Remove the cover <1>.

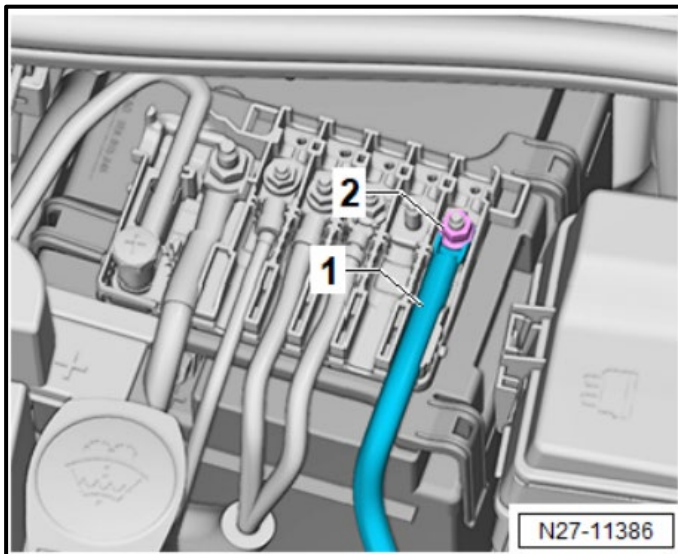
- Loosen the nut <2>.
- Remove the wire <1>.

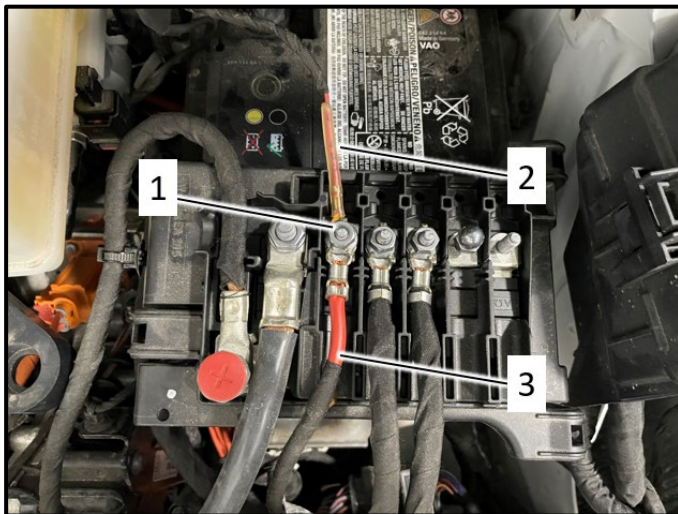
- Loosen the nut <1>.
- Remove wires <2> and <3>.

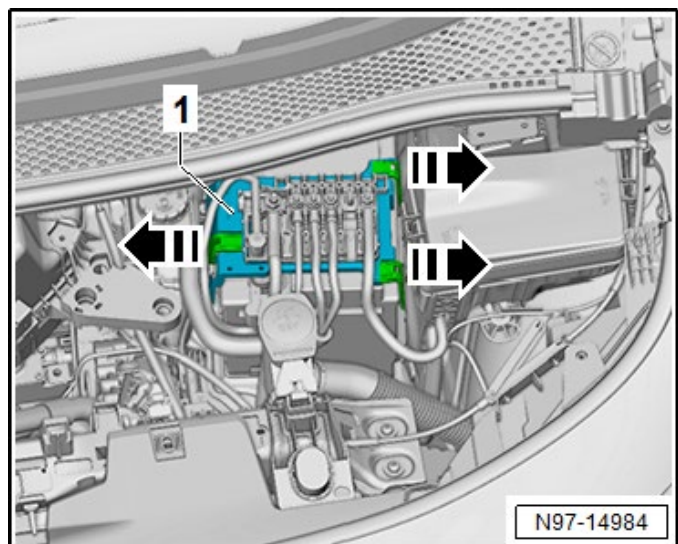
- Release the retaining straps for the bracket for fuse panel A <1> in the direction of <arrow>.
- Remove the bracket for fuse panel A <1> and move it to the side with the wires still connected.

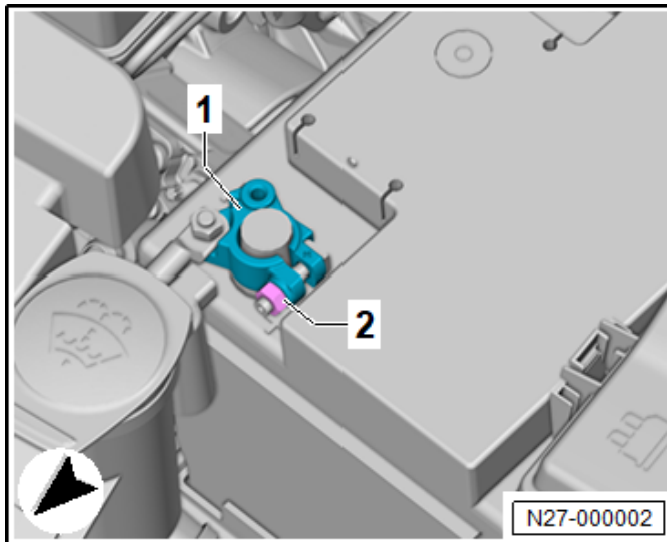
- Loosen the nut <2> several turns and remove the positive terminal battery clamp <1>.

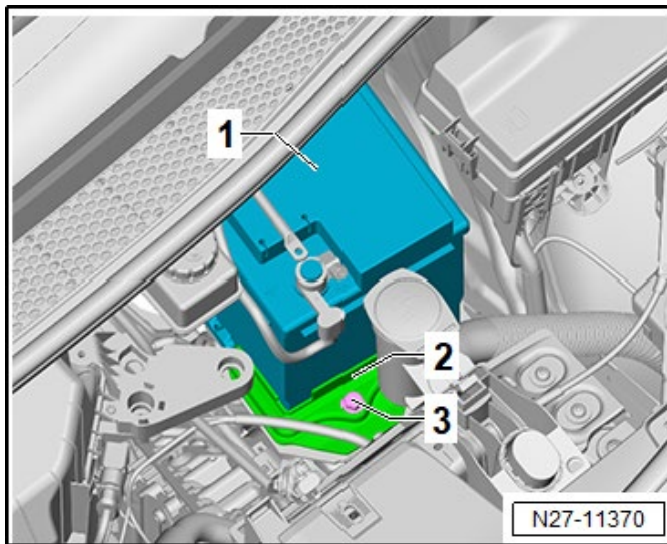
- Remove the bolt <3>.
- Remove the bracket <2>.
- Remove the battery <1> in the direction of travel from the battery tray and lift it upward out of the engine compartment.
- Install the new battery in the reverse order of removal.

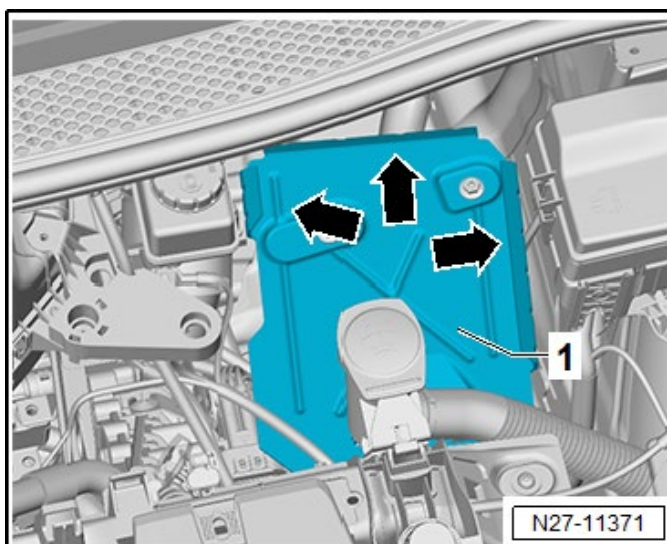
- Insert the battery into the battery tray <1> so that the battery clamping strip touches the rear and side stops <arrows>.

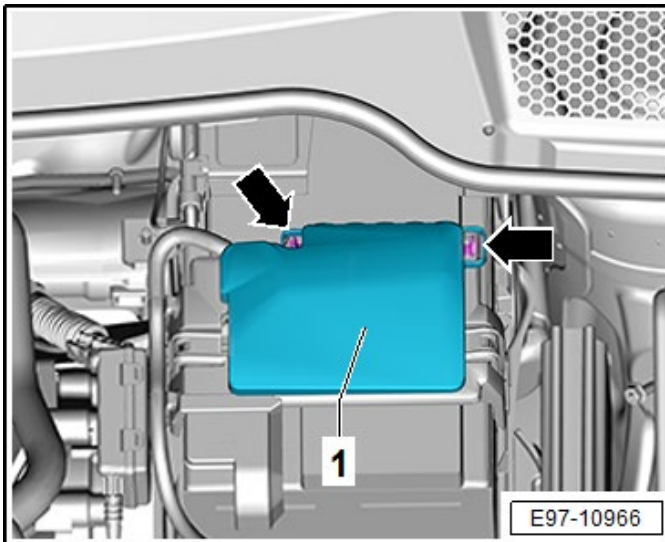
Risk of short circuit
 The battery cable cover <1> must be installed before tightening the battery negative terminal clamp.

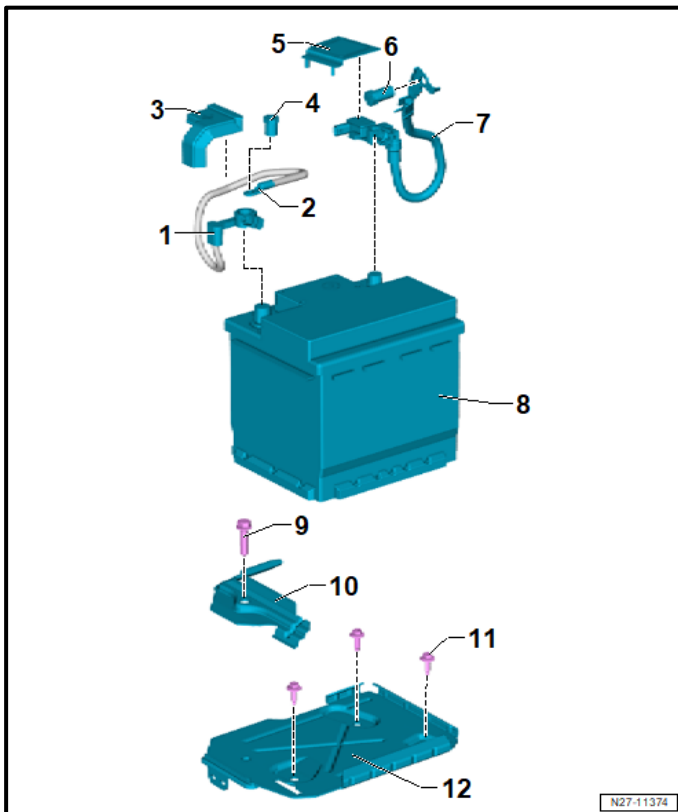
- Torque battery hold-down bolt <9> to 20 Nm.
- Torque battery terminals to 5 Nm.
- Torque power cables on top of battery to 6 Nm.
- Install covers.
- Install impact member and torque bolts to 20 Nm.

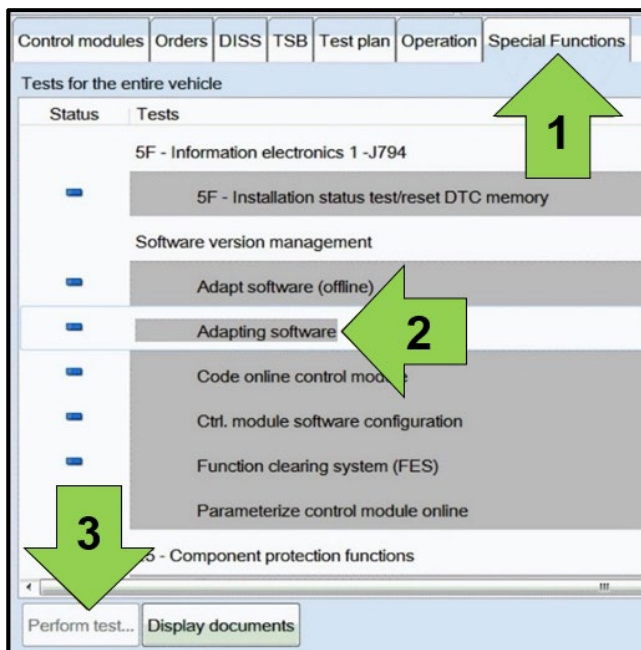
- Once the GFF scan is complete, select “Special functions” <arrow 1>, then “Adapting software” <arrow 2>, then select “Perform test” <arrow 3>.

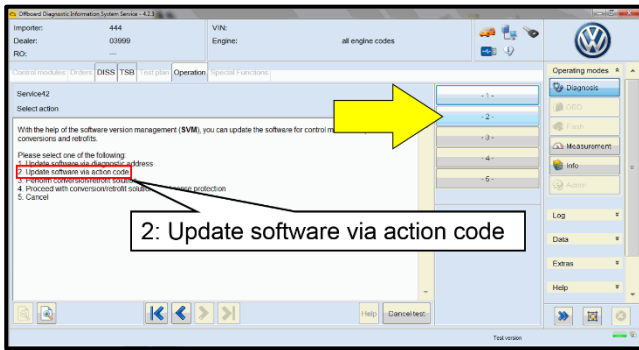
- Select the correct option to “Update software via action code”.

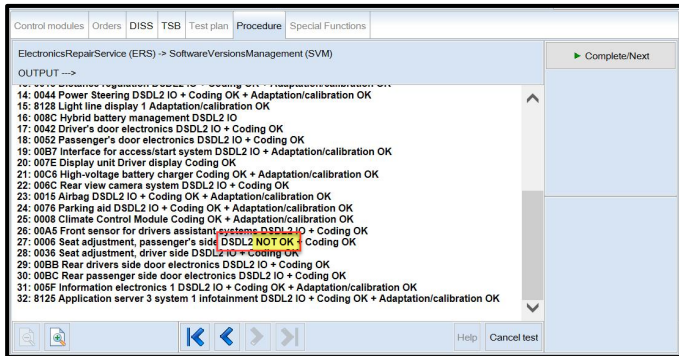
- Pay attention to the status report of the control module updates.
- Any module stating NOT OK will have to be updated again.
- Selecting “Complete/Next” will begin another attempt to update the control module.
- It may take more than one attempt to update every control module.

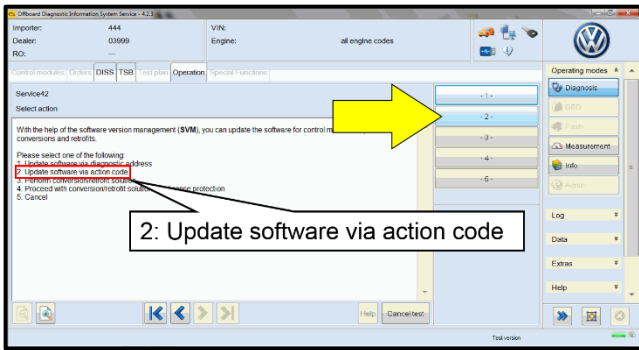
- Select the correct option to “Update software via action code”.

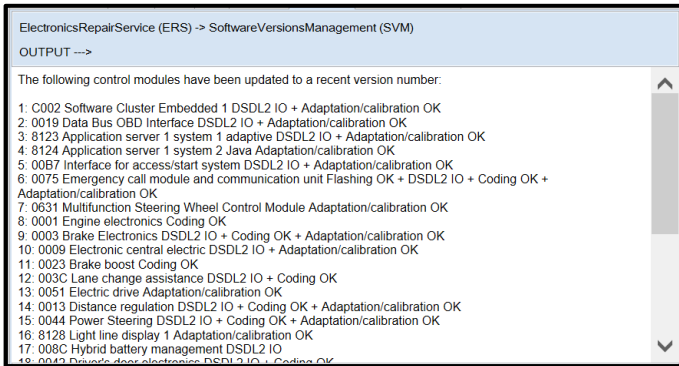
SVM code
S313

- Select “Accept” <arrow> and follow the on screen prompts.
- Pay attention to the status report of the control module updates.
- Any module stating NOT OK will have to be updated again.
- Selecting “Complete/Next” will begin another attempt to update the control module.
- Do not end the diagnostic session.

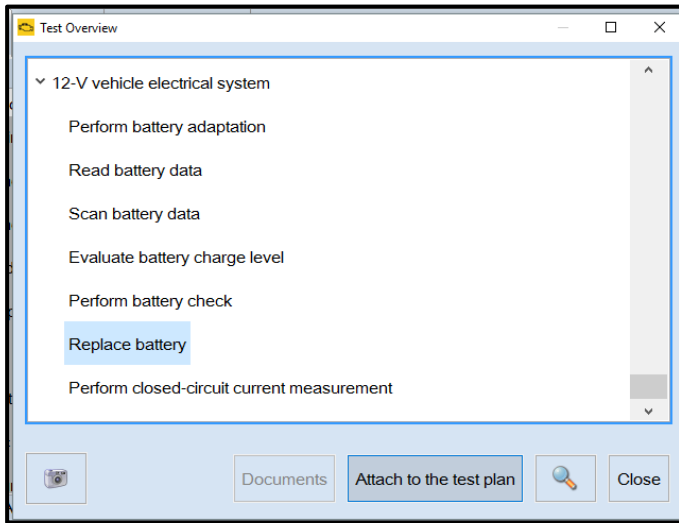
Step 6 – Perform Replace 12V Battery Test Plan

- Perform “**Replace battery**” test plan.
- Follow the on-screen prompts.
- Pay close attention to all steps outlined in the test plan and follow them exactly as described.
- Do not end the diagnostic session.

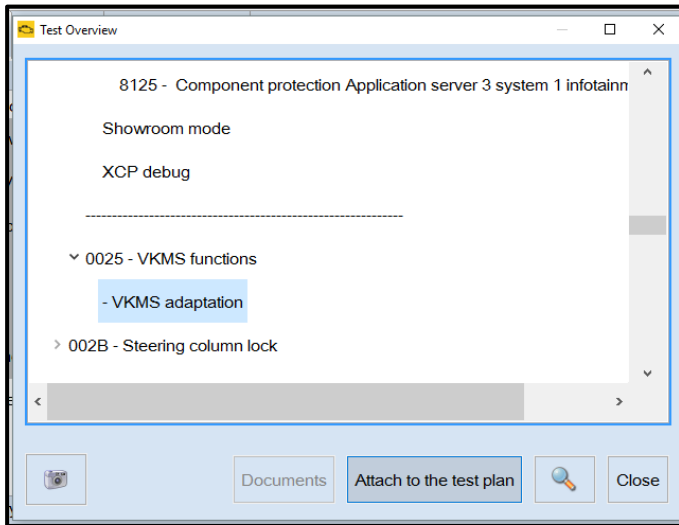
Step 8 – Perform VKMS Adaptation Test Plan

- Perform 0025 Immobilizer “VKMS Adaptation” test plan.

After selecting “Self Test,” use the search function and enter “VKMS” to aid in finding the test plan.

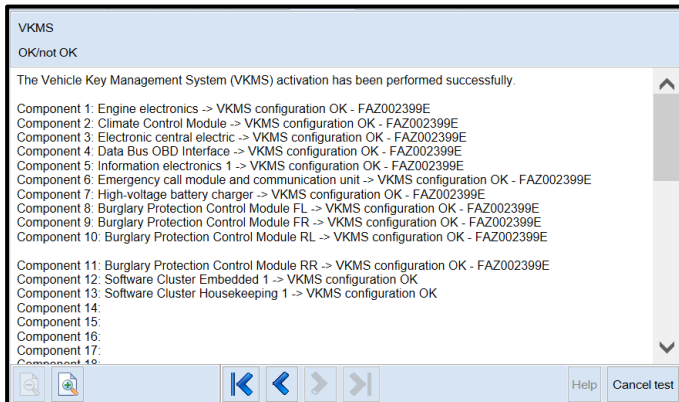
- Ensure each component shows the VKMS configuration is OK.
- If any component does not complete the VKMS adaptation, repeat the test plan.

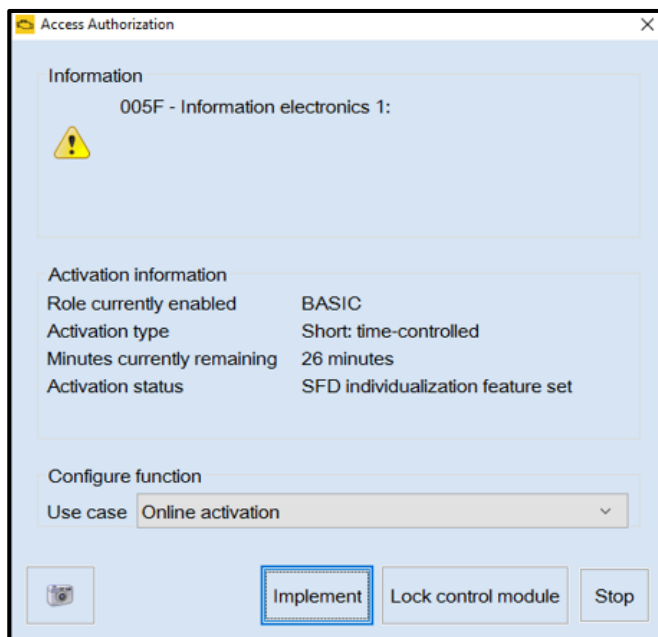
- From the OBD menu, go to: OBD > DA 005F > *Access authorization*.
- Select “Implement” and then enter ODIS login/password if prompted (to unlock SFD).
- Select “stop” to close the window.

- Using Operating mode “OBD”, check 005F adaptation channels \$0548 and \$0549 for the current service interval settings (OBD > DA 005F > *Adaptations*).
- If the values are the same as the previously recorded values, no change is necessary.
- If the values have changed, enter the correct values as needed.

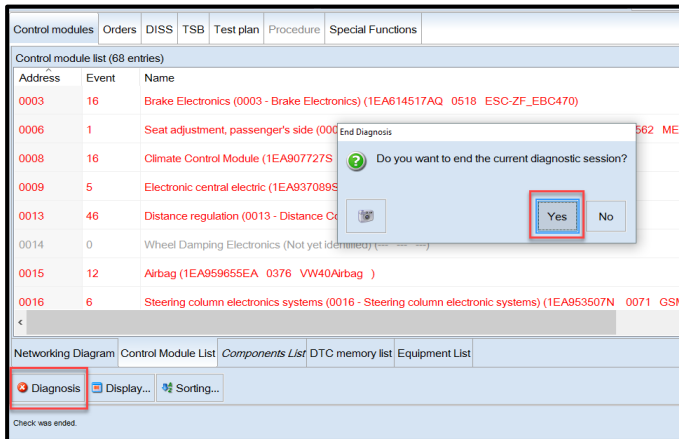
- Exit Diagnosis and select “Yes” to end the diagnostic session.

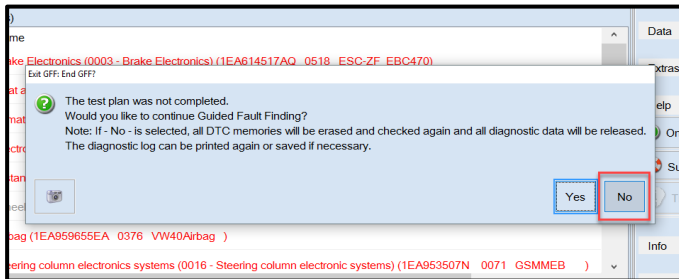
- When prompted to continue Guided Fault Finding, select “NO”.
- GFF will be exited and faults will be erased.

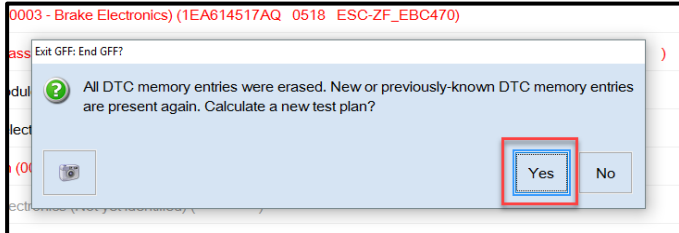
- Static faults created by the flash process will remain.
- When prompted, select “YES” to populate new test plans.

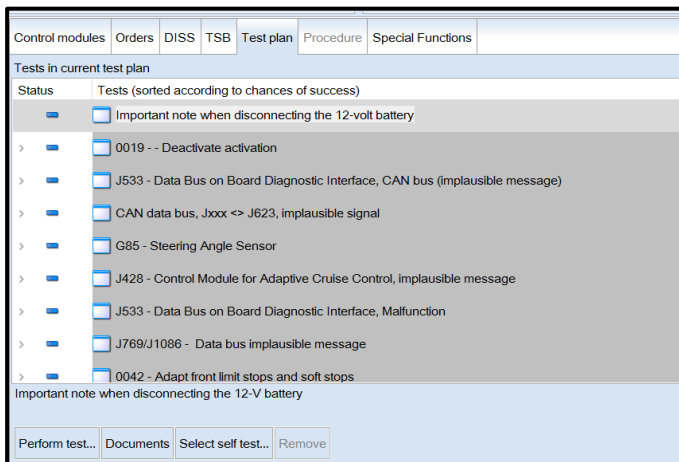
- Work through all test plans for faults created by the flash process.
- Reference any applicable TSBs that address “ghost” faults.
- Pay close attention to all steps outlined in the test plans and follow them exactly as described.
- Exit GFF and send diagnostic protocol online.

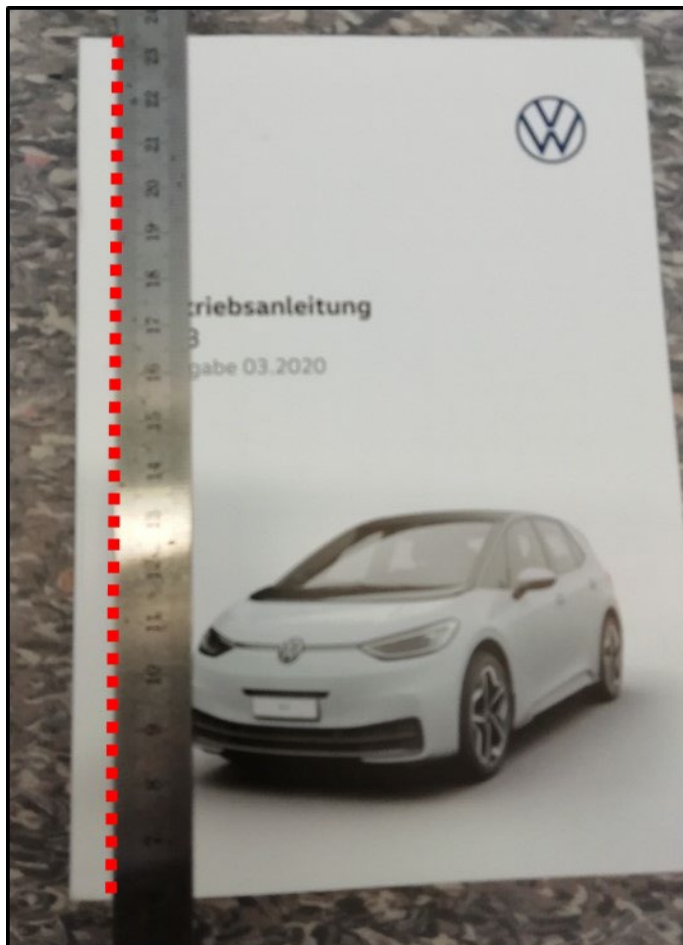
- On the first page (inside) of the owner's manual enclosed in the vehicle there is the vehicle data sticker and information on PDI and date of delivery/registration.
- To ensure this information is not lost to the customer, cut out the first page of the owner's manual with a sharp knife, as shown in the illustration <red dotted line>.
- We recommend the use of a steel ruler or another suitable implement to guide the knife and ensure a straight cutting line.
- Include the cut-out page in the new owner’s manual.
