July 20, 2023

Safety Recall: 2019-22 HR-V Audio Unit Software Update

Update the audio unit system software.

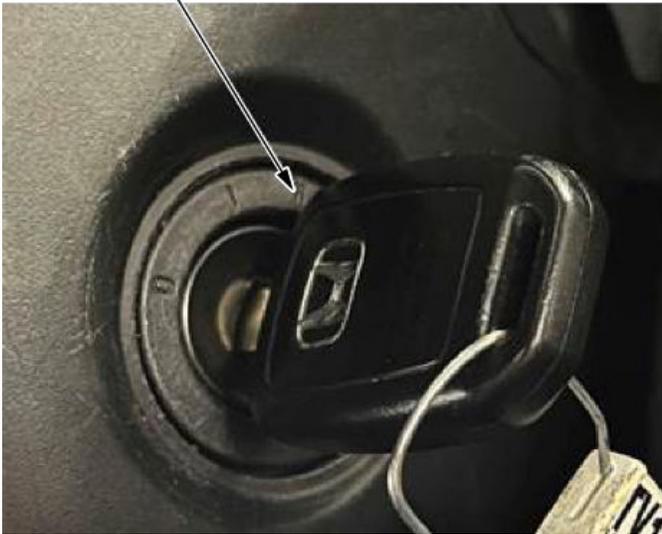
ON (II) POSITION

1. Make sure there are no devices (USB flash drives, smartphones, etc.) installed in the USB port.
2. Connect a fully charged battery jumper to the vehicle and leave it connected during the entire update procedure to maintain constant voltage.
3. Apply the parking brake to keep the headlights off during the procedure.
4. Turn the ignition switch to ON (II).

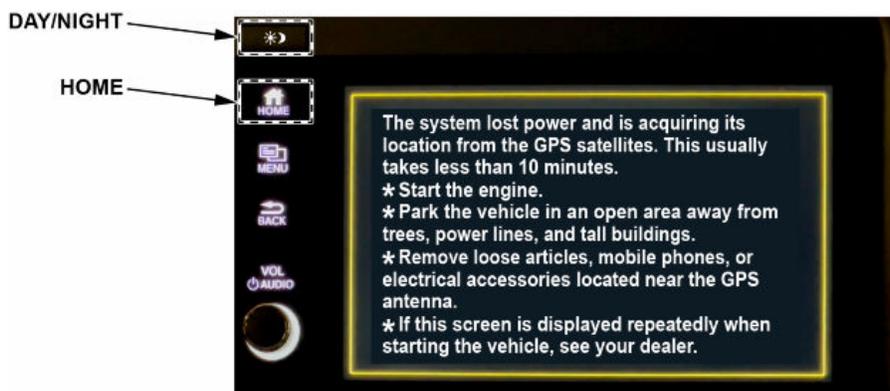
NOTE: If you see this screen, press and hold **DAY/NIGHT** and **HOME** at the same time to bypass this screen.

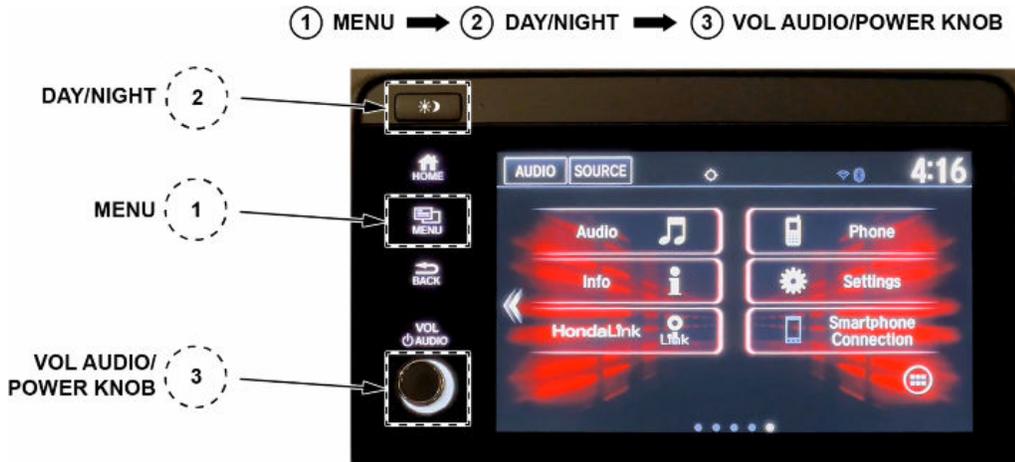
5. From the HOME screen press and hold the following buttons, in the sequence shown, to enter diagnostic mode, **(1)MENU > (2)DAY/NIGHT > (3)VOL AUDIO power knob**.

- Press and hold the buttons in the exact numbered sequence shown to prevent unwanted system reboot.
- Make sure there are no devices (USB flash drives, smartphones, etc.) installed in the USB port.
- Remove any gloves before doing the button push and hold sequence. Not doing so may cause the **MENU** button to not respond.

- If the H logo appears when doing the **(1)MENU > (2)DAY/NIGHT > (3)VOL AUDIO power knob** push and hold sequence:
 - **Do not cycle the ignition switch.**
 - Wait **3 minutes** and the unit will return to the disclaimer screen shown in step 4.
 - If the screen goes blank when doing the **(1)MENU > (2)DAY/NIGHT > (3)VOL AUDIO power knob** push and hold sequence:
 - **Do not cycle the ignition switch.**
 - Press the **DAY/NIGHT** button to return to the **HOME** screen.
6. Select **Detail Information & Settings**.

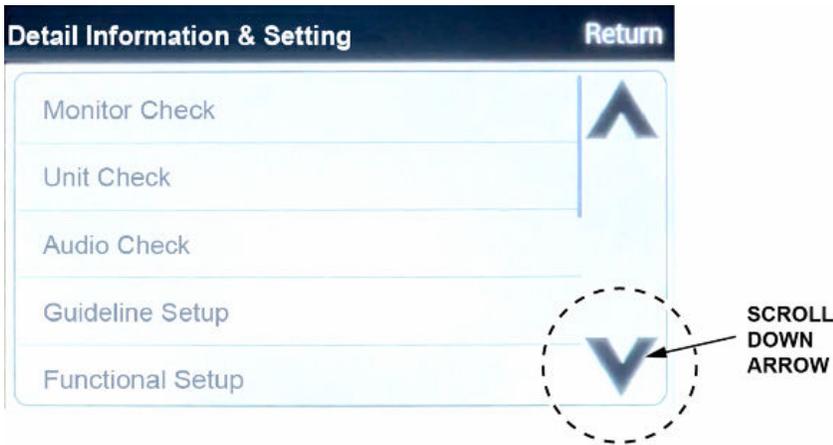
7. Select the scroll down arrow.

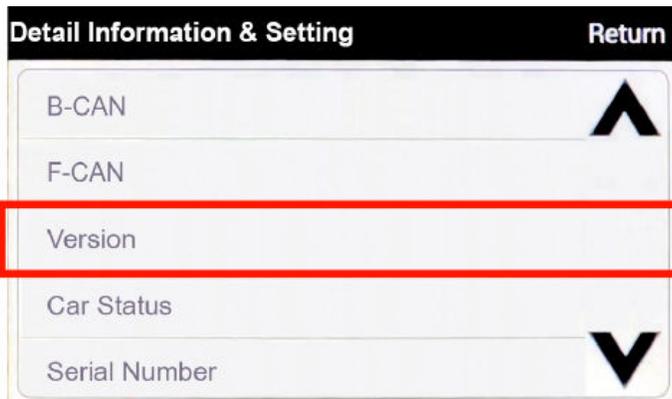
8. Select **Version**.

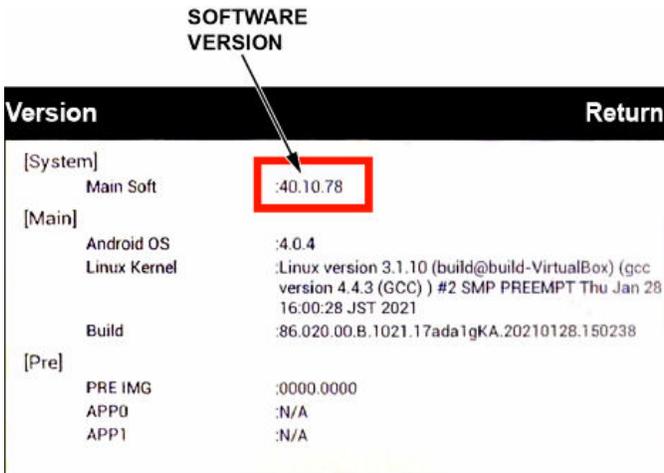
9. Confirm the current software version.

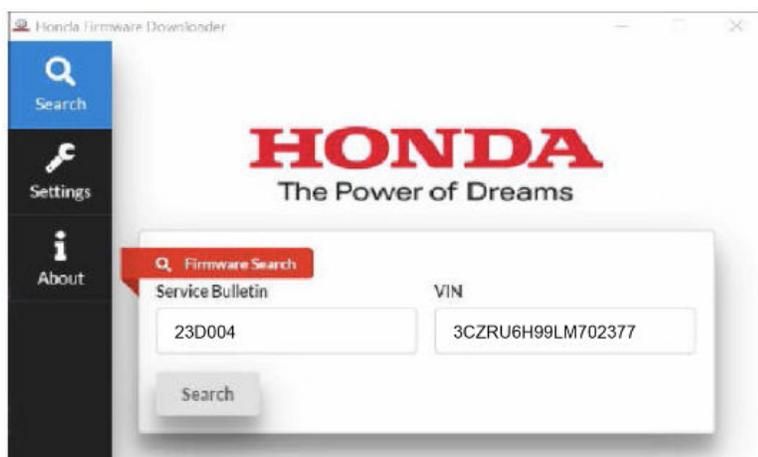
11. From your computer's desktop, open Honda Firmware Downloader. Refer to job aid, *Honda Firmware Downloader* for additional information. Make sure to use an empty USB flash drive that is formatted to FAT 32.

12. In the space where it asks for the Service Bulletin, refer to the below table and enter the appropriate Honda Firmware Downloader Service Bulletin Number that is associated with the vehicle software version on the vehicle you are working on. Next, enter the vehicle's VIN.

- This is very important as there are different update software versions depending on the original audio unit software version
- The Service Bulletin letter and VIN must be entered in all CAPS.

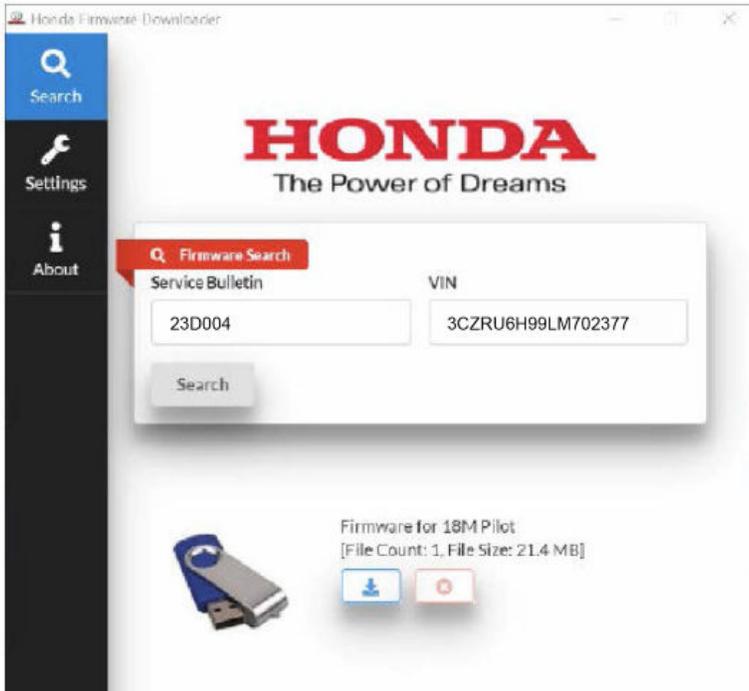
13. Select the download icon.

NOTE: The software download may take up to **15 minutes** depending on the size of the file.

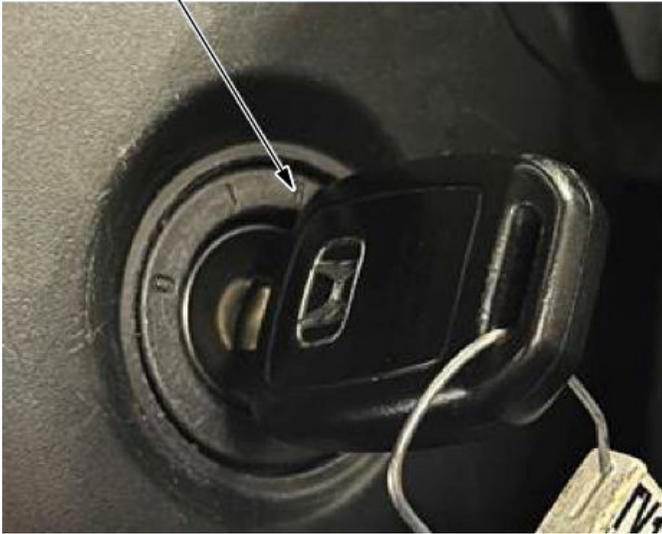
ON (II) POSITION

15. Turn the ignition switch to ON (II).

- Make sure there are no devices (USB flash drives, smartphones, etc.) installed in the USB port.
- Connect a fully charged battery jumper to the vehicle and leave it connected during the entire update procedure to maintain constant voltage.
- Apply the parking brake to keep the headlights off during the procedure.

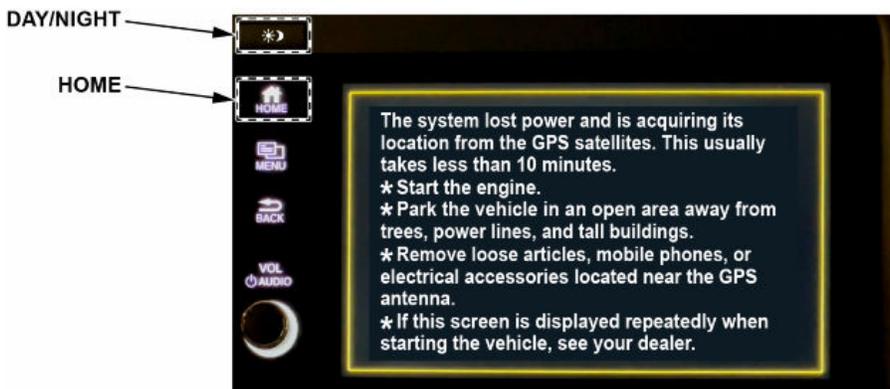
NOTE: If you see this screen, press and hold **DAY/NIGHT** and **HOME** at the same time to bypass this screen.

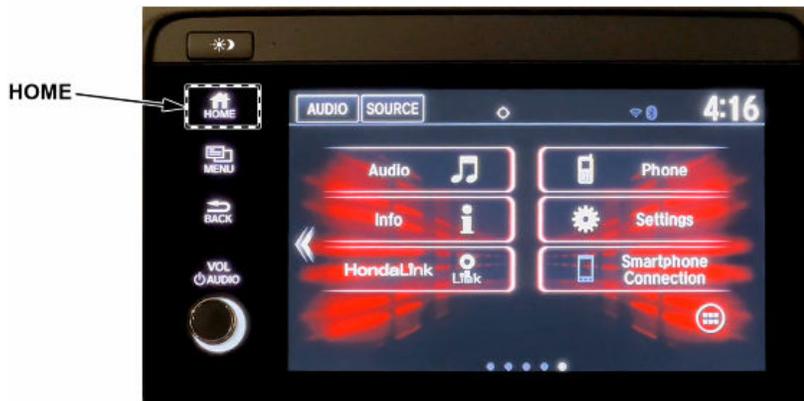
16. Select the HOME screen.

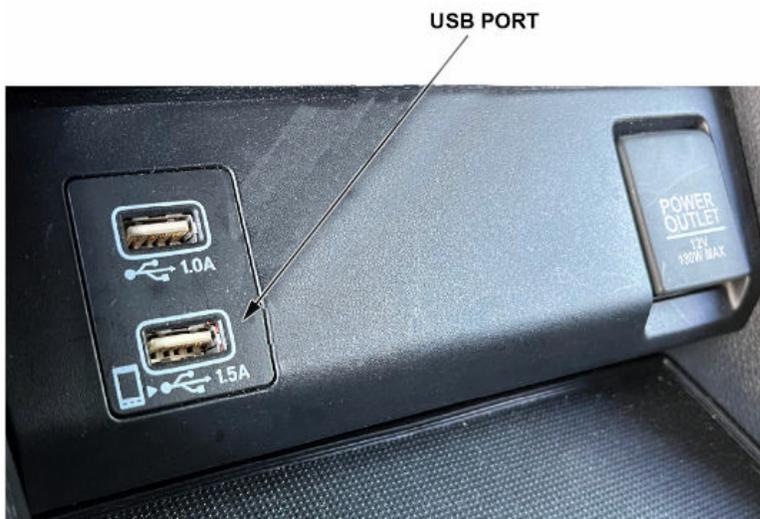
17. Insert the USB flash drive into the vehicle USB port.

NOTE: Once the software update begins, do not remove the USB flash drive or the unit may be damaged.

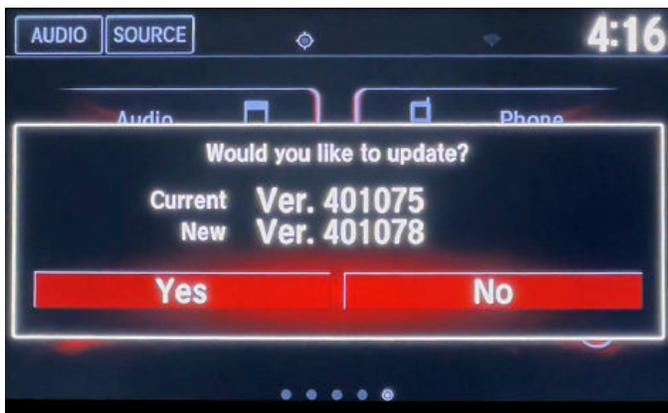
18. Software update pop up will display.

- Make sure the displayed Current and New software versions are correct, then select **Yes**.

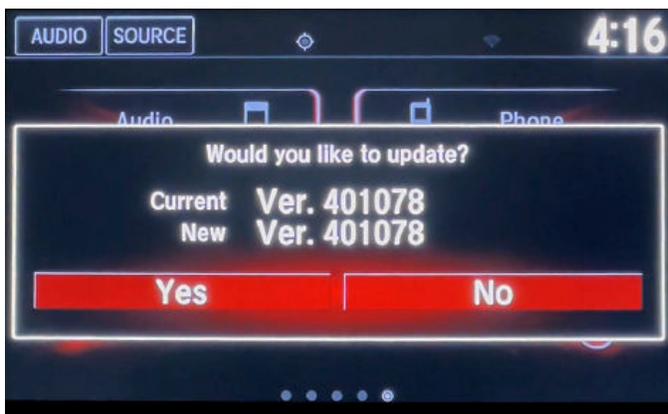
- If this pop up does not display, recheck the loaded software version on the USB flash drive.
- If the current and new software versions are the same, the system is already up to date.

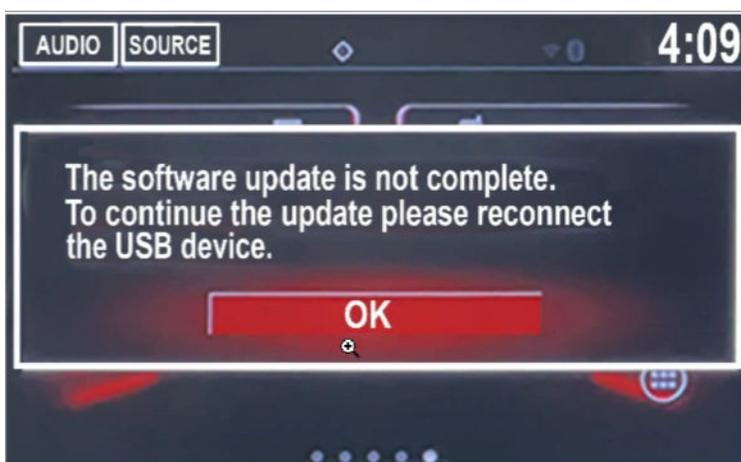
- If the USB flash drive is removed before selecting Yes or No, the *software update is not complete* message will display.

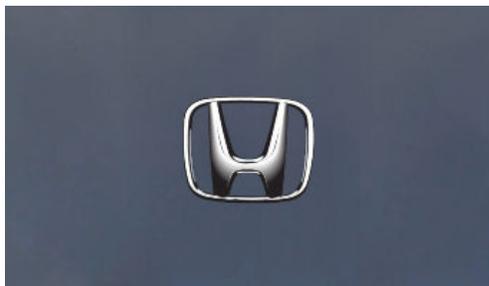
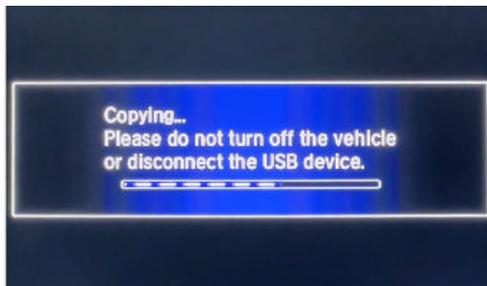
19. The system will reboot and copy the software files. This process will take about **5 minutes** and the system will reboot multiple times.

- The screens shown below will cycle and appear multiple times (approximately **4 to 5 times**). Do not turn off the vehicle or remove the USB flash drive until the update is complete or the unit may be damaged.
- If power is lost during this update procedure, do not remove the USB flash drive. Turn the ignition switch to ON (II) and the H logo will appear for about **5 minutes**. The unit will restart the update procedure on its own.

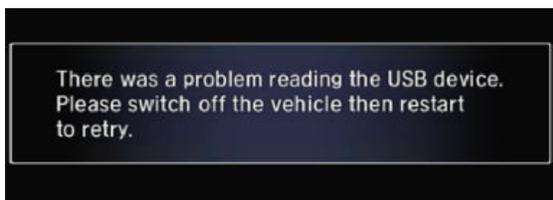
- If the message "There was a problem reading the USB device" or "There was a problem during the update" appears, turn the ignition switch to OFF (0), remove the USB flash drive, then turn the ignition switch to ON (II) and continue from step 16.

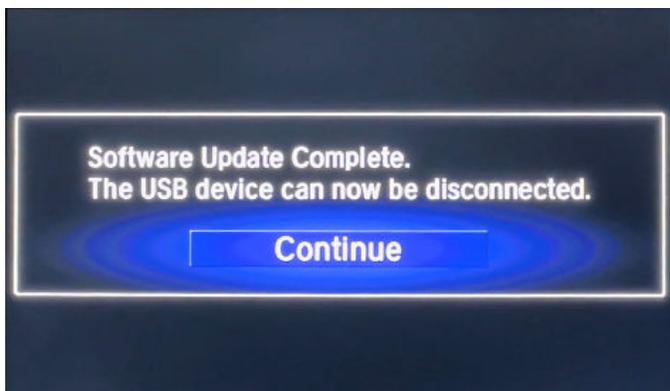
20. Remove the USB flash drive and select **Continue**.

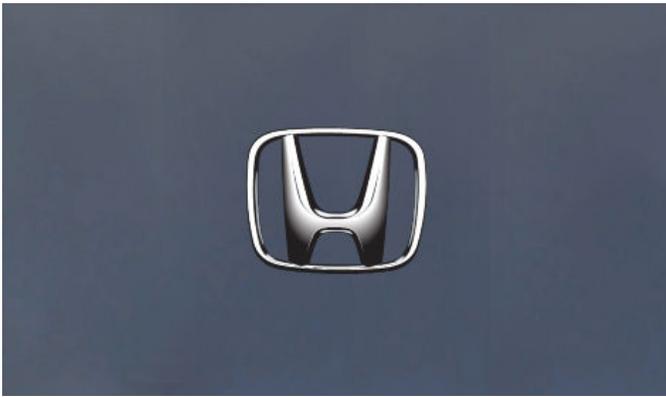
21. The system will reboot to this screen for about **1 minute**.

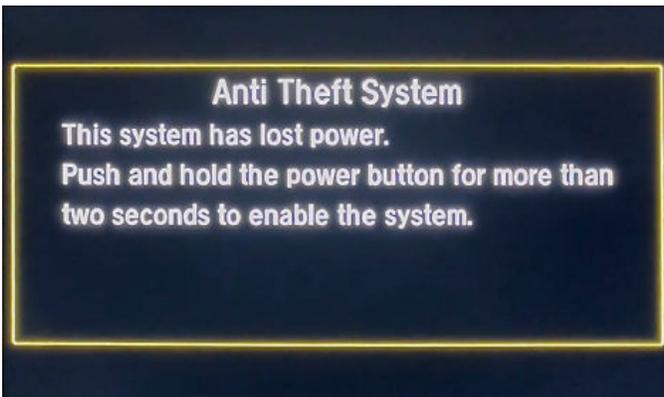
22. When the update is complete, the Anti-theft System screen will display, then follow the screen prompts.

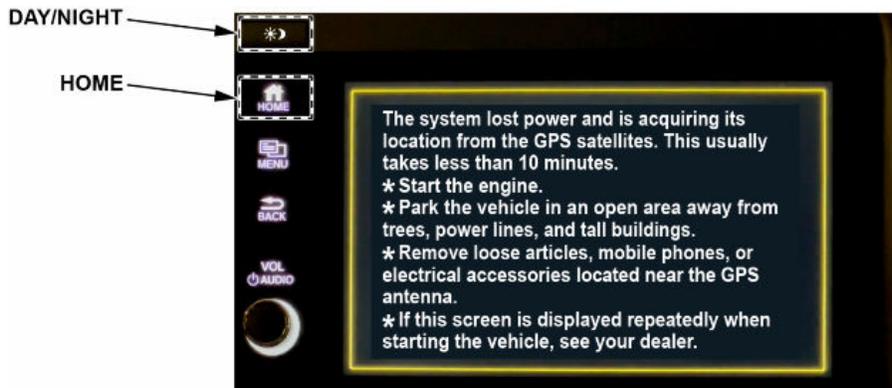
23. Press and hold the **DAY/NIGHT** and **HOME** buttons at the same time to bypass this screen.

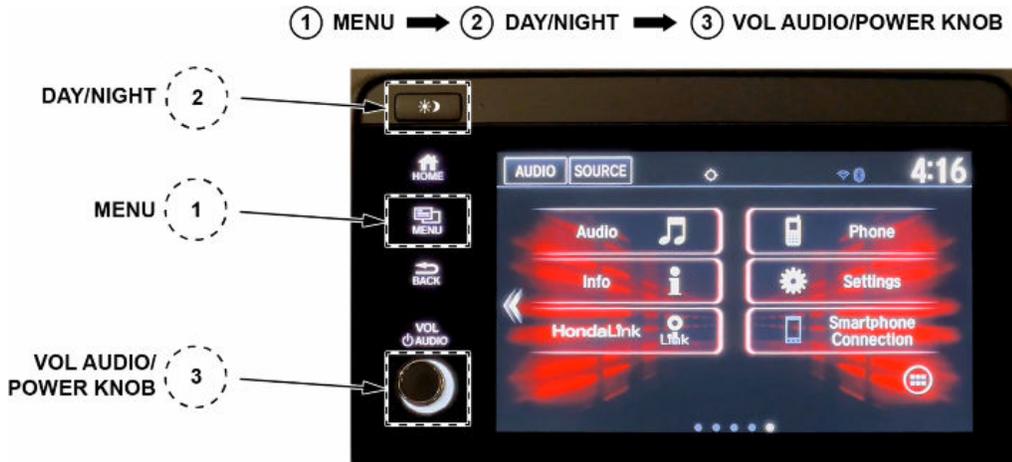
24. From the HOME screen press and hold the following buttons, in the sequence shown, to enter diagnostic mode, **(1)MENU > (2)DAY/NIGHT > (3)VOL AUDIO power knob**.

- Press and hold the buttons in the exact numbered sequence shown to prevent unwanted system reboot.
- Make sure there are no devices (USB flash drives, smartphones, etc.) installed in the USB port.
- Remove any gloves before doing the button push and hold sequence. Not doing so may cause the **MENU** button to not respond.

- If the H logo appears when doing the **(1)MENU > (2)DAY/NIGHT > (3)VOL AUDIO power knob** push and hold sequence:
 - **Do not cycle the ignition switch.**
 - Wait **3 minutes** and the unit will return to the disclaimer screen shown in step 15.
- If the screen goes blank when doing the **(1)MENU > (2)DAY/NIGHT > (3)VOL AUDIO power knob** push and hold sequence:
 - **Do not cycle the ignition switch.**
 - Press the **DAY/NIGHT** button to return to the **HOME** screen.

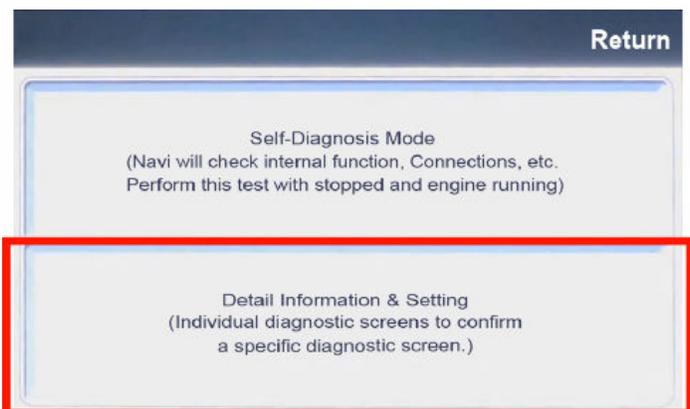
25. Select **Detail Information & Settings**.

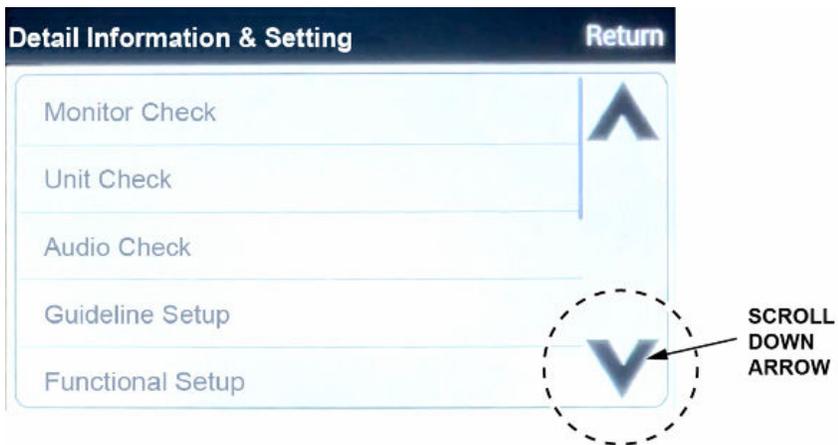
26. Select the scroll down arrow.

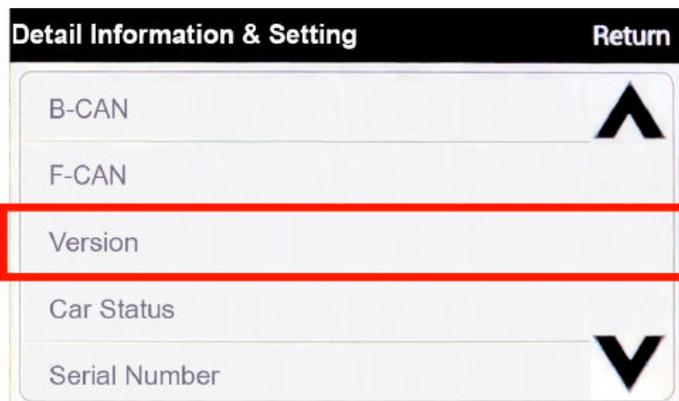
27. Select **Version**.

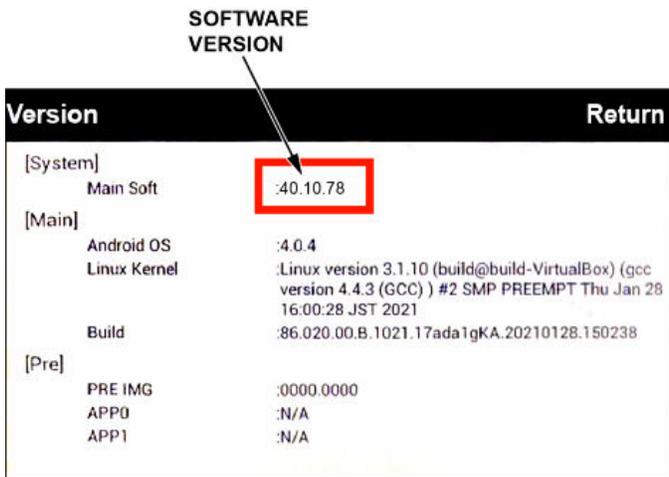
28. Confirm the software update version.
