SUBJECT: **NEW VEHICLE DEMONSTRATION / DELIVERY HOLD**
Compliance Recall 23C01 - Supplement #1
Certain 2023 Model Year F-150 Limited and Platinum
Passenger Instrument Panel Cover Replacement

CERTAIN 2023 MODEL YEAR F-150 VEHICLES — PASSENGER SIDE INSTRUMENT PANEL COVER REPLACEMENT

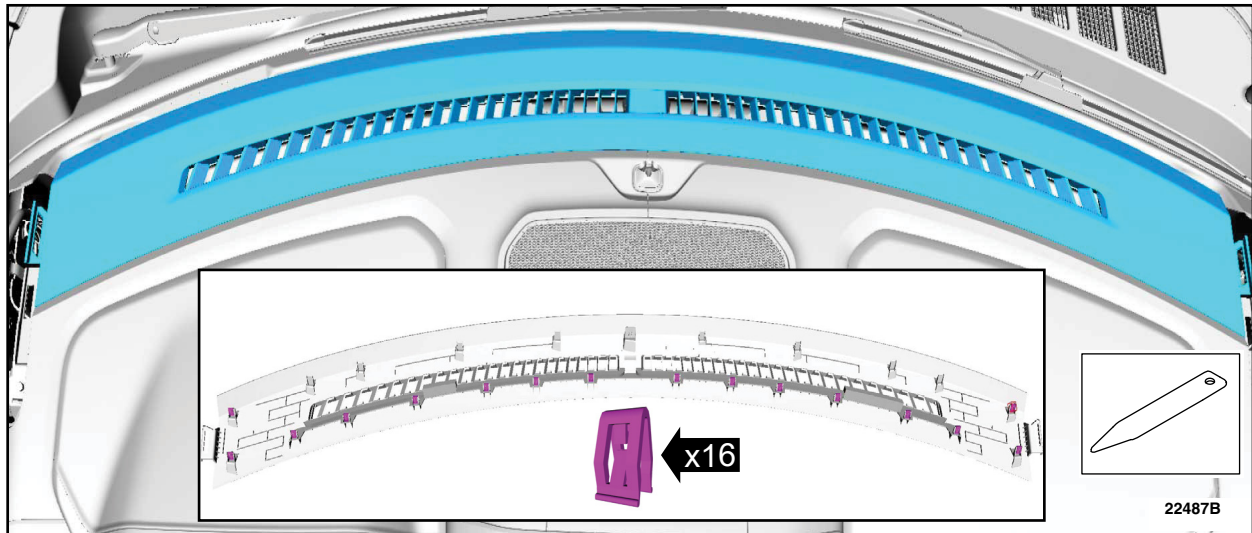
FIGURE 2

4. Release the clips and remove the defrost grille trim panel. See Figure 2.

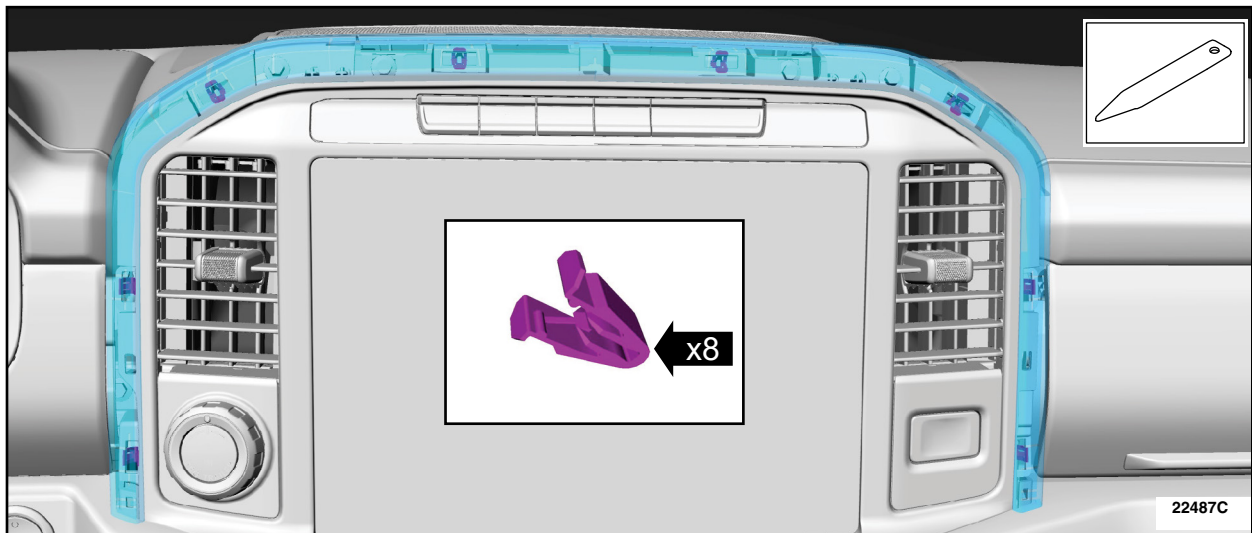
FIGURE 3

5. Release the clips and remove the trim panel. See Figure 3.

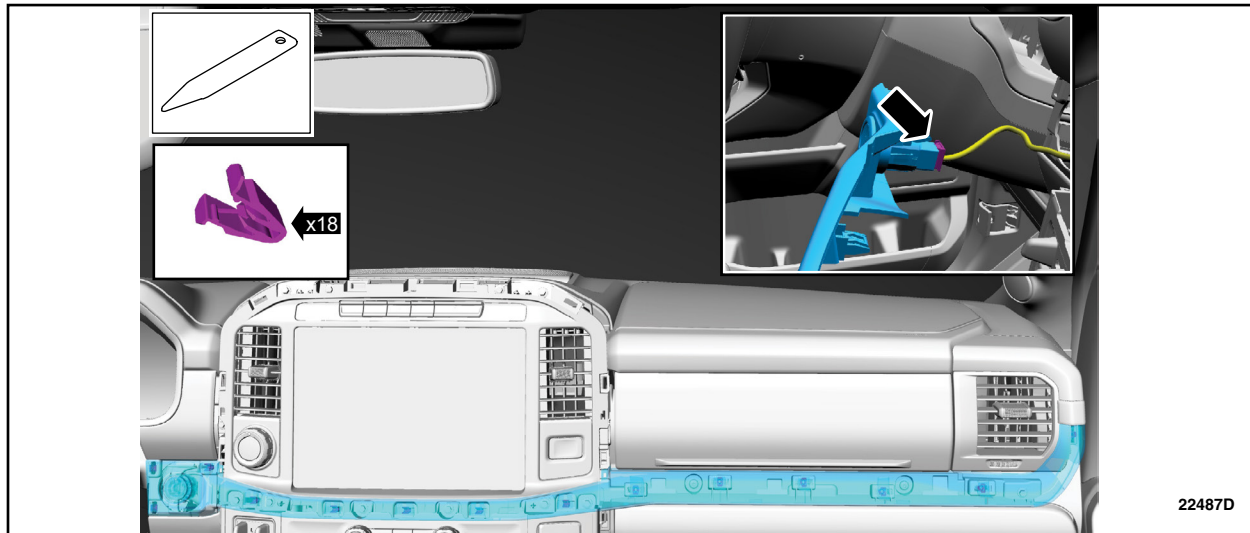
FIGURE 4

6. Release the clips, disconnect the electrical connector and remove the center finish trim. See Figure 4.

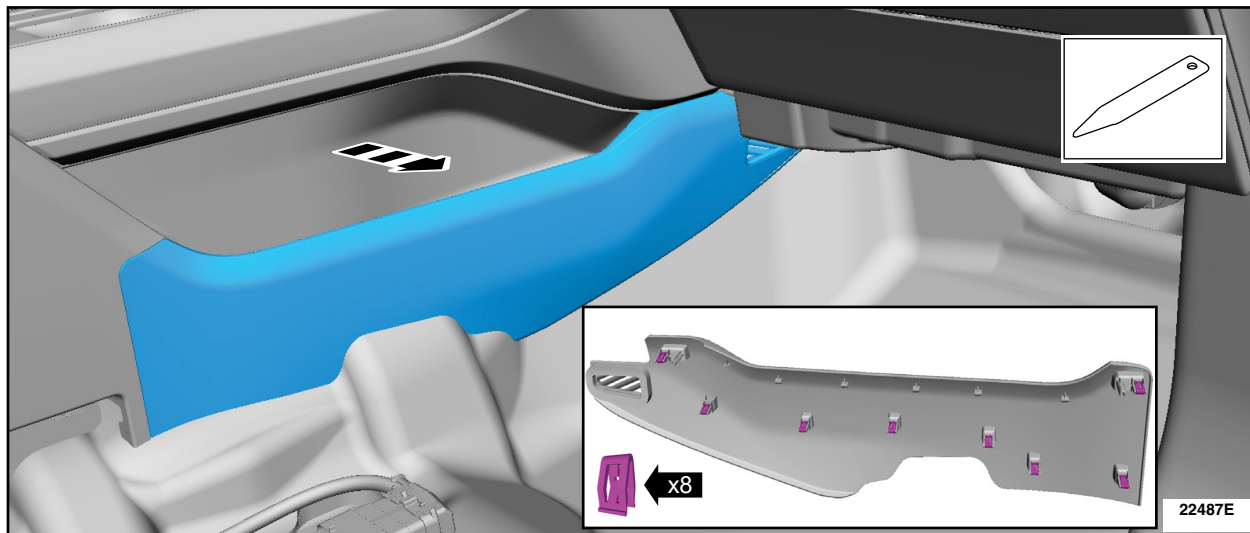
FIGURE 5

7. Release the clips and remove the floor console lower RH trim panel. See Figure 5.

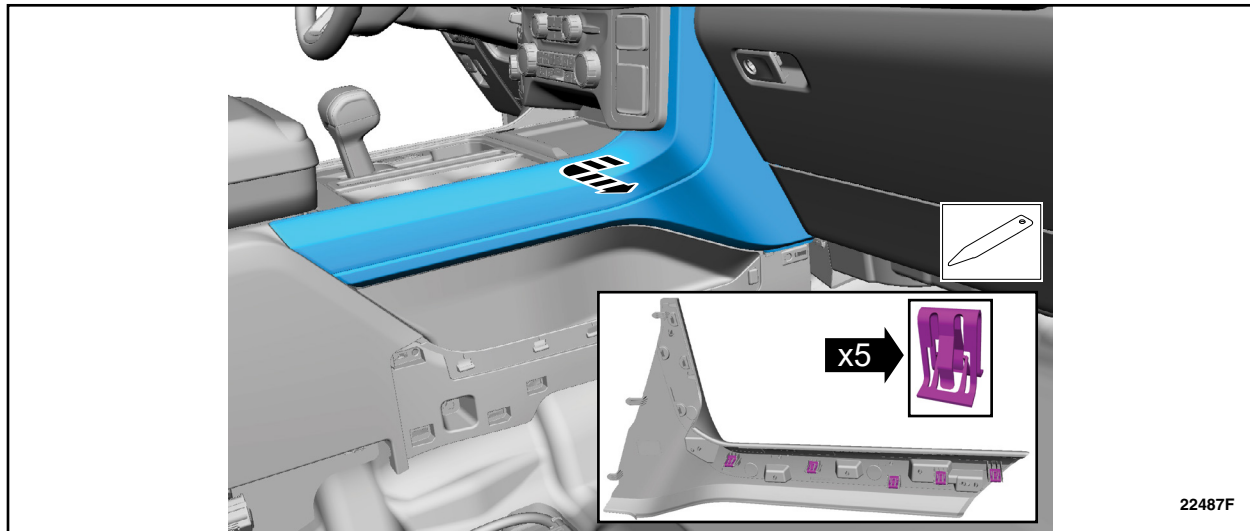
FIGURE 6

8. Release the clips and remove the floor console upper RH trim panel. See Figure 6.

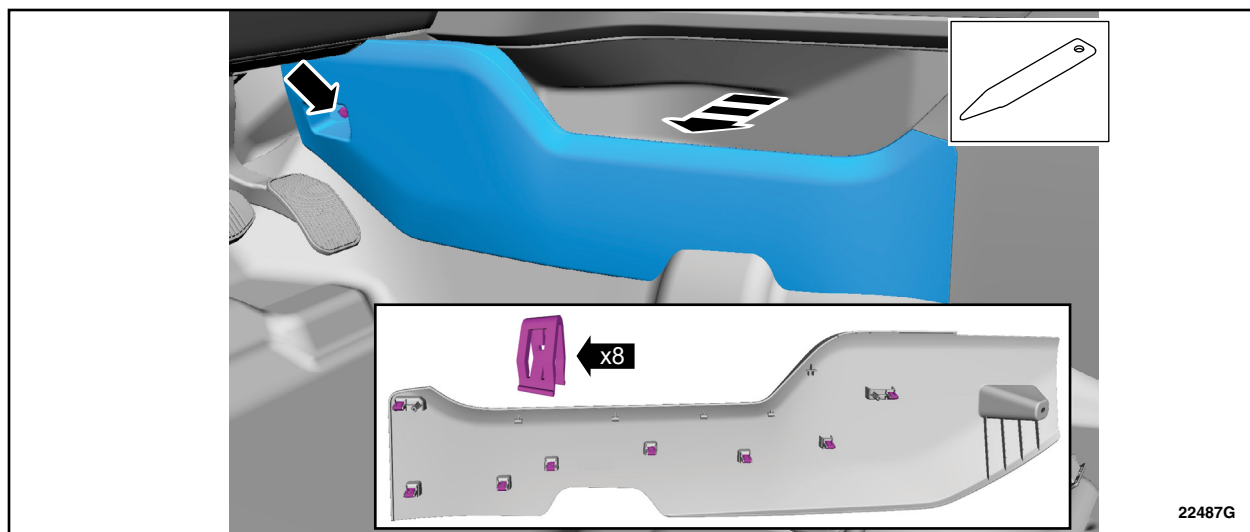
FIGURE 7

9. Remove the bolt, release the clips and remove the floor console lower Left Hand (LH) trim panel. See Figure 7.

• Torque 22 lb.in (2.5 Nm).

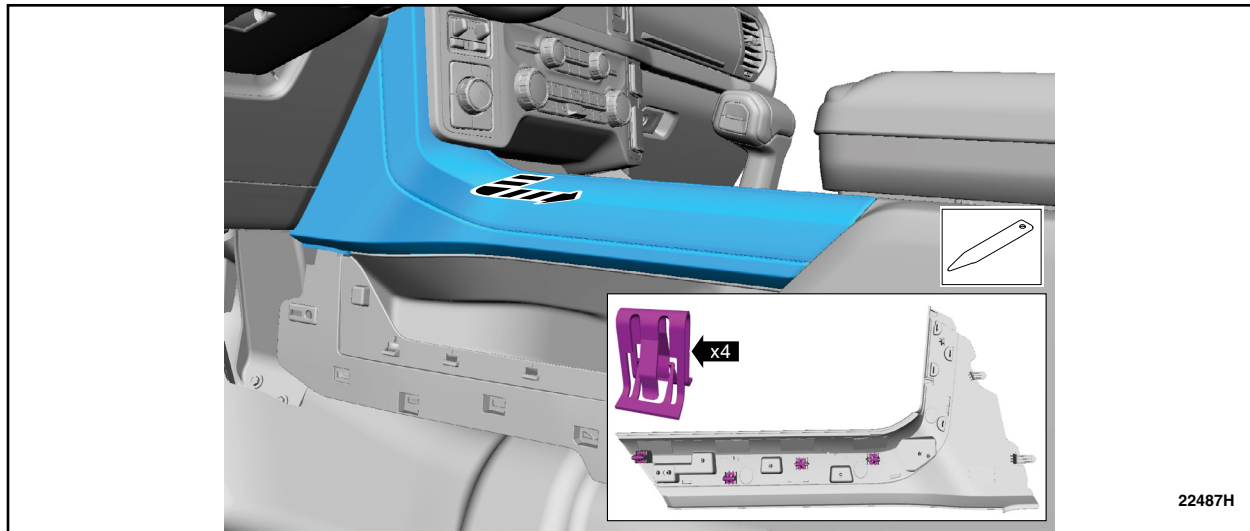
FIGURE 8

10. Release the clips and remove the floor console upper LH trim panel. See Figure 8.

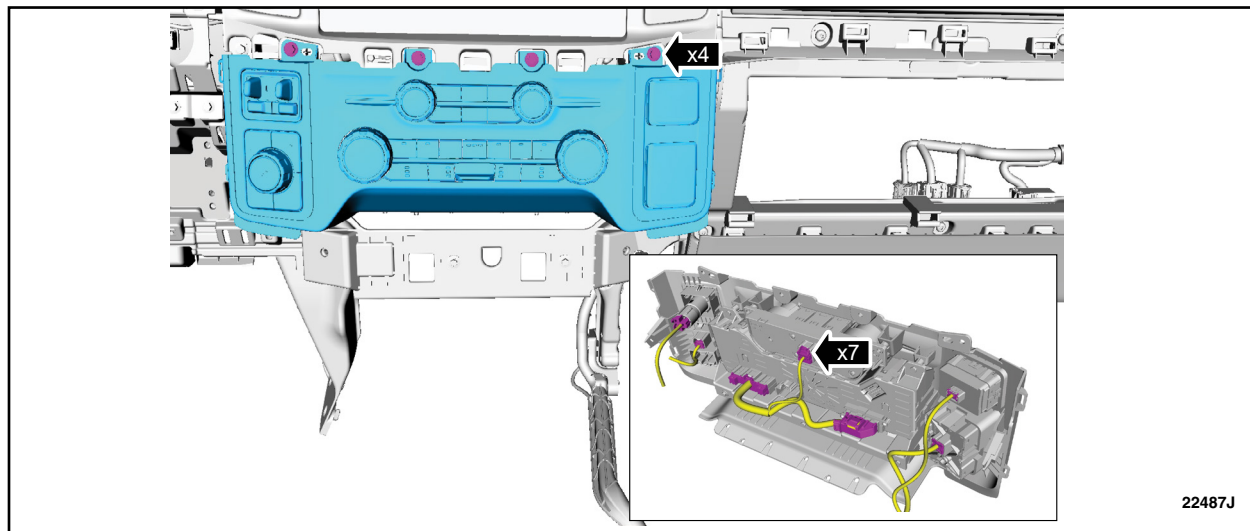
FIGURE 9

11. Remove the bolts, disconnect the electrical connectors and remove the Front Controls Interface Module (FCIM). See Figure 9.

- Torque 22 lb.in (2.5 Nm).

NOTE: Instrument panel removed for clarity.

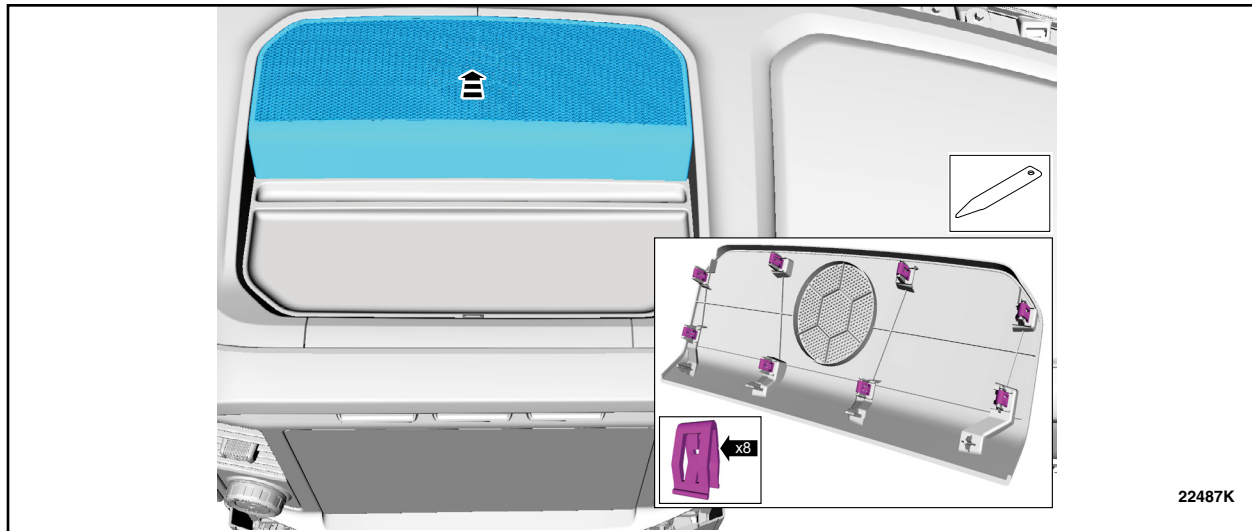
FIGURE 10

12. Release the clips and remove the speaker grille. See Figure 10

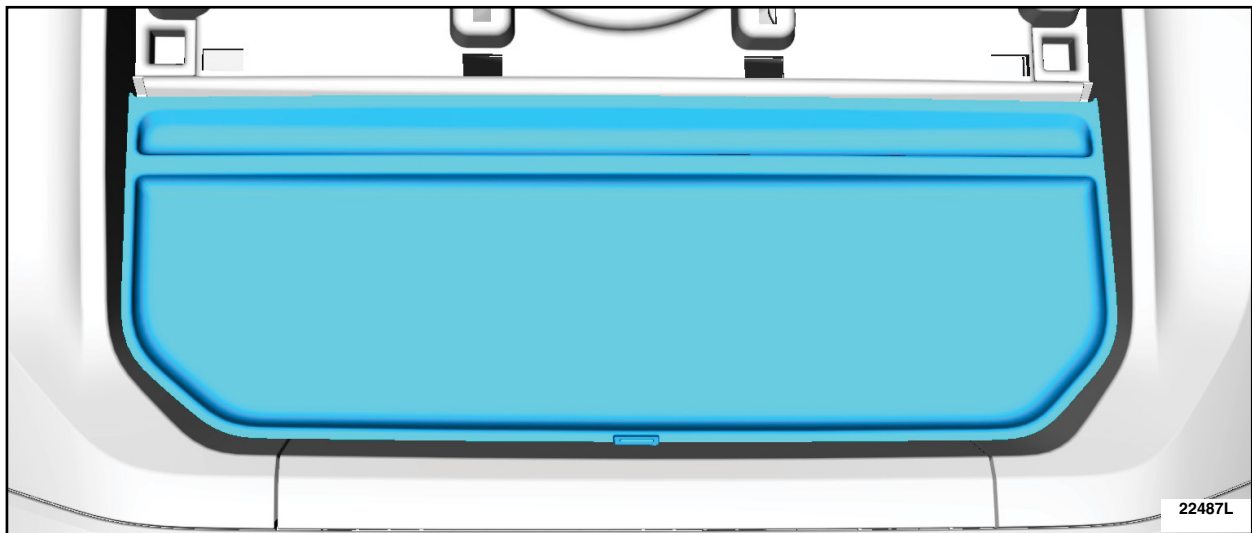
FIGURE 11

NOTE: If equipped remove the rubber pad. See Figure 11.

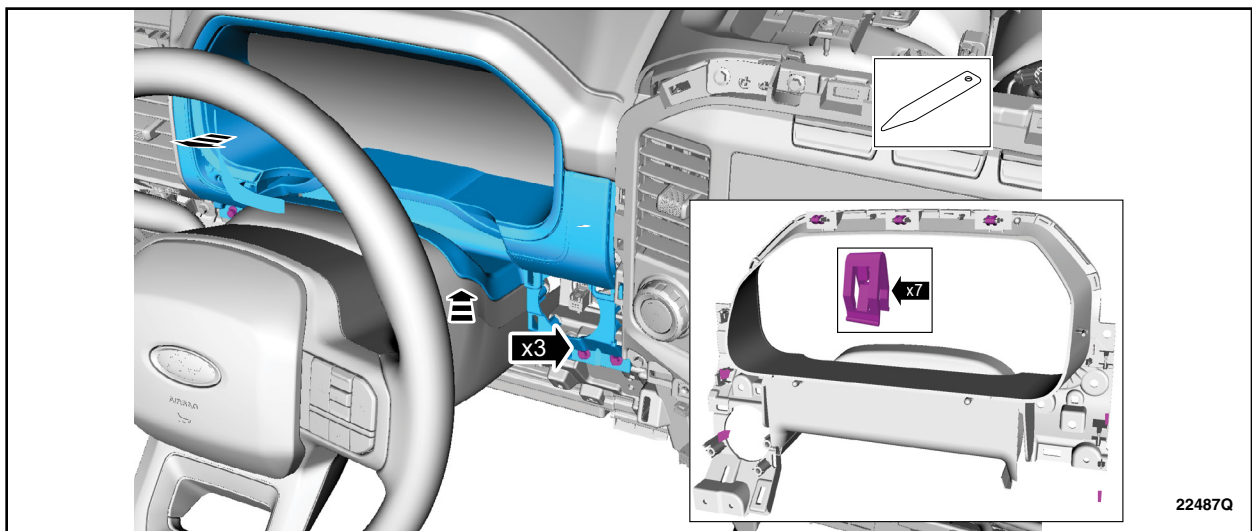
FIGURE 15

16. Remove the bolts, separate the gap hider from the upper steering column shroud, release the 7 clips and remove the IPC bezel. See Figure 15.

- Torque 36 lb.in (4.1 Nm).

NOTE: Instrument panel removed for clarity.

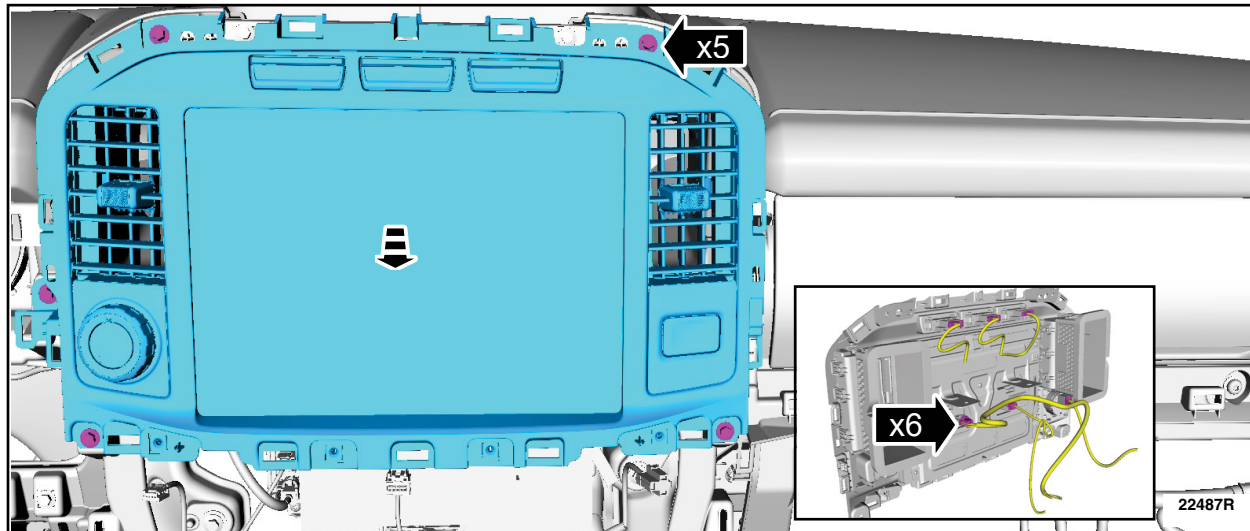
FIGURE 16

17. Remove the bolts, disconnect the electrical connectors and remove the display unit. See Figure 16.

- Torque 22 lb.in (2.5 Nm).

NOTE: Instrument panel removed for clarity.

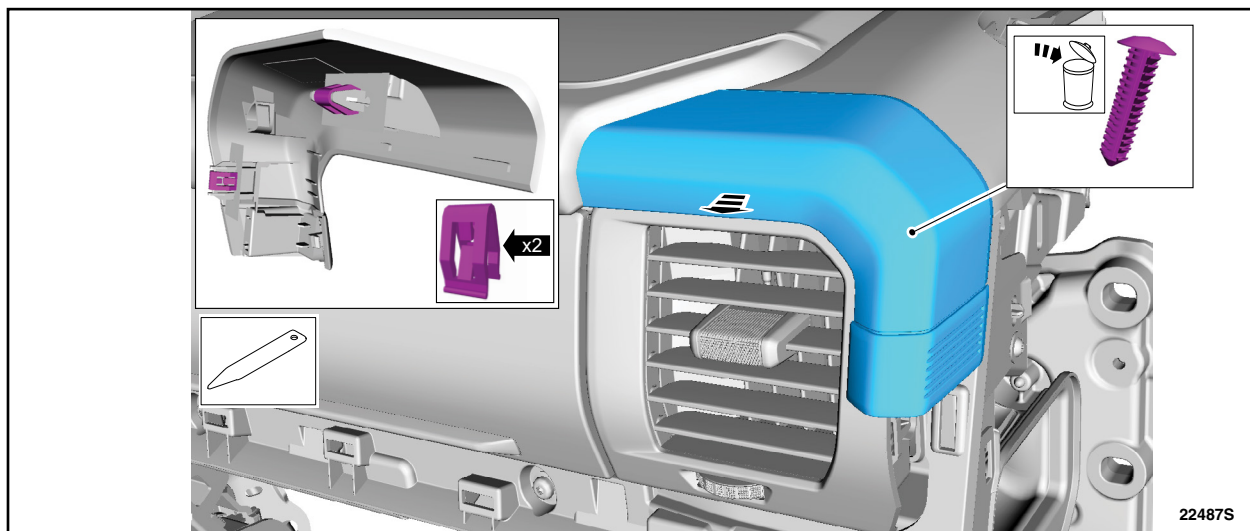
FIGURE 17

18. Release the retainers and remove and discard the push pin. Remove the RH register bezel. See Figure 17.

NOTE: The push pin must be replaced each time the bezel is removed.

NOTE: Instrument panel removed for clarity.

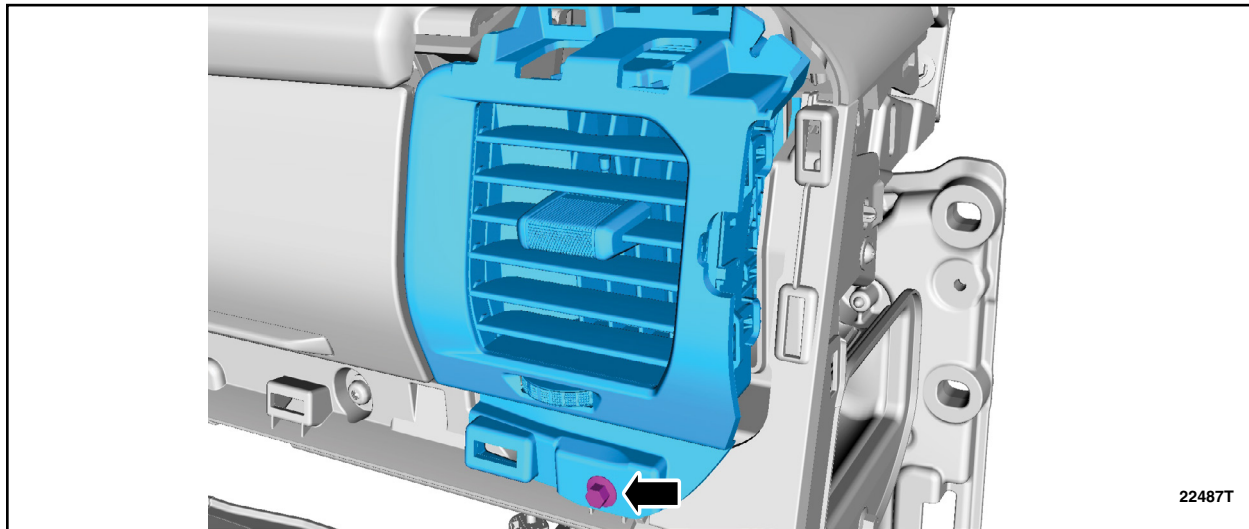
FIGURE 18

19. Remove the bolt and the RH register. See Figure 18.

- Torque 22 lb.in (2.5 Nm).

NOTE: Instrument panel removed for clarity.

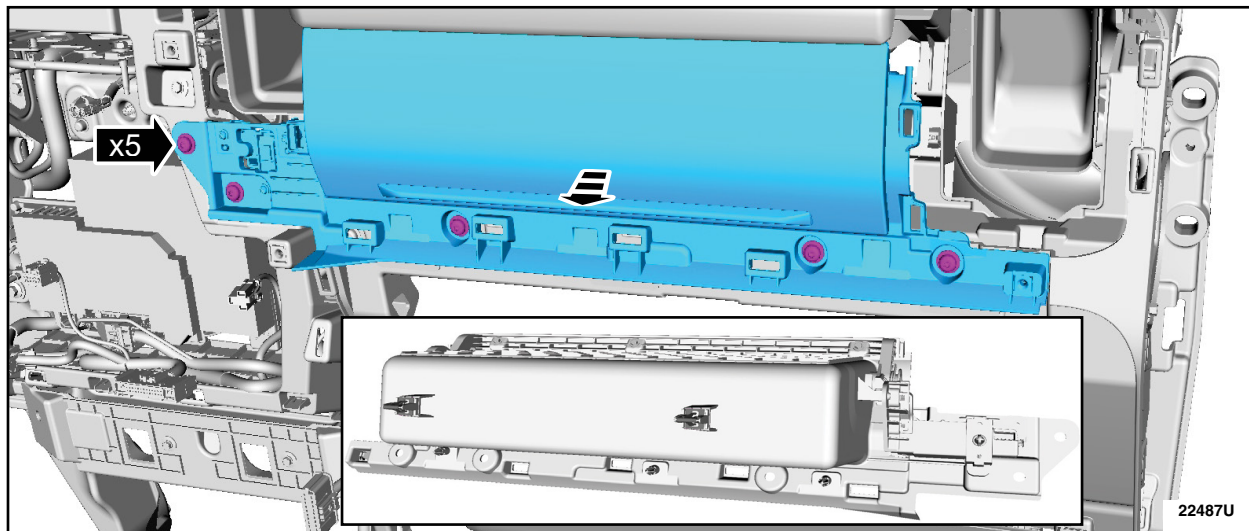
FIGURE 19

20. Remove the bolts and remove the upper storage compartment. See Figure 19.

- Torque 22 lb.in (2.5 Nm).

NOTE: Instrument panel removed for clarity.

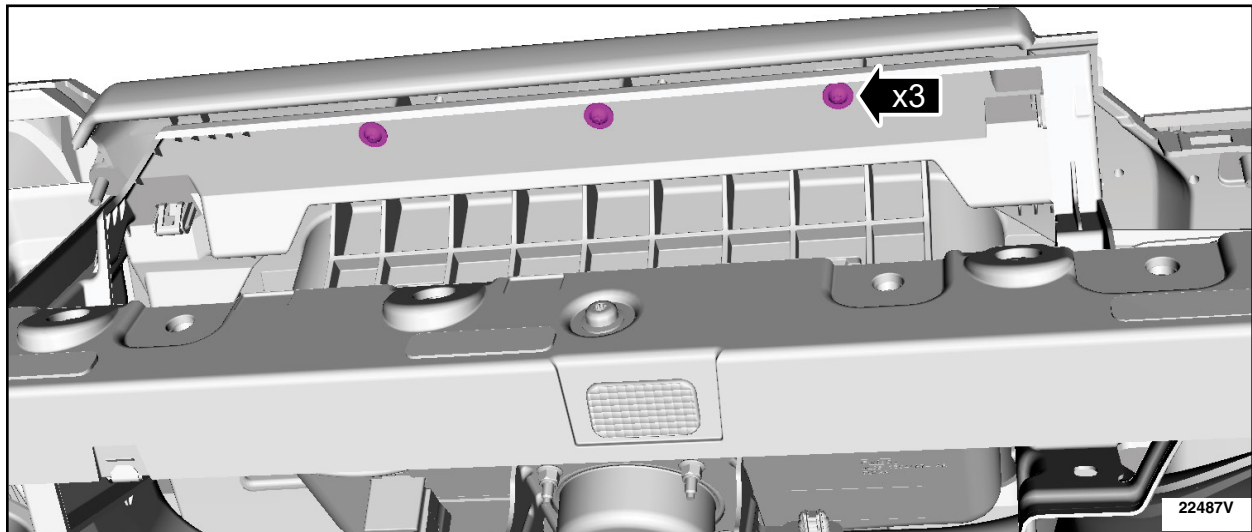
FIGURE 20

21. Remove the screws through the upper stowage bin opening. See Figure 20.

- Torque 11.5 lb.in (1.3 Nm).

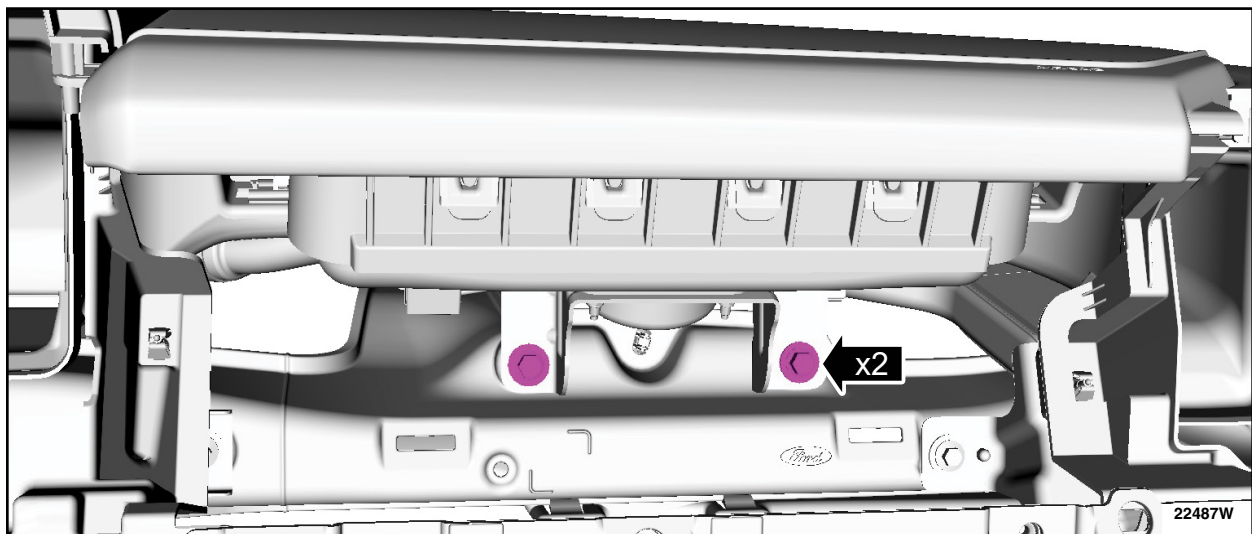
FIGURE 21

22. Remove the bolts. See Figure 21.

- Torque 93 lb.in (10.5 Nm).

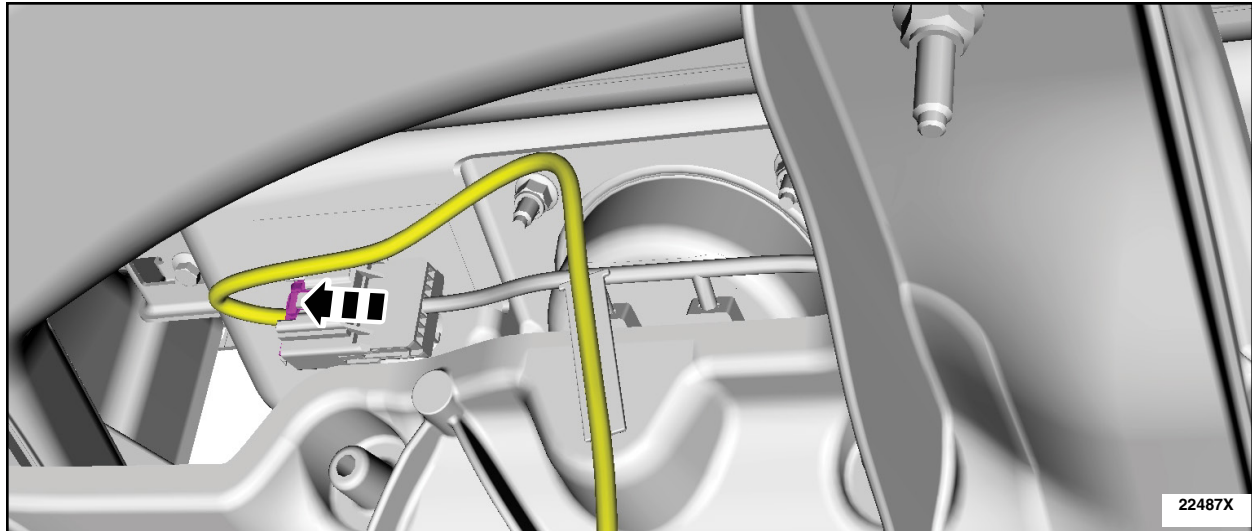
FIGURE 22

23. Disconnect the passenger airbag electrical connector. See Figure 22.

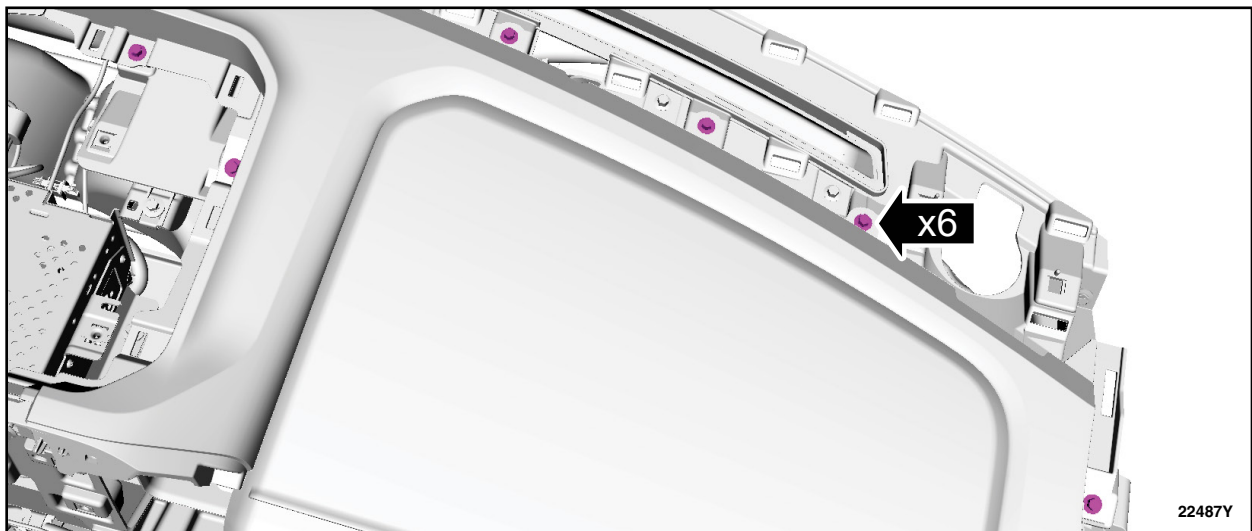
FIGURE 23

24. Remove the RH instrument panel upper section bolts. See Figure 23.

- Torque 22 lb.in (2.5 Nm).

NOTE: Instrument panel removed for clarity.
