**Safety Recall – 2024 CX-90 Pedestrian Alert System Warning Sound Error**

**A. VEHICLE INSPECTION PROCEDURE – AND PREPERATION FOR REPAIR**

## B. REPAIR PROCEDURE

This repair will reprogram or add and update the Approaching Vehicle Audible System Information Sound Box “AVAS ISB” amplifier software in the vehicle, by MDARS

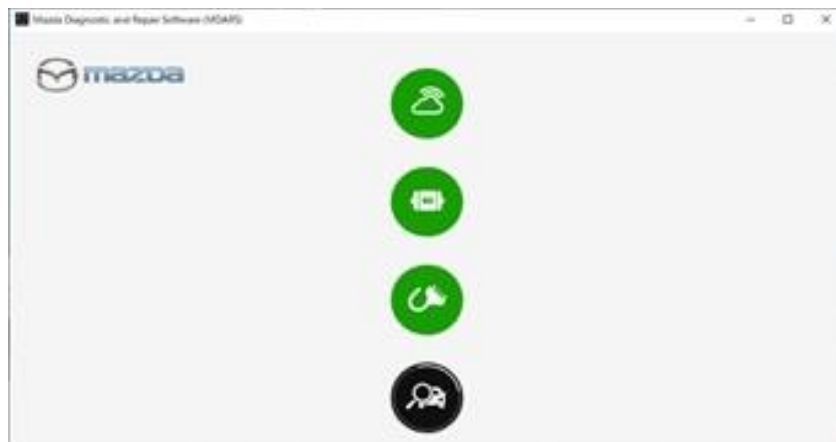
3. The Vehicle Identification process will start and automatically, checking for proper connections. If successful, then you can proceed to the next step.

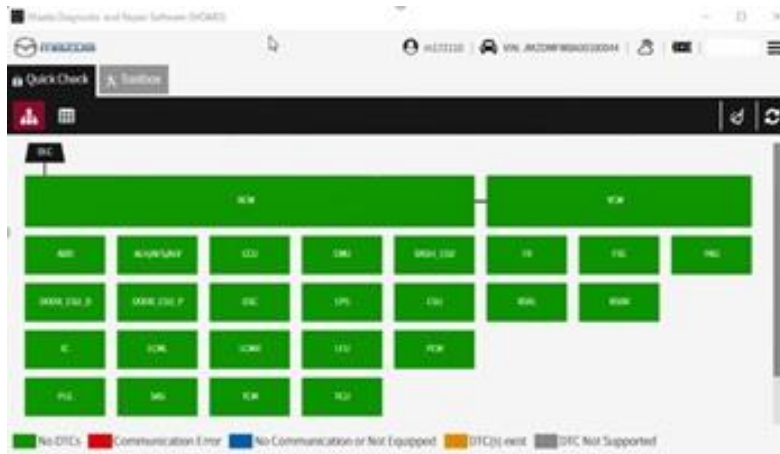
- Verify the DTC according to the directions on the quick check screen. If any DTCs are displayed, perform troubleshooting according to the corresponding DTC inspection.
