# MULTIPLE CAMPAIGNS REPAIR PROCEDURE AND MULTIPLE MODULE REPROGRAMMING

## Section B : Repair Procedure Recall 6223J

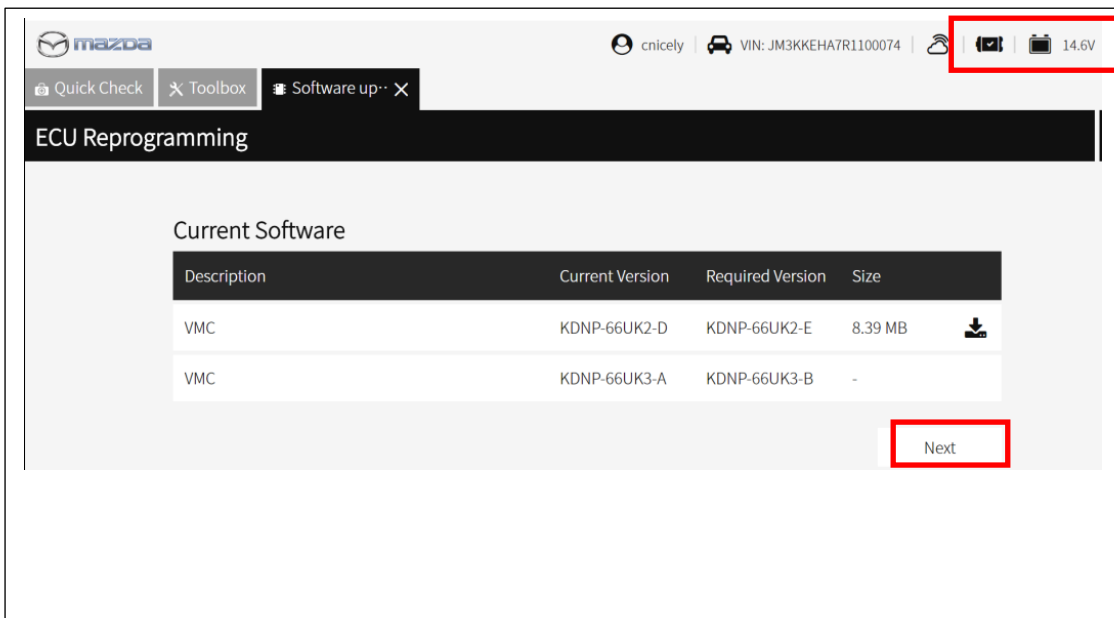
6. After completion of software update, the previous and current software version are shown. Check current version at "Calibration File information" below. Then, click on "Finish" to exit the ECU reprogramming and disconnect the 12V battery charger.

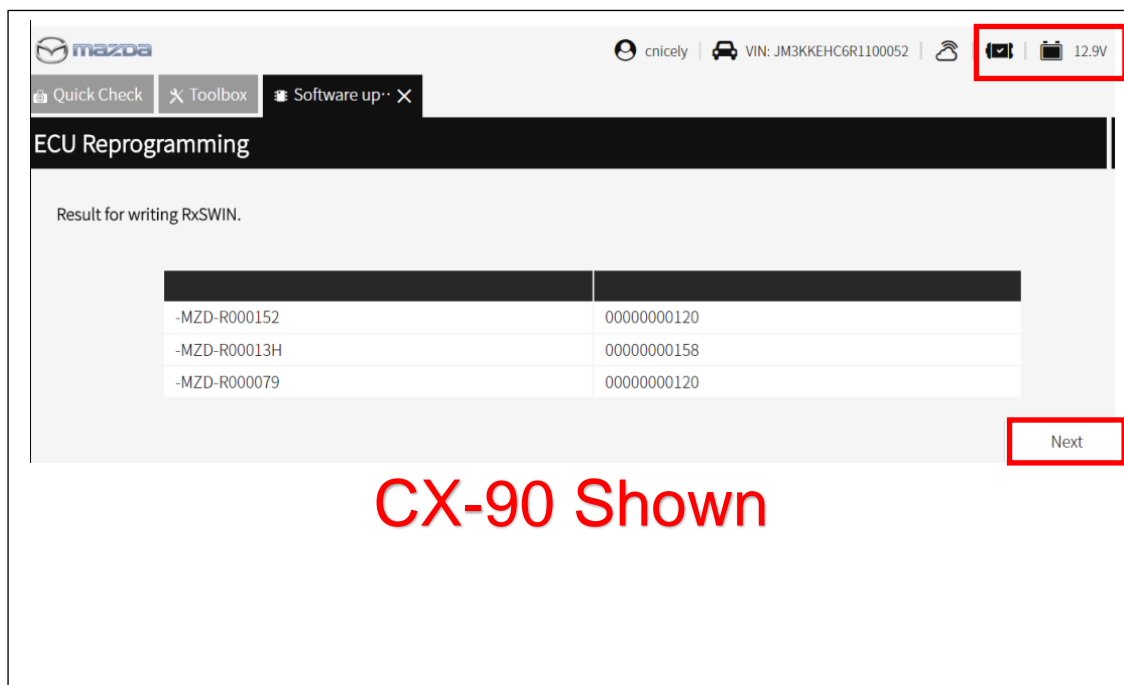
**CX-90 Shown**

The screenshot shows the Mazda software update interface. At the top, there is a navigation bar with 'Quick Check', 'Toolbox', and 'Software up' tabs. The main heading is 'ECU Reprogramming'. Below this, the 'Result for writing RxSWIN' section contains a table with the following data:

-MZD-R000152	00000000120
-MZD-R00013H	00000000158
-MZD-R000079	00000000120

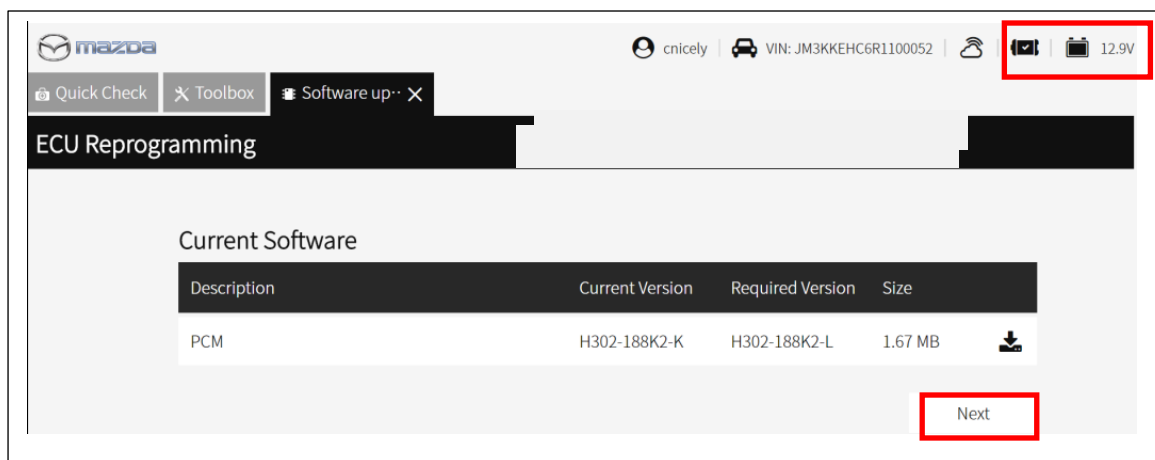
6. After completion of software update, the previous and current software version are shown. Check current version at "Calibration File information" below. Then, click on "Finish" to exit the ECU reprogramming and disconnect the 12V battery charger.

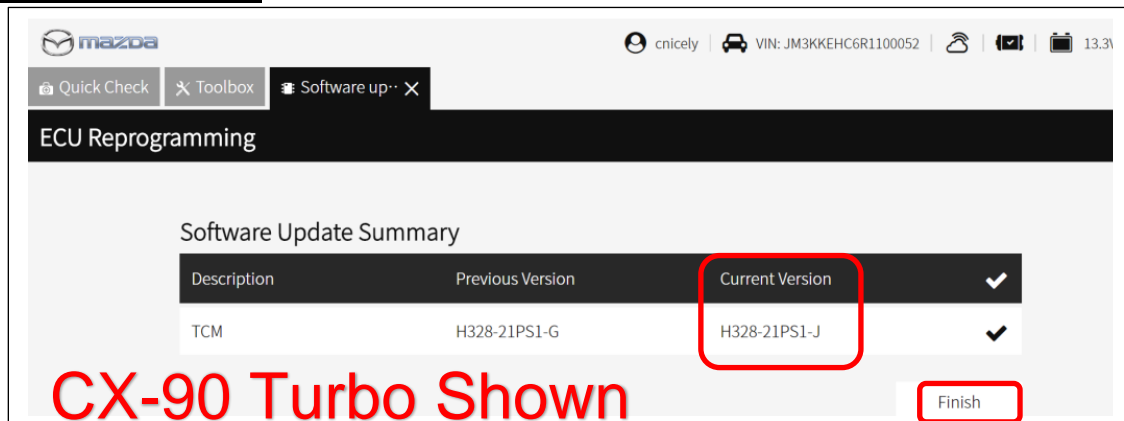
**CX-90 Turbo Shown**

Software Update Summary

Description	Previous Version	Current Version	
TCM	H328-21PS1-G	H328-21PS1-J	✓

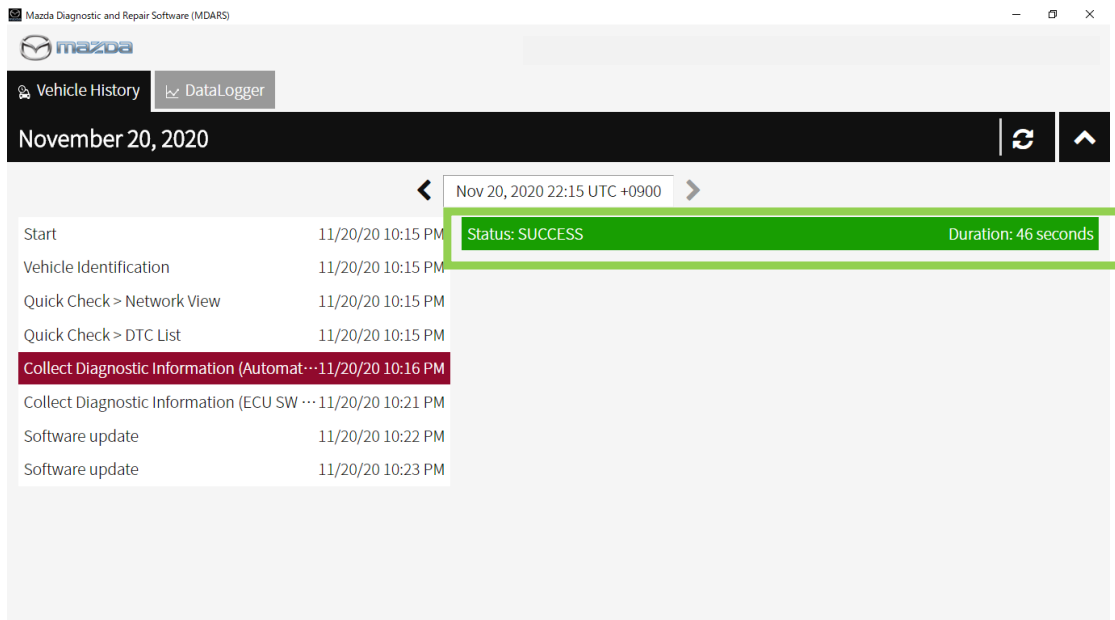
- Click the 'Collect Diagnostic Information' and the status has 'SUCCESS' on green.

Only the latest "Collect Diagnostic Information" is the valid one and that needs to show "SUCCESS"

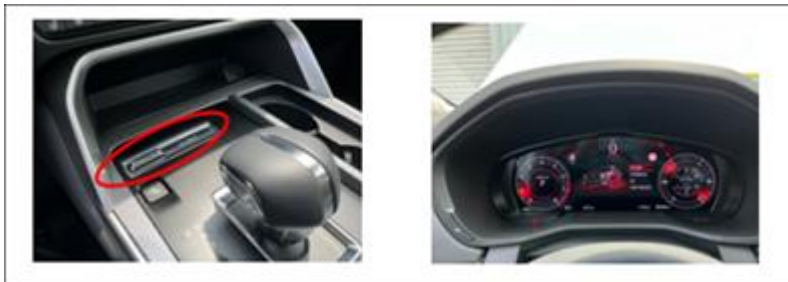
10. Verify the repair by starting the engine. If subject vehicle is PHEV, proceed with following steps. Make sure there is no MIL illumination or abnormal warning lights present.
