RAM

- Remedy available for
- 2023-2024 (D2) RAM 3500 Pickup
- 2023-2024 (DD) RAM 3500 Cab/Chassis
- 2023 (DF) RAM 3500 10K LB. Cab/Chassis
- 2023-2024 (DJ) RAM 2500 Pickup
- 2023-2024 (DP) RAM 4500/5500 Cab Chassis
- 2023 (DS) RAM 1500 Pickup

SYMPTOM DESCRIPTION

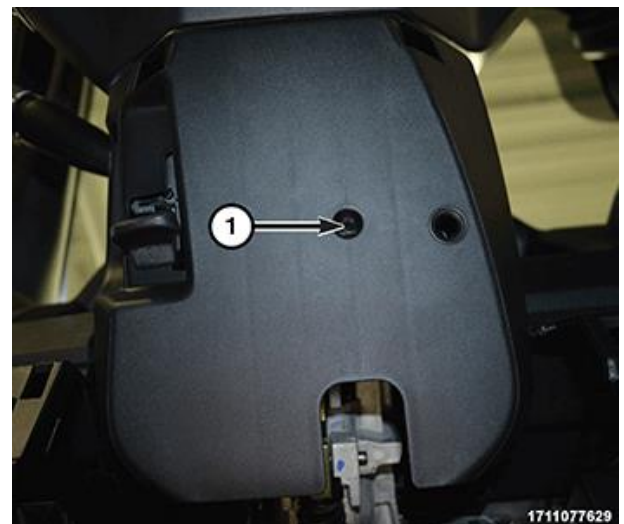
Figure 12 – Steering Column Lower Shroud

23. Remove the lower shroud to column retaining screw (1) and carefully move the lower shroud over the steering column tilt lever and off the steering column (Figure 12).

6. Install the lower shroud, shroud to column retaining screw (1) and tighten securely (Figure 12).
