SAFETY RECALL
NORTH AMERICA
Malfunctioning SCCM

Reference: B2A / NHTSA 23V-799

FCA US LLC

- Remedy available for
- 2023-2024 (D2) RAM 3500 Pickup
- 2023-2024 (DD) RAM 3500 Cab/Chassis
- 2023 (DF) RAM 3500 10K LB. Cab/Chassis
- 2023-2024 (DJ) RAM 2500 Pickup
- 2023-2024 (DP) RAM 4500/5500 Cab Chassis
- 2023 (DS) RAM 1500 Pickup

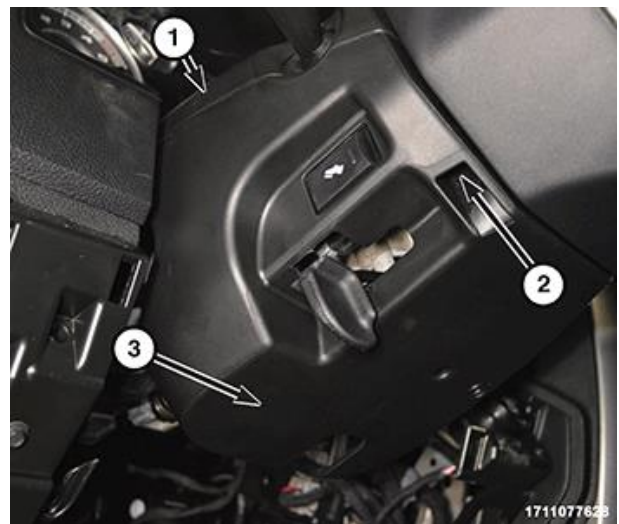
Figure 2 – Steering Column Upper Shroud

1. Place the front wheels in the straight-ahead position.
2. Disconnect and isolate the negative battery cable. If equipped with an Intelligent Battery Sensor (IBS), disconnect the IBS connector first before disconnecting the negative battery cable.
3. Wait 2 minutes for capacitor discharge.
4. From below the steering column, remove the two outboard screws within the recess areas (2) that secure the upper shroud (1) to the lower shroud (3) (Figure 2).

5. Remove the upper shroud (1) by pushing gently inward and upward on both sides of the upper shroud above the parting line of the lower shroud to release the snap features that secure the two shroud halves to each other (Figure 2).
6. Release the steering column tilt lever and lower the column to its most downward position for easiest driver airbag removal access.

21. Position the upper shroud (1) onto the steering column over the lower shroud (3) (Figure 2).
22. Align the snaps features on the upper and lower shroud halves and apply hand pressure to snap together.
23. From below the steering column, install the two outboard screws within the recess areas (2) that secure the upper shroud (1) to the lower shroud (3) (Figure 2).

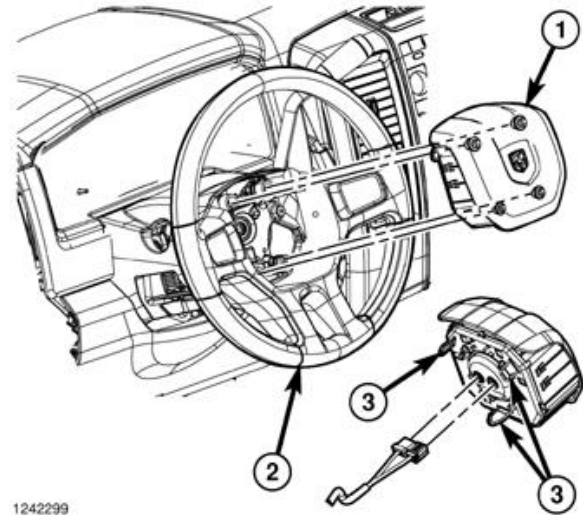
Figure 5 – Airbag Removal

9. Push the handle of the tool downward for the blade to pry the snap retainer wire loop (3) upward far enough to disengage the loop from the hook of the steering wheel armature. At the same time, gently pull the DAB (1) away from the steering wheel (2) to prevent the retainer from snapping back into place over the hook once it is disengaged (Figure 5).
10. Repeat Steps 7 and 8 at the other upper (two o'clock or ten o'clock) access hole to disengage the other upper snap retainer wire loop.
11. Repeat Steps 7 and 8 at the lower (six o'clock) access hole to disengage the lower snap retainer wire loop. The lower snap retainer wire loop has a distinctive V-shape and must always be installed onto the six o'clock hook of the steering wheel armature.

18. Carefully position the DAB (1) into the hub cavity of the steering wheel (2). Be certain that the clockspring pigtail wires and the steering wheel wire harness are not pinched between the DAB and the horn switch, the steering wheel armature or, on vehicles equipped with a diesel engine, the steering wheel damper weight (Figure 5).

19. Engage the lower airbag snap retainer wire loop (3) onto the lower hook of the steering wheel armature. The lower snap retainer wire loop has a distinctive V-shape and must always be installed onto the six o'clock hook of the steering wheel armature (Figure 5).

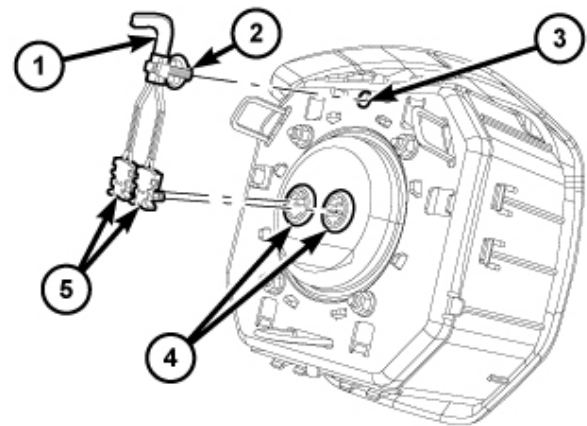
Figure 6 – Pigtail Wiring Harness Retainer

12. Pull the DAB away from the steering wheel far enough to access and disengage the plastic push-in retainer (2) of the clockspring pigtail wire harness (1) from the locator hole (3) at the 12 o'clock position on the back of the airbag housing (Figure 6).

15. Position the Driver AirBag (DAB) close enough to the steering wheel to reconnect the two clockspring DAB pigtail wire (1) electrical connections (5) to the inflator connector receptacles (4) on the back of the airbag housing (Figure 6).

17. Be certain to fully engage the plastic push-in retainer (2) of the clockspring pigtail wires into the locator hole (3) at the 12 o'clock position on the back of the airbag housing (Figure 6).

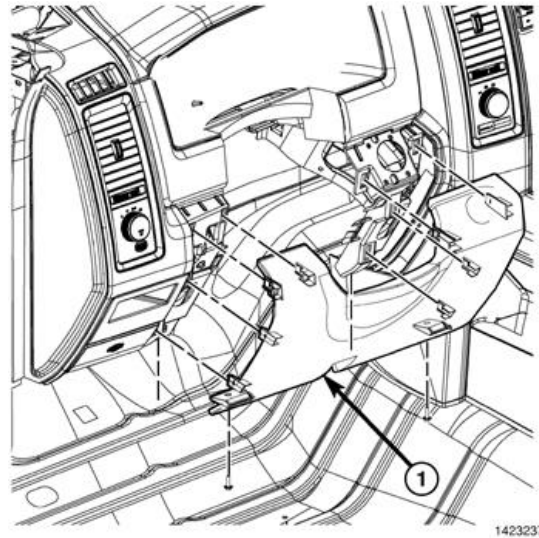
Figure 11 – Steering Column Opening Cover

21. Using a trim stick C-4755 or equivalent, release the retainer clips that secure the steering column opening cover (1) to the instrument panel and remove the cover (Figure 11).
22. Disconnect necessary wire harness connectors.

7. Lift the steering column opening cover into position. Connect necessary wire harness connectors.
8. Align the retainer clips that secure the steering column opening cover (1) to the instrument panel and install the cover (Figure 11).
9. Install the Data Link Connector (3) to the steering column opening cover (2) through the opening on the back side of the cover (Figure 10).
10. Install the two fasteners (2) that secure the bottom of the steering column opening cover (1) to the instrument panel and tighten securely (Figure 9).
11. Engage the retainer clip that secures the hood release to the steering column opening cover (Figure 9).

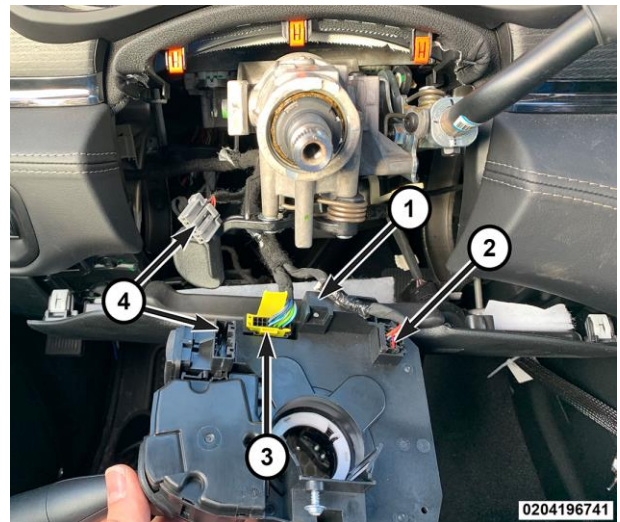
Figure 15 – SCCM Removal

27. Remove the SCCM from the steering column (Figure 15).
28. Disengage the wire harness routing clip (1) (Figure 15).
29. Disconnect the wire harness connectors (2 & 3) (Figure 15).
30. Remove and DISCARD the SCCM from the vehicle.

1. Connect the wire harness connectors (2&3) (Figure 15).
2. Secure the wire harness routing clip (1) (Figure 15).
3. While sliding the SCCM over the steering column connect the pedal adjustment wire harness connector, if equipped.
4. Install and securely tighten the screws (1) (Figures 13 & 14).
5. Remove the lock tab or any other device that is being used to secure the SCCM rotor to the SCCM case to maintain SCCM centering.

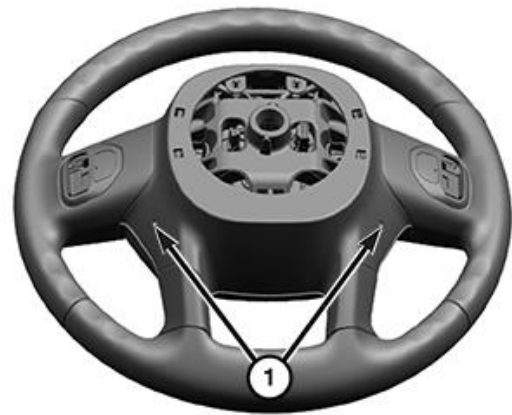
Figure 19 – DAB Removal

5. Wait 2 minutes for capacitor discharge.
6. Locate the access hole dimples (1) in the lower surface of the steering wheel hub rear trim cover near each of the two horizontal spokes.
7. Using the Remover, Driver Air Bag 2050200100, pierce the trim cover at the dimple and insert it through one of the steering wheel access holes. A guide and notch integral to each side of the steering wheel hub rear trim cover and the mounting/horn switch plate will assist in directing the tool to the ends of the retainer spring (Figure 19).

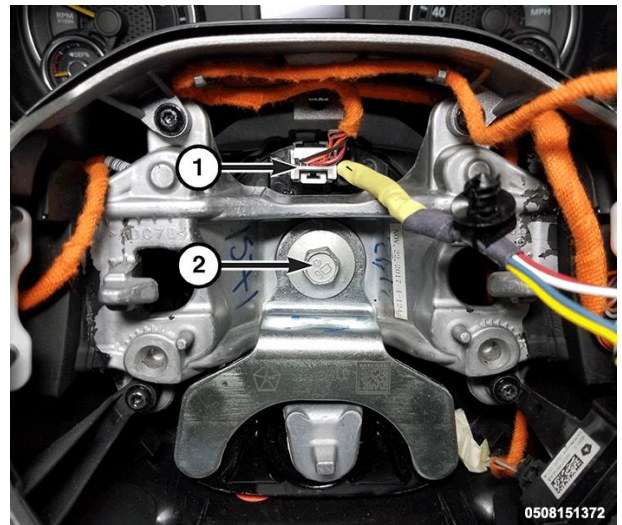
Figure 21 – Steering Wheel Wire Harness Connectors

12. The clockspring DAB pigtail wire connector insulators are secured by integral latches and a Connector Position Assurance (CPA) lock to the airbag tether cutter and inflator connector receptacles, which are located on the back of the floating horn switch plate and the DAB housing. Pull the lock straight away from the connector insulator, then pull the insulators straight away from the connector receptacles to disengage and disconnect them (Figure 20).
13. Remove the DAB and floating horn switch plate from the steering wheel as a unit.
14. Disconnect the steering wheel wire harness connectors (1) (Figure 21).
15. If equipped, disconnect the heated steering wheel wire harness connectors.
16. Remove and **DISCARD** the steering wheel bolt (2) and retain the damper if equipped (Figure 21).

11. Install the steering wheel to the steering column.
12. If equipped, position the damper to the steering wheel, then install a **NEW** steering wheel bolt and tighten the nut to 61 N·m (45 ft. lbs.) (Figure 21).

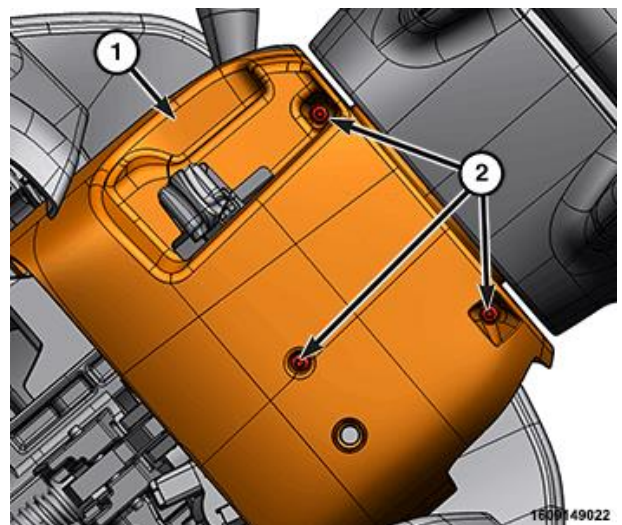
Figure 22 – Steering Column Shroud Screws

17. Remove the three steering column shroud screws (Figure 22).

9. Install and securely tighten the three steering column shroud screws (2) (Figure 22).
10. If equipped, connect the heated steering wheel wire harness connectors and secure the steering wheel wire harness.

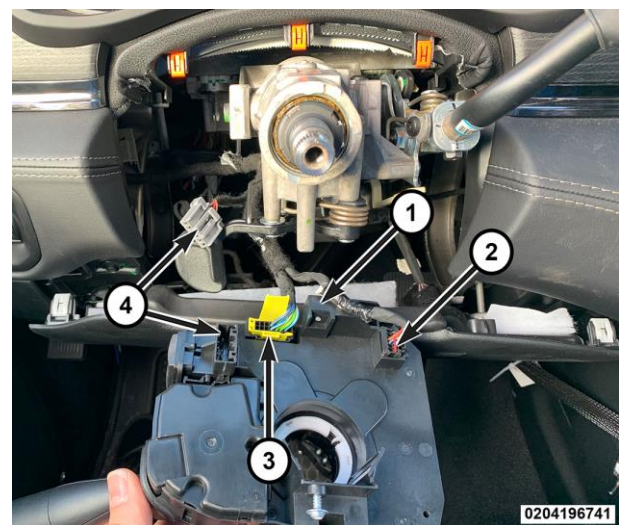
Figure 28 – SCCM

24. Pull the SCCM slightly away from the steering column and disconnect the pedal adjustment wire harness connector (4), if equipped (Figure 28).
25. Remove the SCCM from the steering column.
26. Disengage the wire harness routing clip (1) (Figure 28).
27. Disconnect the wire harness connectors (2 & 3) (Figure 28).

1. Connect the wire harness connectors (2 & 3) (Figure 28).
2. Secure the wire harness routing clip (1) (Figure 28).
3. While sliding the **NEW** SCCM over the steering column connect the pedal adjustment wire harness connector.
