PRODUCT CAMPAIGN BULLETIN

APPLICABILITY: 2018 Model Year Legacy, Outback, and BRZ Vehicles

NUMBER: WTZ-85R

SUBJECT: Harman Kardon Head Unit FMVSS 111 Noncompliance Recall

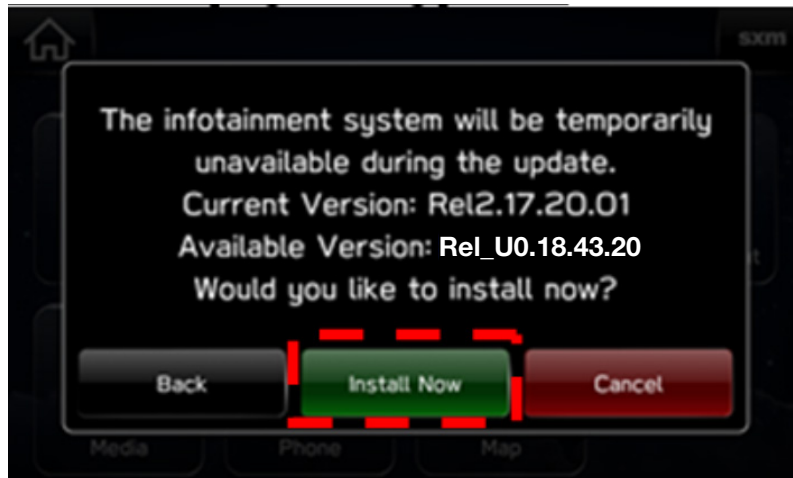
- The current and available software version information will be displayed. The Available Version I.D should be **Rel_U0.18.43.20**.

- After confirming the Available Version, press “Install Now” to start the reprogramming process.
