SERVICE PROGRAM BULLETIN

APPLICABILITY: 2018 MY Legacy
 2018 MY Outback
 2017-2018 MY Impreza
 2018 MY Crosstrek

NUMBER: WUA-86R

SUBJECT: Harman Kardon Head Unit Reprogramming

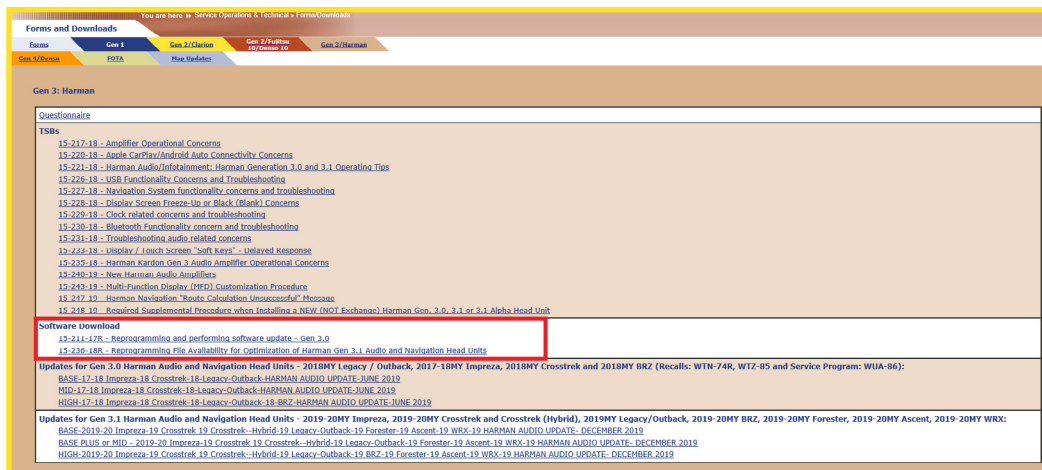
- If the files are being **downloaded from Subarunet**, they will be .zip files and must be unzipped before they can be used. An EXAMPLE image of the Subarunet links page is provided below.

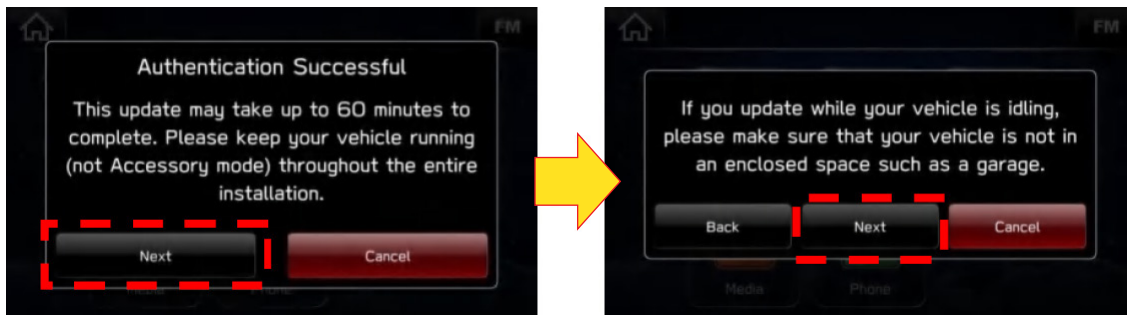
- After the unit “authenticates” the USB flash drive, press “Next” and after the second screen is displayed, press “Next” again.
