David J. Johnson
 Director
 Service Engineering Operations
 Ford Customer Service Division

SUBJECT: **Customer Satisfaction Program 21B49 - Supplement #1**
 Certain 2021 Model Year Bronco Vehicles Equipped with a Hard Top Roof
 Roof Panel Delamination

Dealers will replace all hard top roof panels and the hard top rear cap assembly and install new fixed quarter glass in the new rear cap assembly on all the affected vehicles. This service must be performed on all affected vehicles at no charge to the vehicle owner.

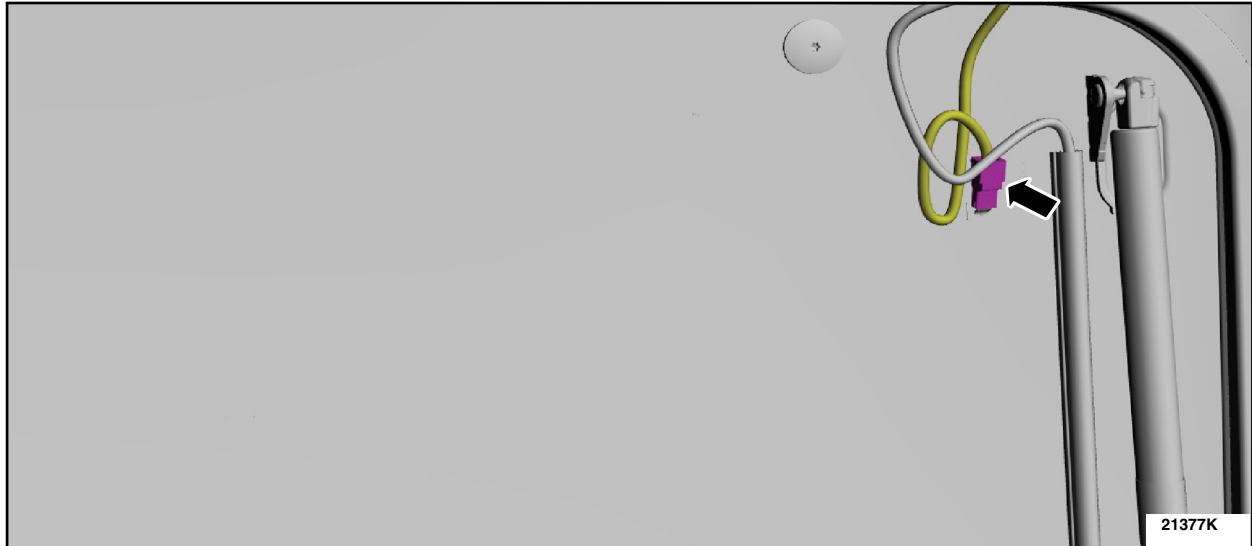
FIGURE 16

3. On both sides, disconnect the heated rear window element electrical connectors. See Figure 16.

NOTE: Liftgate window glass shown closed for clarity.

NOTE: LH shown, RH similar.

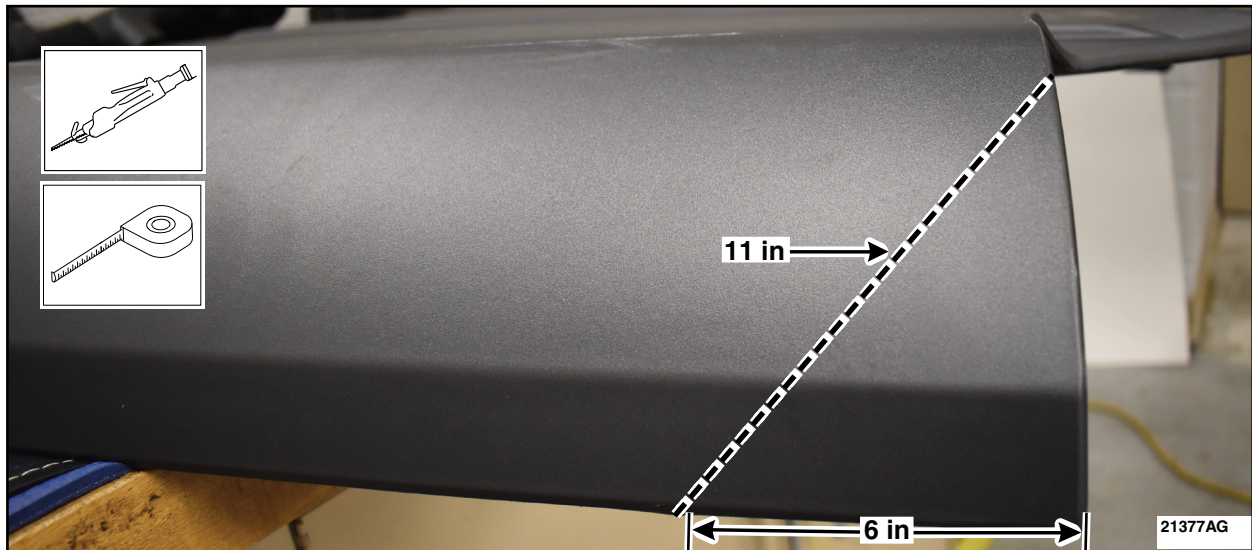
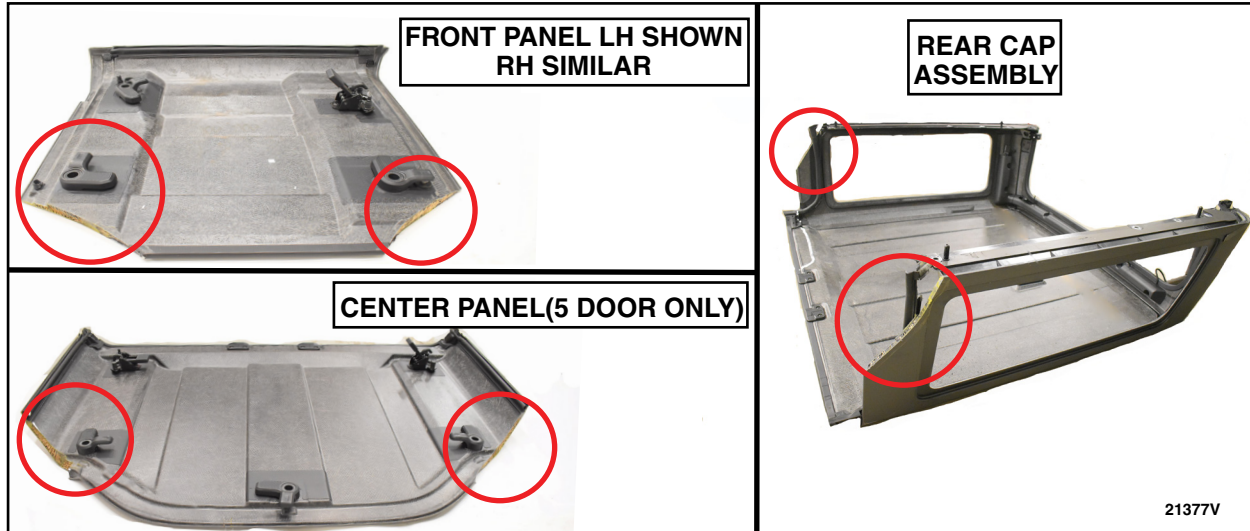
NOTE: The hard top panels and hard top rear cap assembly disablement must take place at two different corner locations on each panel and rear cap assembly and it will have to be captured in the photo evidence. The hard top panels and the hard top rear cap assembly must not be able to be reused after disablement. See Figures 22 and 23.

NOTE: Hard top center panel (5 door only) shown, other panels are similar.

1. **ALL** hard top panels and hard top rear cap assembly removed from vehicles must immediately be made unusable by cutting two corners of each hard top panel and hard top rear cap assembly at a minimum of 6 inches in length from the corner, and cutting on an angle through the panel at an minimum of 11 inches making sure to cut through the weather seal where applicable. See Figures 22 and 23.
