SUBJECT: **Customer Satisfaction Program 21M08 - Supplement #1**
 Certain 2021-2022 Model Year F-150 Vehicles Equipped with a Power Release Tailgate - Unintended Tailgate Opening

REF: **Customer Satisfaction Program 21M08**
 Dated May 20, 2022

CERTAIN 2021-2022 MODEL YEAR F-150 VEHICLES EQUIPPED WITH A POWER RELEASE TAILGATE — UNINTENDED TAILGATE OPENING

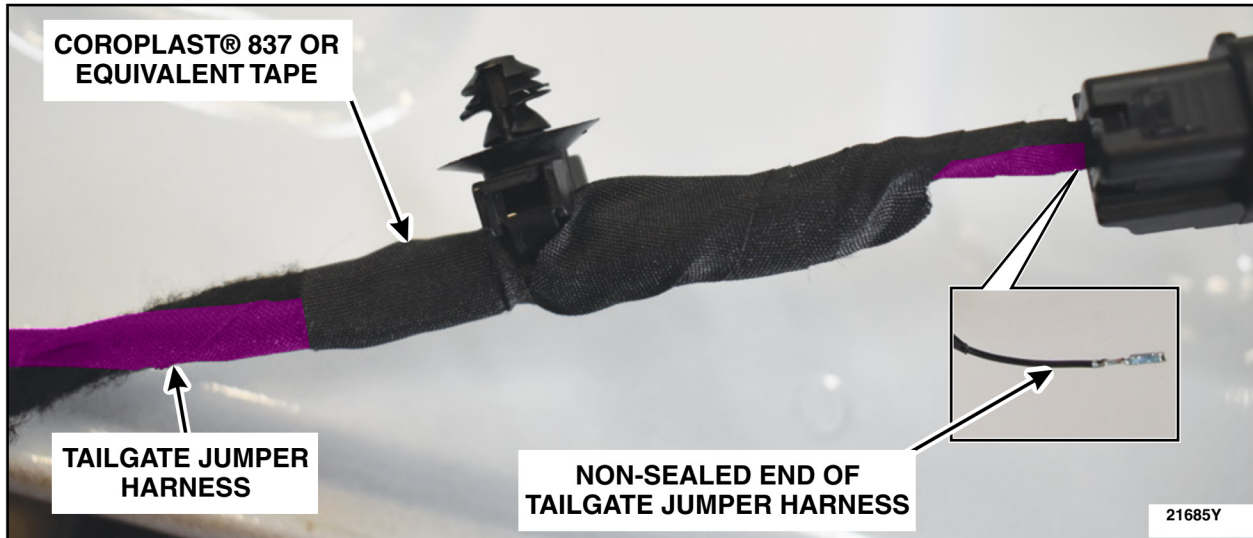
FIGURE 25

29. Install the Tailgate Jumper Harness non-sealed end terminal into the open pin in the tailgate latch control assembly electrical connector. Secure using Coroplast® 837 or Equivalent Electrical Wire Harness Tape. Reinstall the white locking tab. See Figure 25.

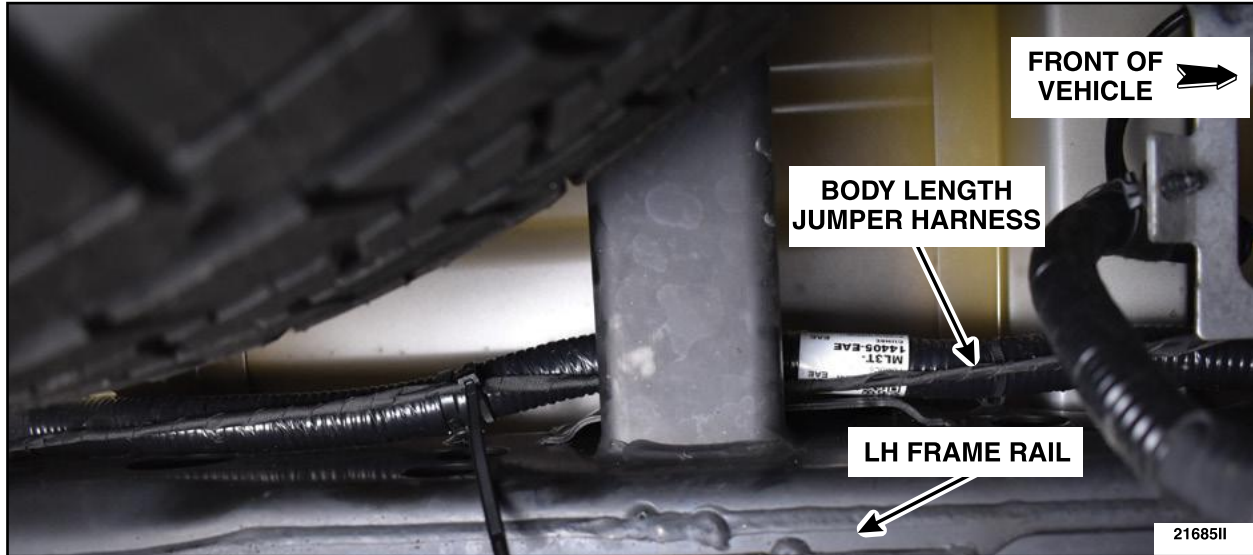
FIGURE 35

40. Route the Body Length Jumper Harness along the LH frame rail towards the front of the vehicle keeping the harness as close to the bed as possible. Secure using tie straps every 12 in (305 mm). See Figure 35.

NOTE: The tie straps were left untrimmed for clarity. Trim any excess from the tie straps once installed.

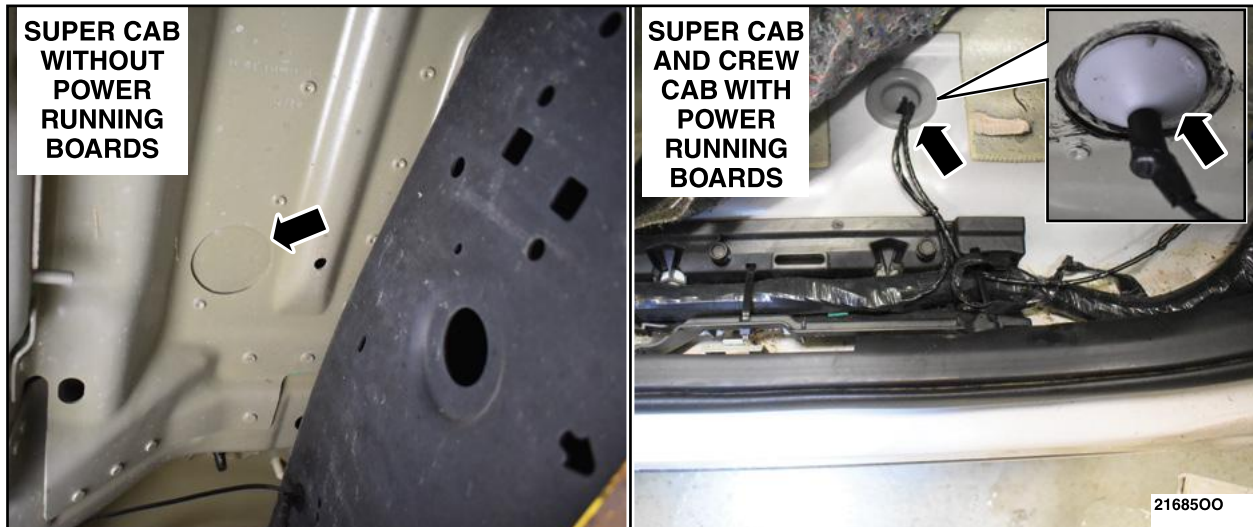
FIGURE 39

43. **ALL** vehicles equipped **WITH** power running boards have a grommet located on the front passenger floor board. **Super Cab** vehicles **WITHOUT** power running boards have no hole present on the front passenger floor board. **Crew Cab** vehicles **WITHOUT** power running boards have a plug on the front passenger floor board. See Figure 39.

NOTE: Floor board grommet shown, floor board plug similar.

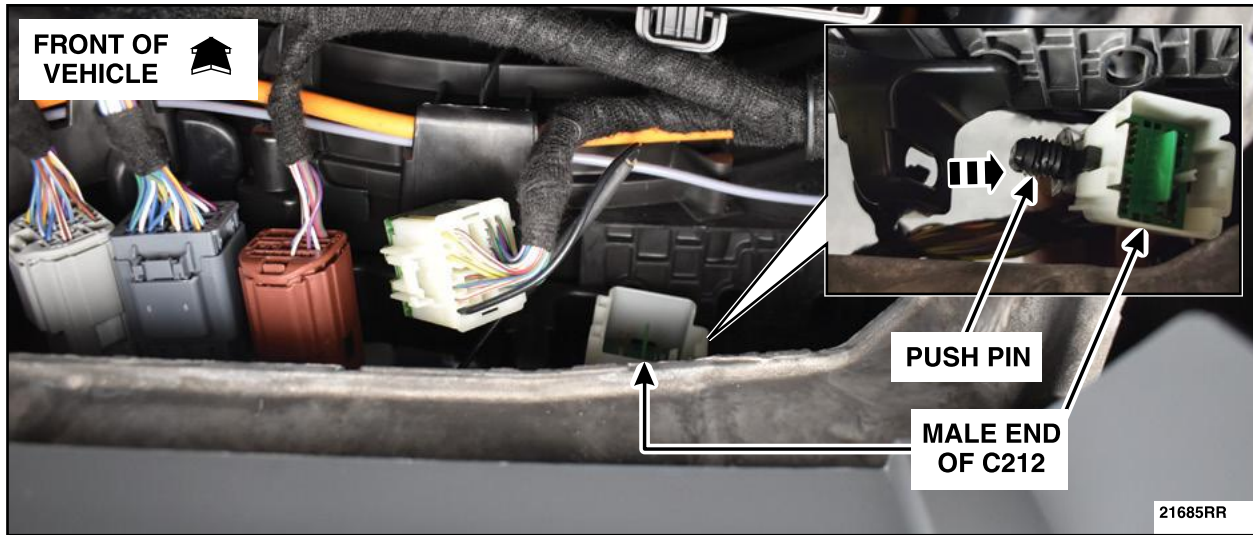
FIGURE 44

47. Disconnect the push pin of the male end of C212 from the instrument panel bracket. See Figure 44.
