**SUBJECT:** **Customer Satisfaction Program 21M05 - Supplement # 2**  
Certain 2017-2022 Model Year Super Duty Vehicles Equipped with a Power Release Tailgate - Unintended Tailgate Opening

*Technical Information: Updated with revised instructions to account for wire color differences across multiple model year vehicles.*

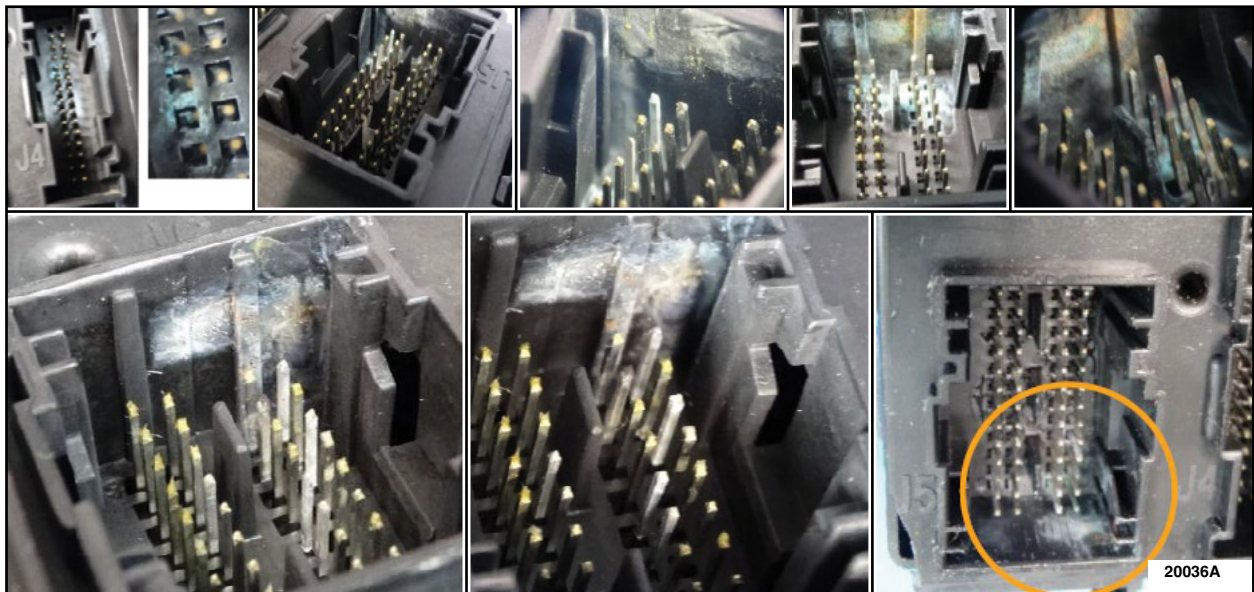
**FIGURE 1**

1. Lower the tailgate of the vehicle.
2. Open the hood of the vehicle.
3. If equipped, open the roof opening panel.
4. Disconnect the negative battery cable(s) and position aside. Please follow the Workshop Manual (WSM) procedures in Section 414-01.
5. Remove the Body Control Module (BCM). Please follow the WSM procedures in Section 419-10.
6. Inspect the BCM for any sign(s) of moisture and/or corrosion. See Figure 1 for examples of corrosion.
  - Was any sign(s) moisture and/or corrosion present?

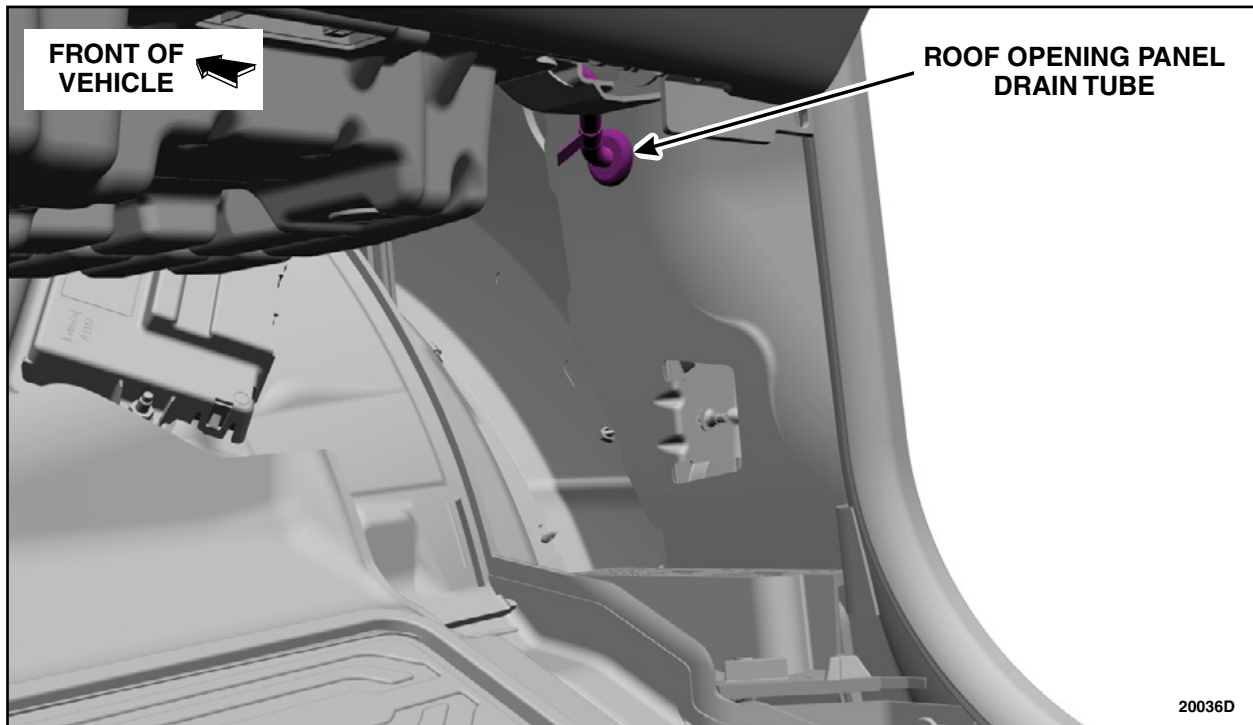
**FIGURE 4**

9. Locate the roof opening panel drain tube on the Right Hand (RH) side of the vehicle behind the BCM. See Figure 4.

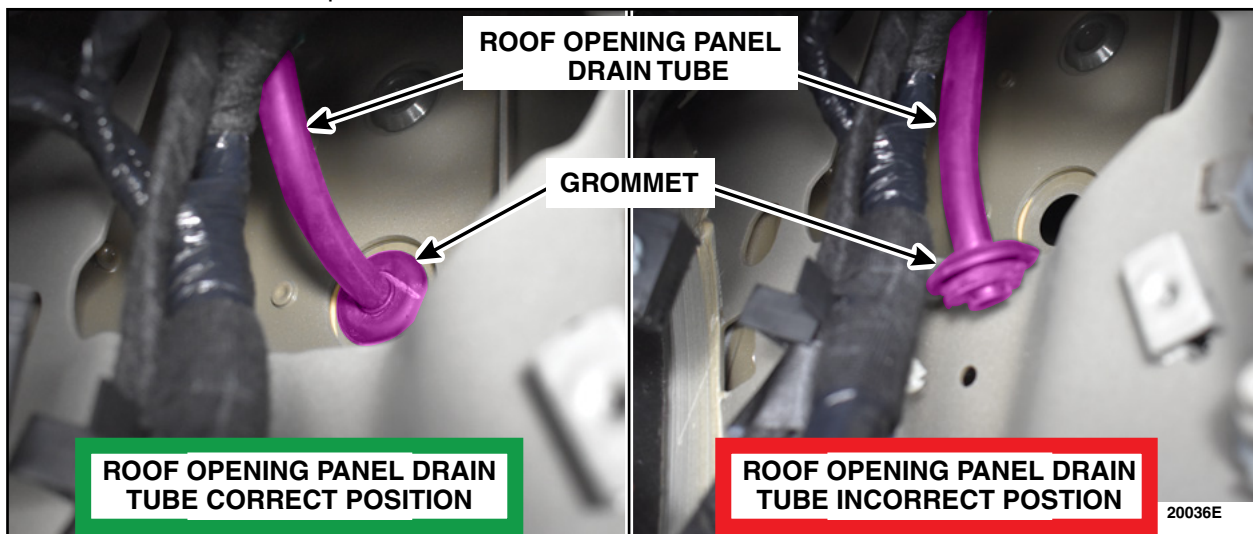
**FIGURE 5**

10. Inspect the roof opening panel drain tube and grommet.  
- Is the drain tube and grommet in the correct position? See Figure 5.

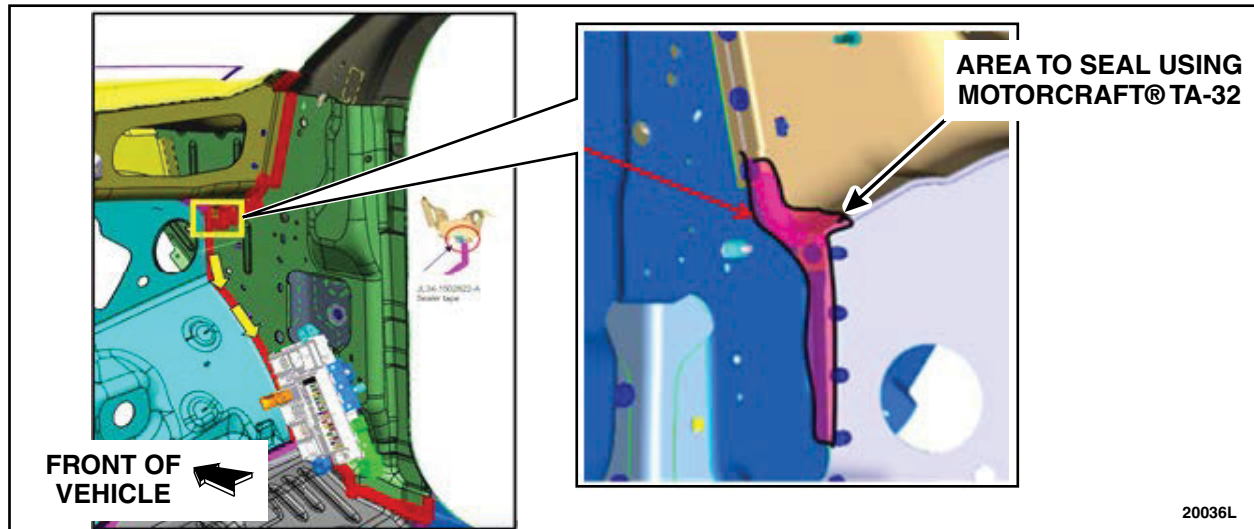
**FIGURE 12**

23. Using Motorcraft® TA-32 Clear Silicone Rubber Sealer or equivalent, apply a bead along the body patch and allow it to dry. See Figure 12. Retest by performing Step 19 once the Clear Silicone Rubber is dry.

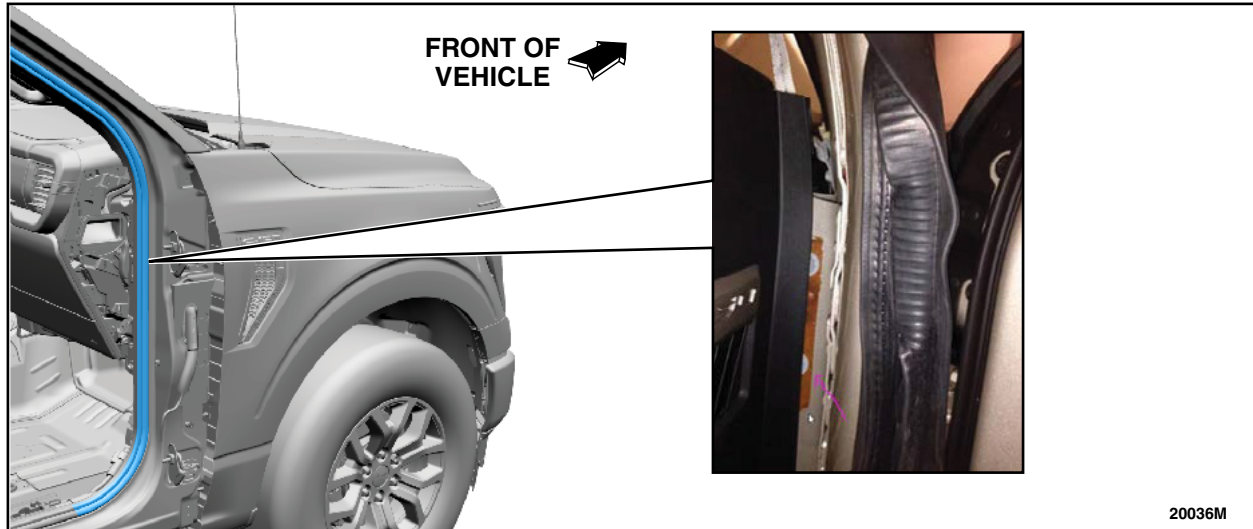
**FIGURE 13**

25. Inspect the front RH side door weatherstrip for any rips or deformity. See Figure 13.  
- Were any rips or deformity present?

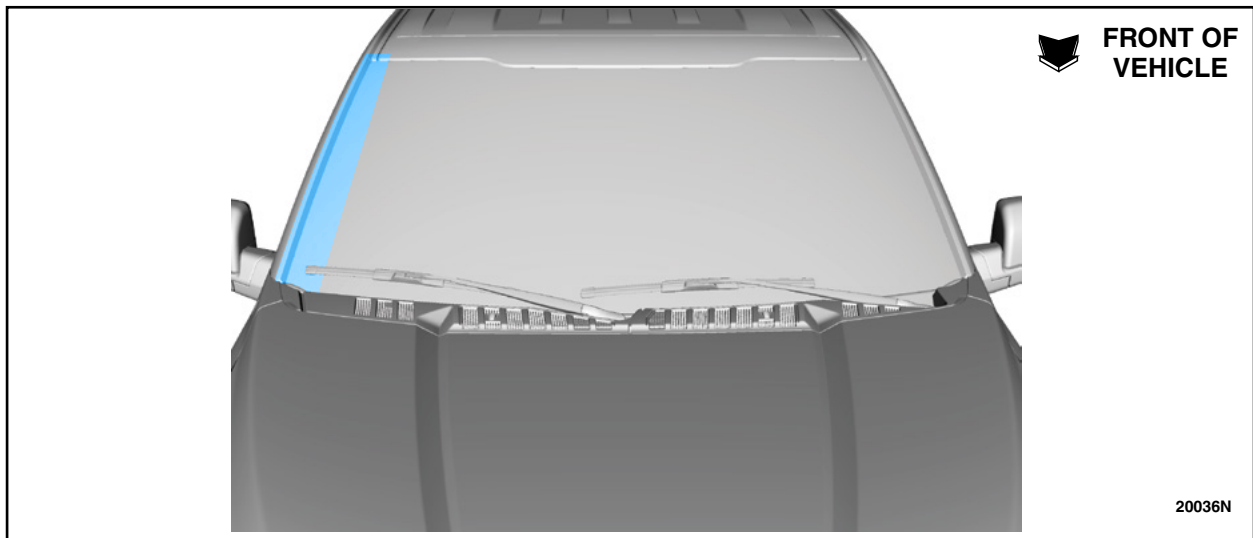
**FIGURE 14**

26. Using a garden hose, spray down the RH side of the windshield, then immediately inspect the A-pillar area within the vehicle for signs of moisture and/or leakage. See Figure 14.  
- Was any sign of moisture and/or leakage found around the A-pillar?

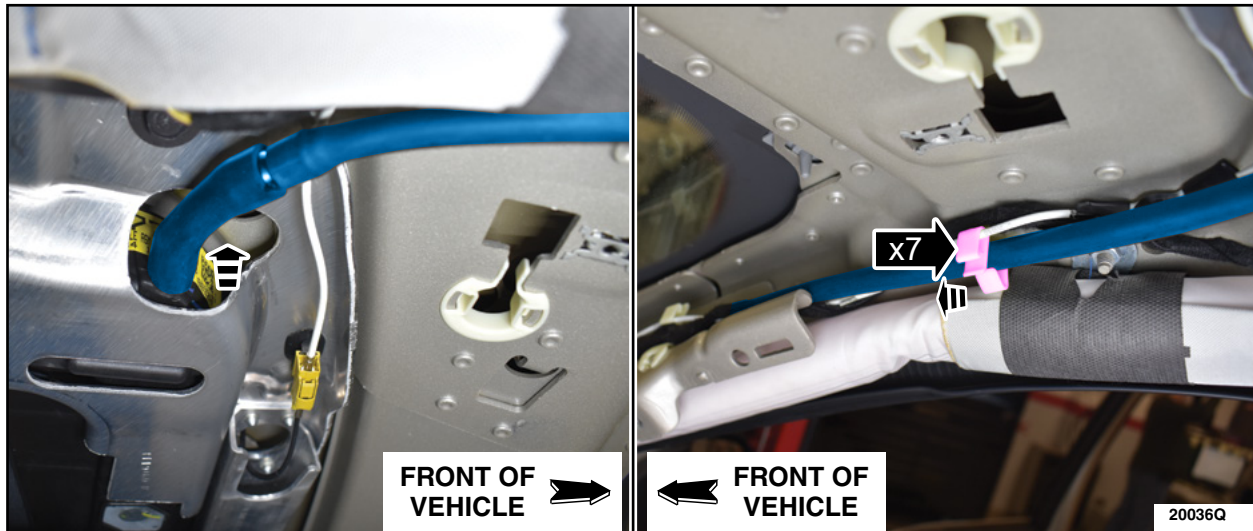
**FIGURE 18**

31. Remove the roof opening panel drain tube. See Figure 18.

1. Remove the drain tube grommet located behind the BCM.
2. Disconnect the drain tube at the roof opening panel.
3. Release the drain tube retainers located along the RH A-pillar down through the IP.
4. Remove the drain tube out the top of the IP.

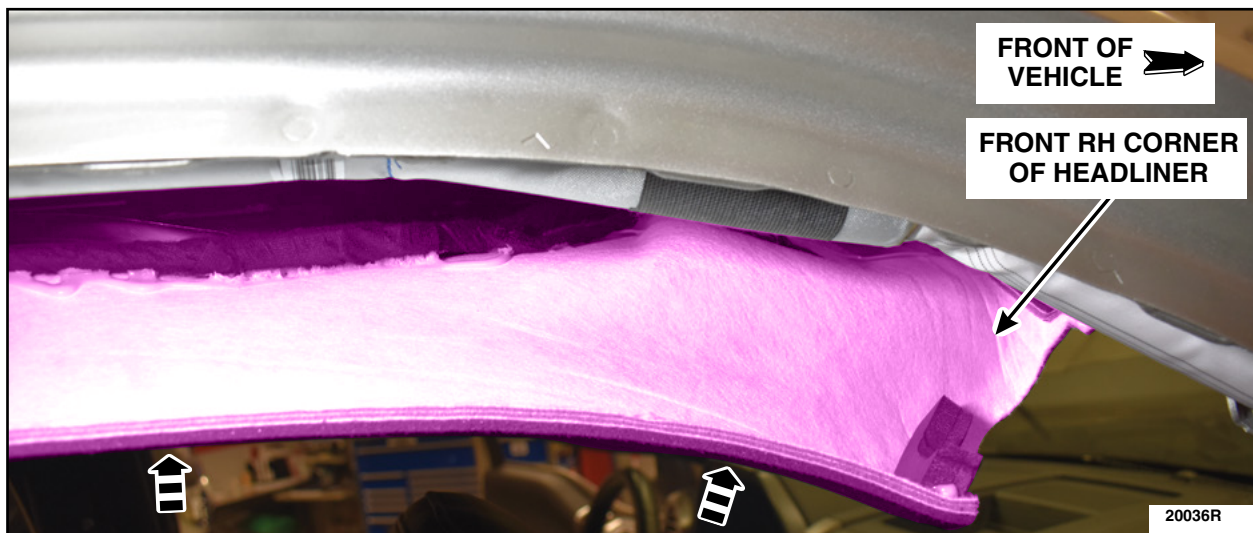
**FIGURE 19**

33. Position back the front RH corner of the headliner. See Figure 19.

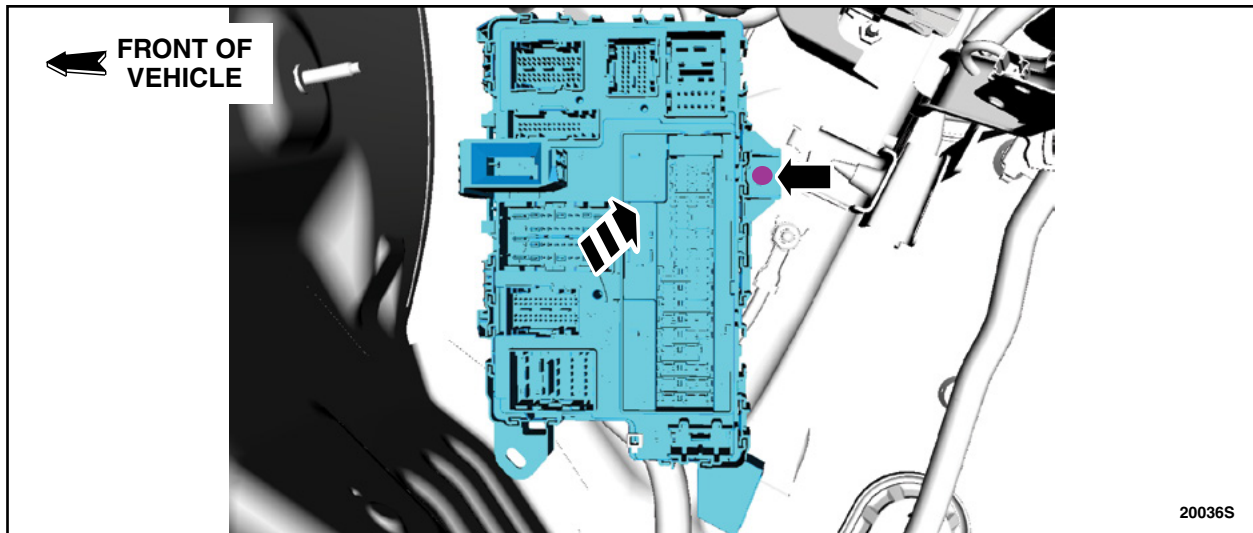
**FIGURE 20**

37. Install the BCM and retainer. See Figure 20.

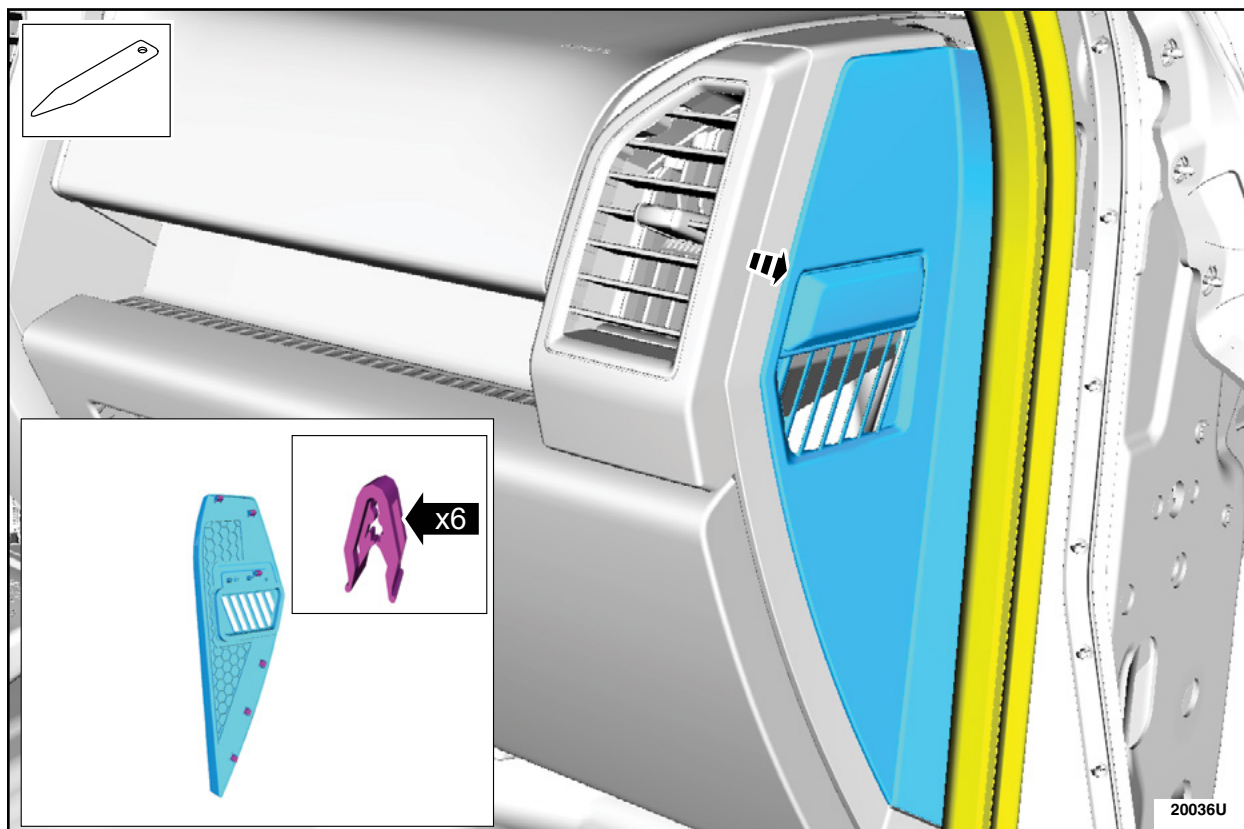
**FIGURE 22**

39. Position aside the weatherstrip, release the clips and remove the RH instrument panel finish panel.  
See Figure 22.

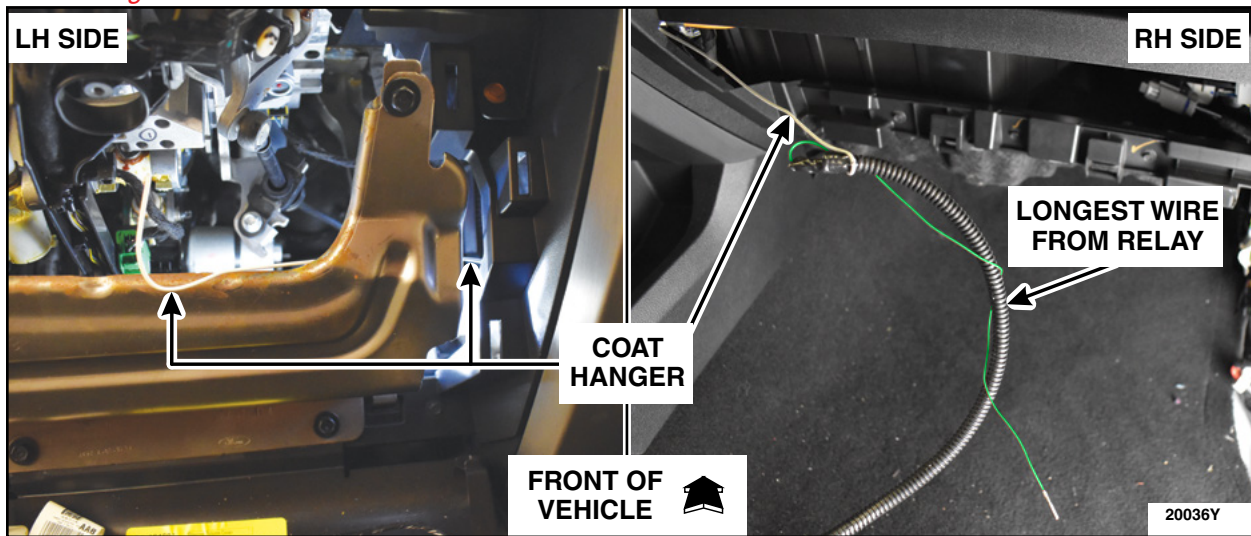
FIGURE 27

45. Using a coat hanger, route the longest wire from the relay through the instrument panel.  
See Figure 27.

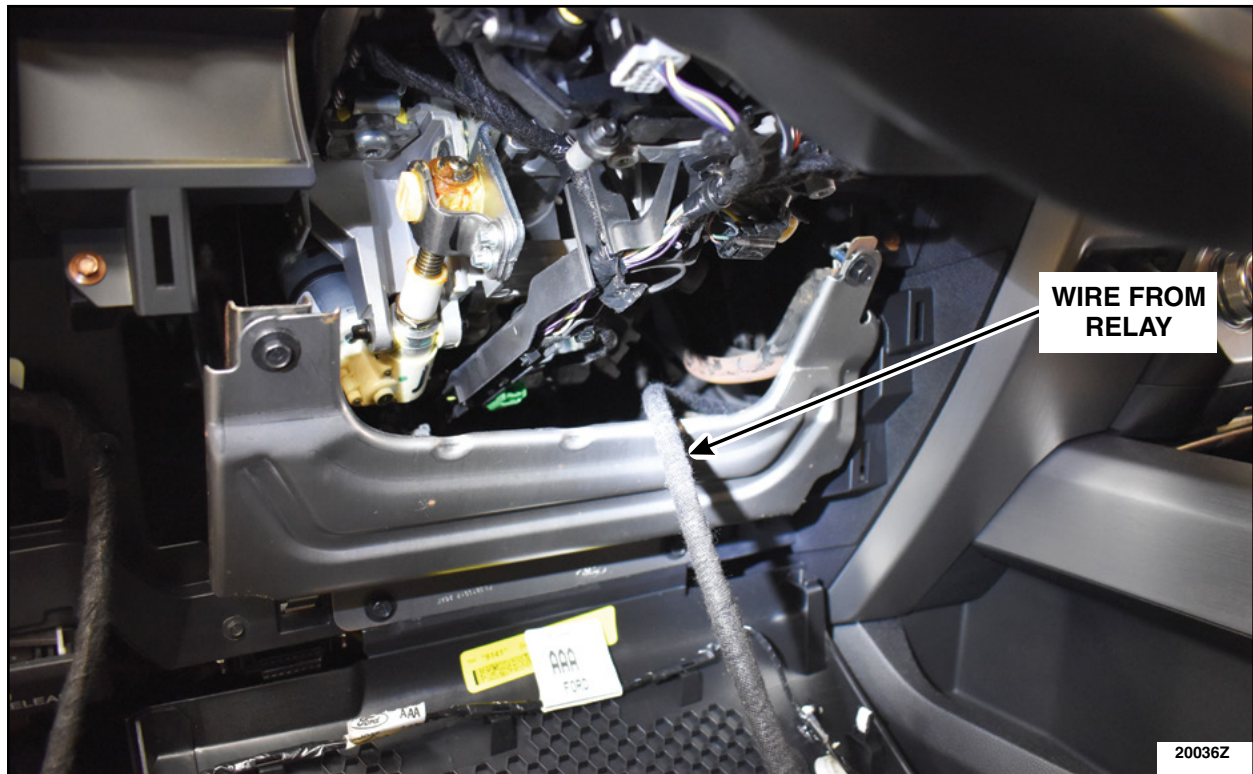
**FIGURE 28**

46. Pull the wire from the relay through the vehicle's instrument panel to the Left Hand (LH) steering wheel opening. See Figure 28.

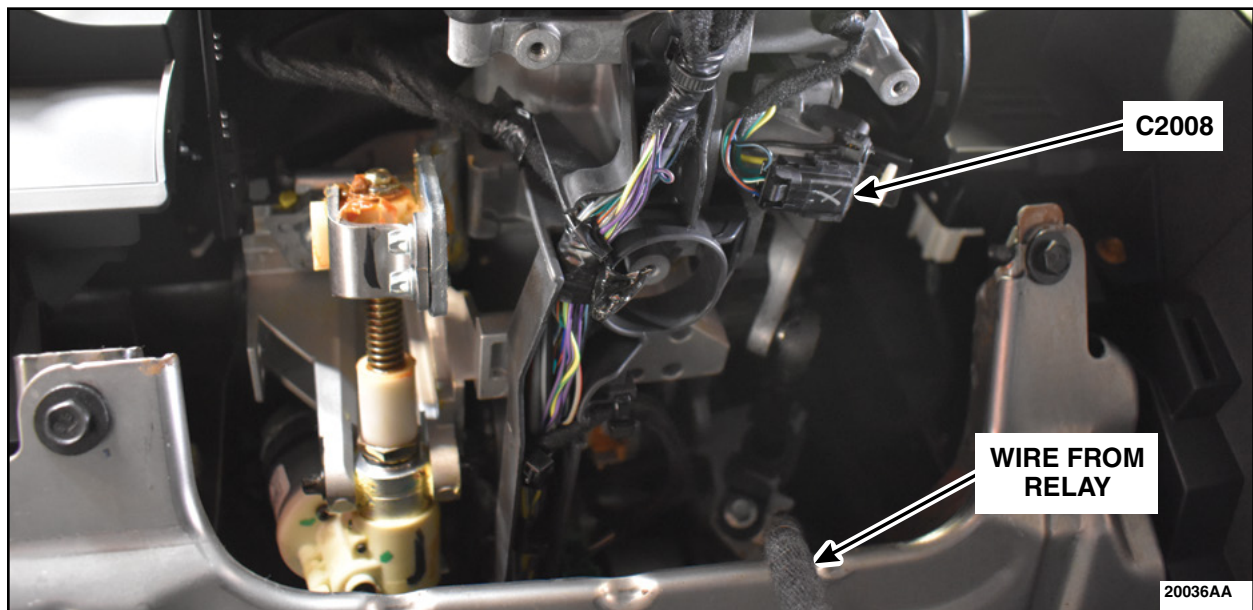
**FIGURE 29**

47. Disconnect C2008 from the underside of the steering column. See Figure 29.

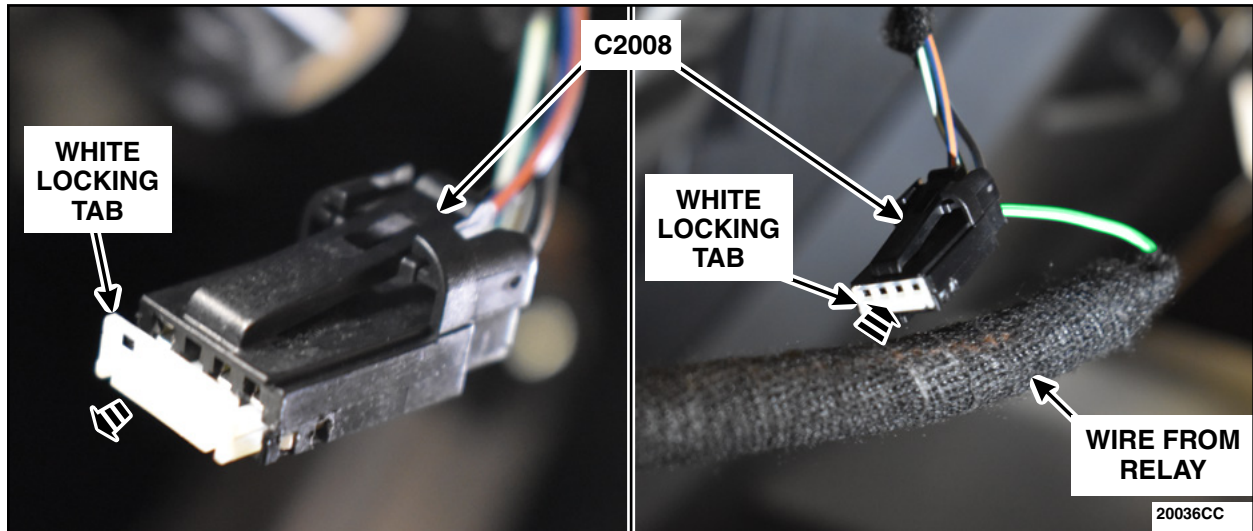
FIGURE 30

48. Disengage the white locking tab on C2008. Install the wire from the relay into the open cavity of C2008. Engage the white locking tab. See Figure 30.

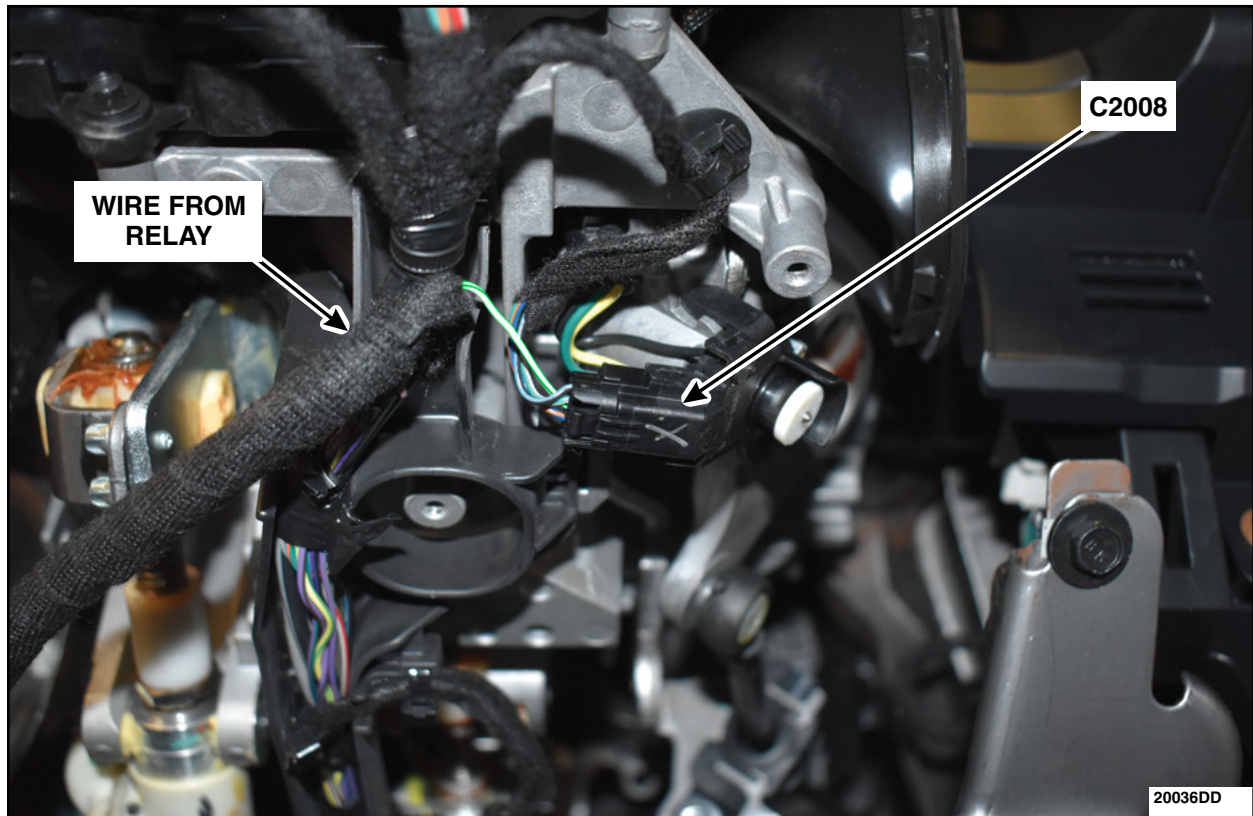
FIGURE 31

49. Reconnect C2008. See Figure 31.

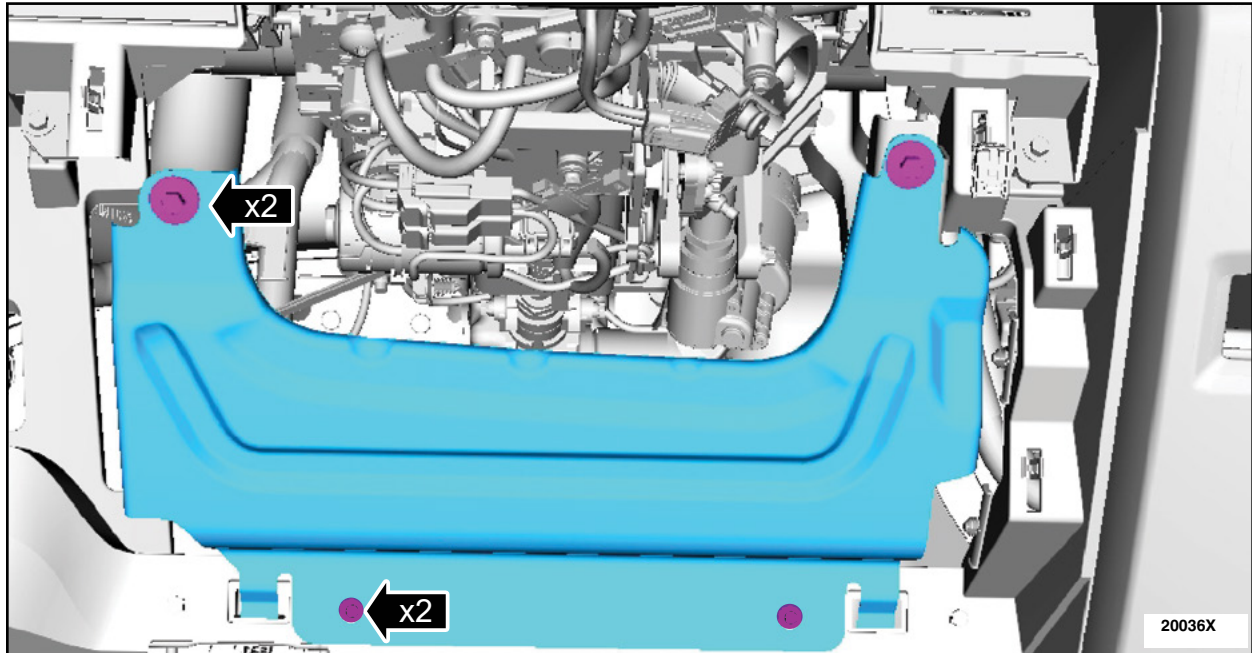
FIGURE 33

51. Install the steering column reinforcement panel and the bolts. See Figure 33.

- Torque: 80 lb.in (9 Nm)

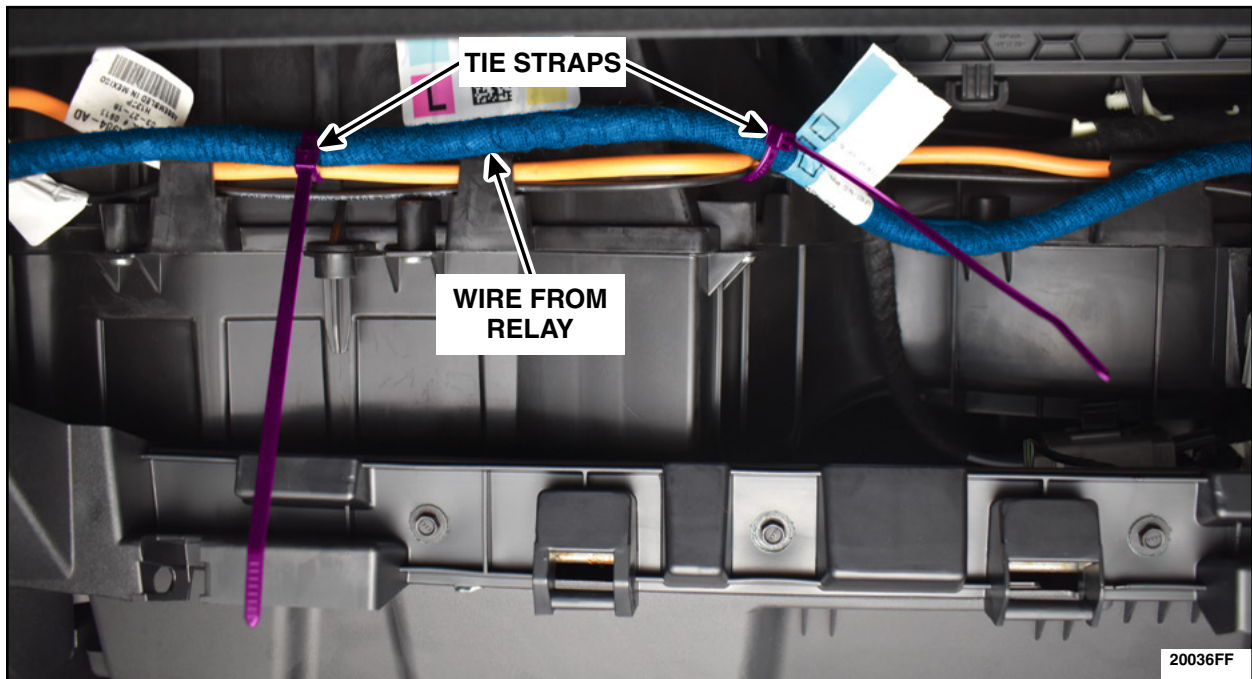
FIGURE 34

52. Secure the wire from the relay to the wiring harness on the climate control housing using tie straps. See Figure 34.

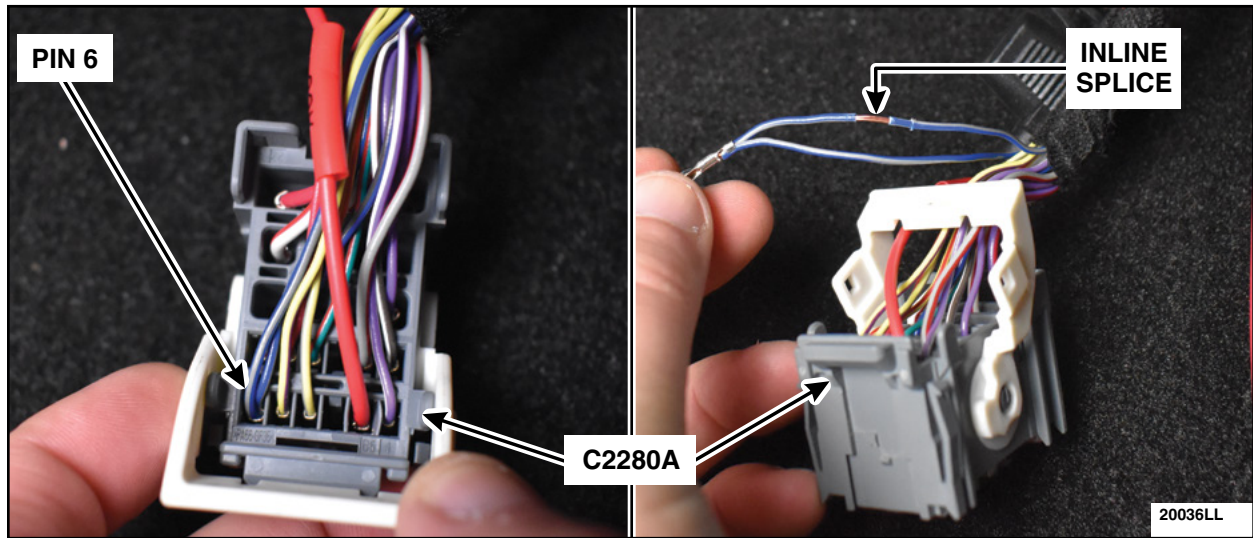
**FIGURE 39**

57. Remove the wire from pin 6 and strip back the wire coating to begin an inline splice. See Figure 39.

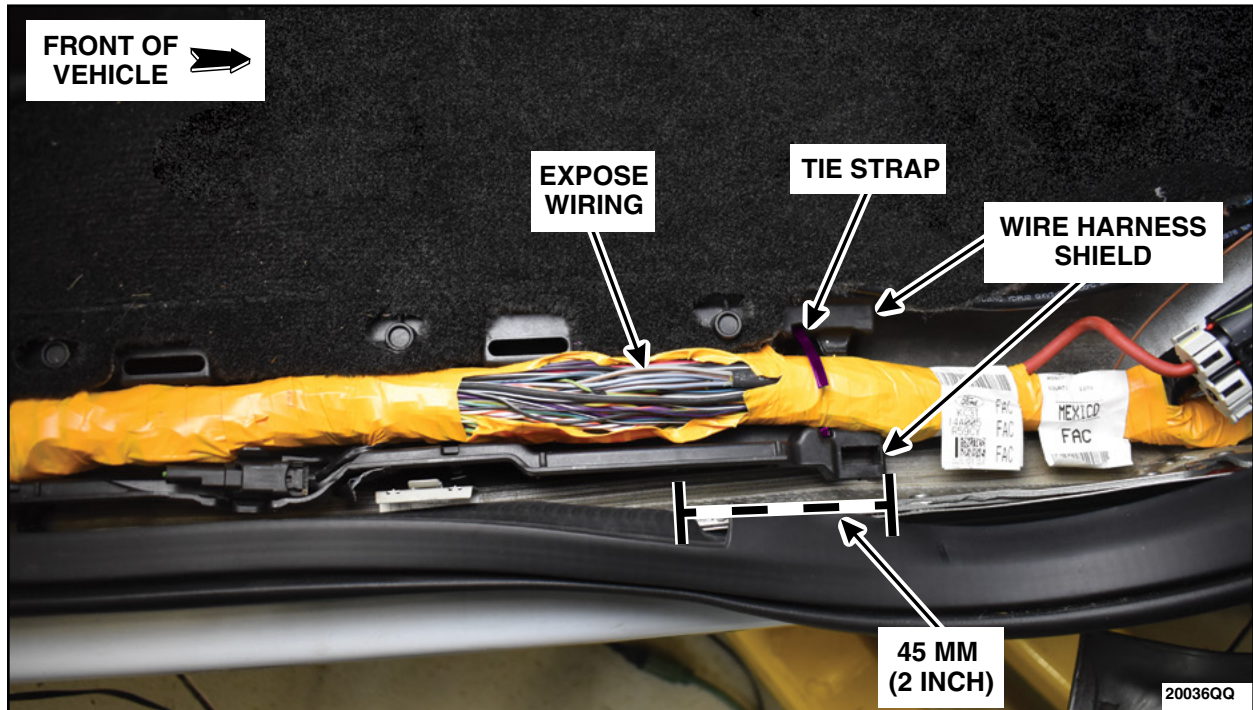
FIGURE 48

65. On the floor of the front passenger side door, cut the wire harness tie strap. Using a Harness Ripper tool or equivalent, carefully open up the harness 75 mm (3 inch) from the front of the wire harness shield to expose the wiring. See Figure 48.

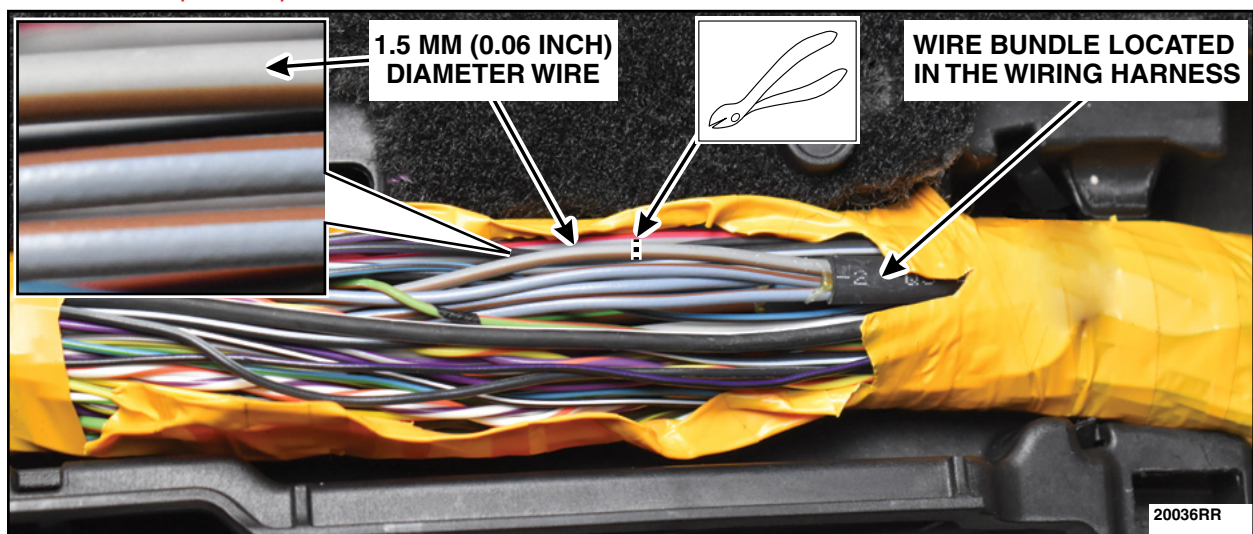
FIGURE 49

67. *Locate the wire bundle within the wiring harness. Using a Vernier Caliper tool, measure all the Grey-Brown (GY-BN) wires within the bundle and isolate the 1.5 mm (0.06 inch) wire. This is the largest wire within the bundle. See Figure 49. Cut the 1.5 mm (0.06 inch) wire. Test the vehicles door locks. If the door locks work, the correct wire has been cut. If the door locks do not work, repair the wire and repeat Step 67.*

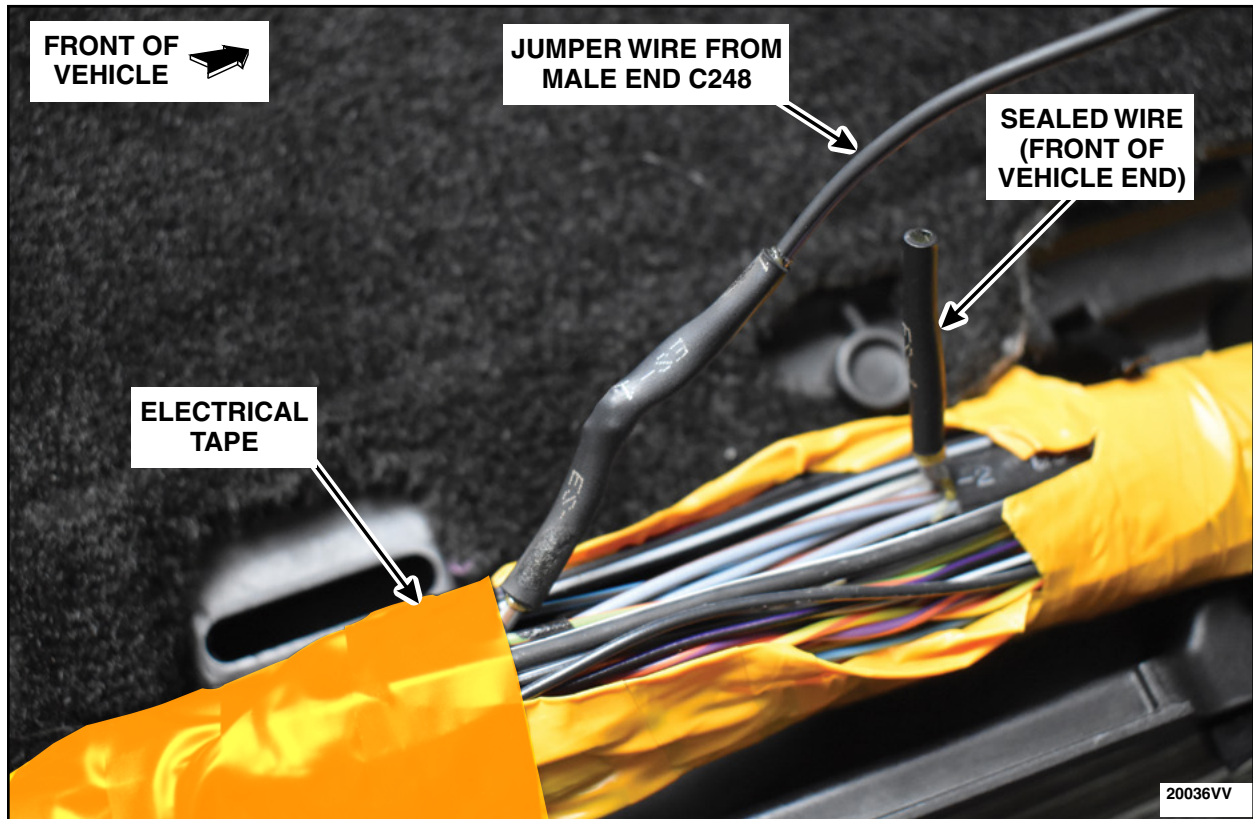
**FIGURE 50**

68. Disconnect the negative battery cable(s) and position aside. Please follow the WSM procedures in Section 414-01.
69. Apply heat shrink tubing and seal the front of vehicle end of the cut wire. Strip, solder and seal with heat shrink the jumper wire from C248 to the rear of the vehicle end of the cut wire. See Figure 50. Re-wrap the harness using the appropriate (black or orange) electrical tape.

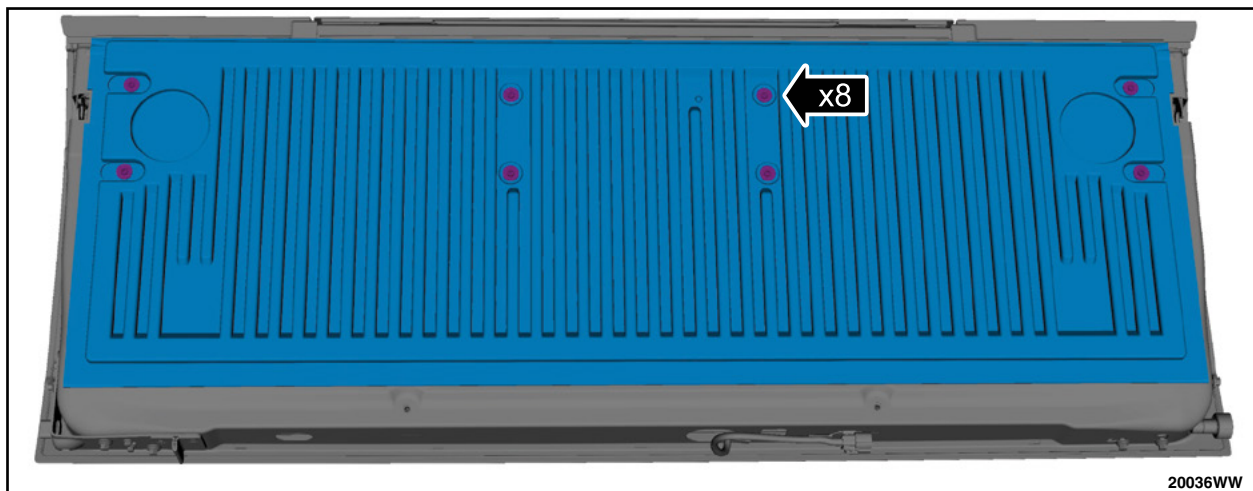
**FIGURE 51**

70. Reinstall the Glove Compartment. Please follow the WSM procedures in Section 501-12.
71. If equipped, remove the bedliner tailgate cover. See Figure 51.

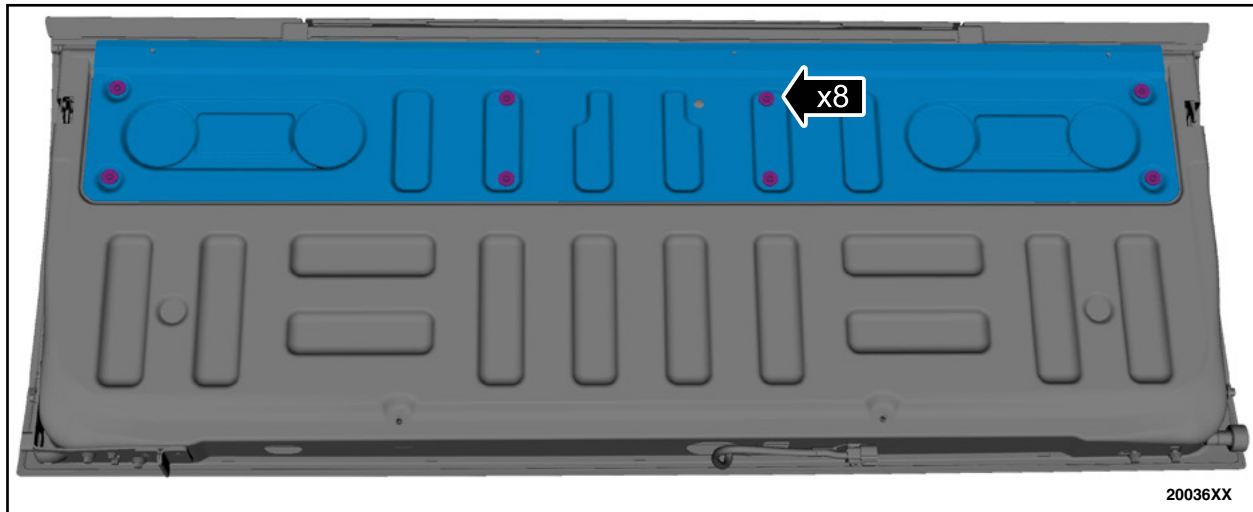
FIGURE 52

72. Remove the tailgate access panel bolts and the tailgate access panel. See Figure 52.

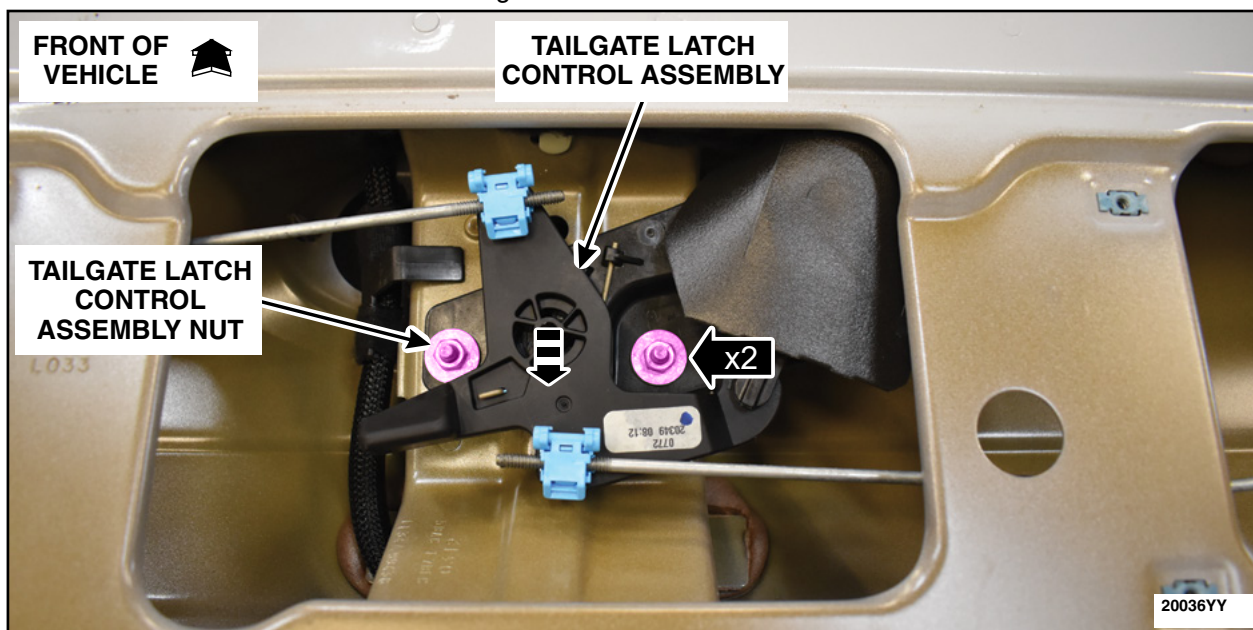
FIGURE 53

73. Remove the tailgate latch control assembly nuts and position the tailgate latch control assembly towards the rear of the vehicle. See Figure 53.

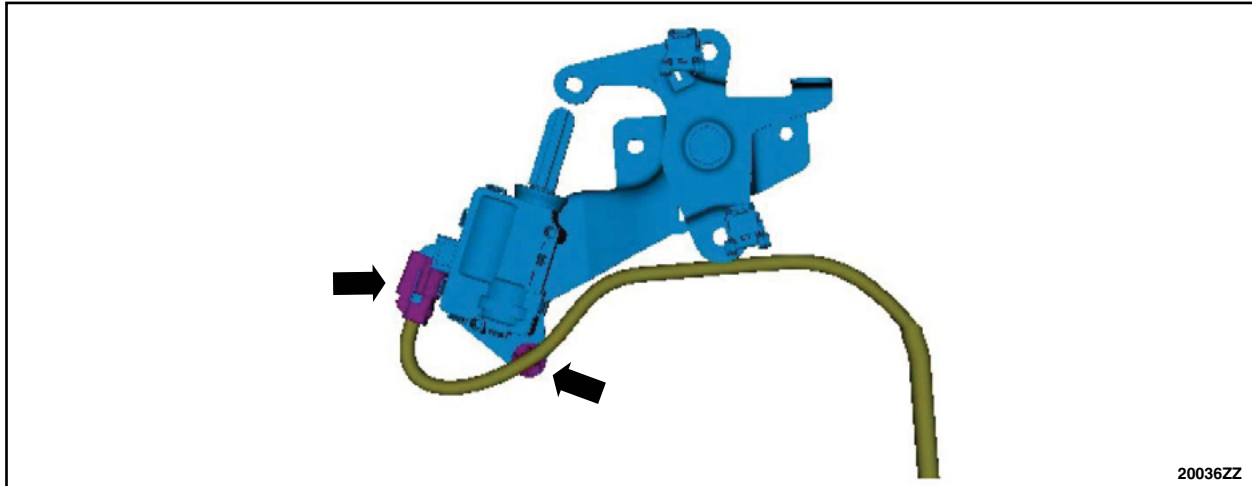
**FIGURE 54**

74. Disconnect the electrical connector and the push pin retainer. See Figure 54.

**NOTE:** Tailgate latch control assembly shown outside of the vehicle for clarity.

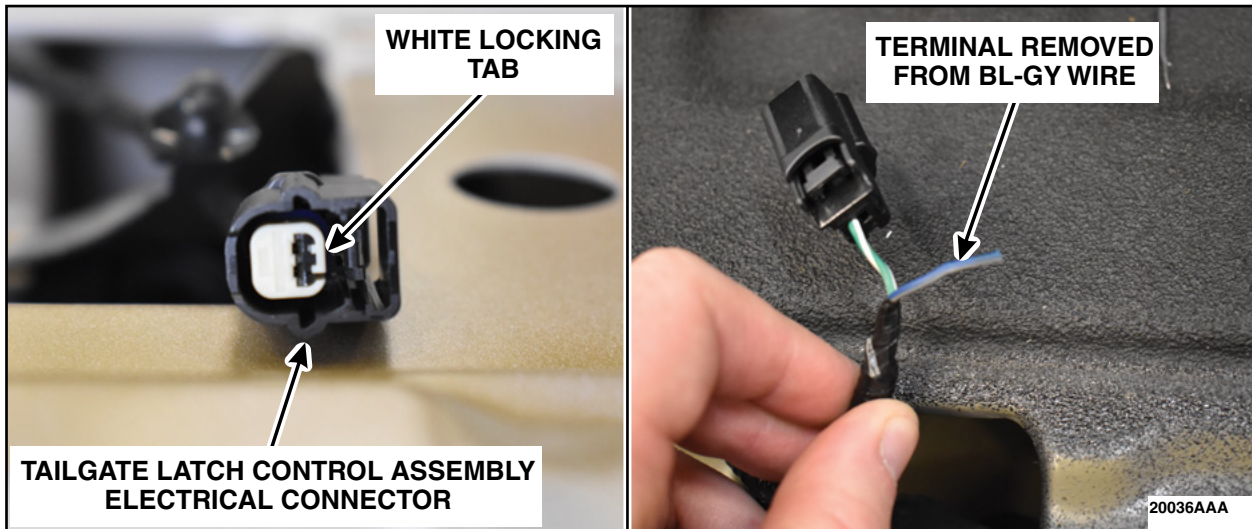
**FIGURE 55**

75. Remove the white locking tab and the Blue-Grey (BL-GY) wire from the tailgate latch control assembly connector. Cut off the terminal of the BL-GY wire. See Figure 55.

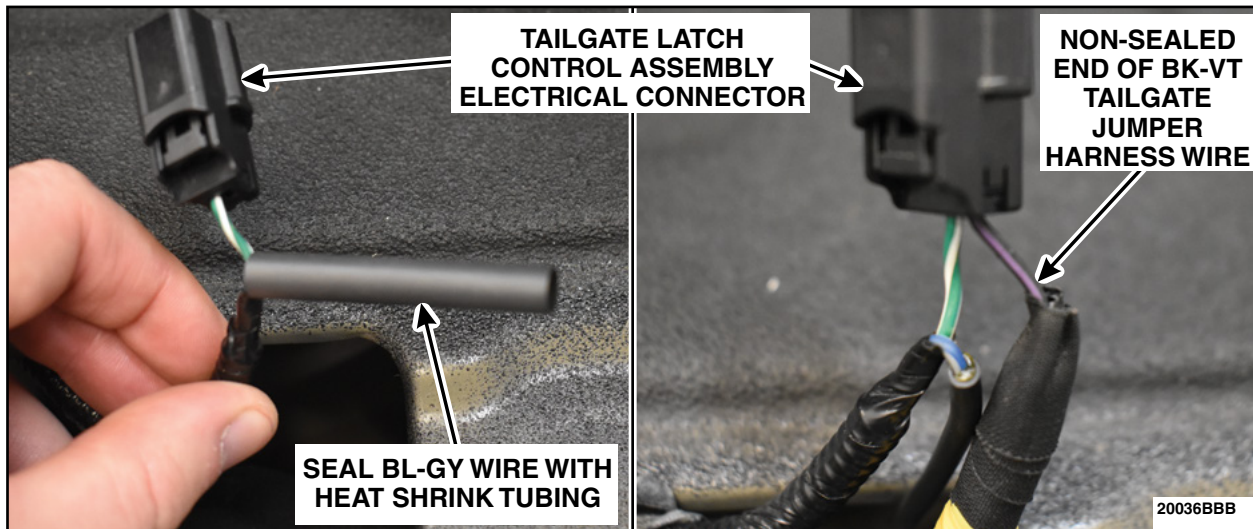
FIGURE 56

76. Seal the BL-GY wire using heat shrink tubing. Install the non-sealed end of the BK-VT Tailgate Jumper Harness wire into the tailgate latch control assembly electrical connector. See Figure 56.

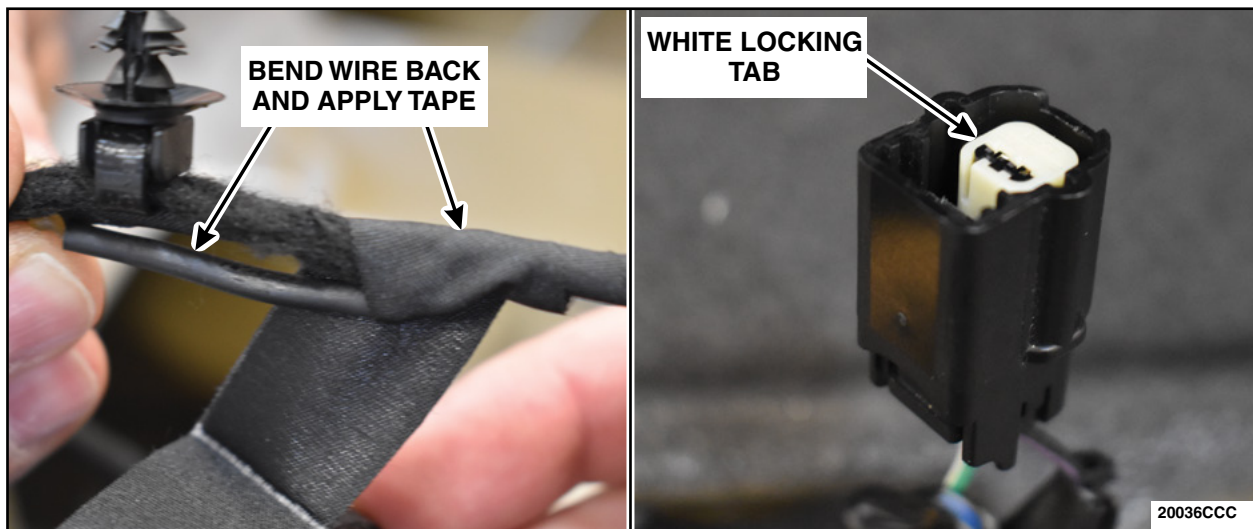
FIGURE 57

77. Bend back the sealed wire and secure using Coroplast® 837 or Equivalent Electrical Wire Harness Tape. Install the white locking tab. See Figure 57.

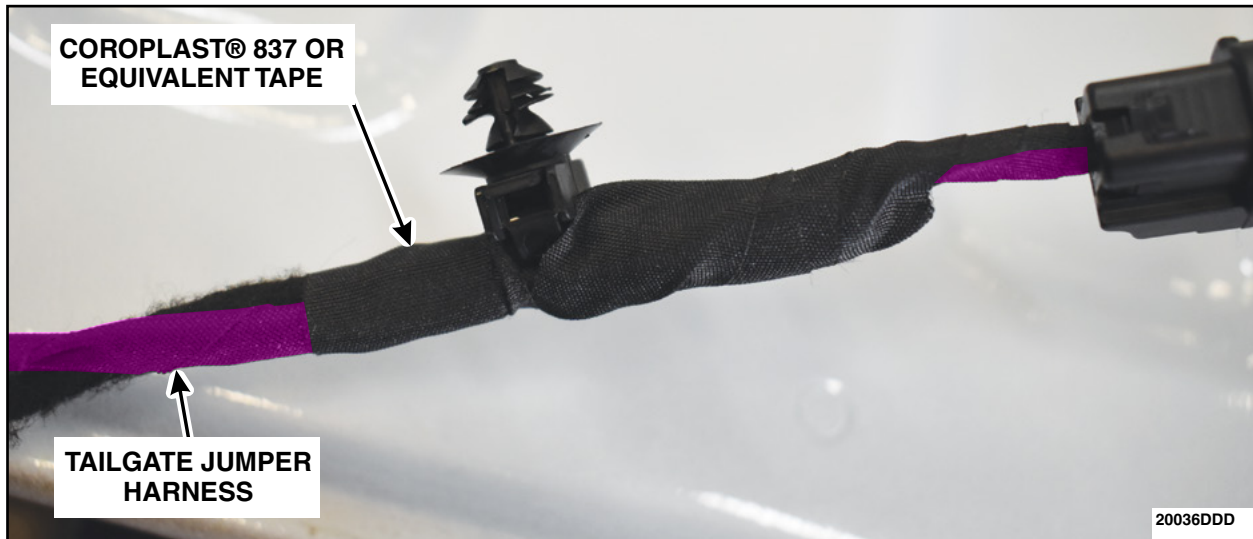
FIGURE 58

78. Apply a piece of Coroplast® 837 or Equivalent Electrical Wire Harness Tape after the push pin retainer to secure the Tailgate Jumper Harness. See Figure 58.
