**SUBJECT:** **Customer Satisfaction Program 21M05 - Supplement # 2**  
Certain 2017-2022 Model Year Super Duty Vehicles Equipped with a Power Release Tailgate - Unintended Tailgate Opening

*Technical Information: Updated with revised instructions to account for wire color differences across multiple model year vehicles.*

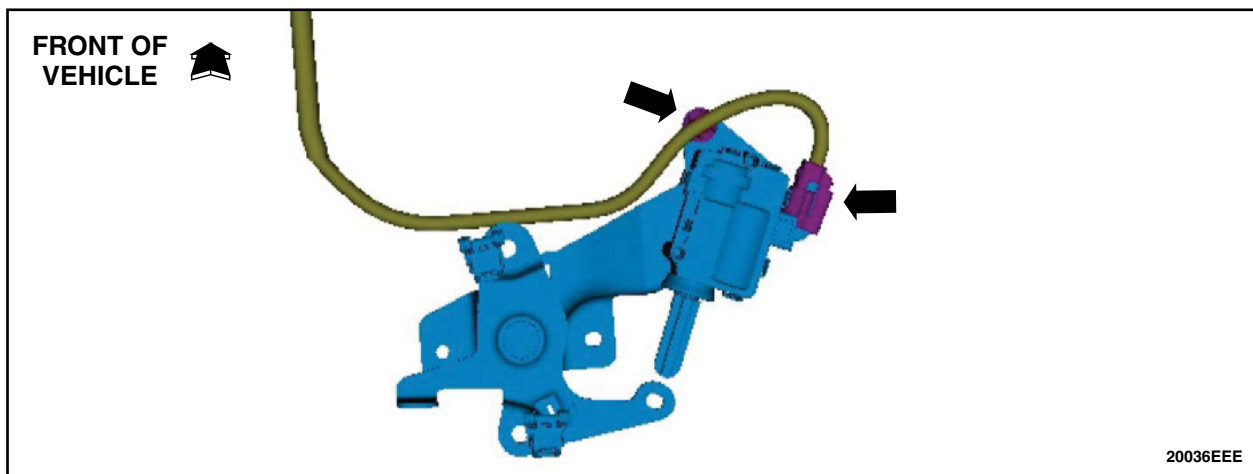
FIGURE 59

79. Reconnect the electrical connector and the push pin retainer. See Figure 59.

**NOTE:** Tailgate latch control assembly shown outside of the vehicle for clarity.

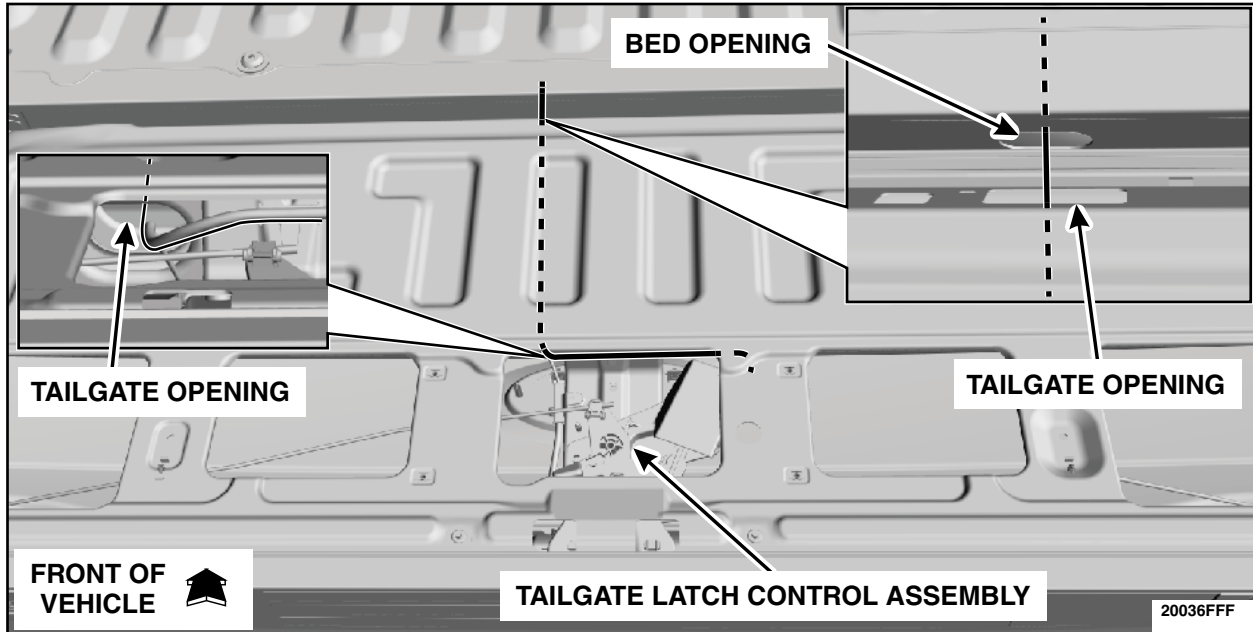
FIGURE 60

80. Using a straightened coat hanger, tape the sealed terminal end of the Tailgate Jumper Harness Wire to one end of the coat hanger. Route the wire and coat hanger on the LH side of the tailgate latch control assembly and through the opening in the center bottom of the tailgate. Continue to pass through the opening in the bed and down through the bottom of the vehicle. See Figure 60.

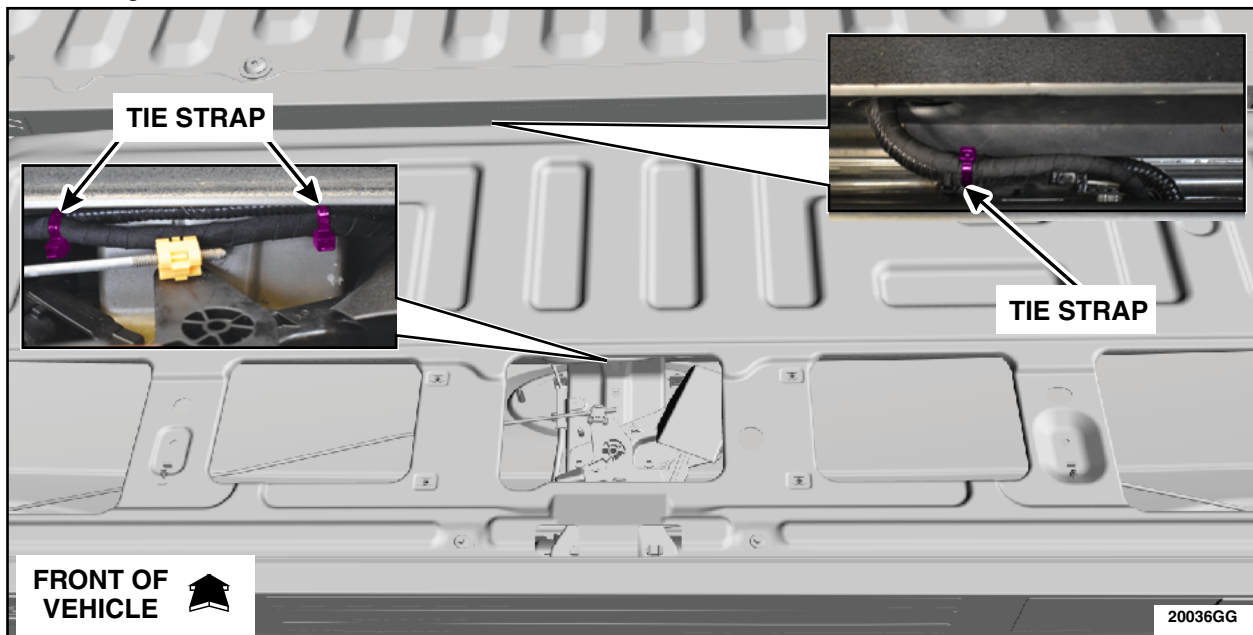
FIGURE 61

81. Secure the Tailgate Jumper Harness using tie straps and trim any tie strap excess length. See Figure 61.

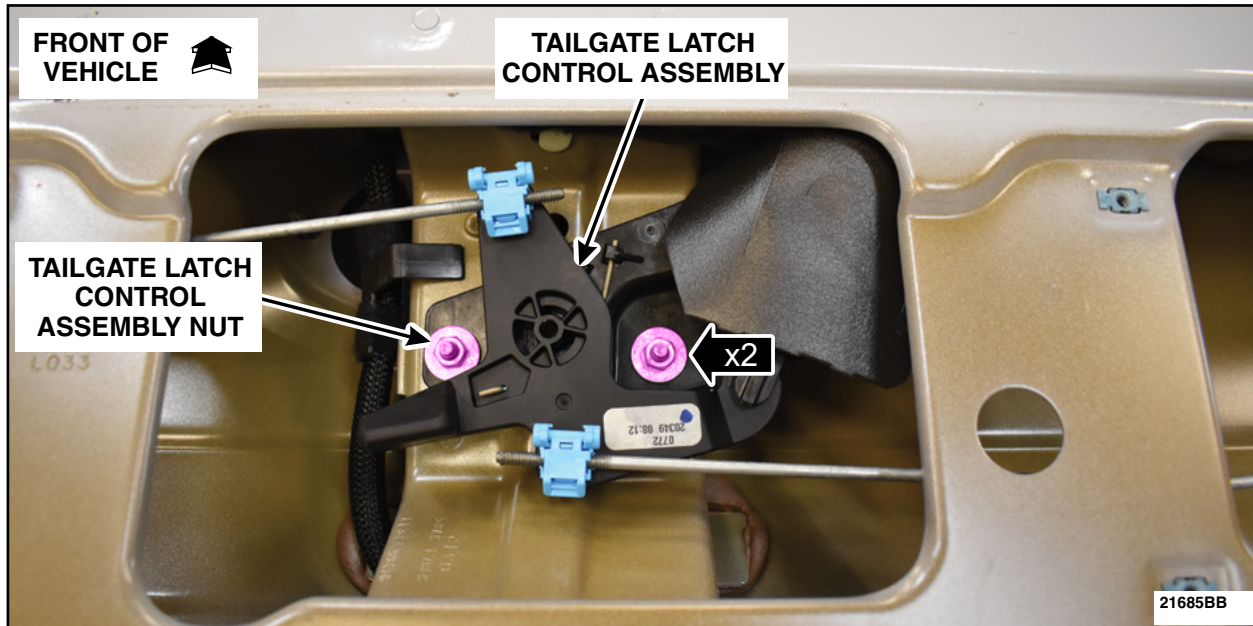
**FIGURE 62**

82. Position back the tailgate latch control assembly and install the nuts. See Figure 62.

- Torque 80 lb.in (9 Nm)

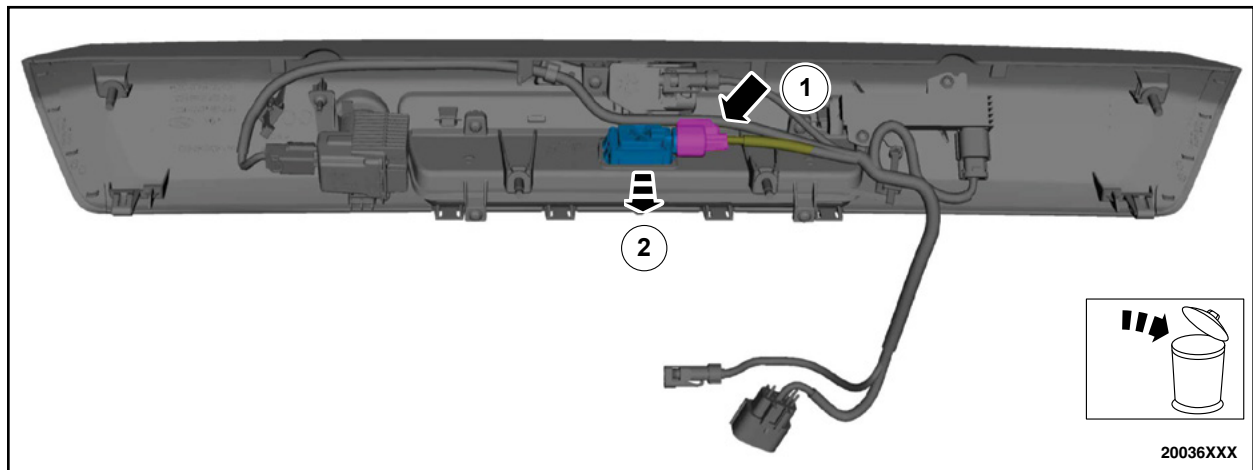
**FIGURE 63**

84. Remove and discard the Tailgate Release Switch. See Figure 63.

85. Install the *new* Tailgate Release Switch by reversing the removal procedure. See Figure 63.

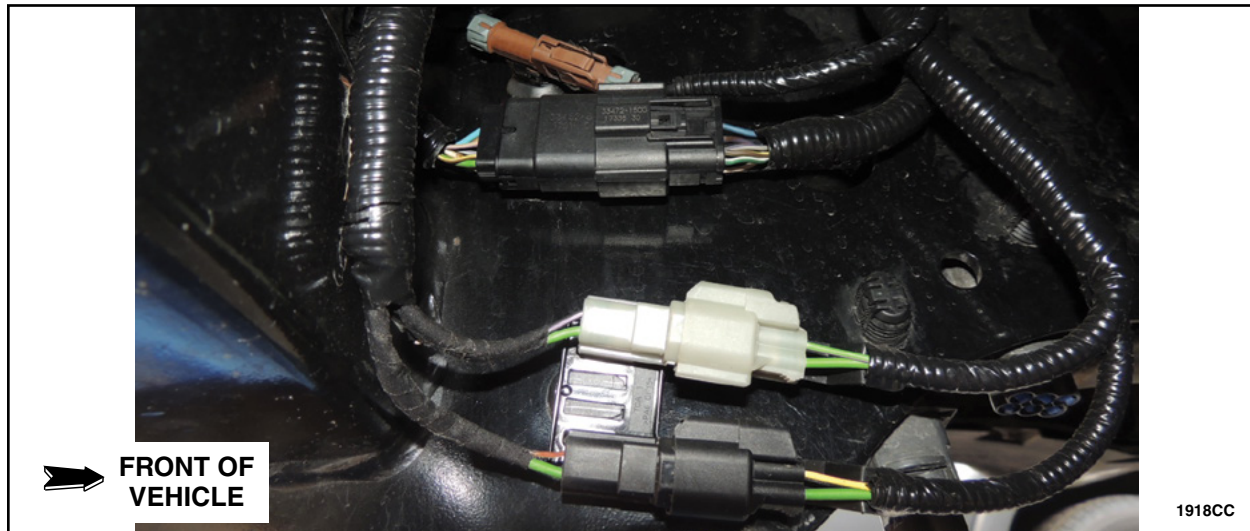
**FIGURE 64**

**NOTE:** For 2017-2019 model year vehicles, the Safety Recall 19S48 Tailgate Jumper Harness Kit **MUST** be installed in order to complete this repair. See Figure 64.

**NOTE:** For 2020-2022 model year vehicles, all vehicles are equipped with the Tailgate Jumper Harness Kit from the manufacturer. See Figure 64.

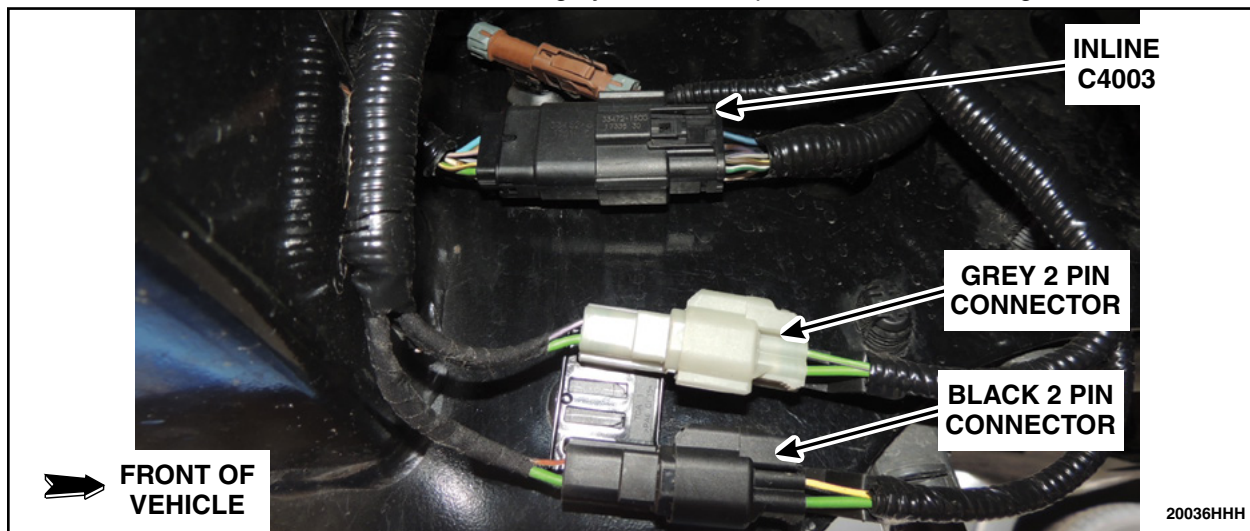
**FIGURE 65**

87. Position the vehicle on a hoist. Please follow the WSM procedures in Section 100-02.
88. Using the vehicle spare tire rod, lower the spare tire and secure it out of the way using a ratchet strap or other similar device.
89. Disconnect the black inline C4003 and the grey and black 2 pin connectors. See Figure 65.

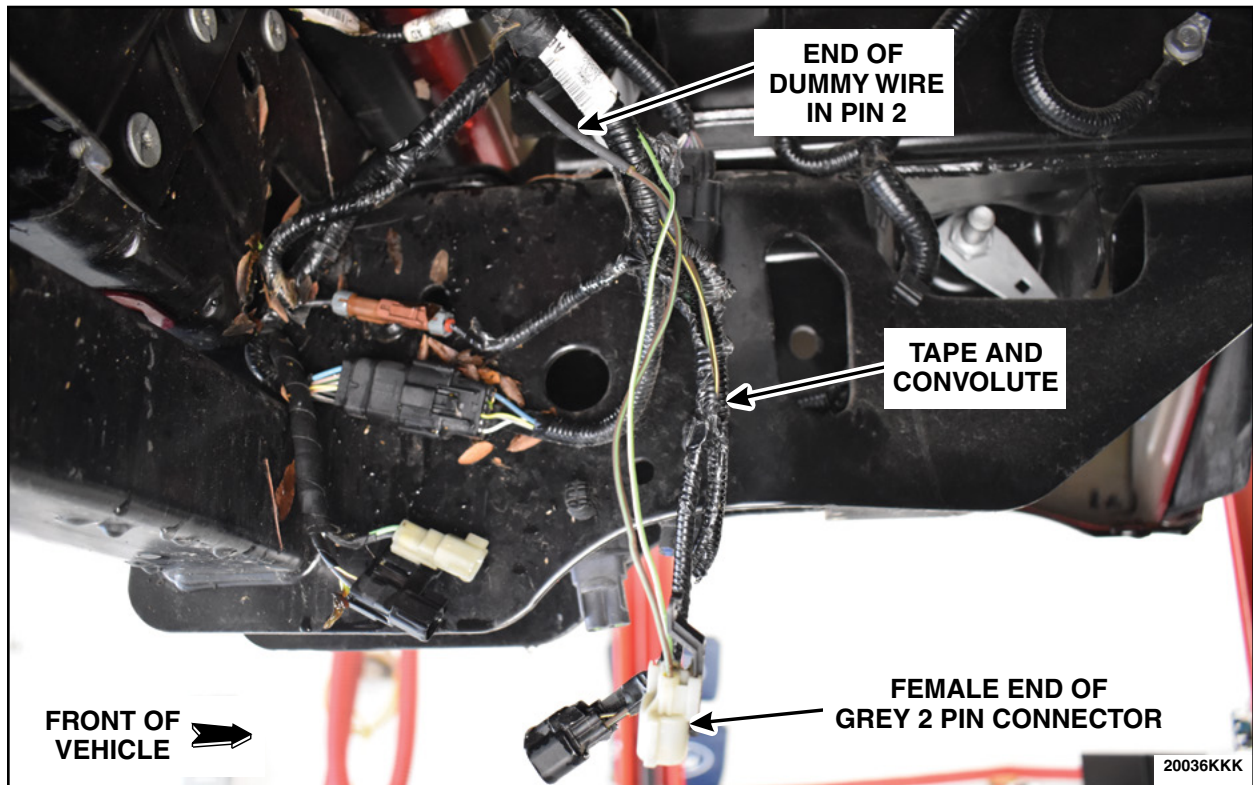
FIGURE 66

90. Remove the tape and convolute of the female side of the Grey 2 pin connector to expose the end of the dummy wire located in Pin 2. See Figure 66.

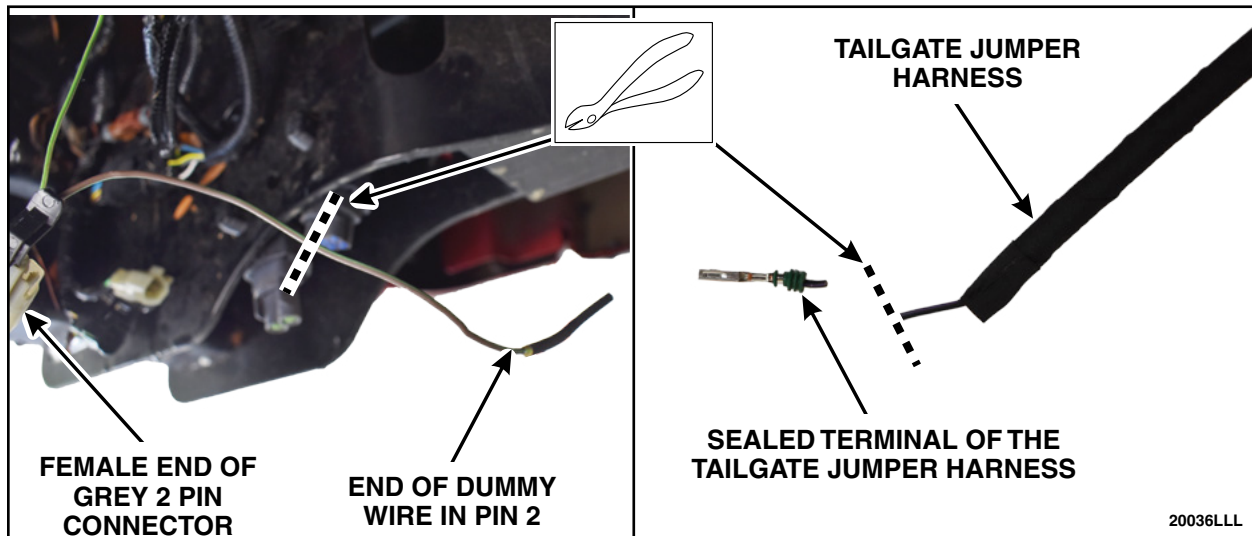
FIGURE 67

91. On the female end of the Grey 2 pin connector, cut the end of the dummy wire in Pin 2 halfway between the heat shrink and the connector. Cut off the sealed terminal on the Tailgate Jumper Harness. See Figure 67.

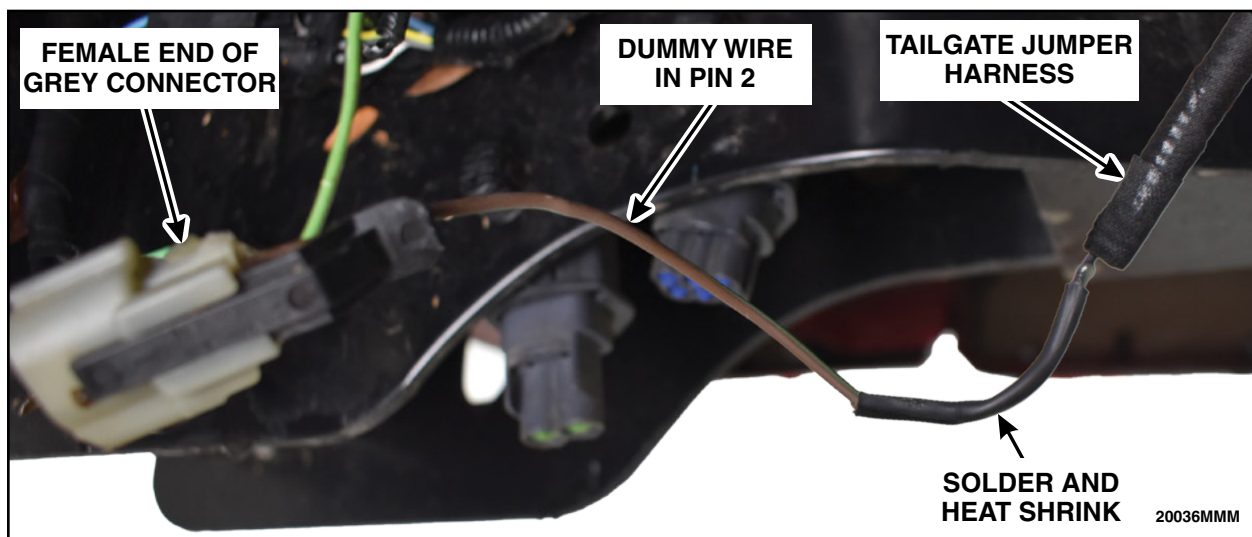
FIGURE 68

92. Solder and heat shrink the Tailgate Jumper Harness to the dummy wire in Pin 2 of the grey 2 pin female end connector. See Figure 68.

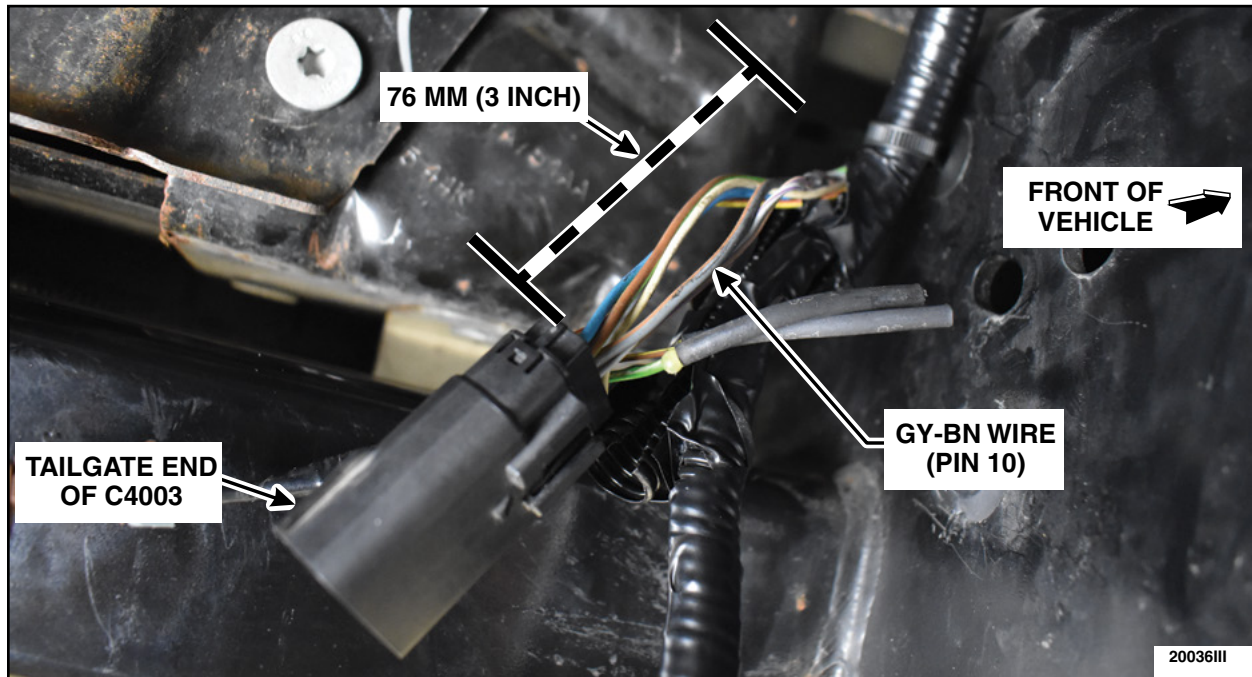
FIGURE 69

93. Remove 76 mm (3 in) of tape and convolute of the male end of C4003 to expose the wiring. Locate the Grey-Brown (GY-BN) wire in C4003 (pin 10). See Figure 69.

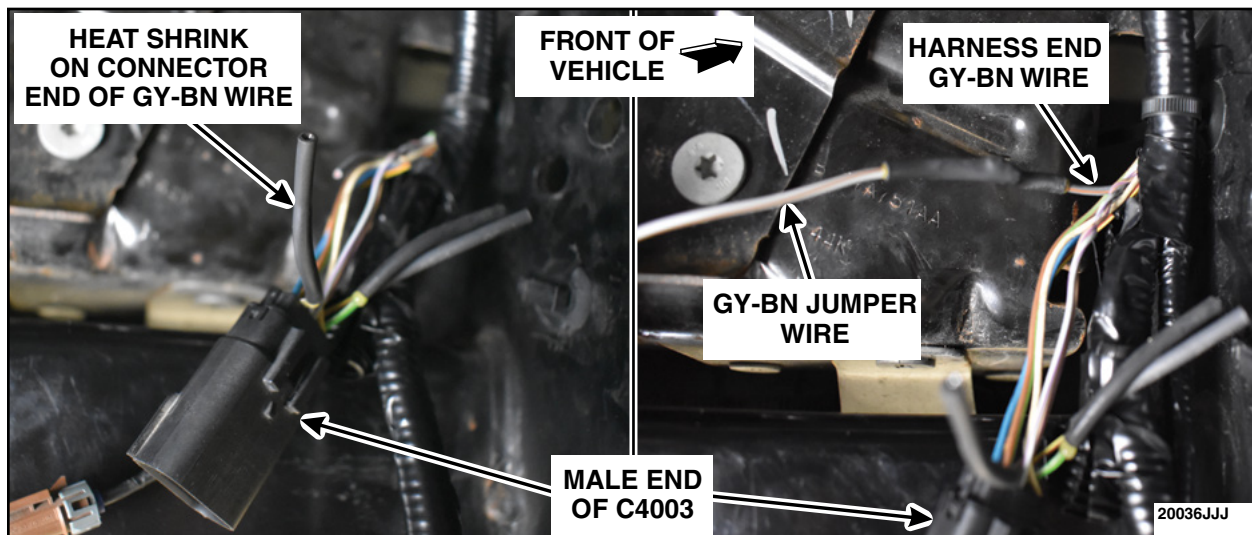
FIGURE 70

94. Cut the GY-BN wire and seal the connector end of the wire using heat shrink tubing. Solder in the GY-BN jumper wire into the harness end of the cut wire. Seal using heat shrink tubing. See Figure 70.

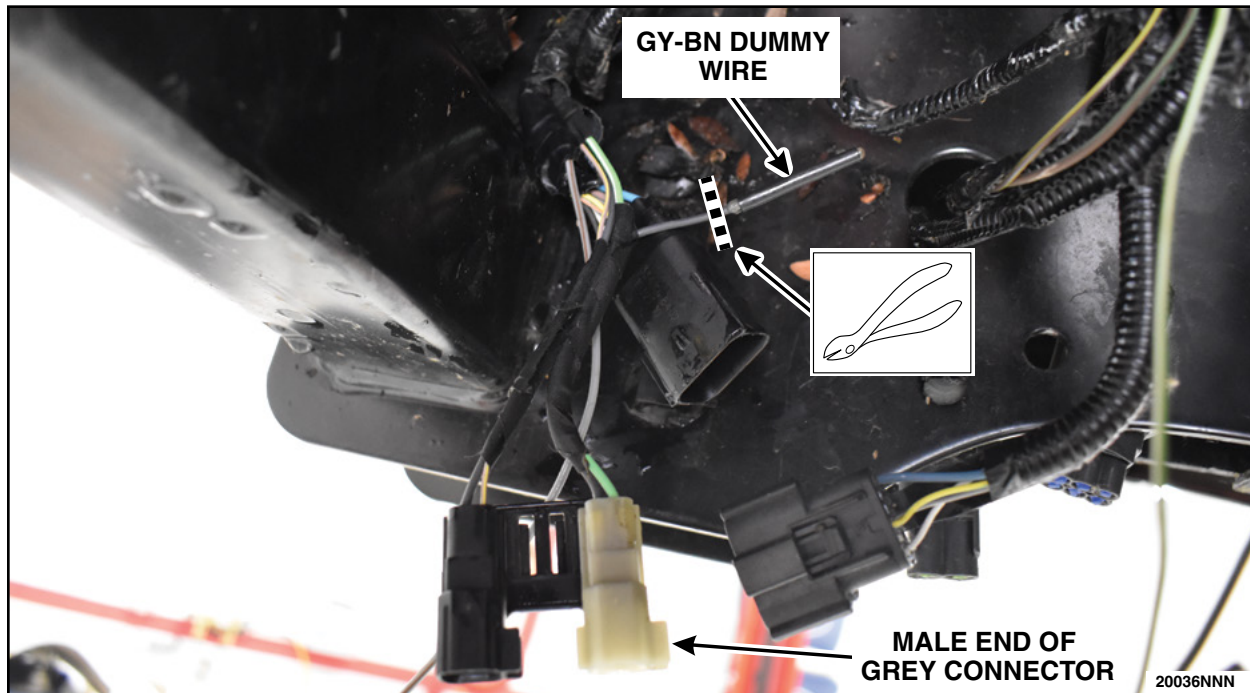
FIGURE 71

95. Remove the tape and convolute on the male end of the Grey connector to expose the GY-BN dummy wire. Cut the GY-BN wire just in front of the heat shrink tubing and discard the heat shrink tubing. See Figure 71.

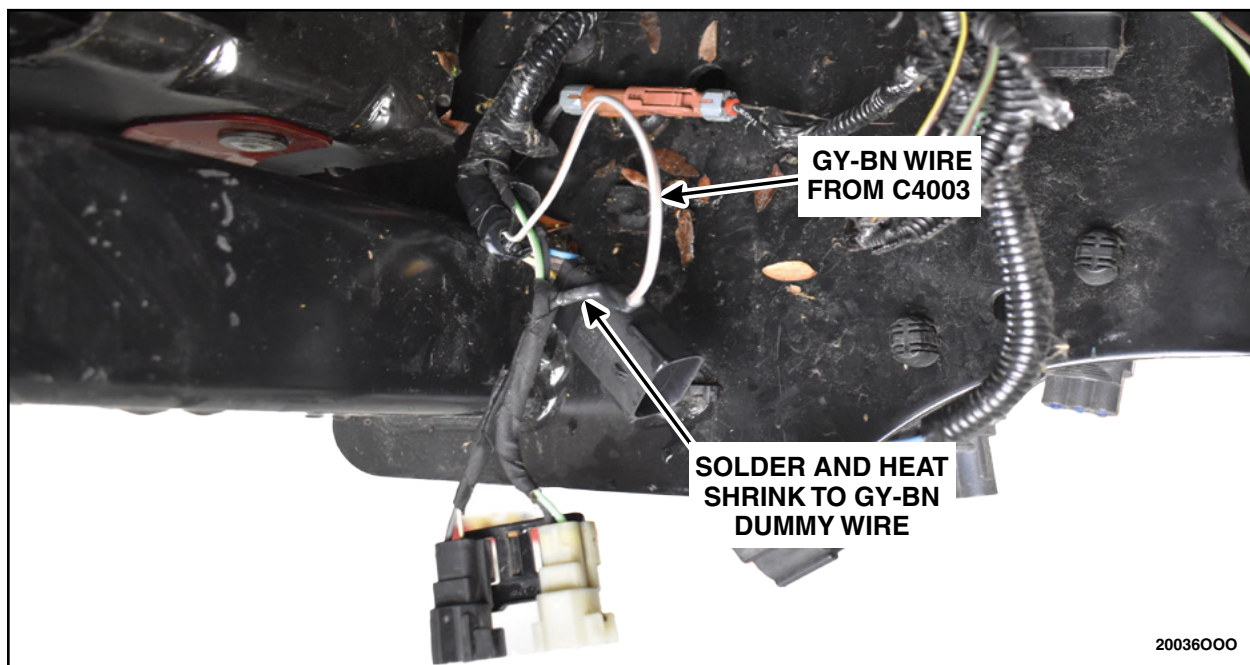
FIGURE 72

96. Apply heat shrink tubing to the GY-BN wire from C4003. Solder the GY-BN wire from C4003 to the GY-BN wire of the male end Grey connector. See Figure 72.

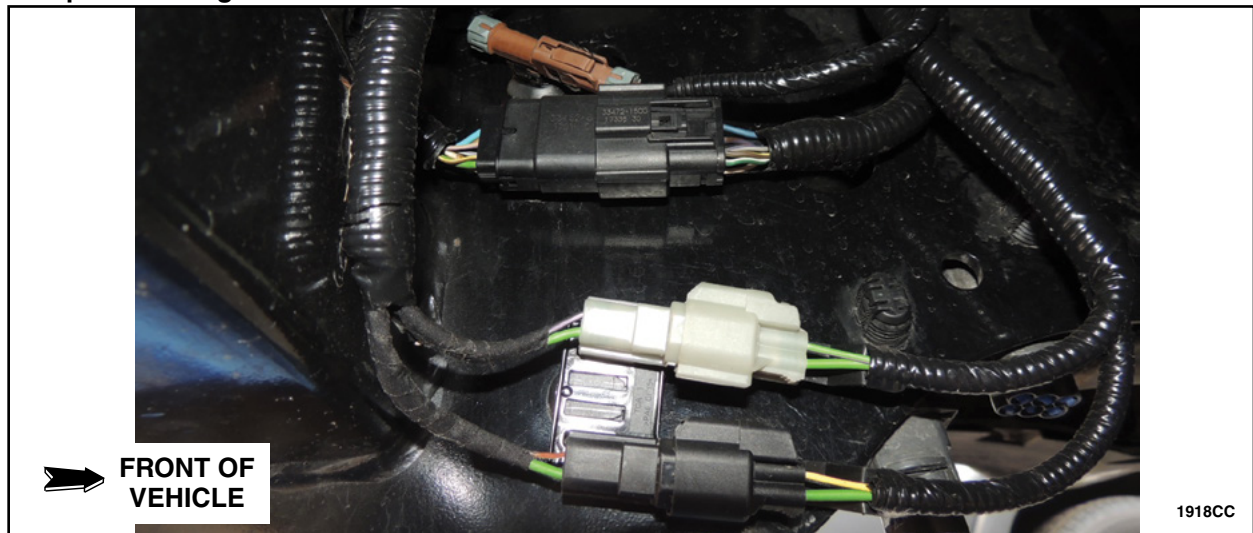
FIGURE 75

98. Secure the tailgate jumper harness using a tie strap then cut the excess length of the tie strap. Return the connectors into the proper locations. See Figures 74 and 75.

Completed Wiring Modification

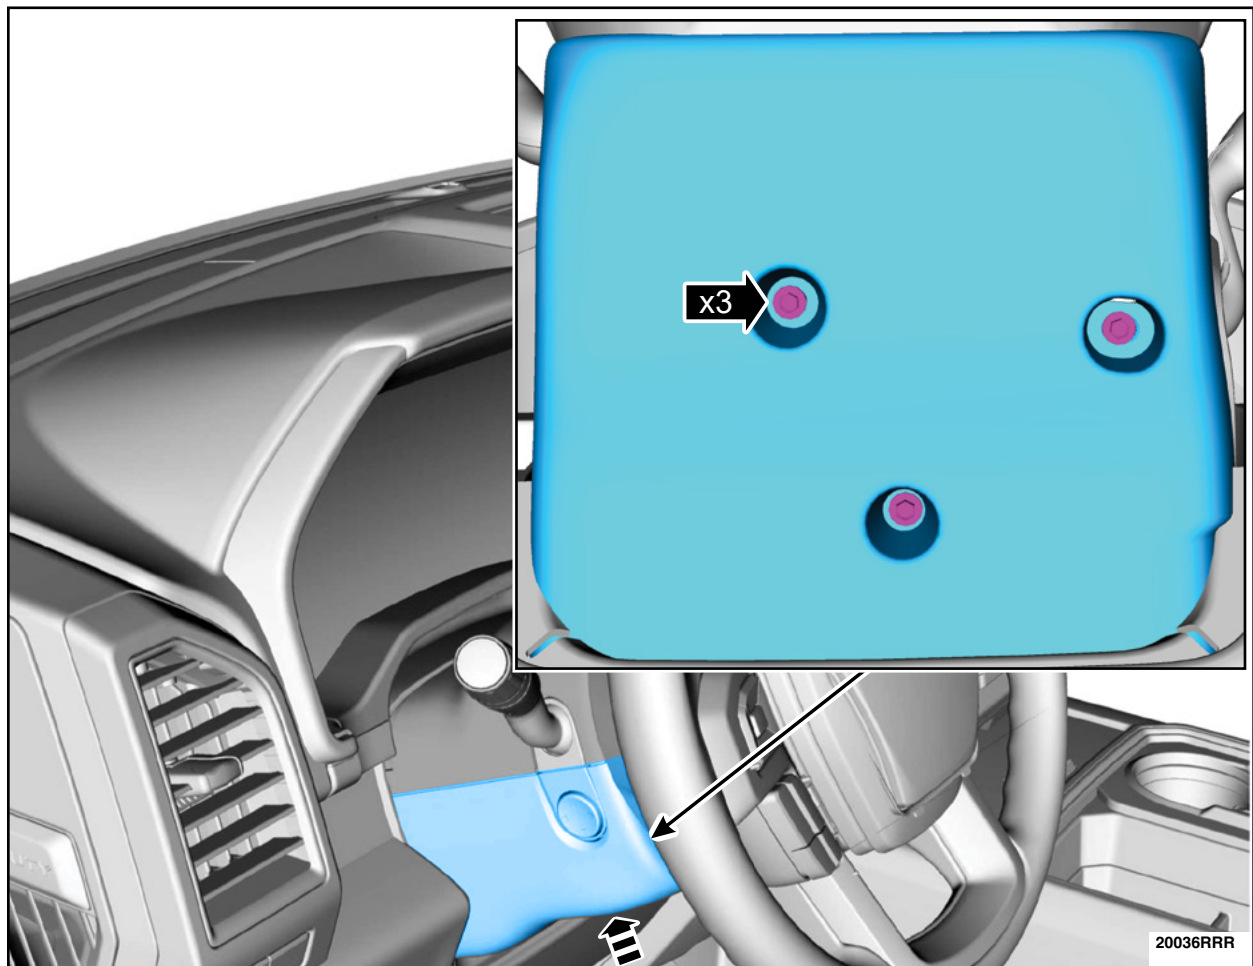
FIGURE 76

100. Install the lower steering column shroud and the bolts. See Figure 76.

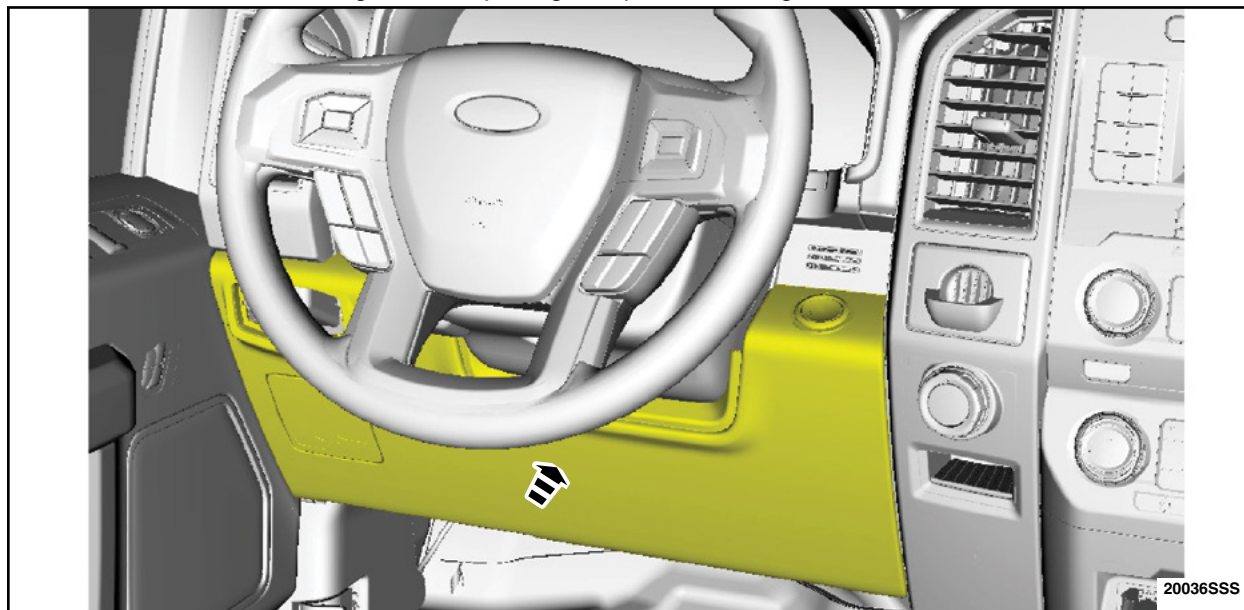
**FIGURE 77**

101. Position back the steering column opening trim panel. See Figure 77.

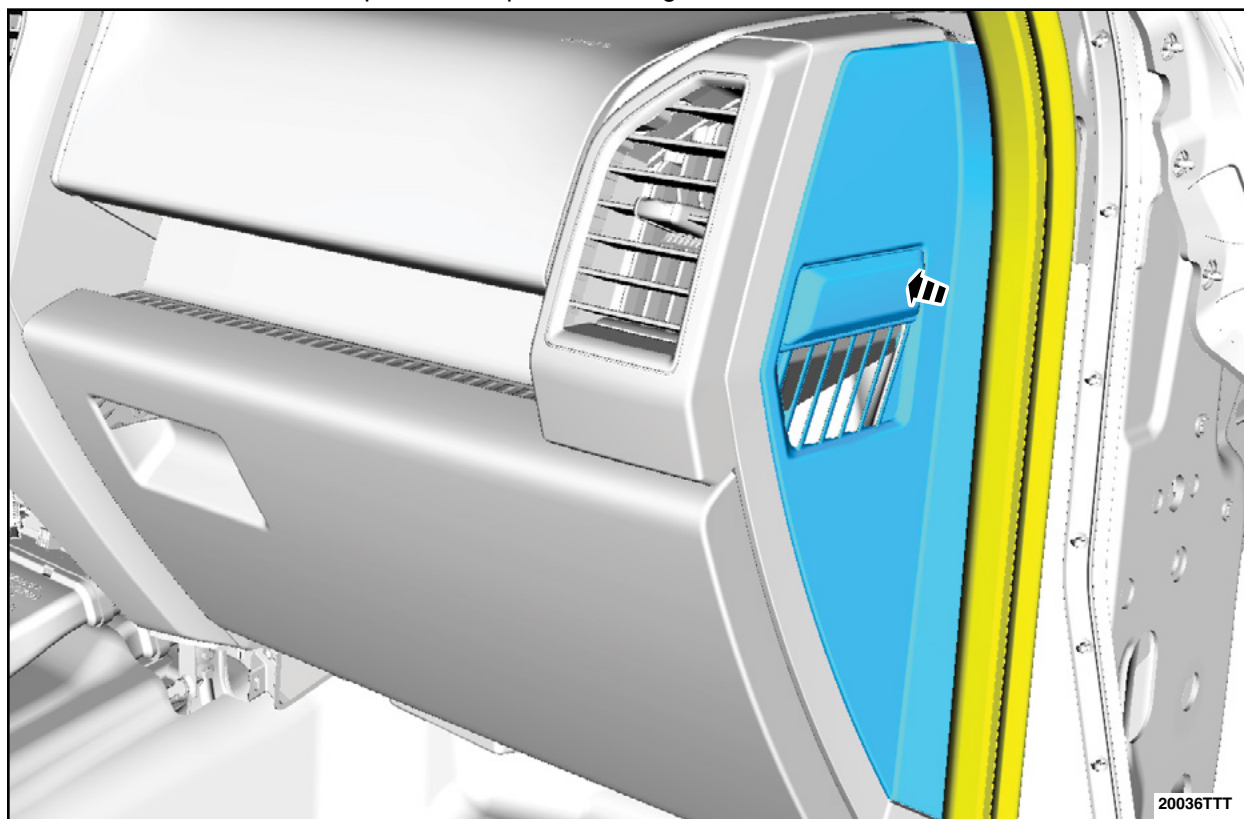
**FIGURE 78**

102. Install the RH instrument panel finish panel. See Figure 78.

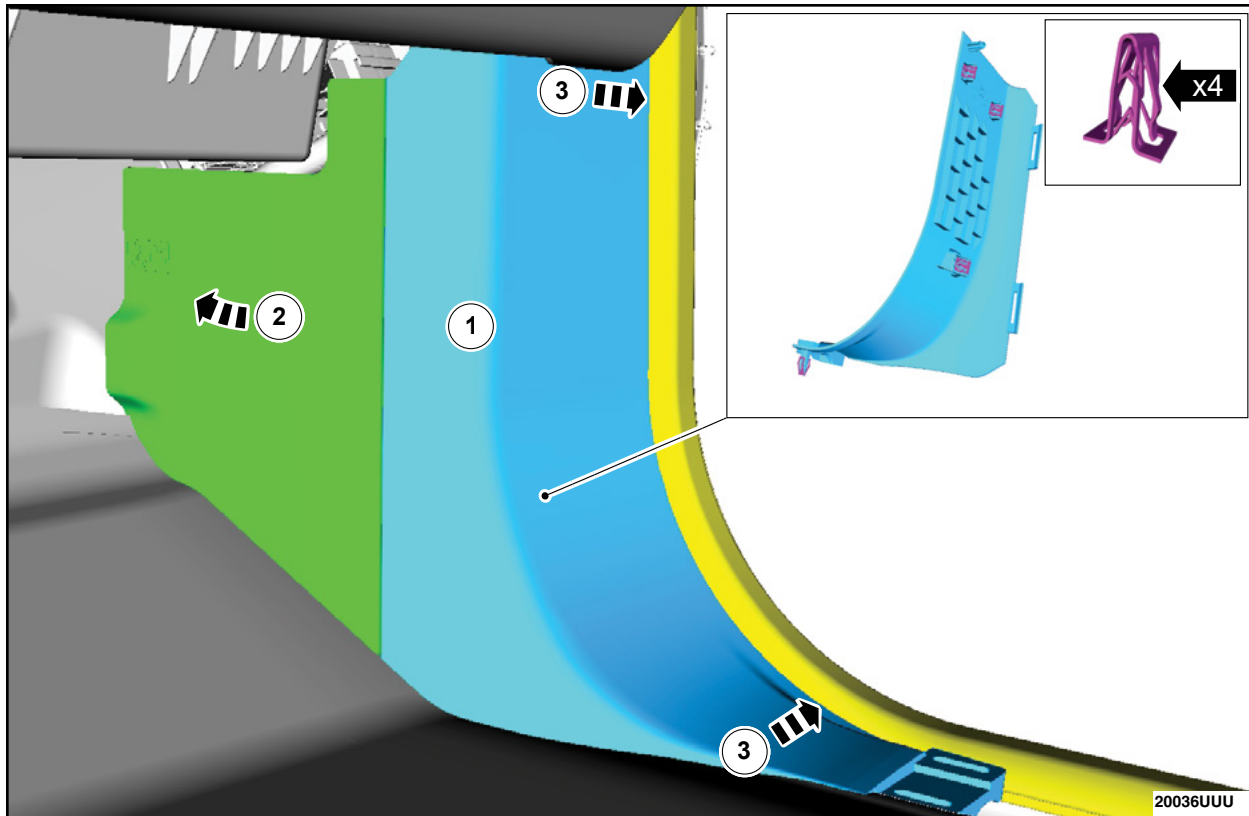
FIGURE 79

103. Install the RH lower cowl trim panel and the access cover. Position back the weatherstrip.  
See Figure 79.

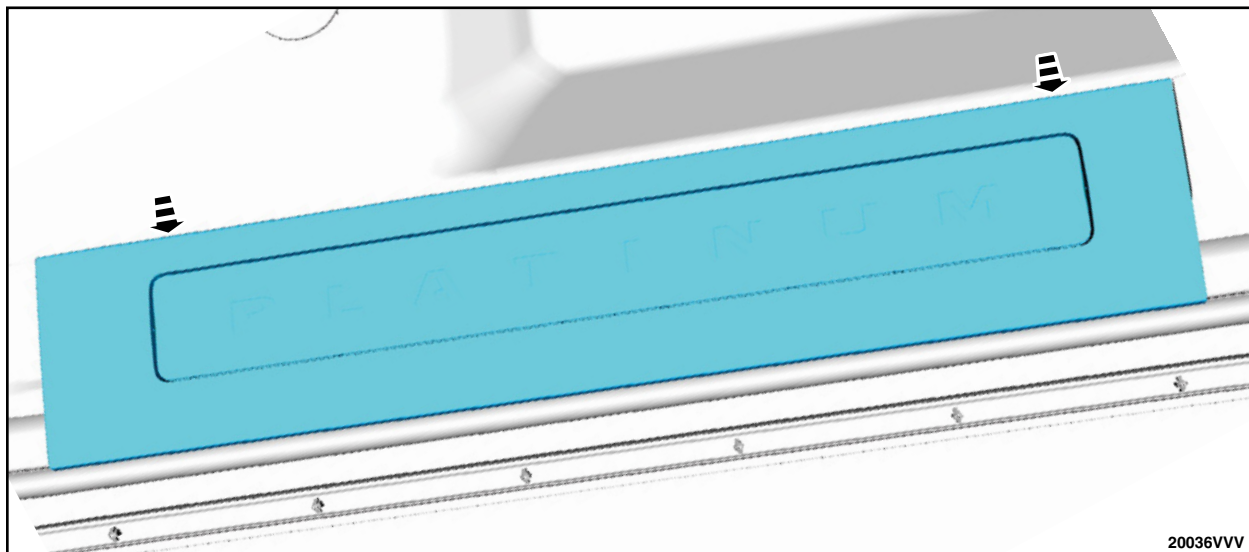
FIGURE 80

104. Install the RH scuff plate. See Figure 80.
