David J. Johnson
 Director
 Service Engineering Operations
 Ford Customer Service Division

SUBJECT: **Customer Satisfaction Program 21B49 - Supplement #2**
 Certain 2021 Model Year Bronco Vehicles Equipped with a Hard Top Roof
 Roof Panel Delamination

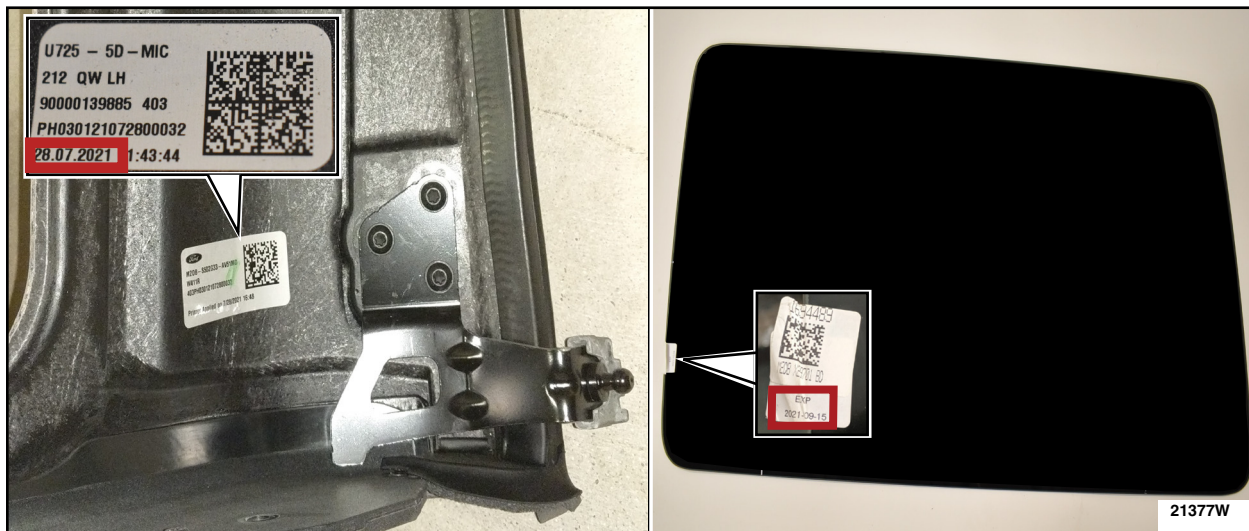
FIGURE 3

2. Inspect the *new* hard top rear cap assembly and the *new* quarter glass labels to make sure the primer has not expired. See Figure 3.

- Is the primer expired (built date is 90 days old or more) or the label is missing?

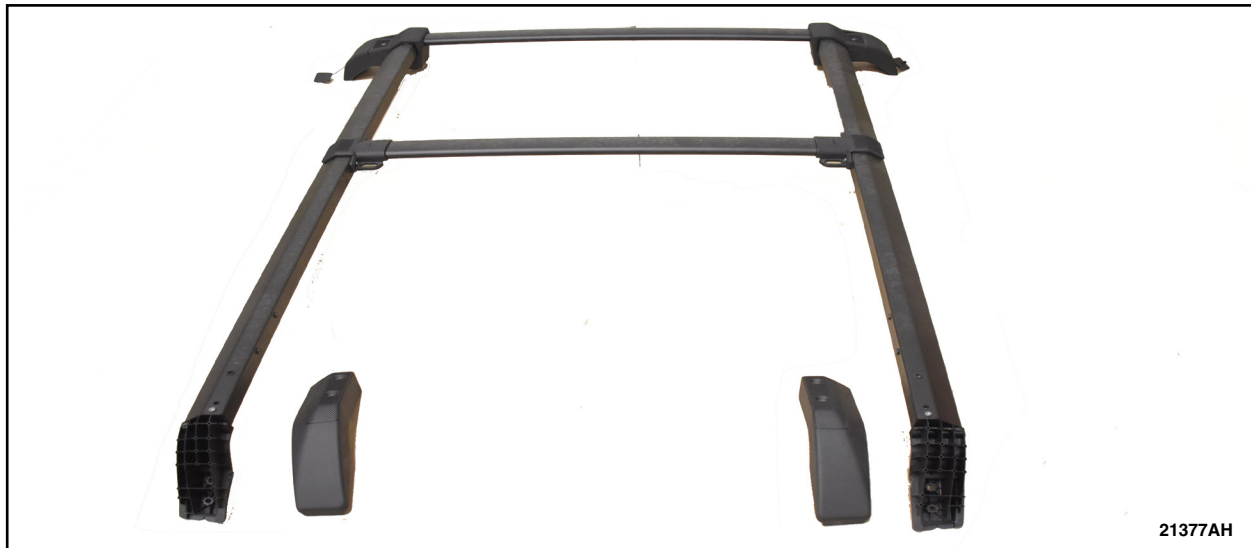
FIGURE 13

6. Place the roof rack assembly in a secure location until it is reinstalled on the *new* hard top assembly later in this procedure.

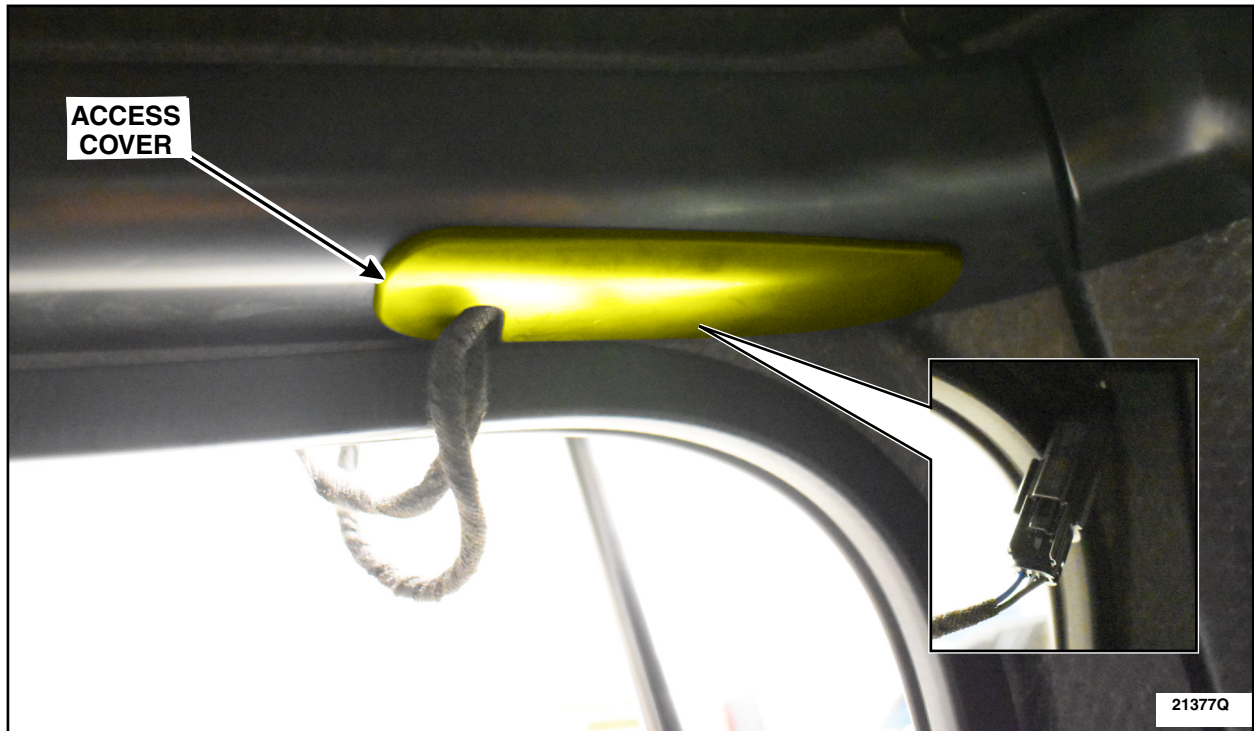
FIGURE 18

5. Remove the access cover located at the rear of the hard top rear cap assembly and disconnect the liftgate window glass electrical connector. See Figure 18.

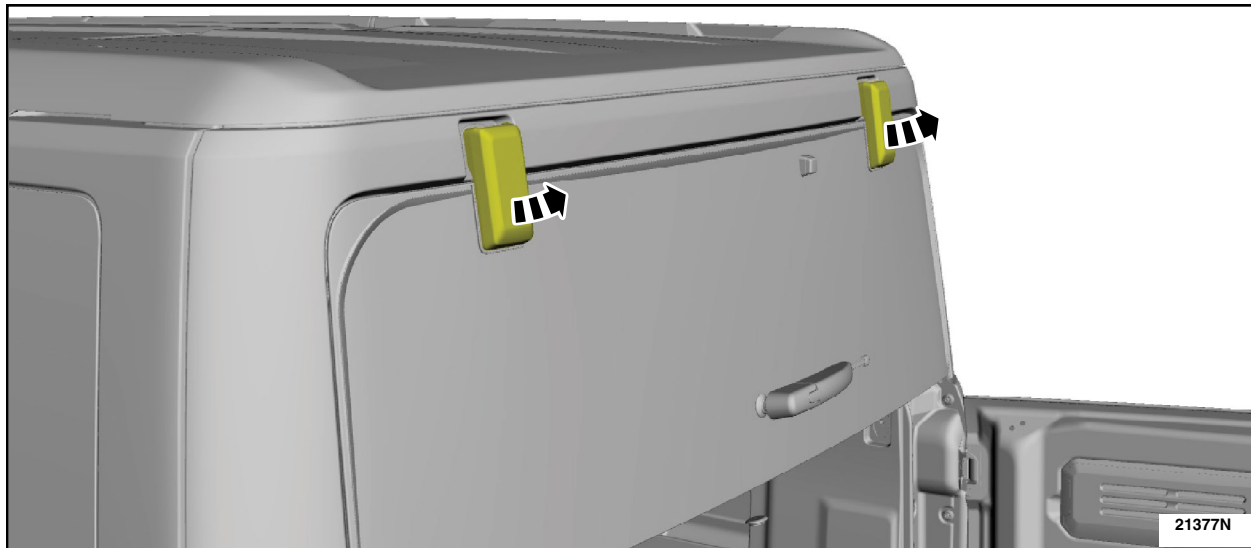
FIGURE 20

7. Release the liftgate window glass hinge trim covers. See Figure 20.

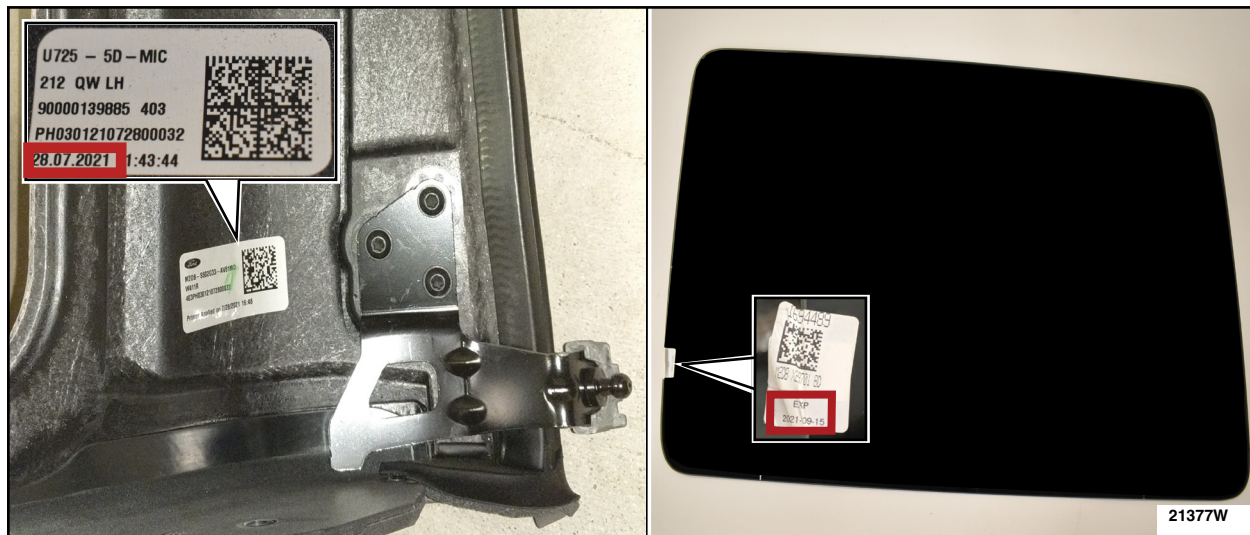
FIGURE 1

2. Inspect the *new* hard top rear cap assembly and the *new* quarter glass labels to make sure the primer has not expired. See Figure 1.

- Is the primer expired (built date is 90 days old or more) or the label is missing?
