# Service Update

## N222369401 Advanced Diagnostic Software (ADS) Improvements

**Release Date:** September 2022 **Revision:** 01  
**Revision Description:** This bulletin has been revised to include model years 2020 and 2021 for the Bolt EV. Please discard all previous copies of bulletin N222369401.

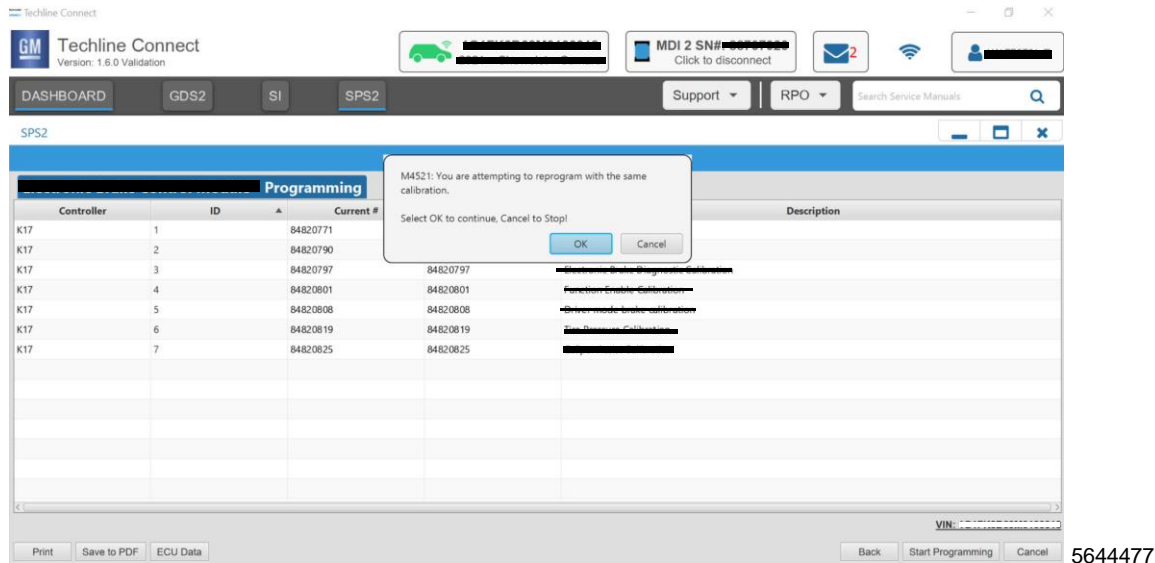
**Important:** Techline Connect screens shown above.

**Important:** If the same calibration/software warning is noted on the TLC Summary screen, select OK and follow screen instructions. After a successful programming event, the WCC is located in the Service Programming System dialogue box of the SPS Summary screen. No further action is required. Refer to the Warranty section of the bulletin.
