**SUBJECT:** **Customer Satisfaction Program 21M06 - Supplement #1**  
 Certain 2015-2020 Model Year F-150 Vehicles Equipped with a Power Release Tailgate - Unintended Tailgate Opening

**New! REASON FOR THIS SUPPLEMENT**

*Parts ordering information and full repair instructions are now available to support completion of this customer satisfaction program.*

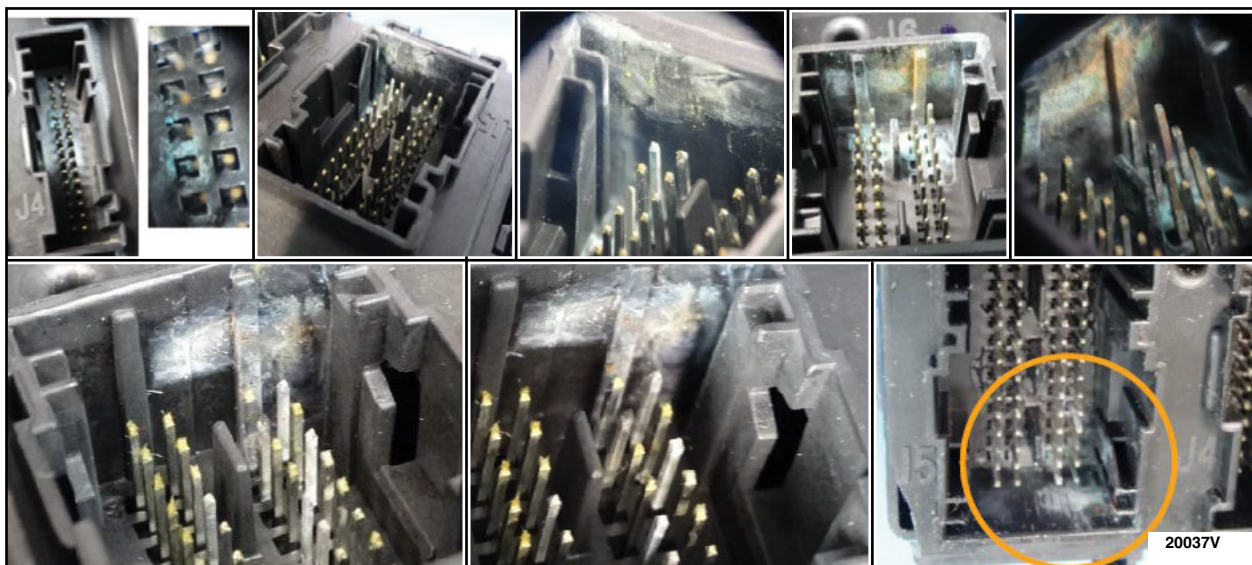
**FIGURE 1**

1. Lower the tailgate of the vehicle.
2. Open the hood of the vehicle.
3. If equipped, open the roof opening panel.
4. Disconnect the negative battery cable(s) and position aside. Please follow the Workshop Manual (WSM) procedures in Section 414-01.
5. Remove the Body Control Module (BCM). Please follow the WSM procedures in section 419-10.
6. Inspect the BCM for any sign(s) of moisture and/or corrosion. See Figure 1 for examples of corrosion.  
- Was any sign(s) of moisture and/or corrosion present?

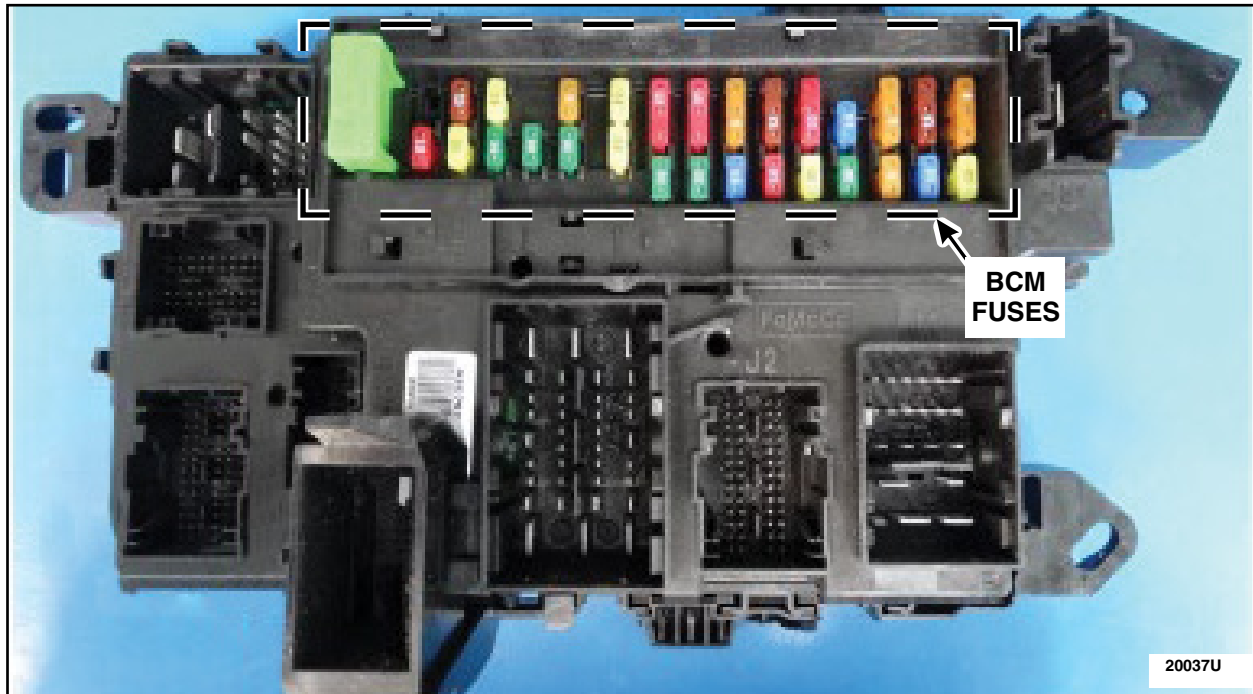
FIGURE 2

7. Remove each BCM fuse, one at a time, and inspect for sign(s) of moisture and/or corrosion.

See Figure 2.

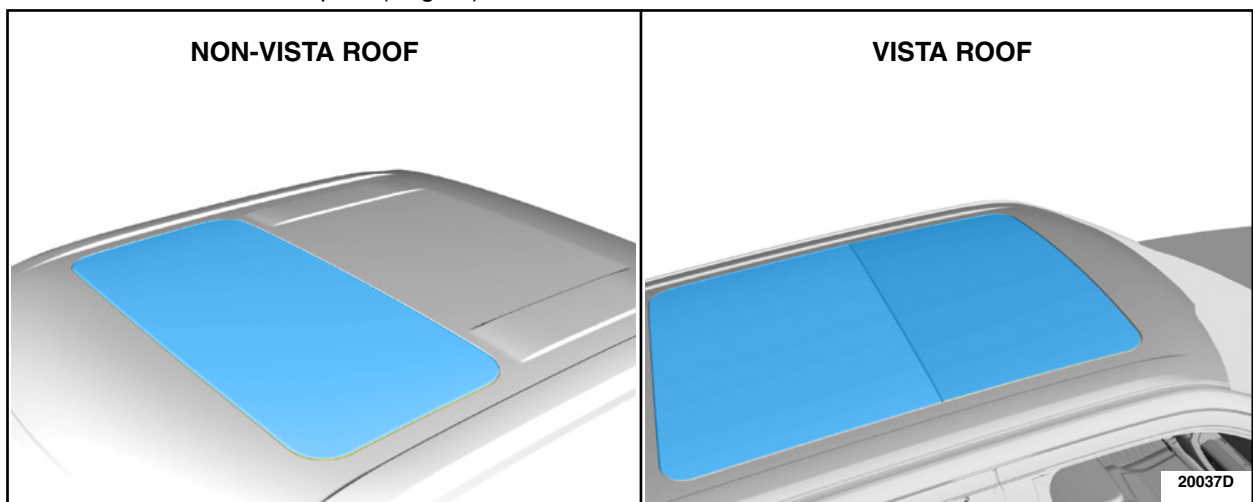
FIGURE 3

8. Is the vehicle equipped with a roof opening panel? See Figure 3.

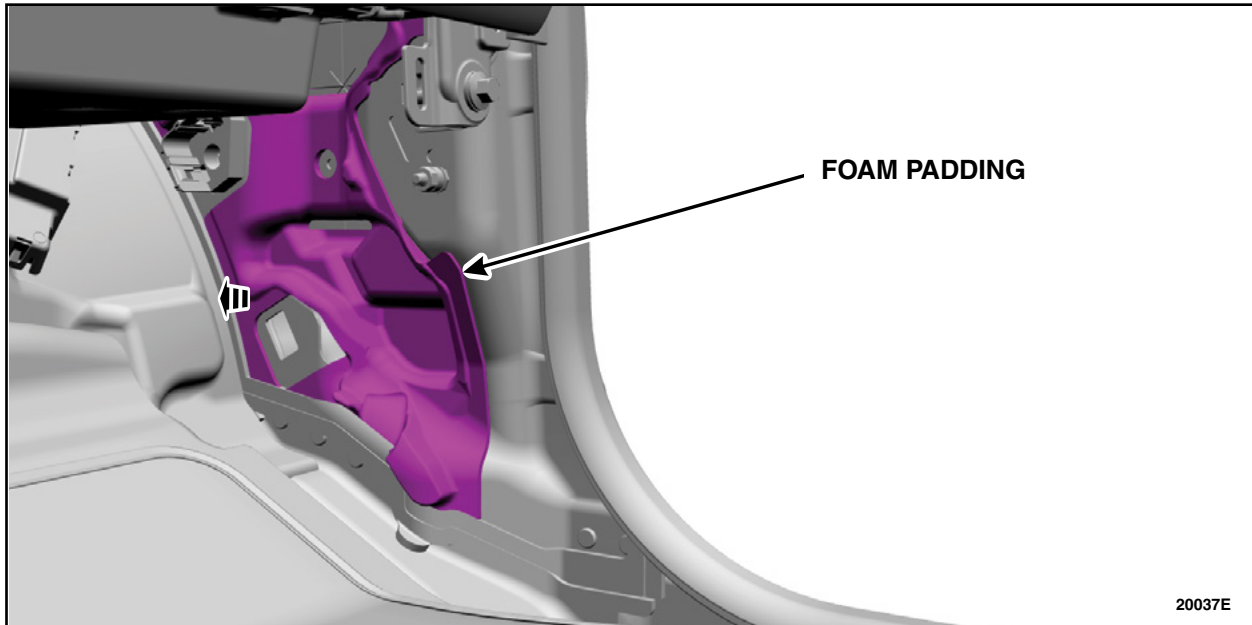
**FIGURE 4**

9. Remove the foam padding located behind the BCM. See Figure 4.

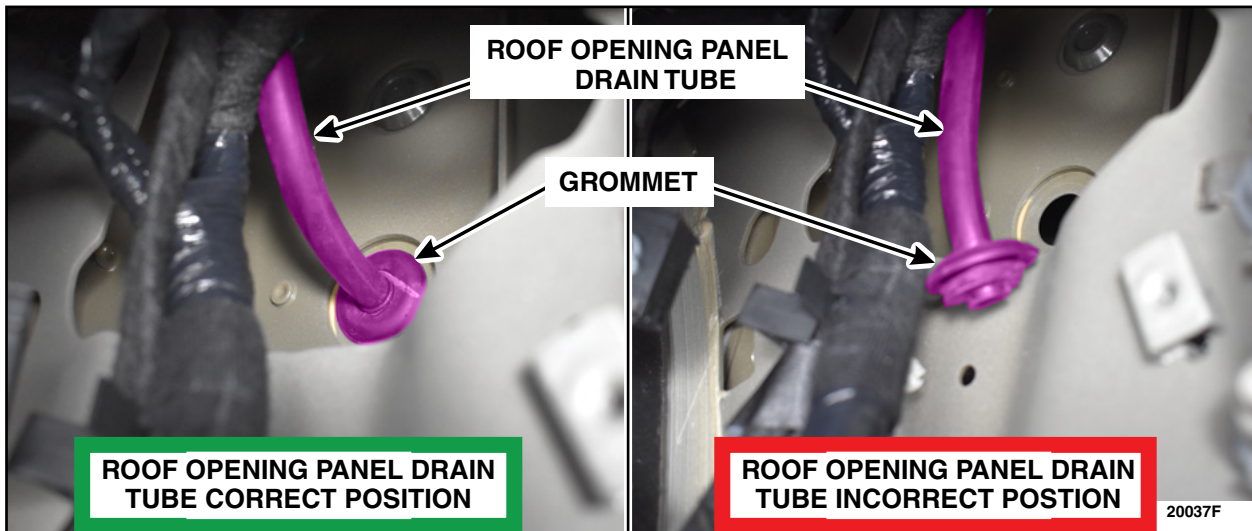
**FIGURE 5**

10. Inspect the roof opening panel drain tube and grommet located behind the BCM area.  
- Is the drain tube and grommet in the correct position? See Figure 5.

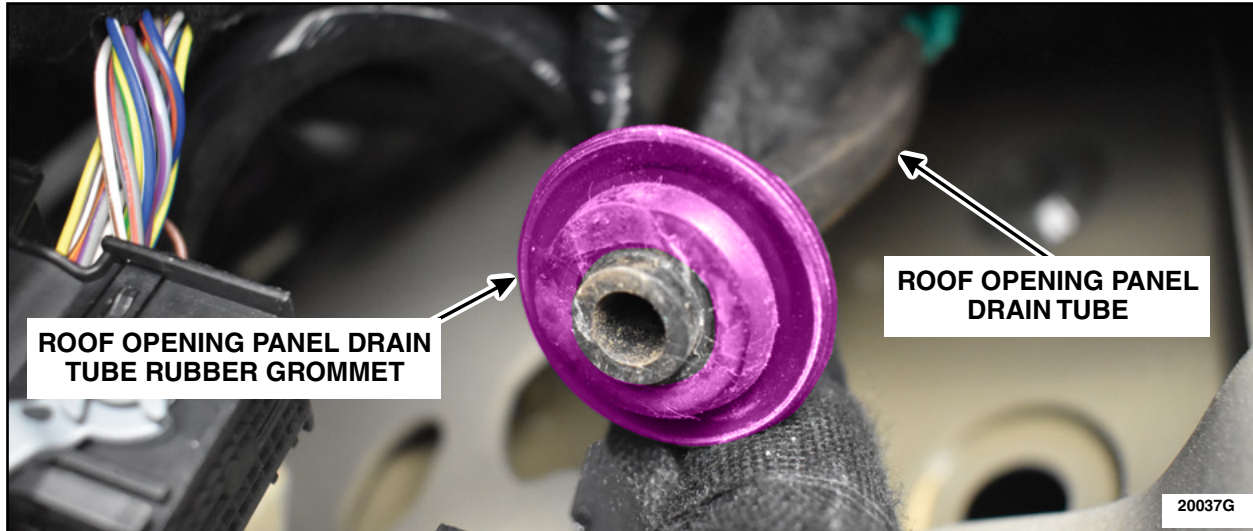
**FIGURE 6**

11. Is the grommet attached to the roof opening panel drain tube as seen in See Figure 6?

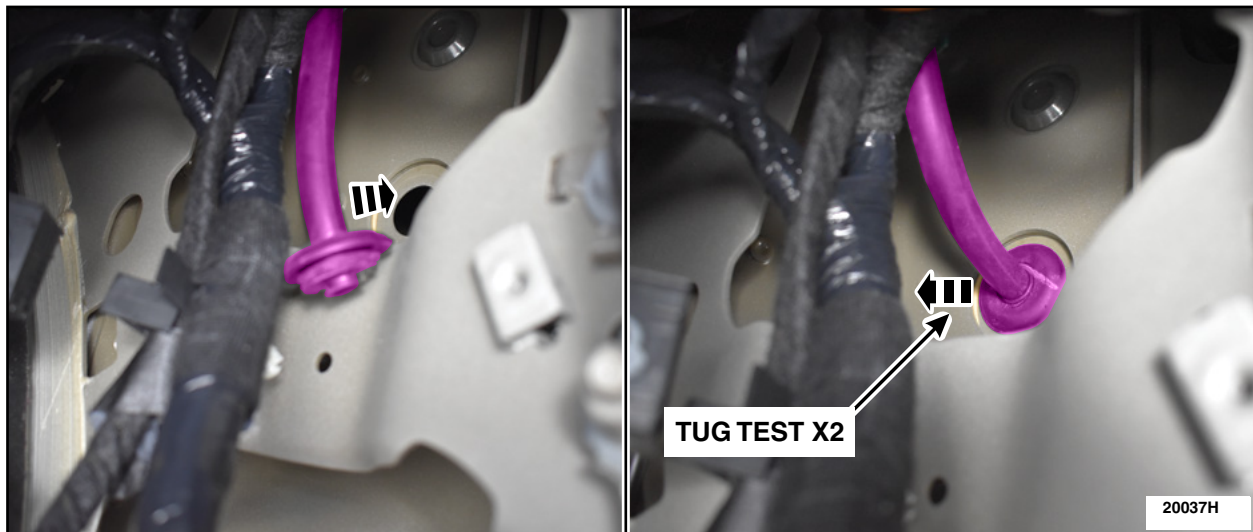
**FIGURE 7**

12. Install the roof opening panel drain tube into the body panel making sure that the grommet is fully seated. Perform a 2-tug test on the roof opening panel drain tube.

- Did the drain tube and grommet remain in place? See Figure 7.

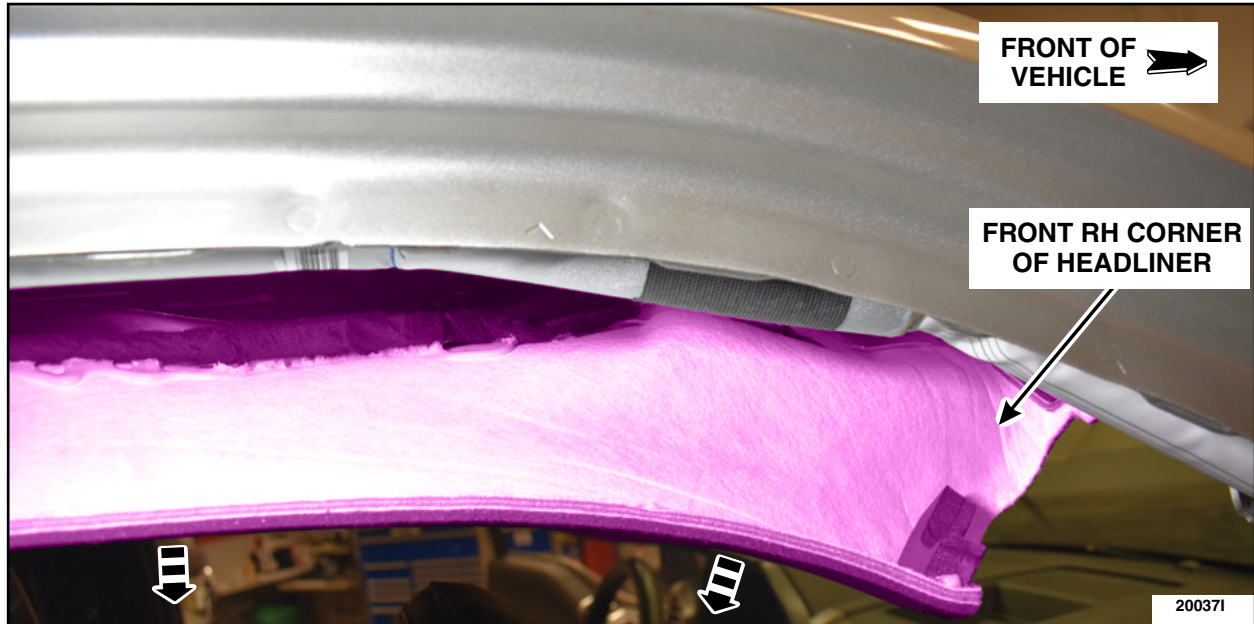
**FIGURE 8**

14. Lower the front RH corner of the headliner. See Figure 8.

**CAUTION:** Do not bend or crease the headliner.

28. Lower the front RH corner of the headliner. See Step 14, Figure 8. Pour a glass of water into the roof opening panel drain tube channel and immediately inspect the drain tube at the roof opening panel for water leakage. See Figure 17.

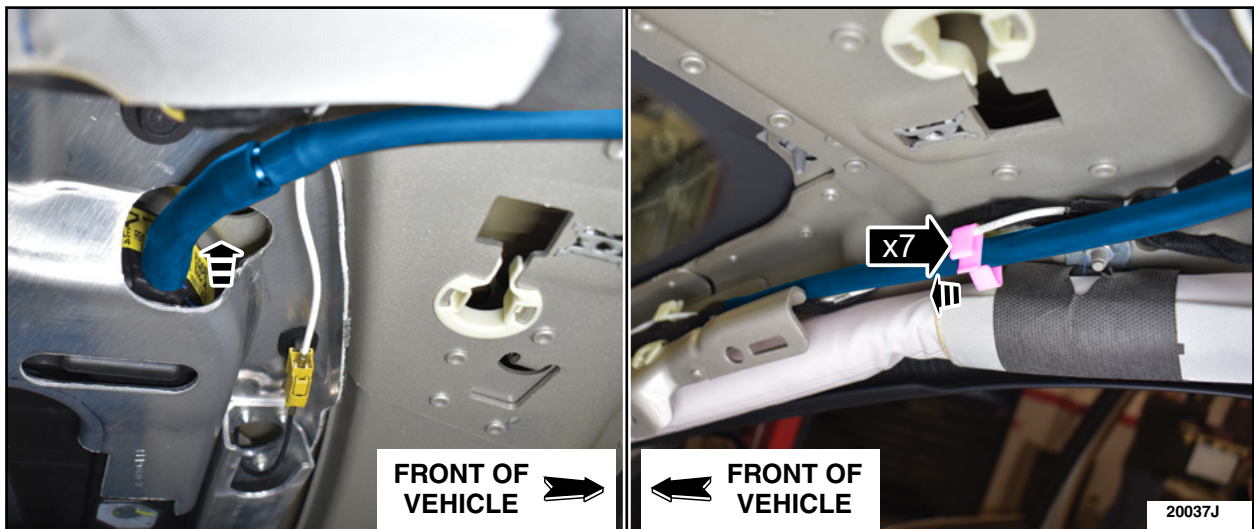
**FIGURE 9**

15. Remove the roof opening panel drain tube. See Figure 9.

1. Remove the drain tube grommet located behind the BCM.
2. Disconnect the drain tube at the roof opening panel.
3. Release the drain tube retainers located along the RH A-pillar down through the Instrument Panel (IP).
4. Remove the drain tube out the top of the IP.

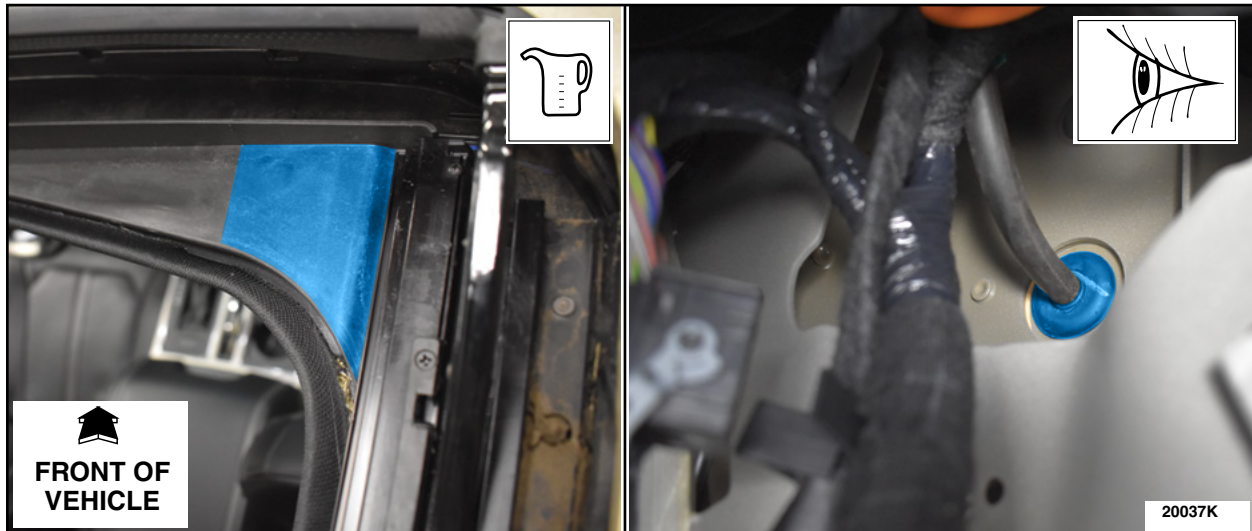
**FIGURE 10**

16. Install a *new* roof opening panel drain tube by reversing Step 15.
17. Pour a glass of water into the roof opening panel drain tube channel and immediately inspect the roof opening panel drain tube grommet for water leakage. See Figure 10.
- Is there water leakage inside the vehicle at the grommet

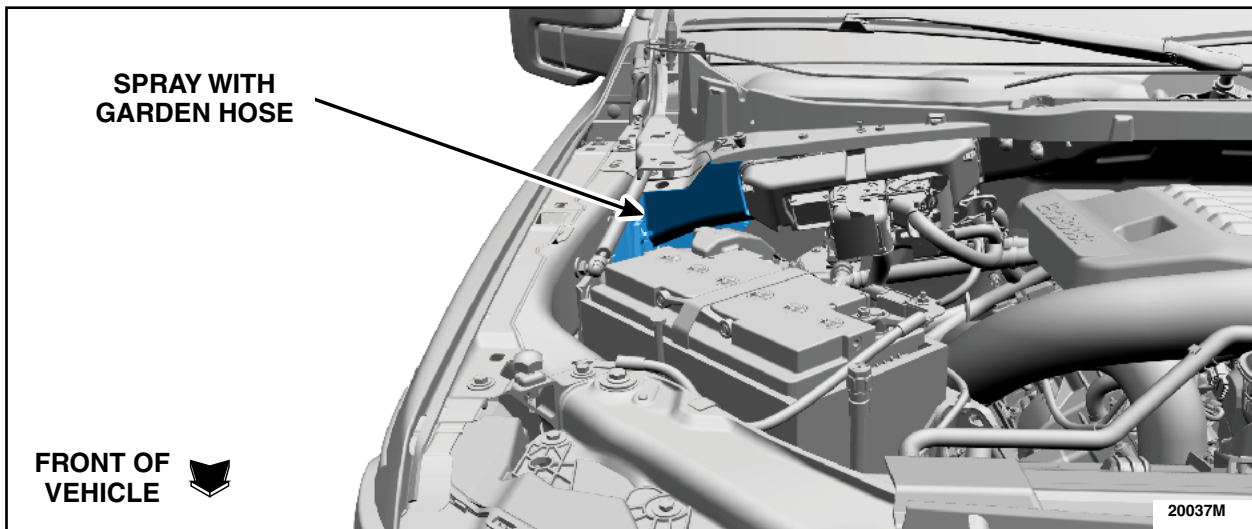
**FIGURE 11**

19. Using a garden hose, spray the upper RH side of the engine compartment fire wall. See Figure 11.

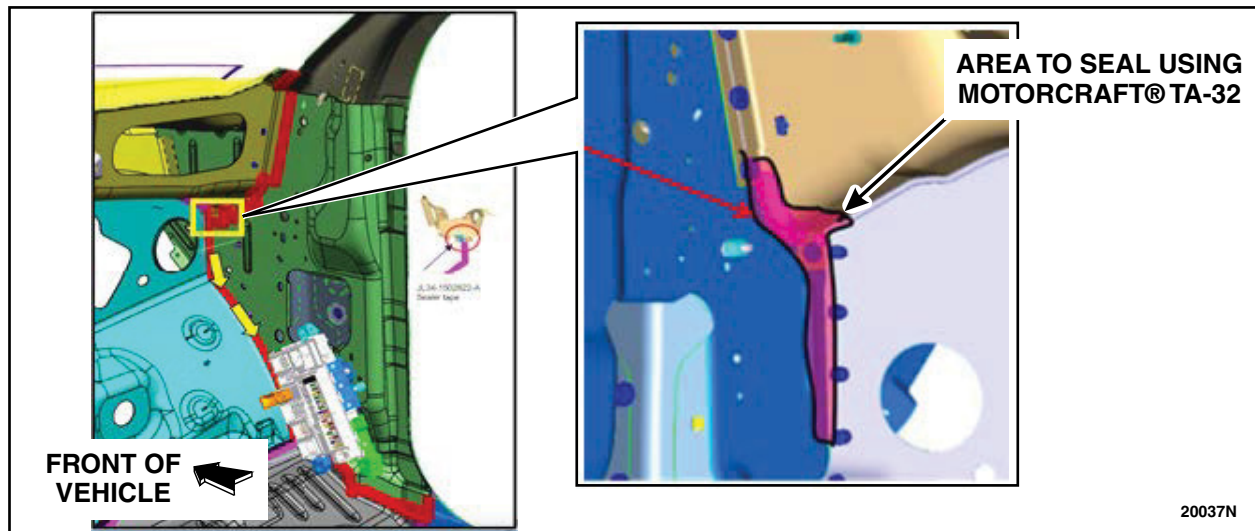
**FIGURE 12**

22. Using Motorcraft® TA-32 Clear Silicone Rubber Sealer or equivalent, apply a bead along the body patch and allow it to dry. See Figure 12. Retest by performing Step 19 once the Clear Silicone Rubber is dry.

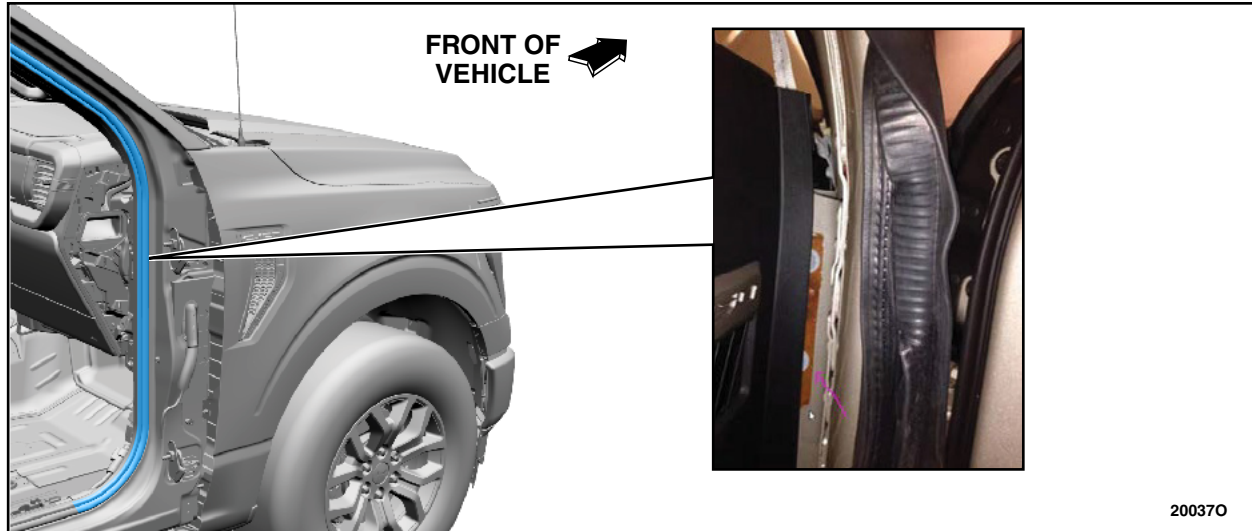
FIGURE 13

24. Inspect the front RH side door weatherstrip for any rips or deformity. See Figure 13.  
- Were any rips or deformity present?

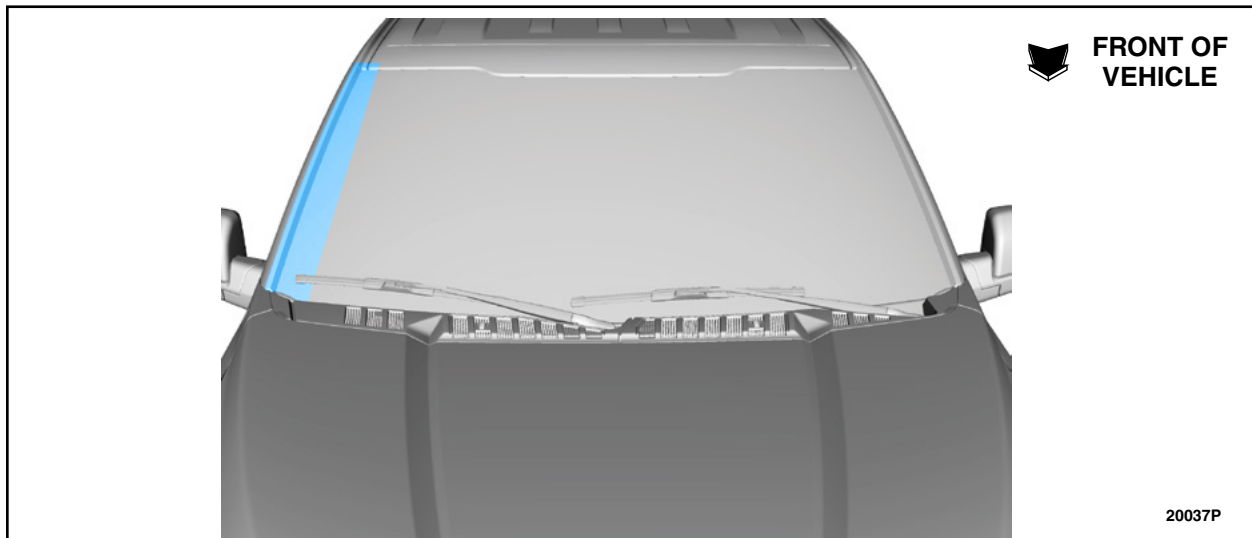
FIGURE 14

25. Using a garden hose, spray down the RH side of the windshield, then immediately inspect the A-pillar area within the vehicle for signs of moisture and/or leakage. See Figure 14.  
- Was any sign of moisture and/or leakage found around the A-pillar?

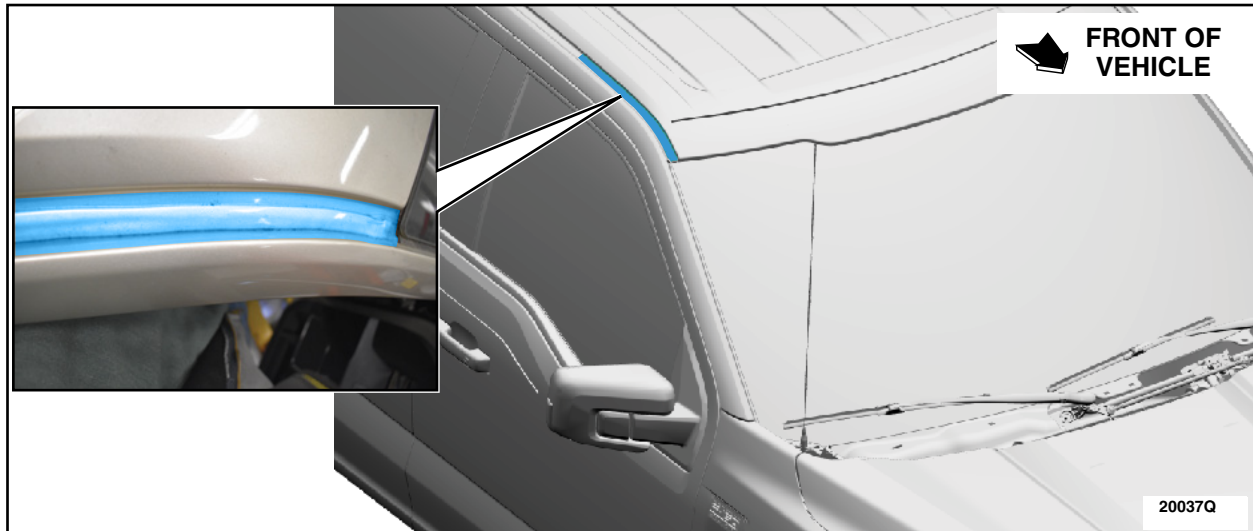
**FIGURE 15**

26. Using a garden hose, run water over the front RH roof ditch, immediately inspect the A-pillar inside the vehicle for signs of moisture and/or leakage. See Figure 15.

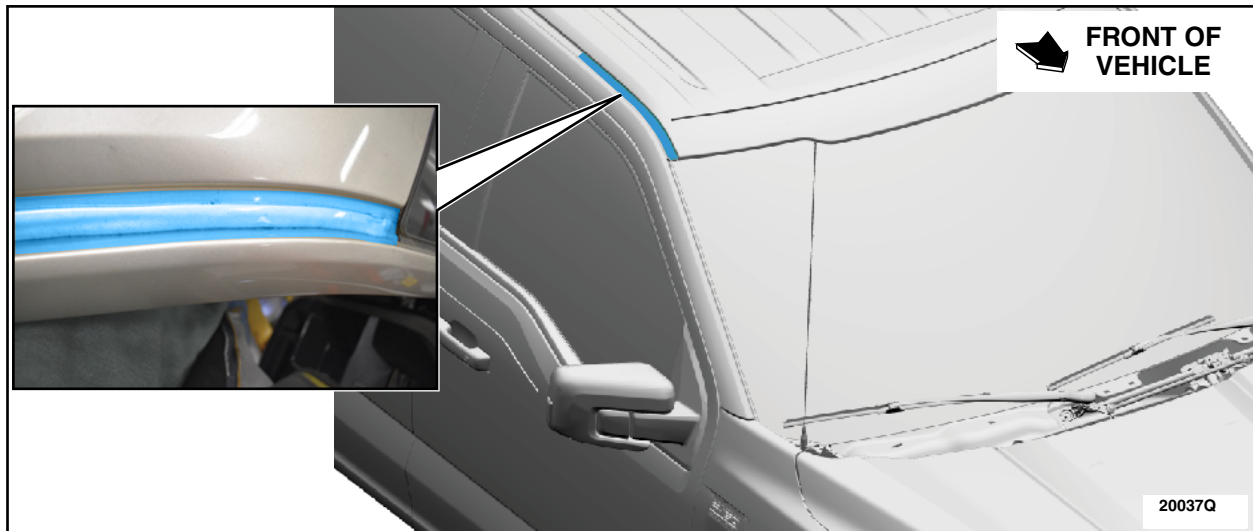
**FIGURE 16**

27. Neatly apply some Motorcraft® TA-32 Clear Silicone Rubber to the front RH roof ditch. See Figure 16. Allow the sealer to cure, then proceed to Step 28.

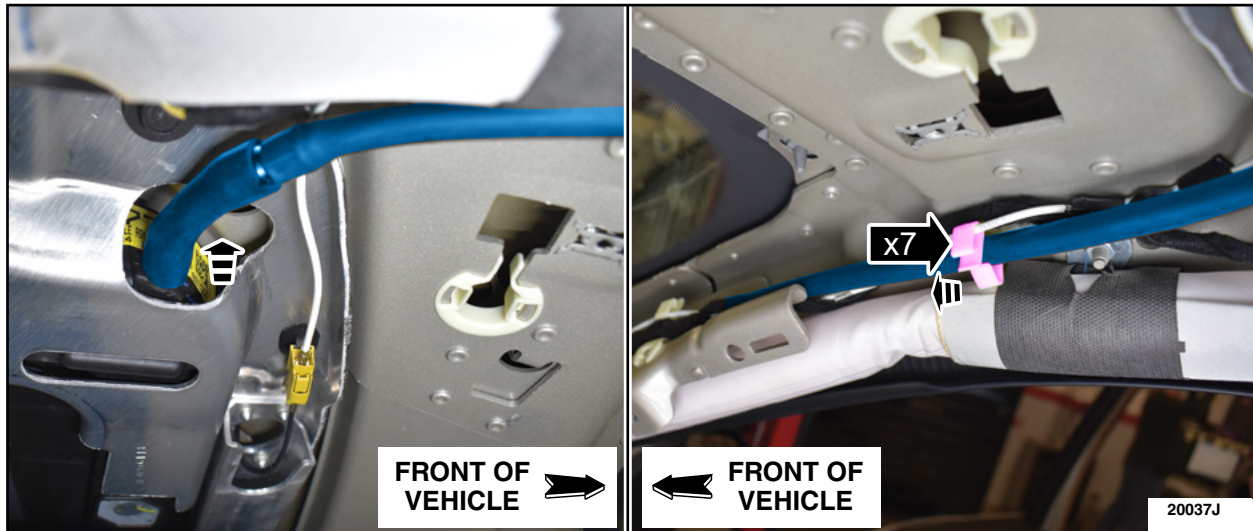
**FIGURE 18**

30. Remove the roof opening panel drain tube. See Figure 18.

1. Remove the drain tube grommet located behind the BCM.
2. Disconnect the drain tube at the roof opening panel.
3. Release the drain tube retainers located along the RH A-pillar down through the IP.
4. Remove the drain tube out the top of the IP.

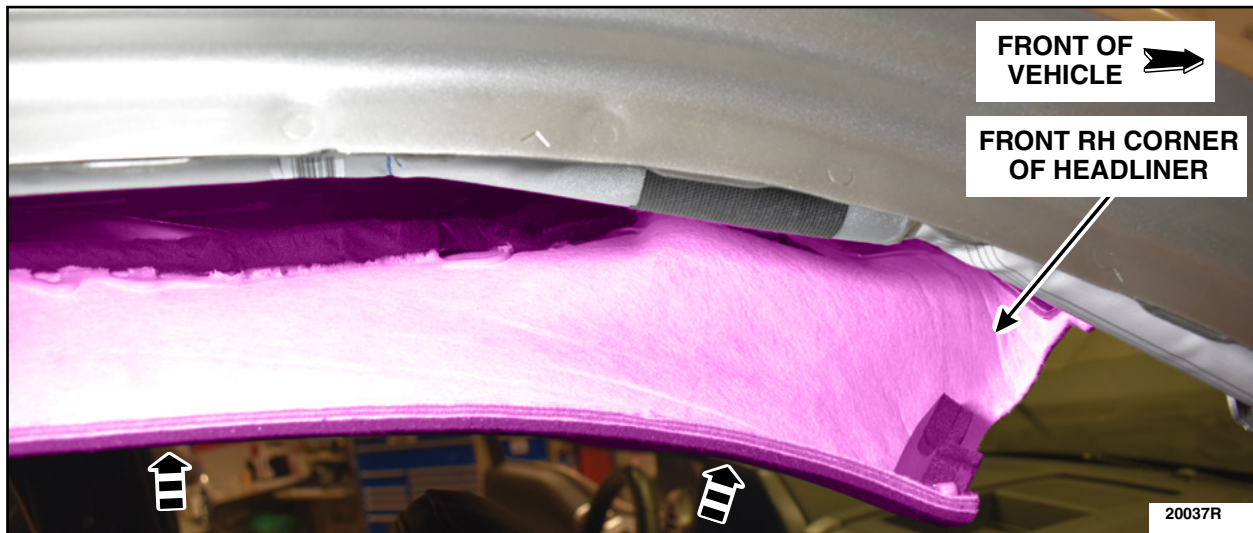
**FIGURE 19**

32. Position back the front RH corner of the headliner. See Figure 19.

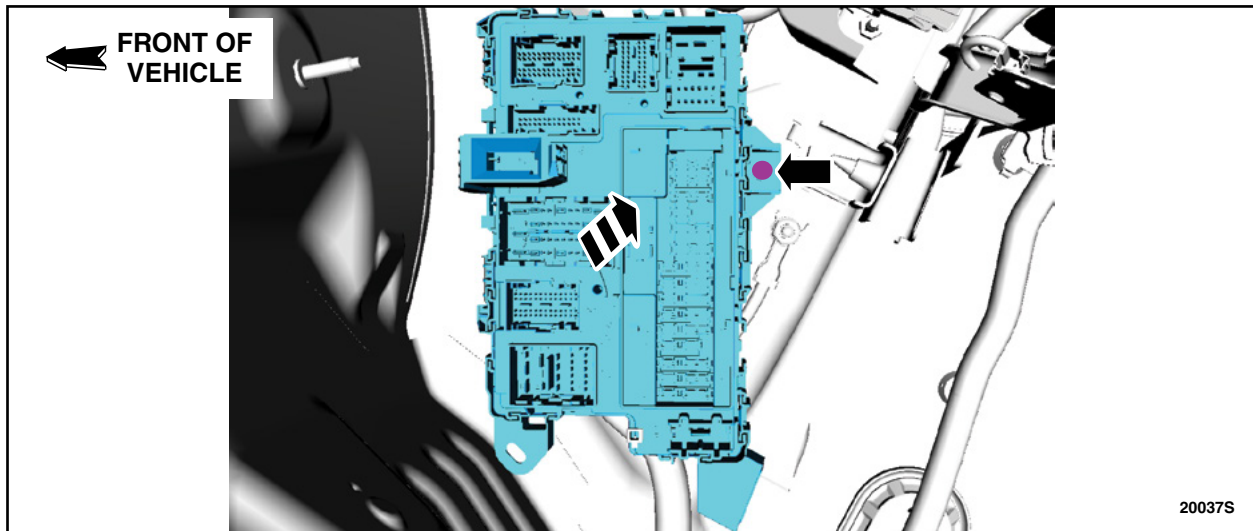
**FIGURE 20**

36. Install the BCM and retainer. See Figure 20.

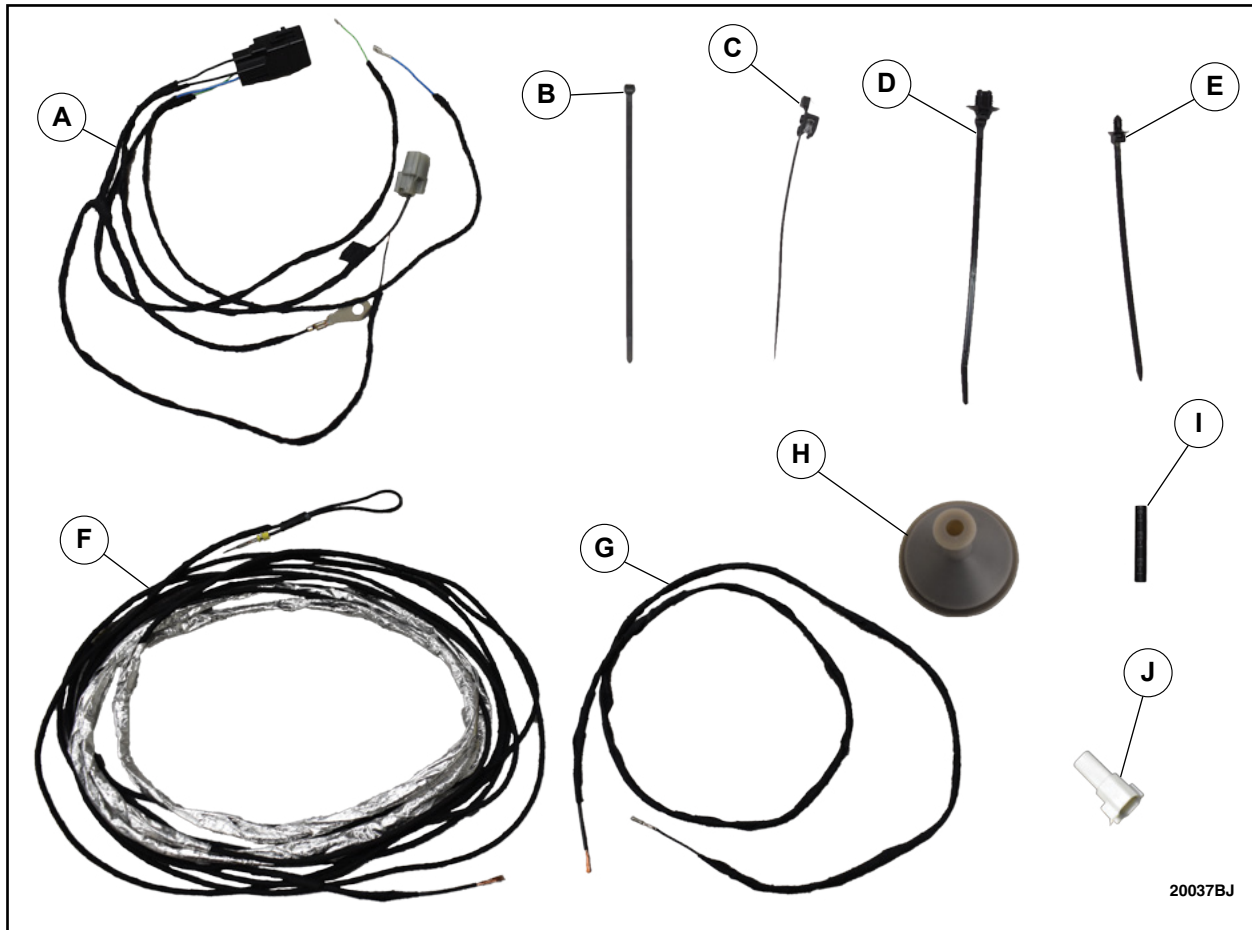
**FIGURE 21**

**Complete Tailgate Actuator Ground Wiring Part Kit**

ITEM	DESCRIPTION	QUANTITY
A	Relay Harness	1
B	Tie Strap	-
C	Edge Biter Style Tie Strap	-
D	Oval Push Pin Style Tie Strap	-
E	Round Push Pin Style Tie Strap	-
F	Body Length Jumper Harness	1
G	Tailgate Jumper Harness	1
H	Grommet	1
I	Heat Shrink Tubing	-
J	Male end 2 Pin Connector	1

**NOTE:** The parts being installed in this procedure are not labeled. Refer to Figure 21 for component identification.

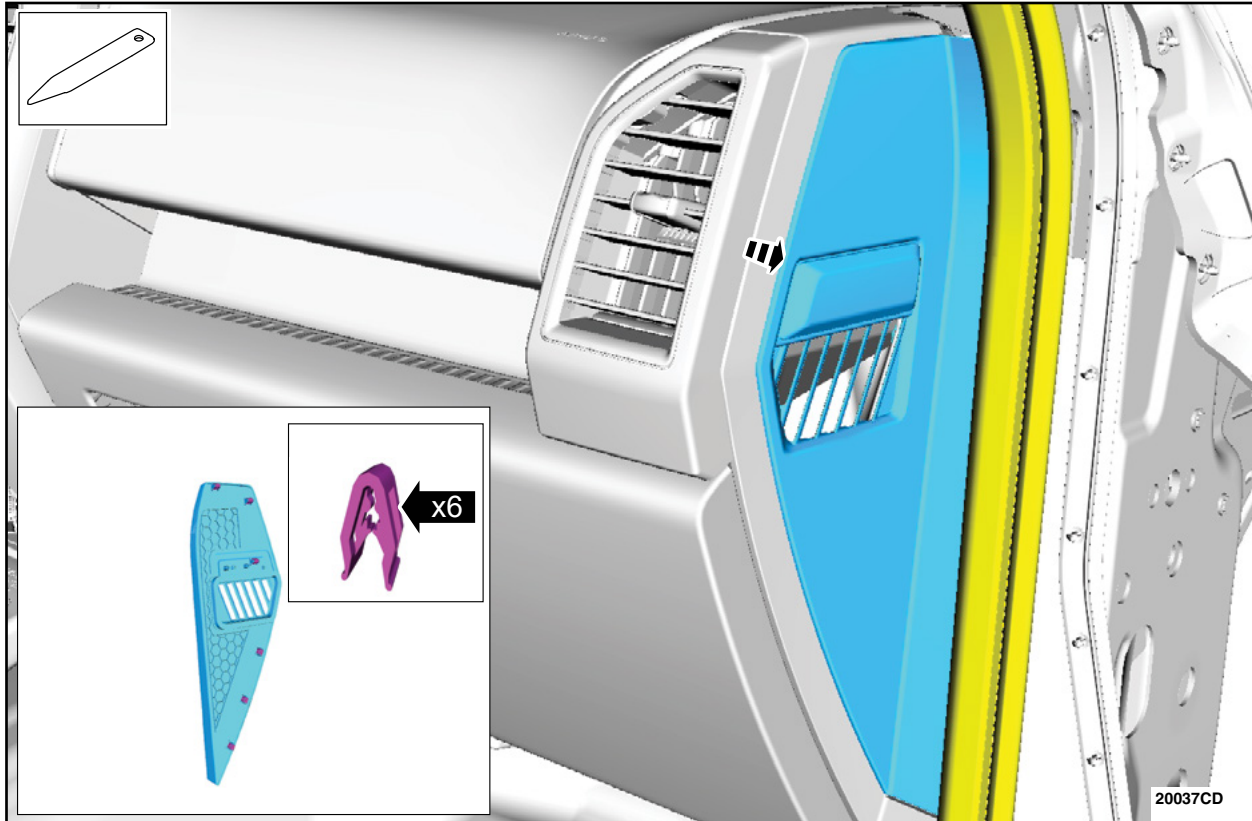
**FIGURE 22**

38. Position aside the weatherstrip, release the clips and remove the RH instrument panel finish panel.  
See Figure 22.

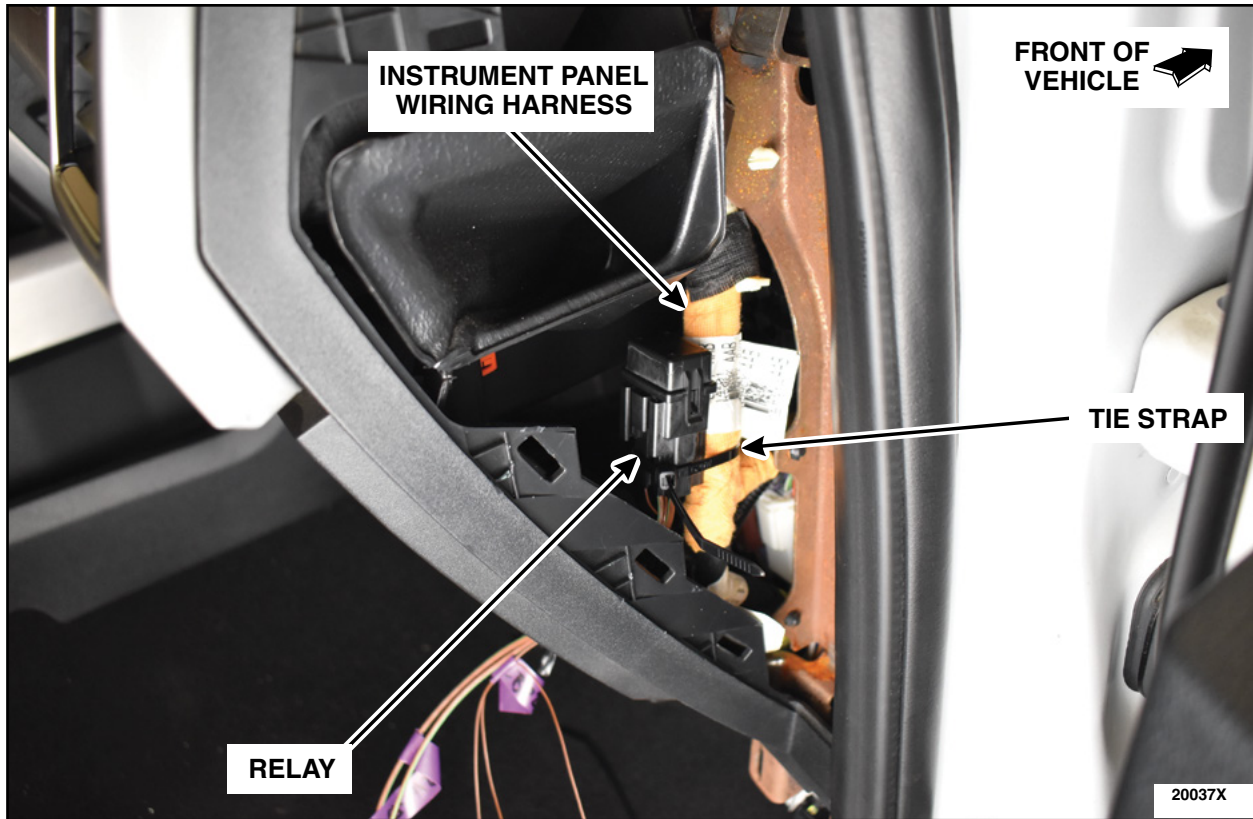
FIGURE 23

40. Place the relay, included in the kit, onto the instrument panel wiring harness and secure using a tie strap. See figure 23.

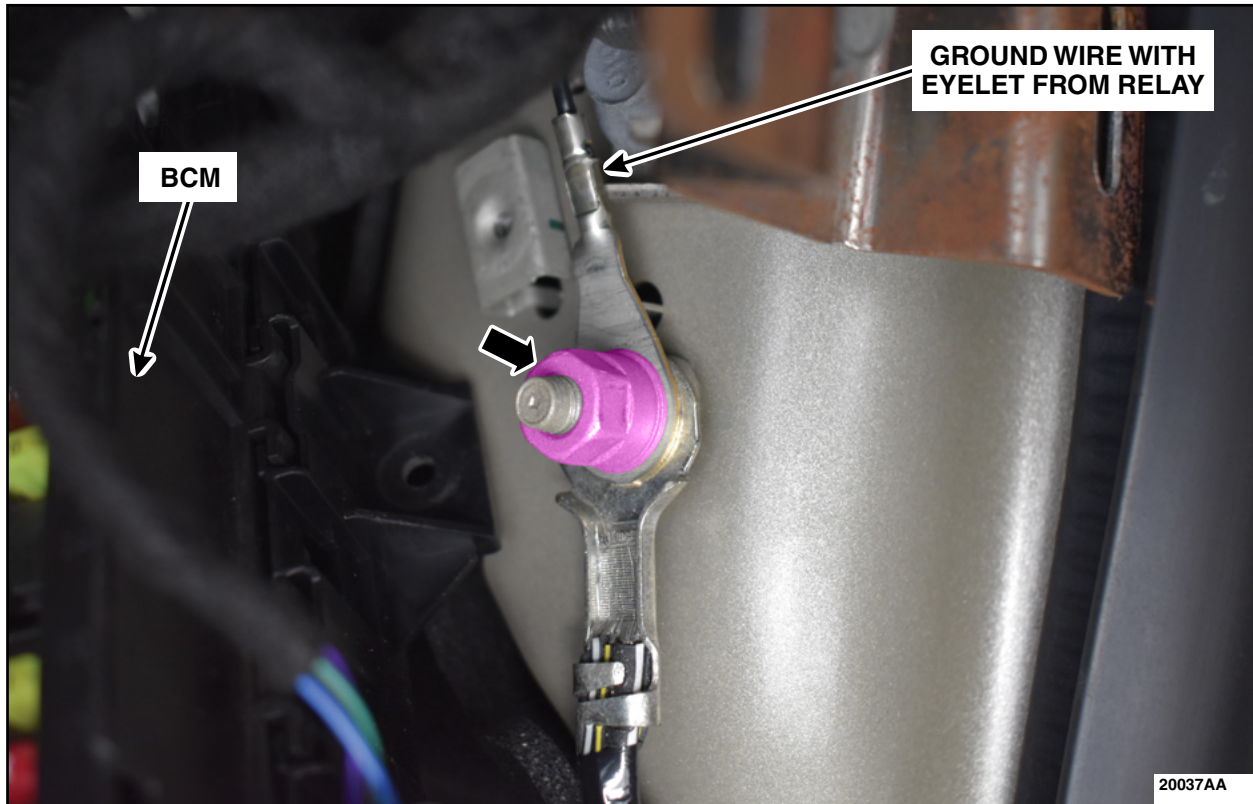
FIGURE 24

41. Remove the ground nut, install the ground wire with the eyelet from the relay on to the ground stud. Reinstall the ground stud nut. See Figure 24.

- Torque: 70 lb. in (8 Nm)

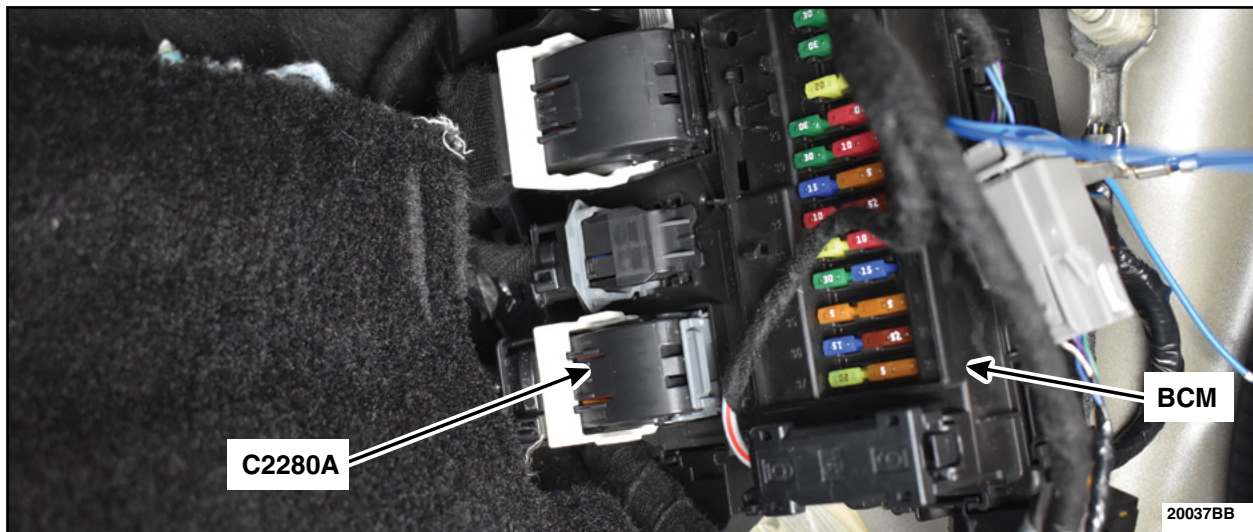
FIGURE 25

42. Disconnect BCM C2280A. See Figure 25.

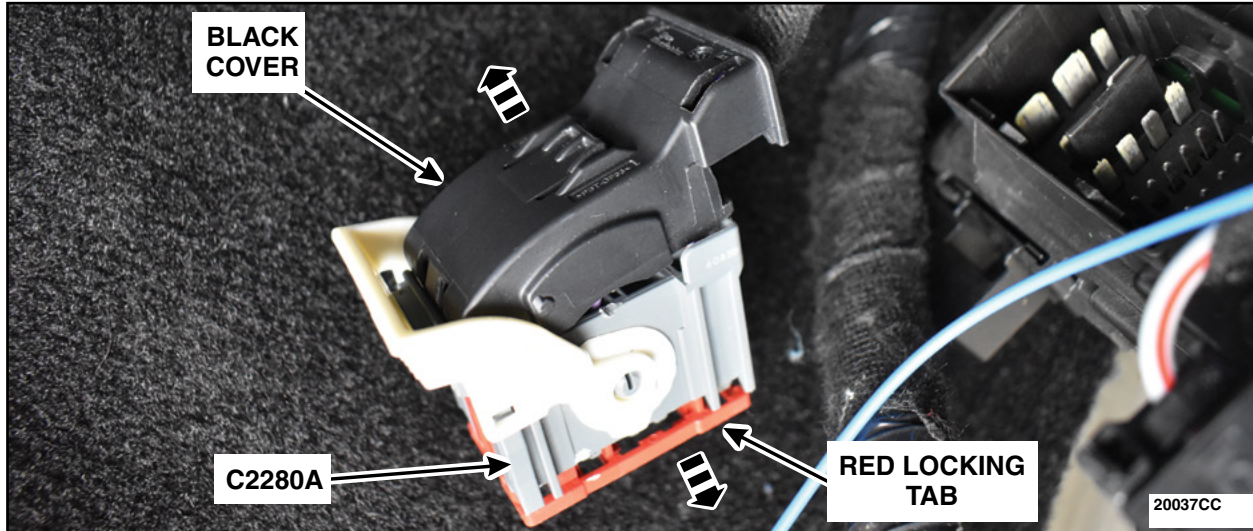
**FIGURE 26**

43. Remove the tie strap, black cover and the red locking tab of C2280A. See Figure 26.

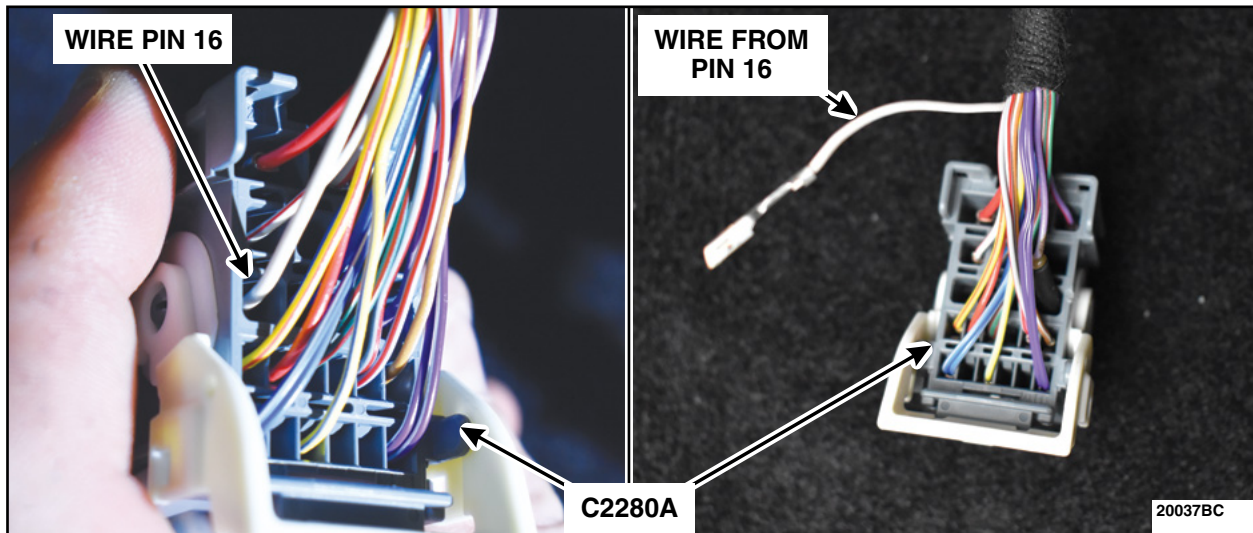
**FIGURE 27**

45. Remove the wire from pin 16 from C2280A. See Figure 27.

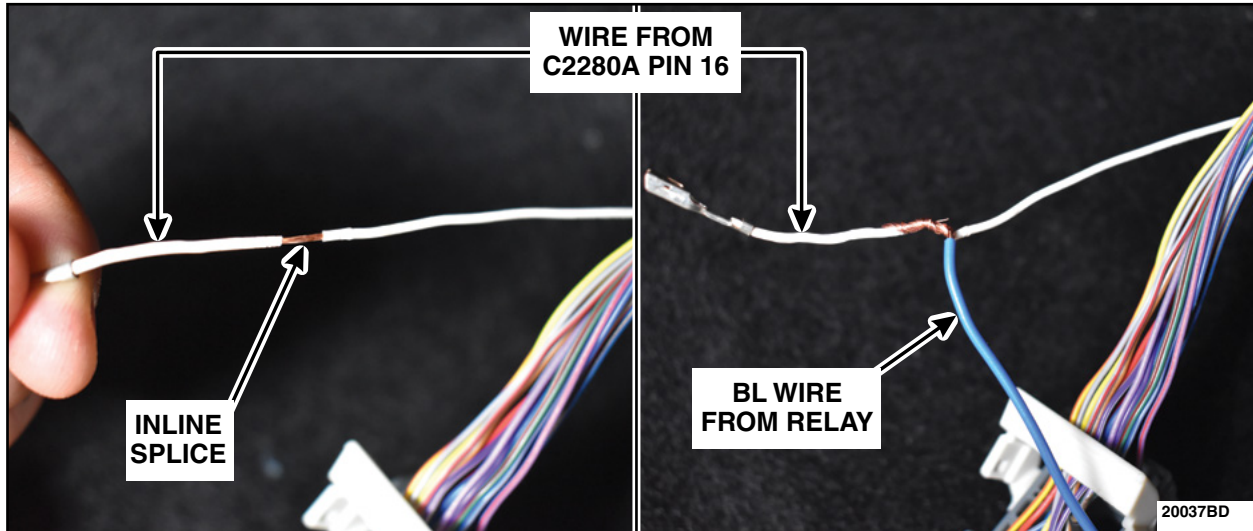
FIGURE 28

46. Remove and discard the terminal on the Blue (BL) wire from the relay. On the wire removed from C2280A pin 16, create an inline splice and wrap the BL wire around the inline splice. See Figure 28.

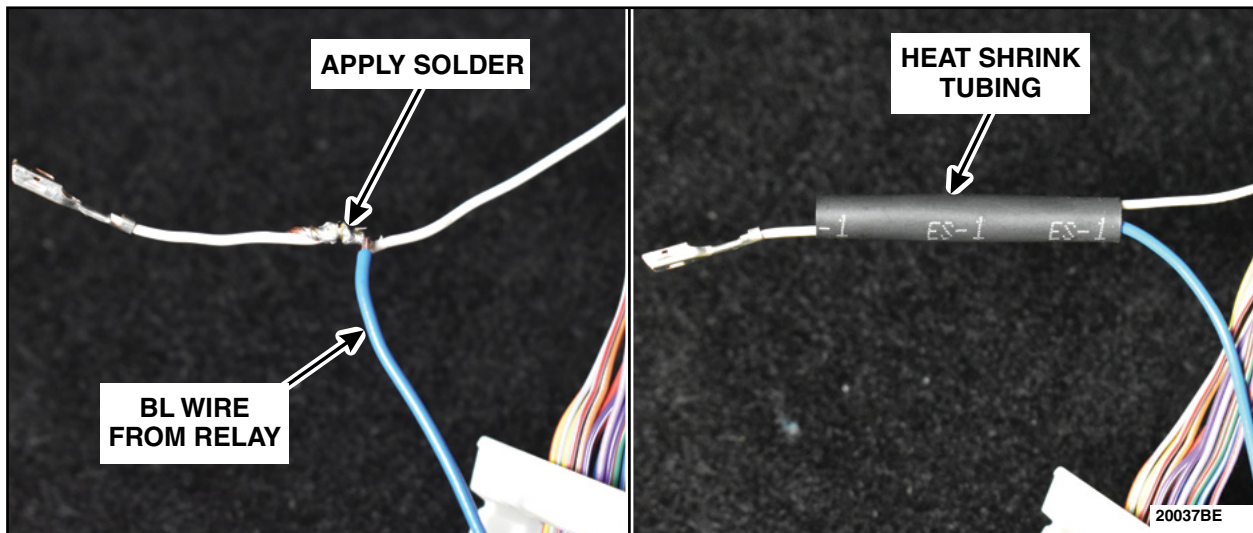
FIGURE 29

47. Solder the BL wire from the relay to the inline splice. Install heat shrink tubing over the inline splice. See Figure 29.

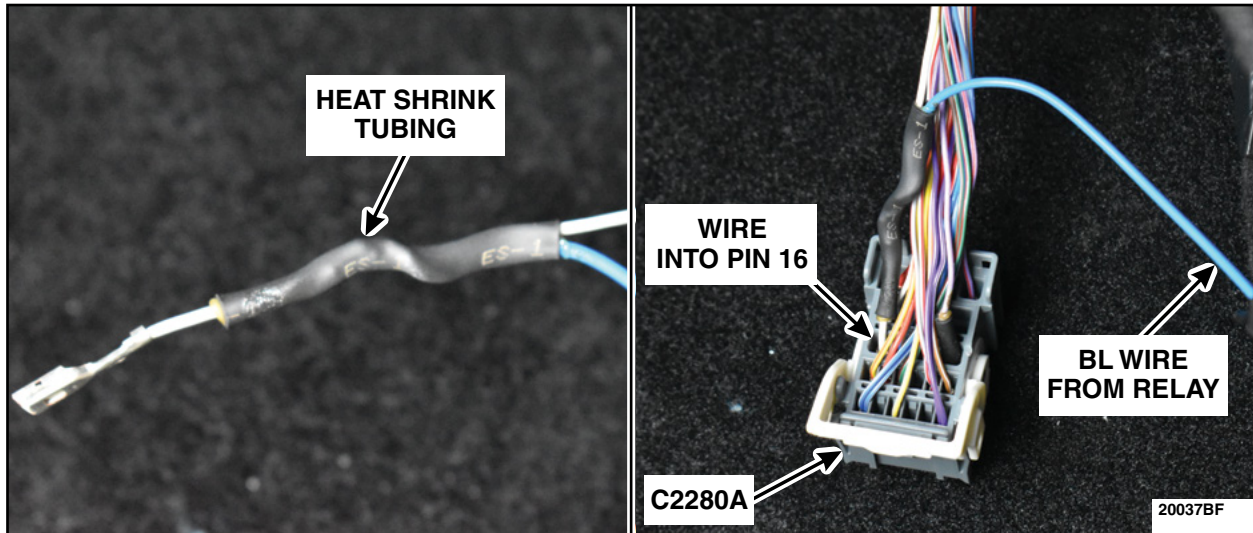
FIGURE 30

48. Apply heat to the heat shrink tubing to seal the inline splice. Reinstall the wire into pin 16 of C2280A. See Figure 30. Proceed to Step 50.
