**SUBJECT:** **Customer Satisfaction Program 21M06 - Supplement #1**  
 Certain 2015-2020 Model Year F-150 Vehicles Equipped with a Power Release Tailgate - Unintended Tailgate Opening

**New! REASON FOR THIS SUPPLEMENT**

*Parts ordering information and full repair instructions are now available to support completion of this customer satisfaction program.*

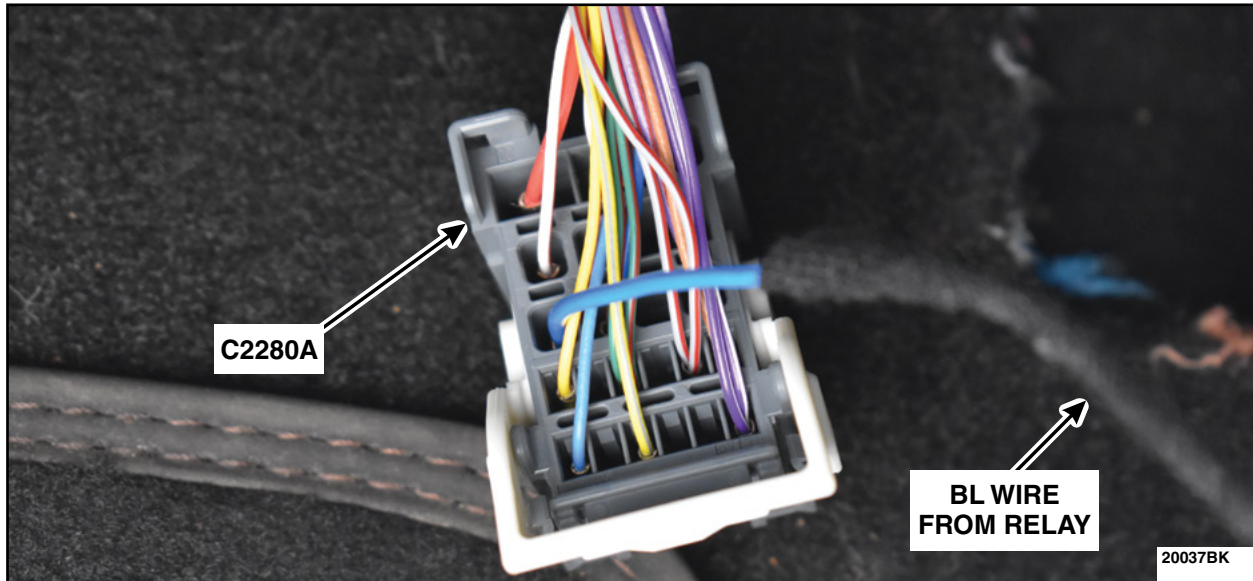
FIGURE 31

49. Install the BL wire from the relay into the open pin 16 of C2280A. See Figure 31.

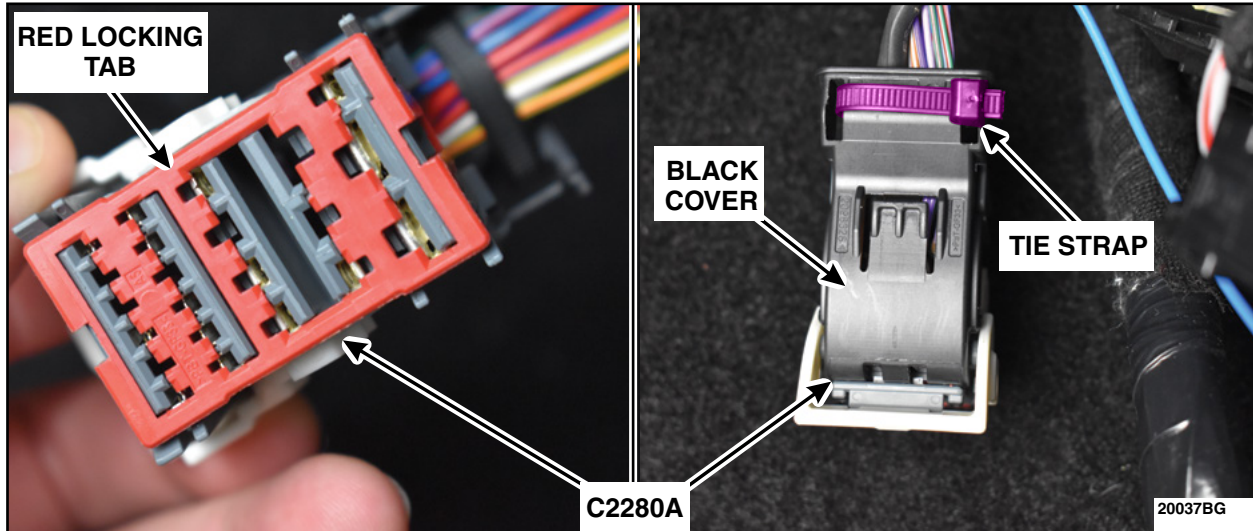
FIGURE 32

50. Reinstall the red locking tab and the black cover. Secure using a tie strap. See Figure 32. Reconnect C2280A to the BCM.

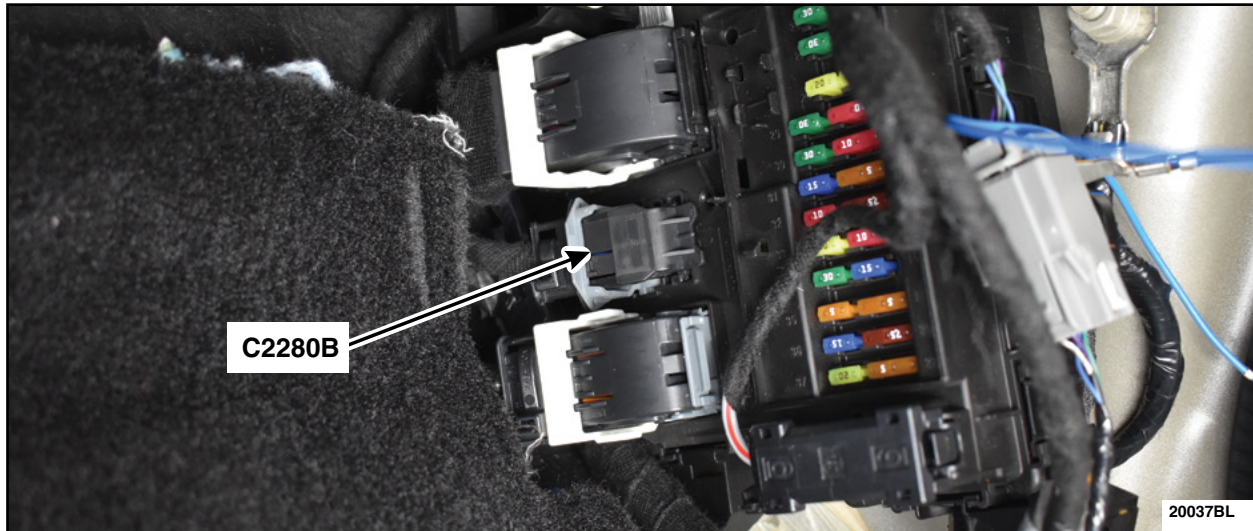
FIGURE 33

51. Disconnect C2280B. See Figure 33.

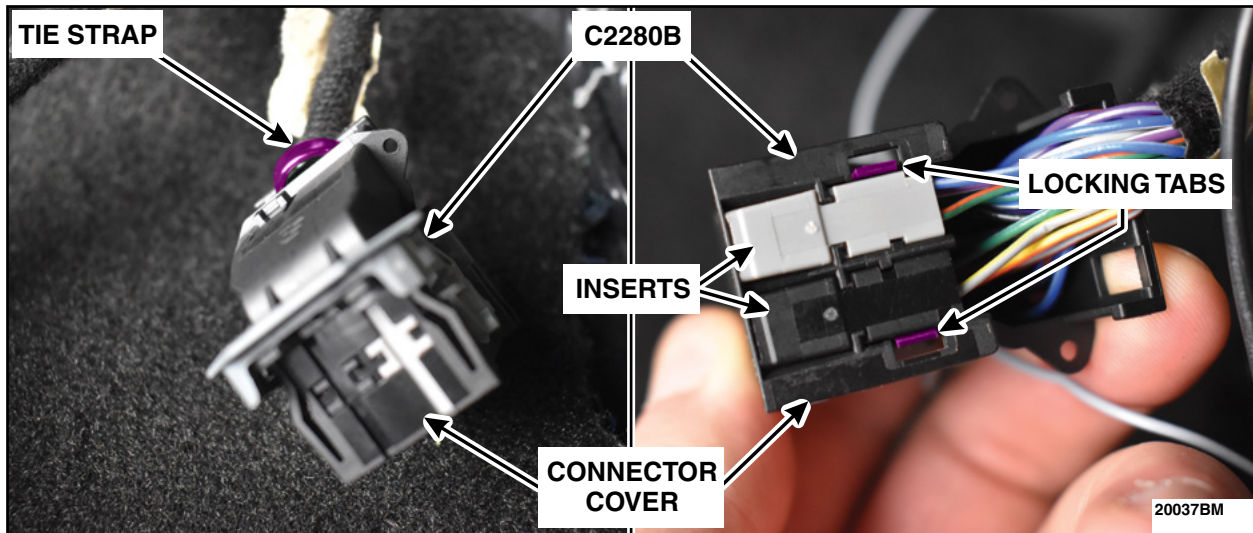
**FIGURE 34**

52. Remove the tie strap, release the locking tabs and remove the inserts from the connector cover.  
See Figure 34.

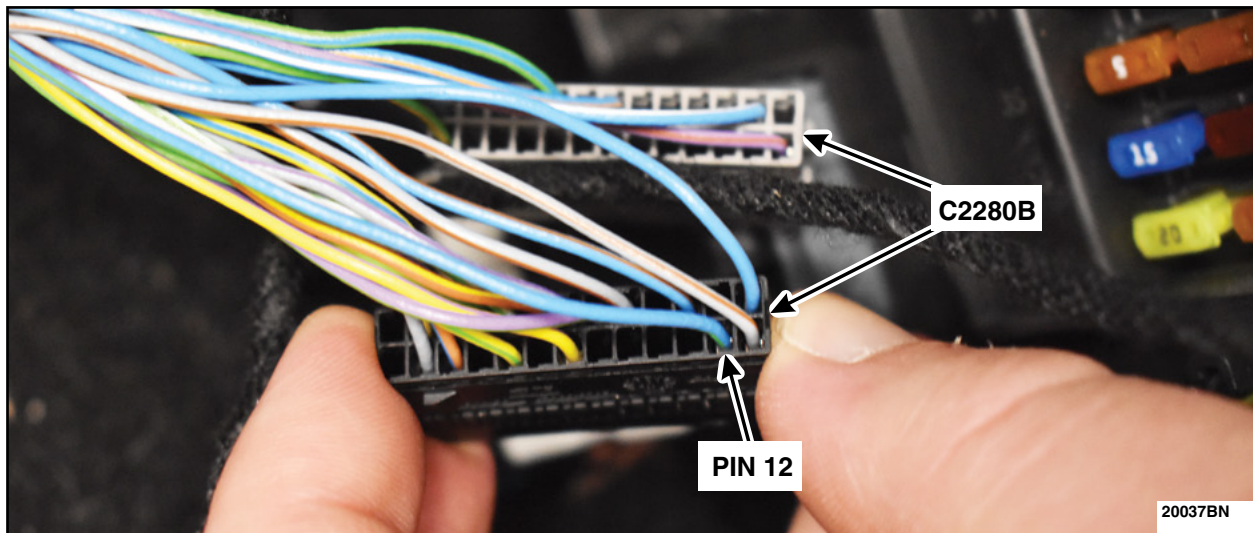
**FIGURE 35**

53. Is pin 12 of C2280B open or occupied with an existing wire? See Figure 35.

If OPEN - Insert the Green (GN) wire from the relay into pin 12, then proceed to Step 58.  
If OCCUPIED - Proceed to Step 54.

**NOTE:** Pin 12 occupied shown.

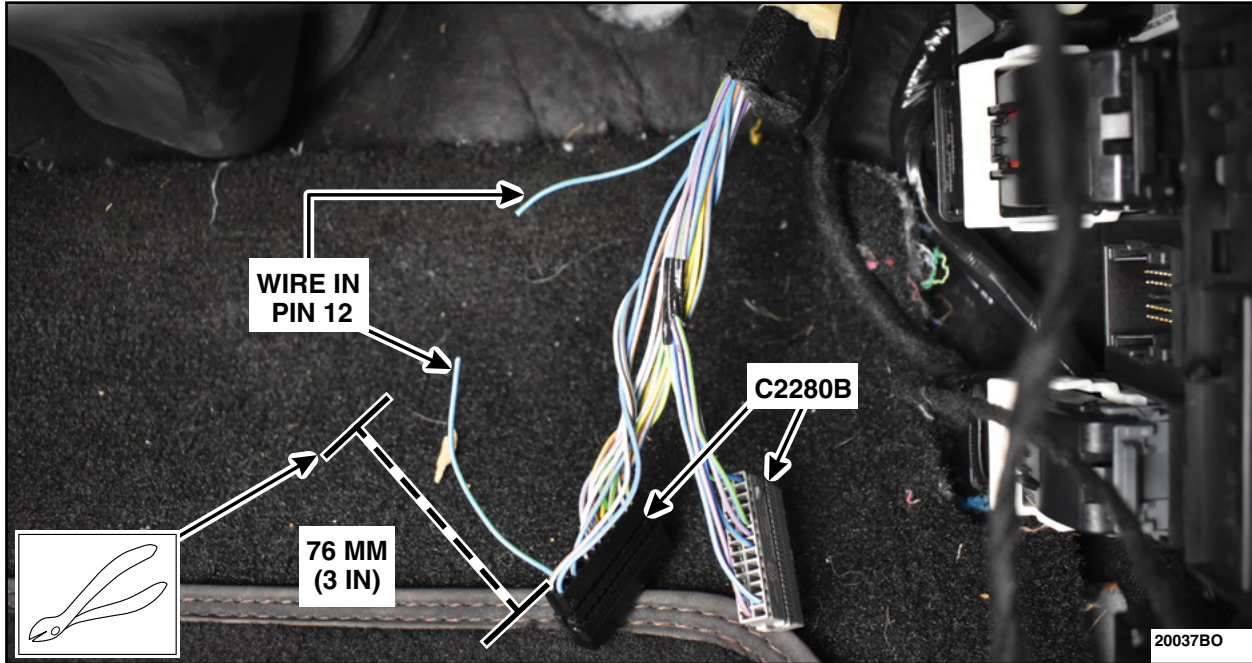
FIGURE 36

54. Measure and cut the pin 12 wire 76 mm (3 in) from the back of the black C2280B. See Figure 36.

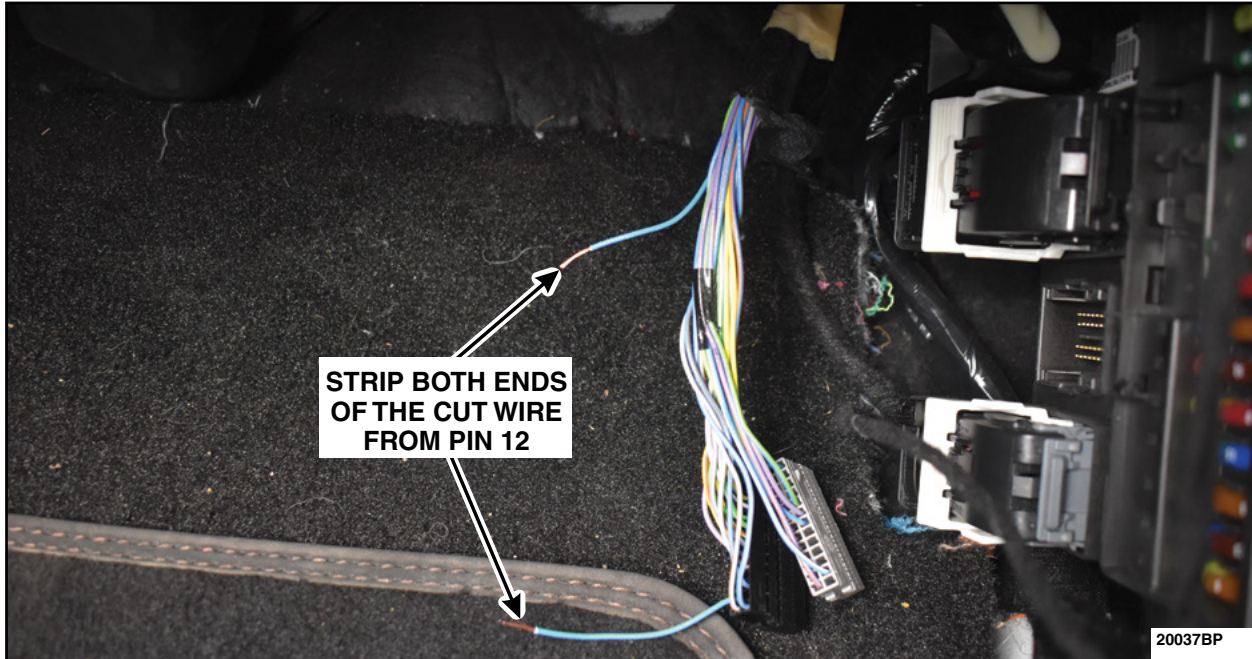
FIGURE 37

55. Strip both ends of the cut wire from pin 12. See Figure 37.

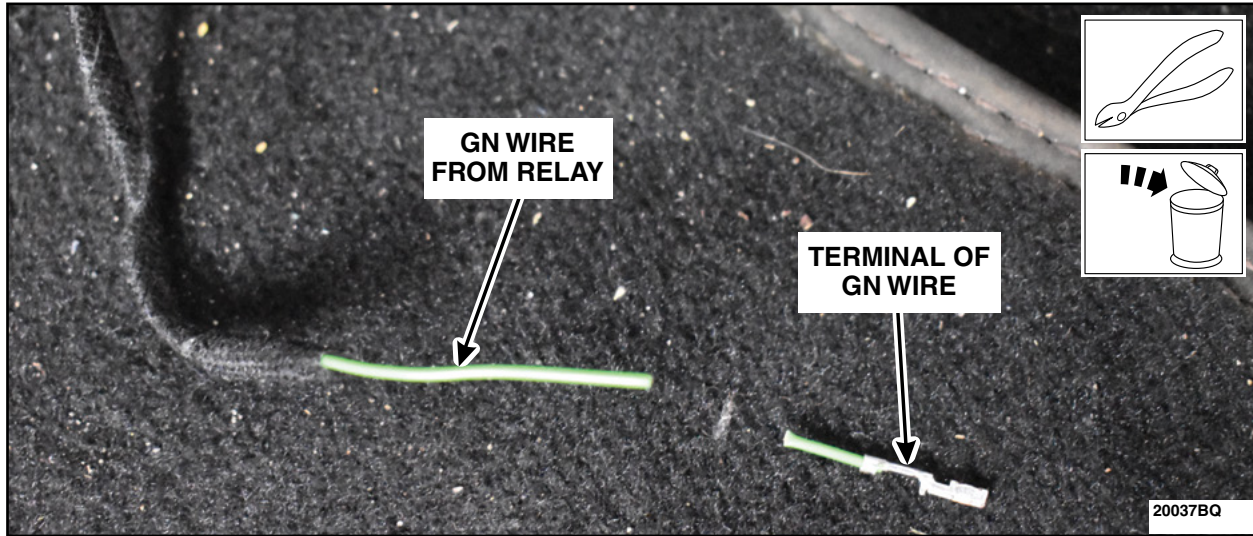
FIGURE 38

56. Cut off and discard the terminal of the Green (GN) wire from the relay. See Figure 38.

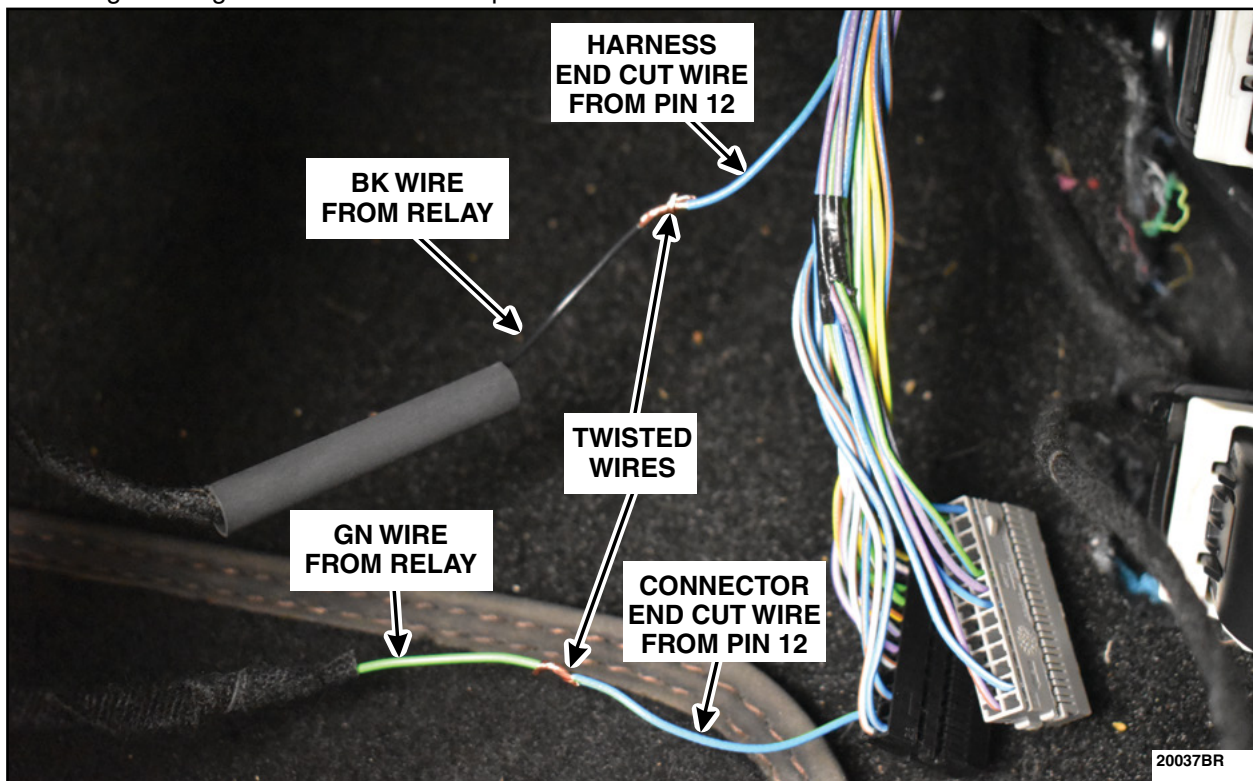
FIGURE 39

57. Apply heat shrink tubing to the BK and GN wires from the relay. Twist the BK wire from the relay to the harness end of the cut wire from pin 12. Twist the BK wire from the relay to the connector end of the cut wire from pin 12. Solder the twisted wires and seal the solder connection with the heat shrink tubing. See Figure 39. Proceed to Step 59.

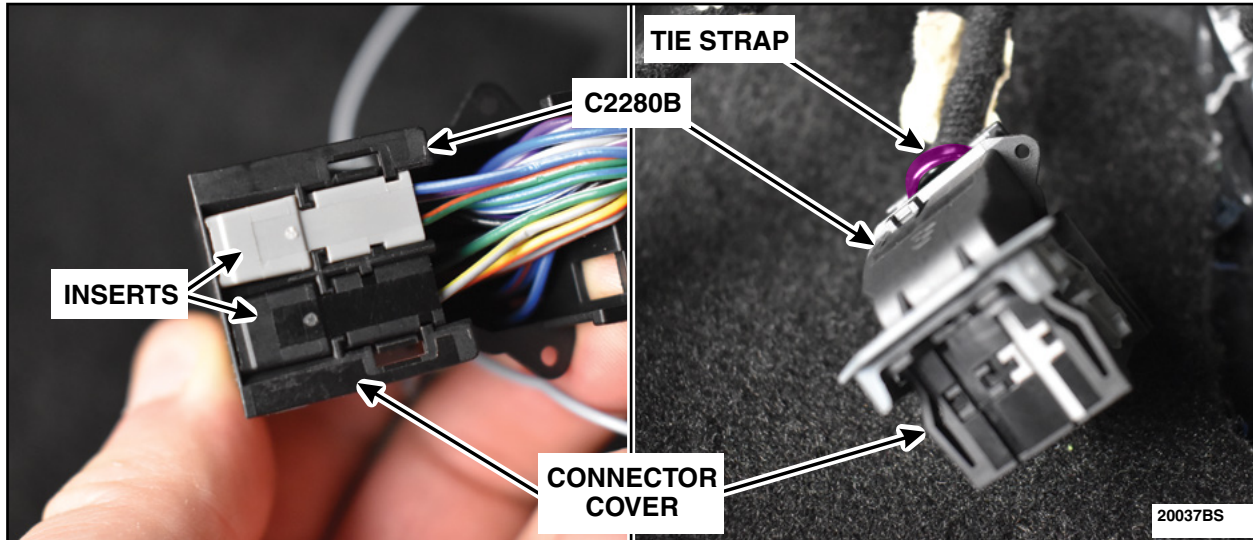
FIGURE 40

58. Locate the Black (BK) wire from the relay. Apply heat shrink tubing and seal the end of the BK wire. Wrap the wire up and secure it to the relay using electrical tape.
59. Reinstall the inserts into the connector cover. Secure using a new tie strap and trim any excess. See Figure 40. Reconnect C2280B to the BCM.

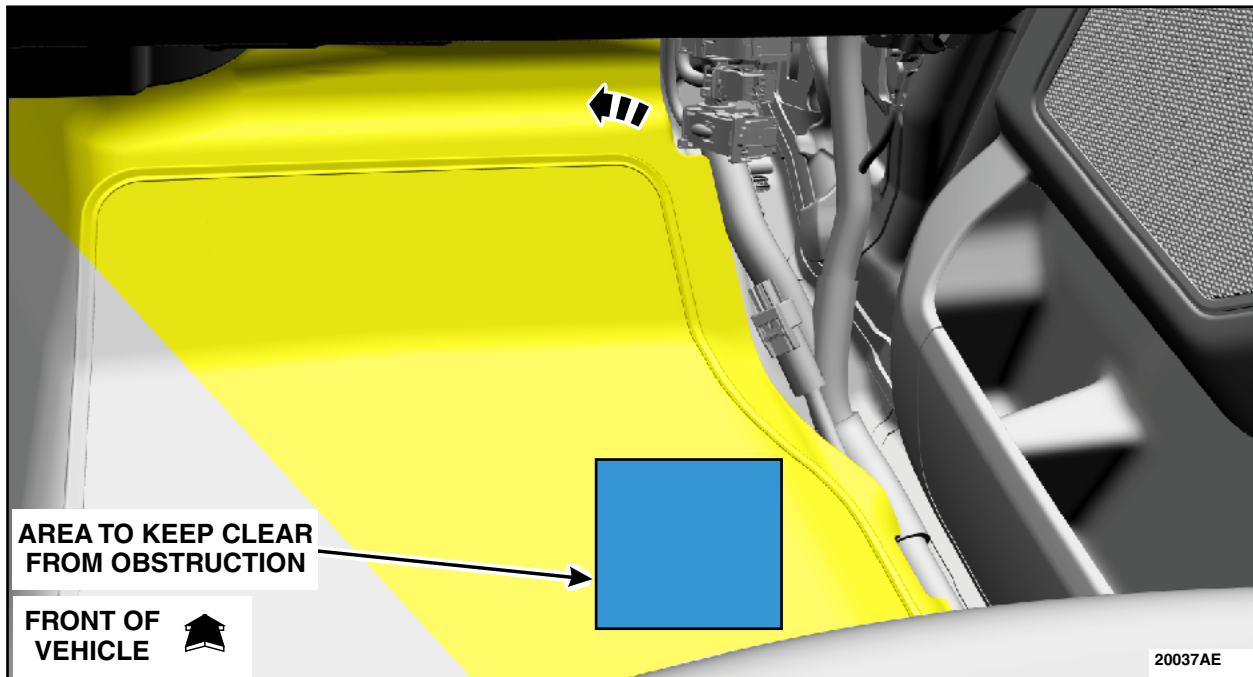
FIGURE 41

60. Position aside the RH front carpet to expose the floorboard. Use a block of wood or similar device to retain the carpet away from the area to be clear of obstruction. See Figure 41.

**CAUTION:** The area highlighted below should be kept clear from obstruction to avoid any damage to carpeting and/or wiring.

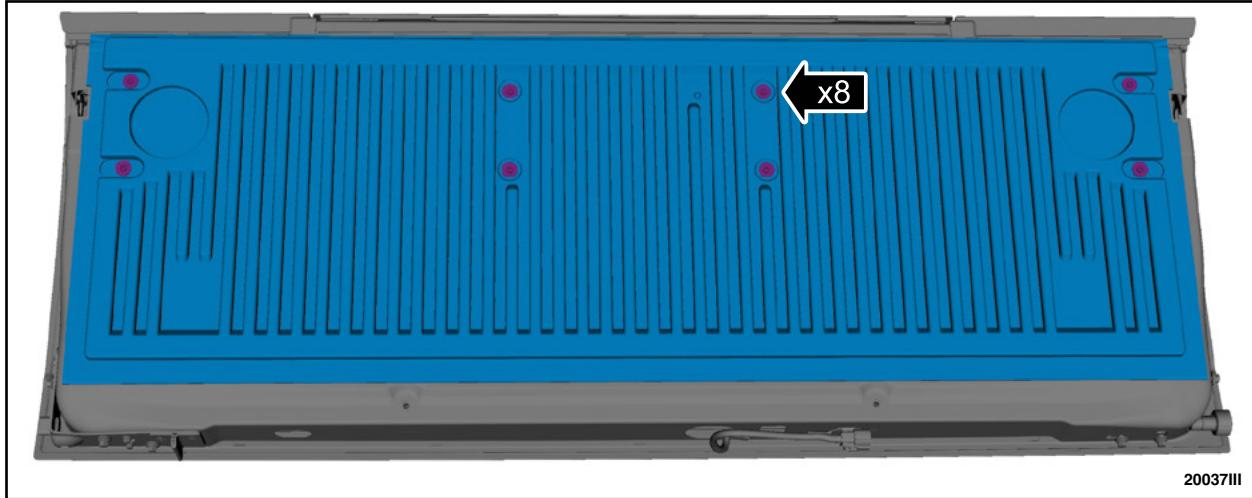
FIGURE 42

61. If equipped, remove the bedliner tailgate cover. See Figure 42.

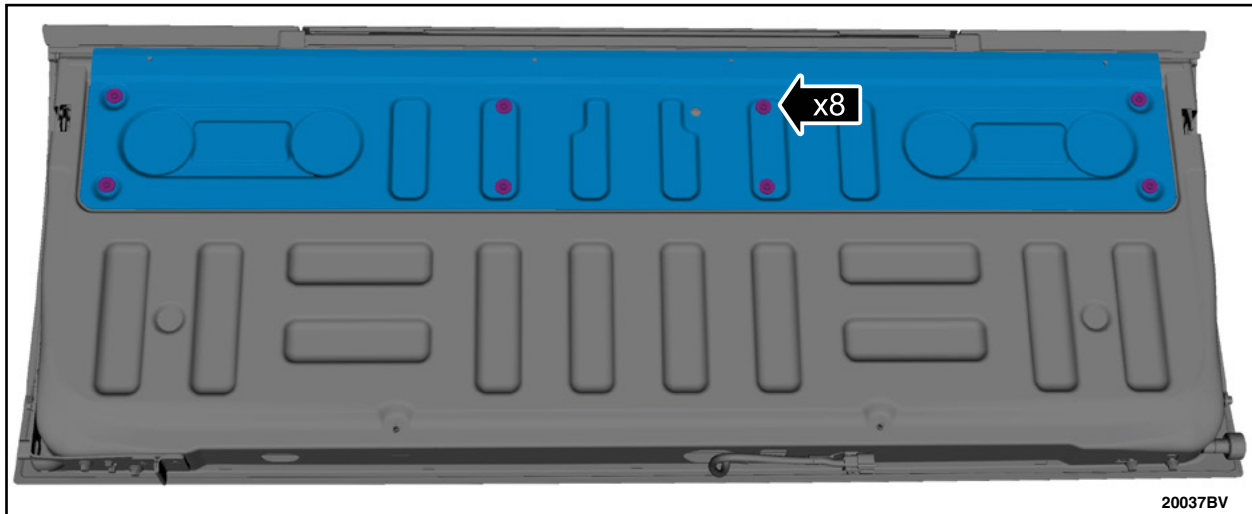
FIGURE 43

62. If equipped, remove the tailgate access panel bolts and the tailgate access panel. See Figure 43.

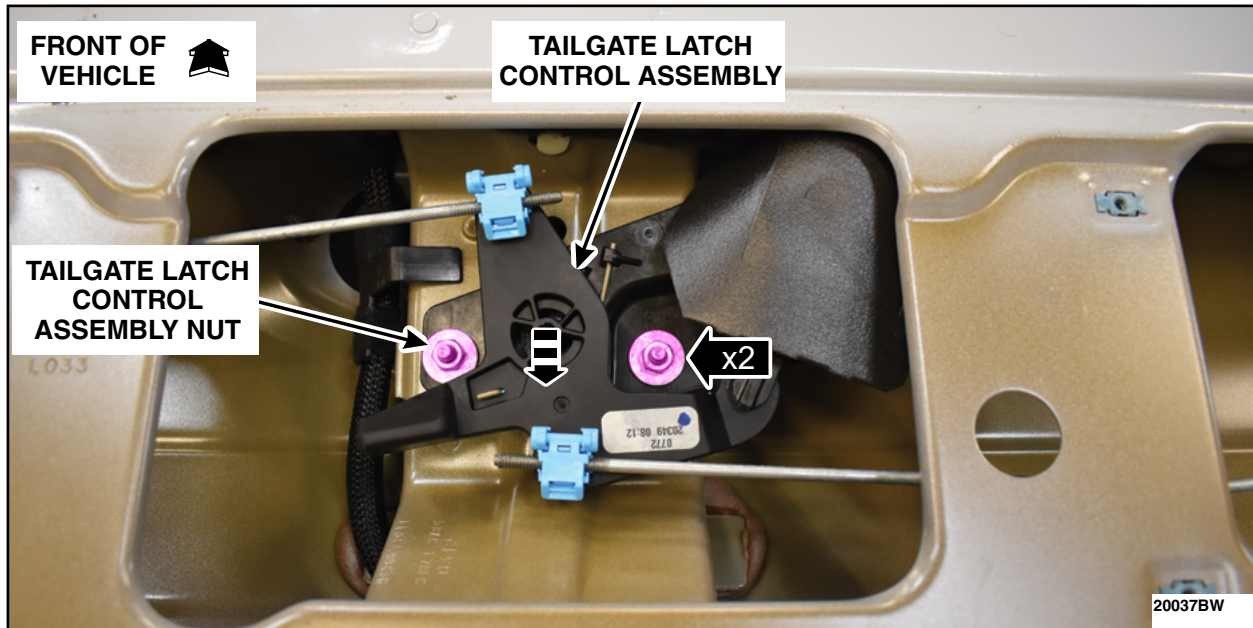
FIGURE 44

63. Remove the tailgate latch control assembly nuts and position the tailgate latch control assembly towards the rear of the vehicle. See Figure 44.

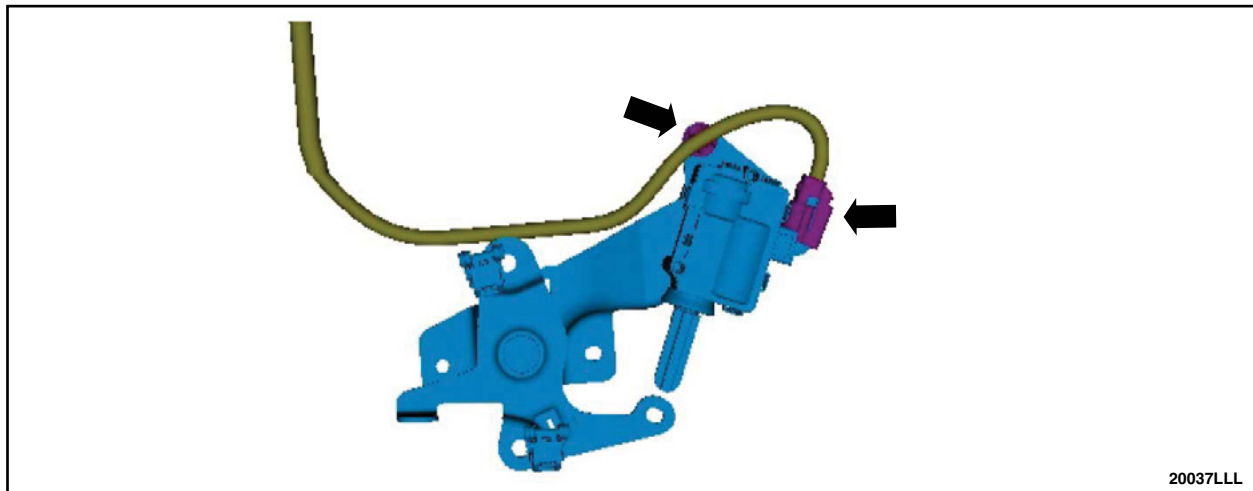
FIGURE 45

64. Disconnect the electrical connector and the push pin retainer. See Figure 45.

**NOTE:** Tailgate latch control assembly shown outside of the vehicle for clarity.

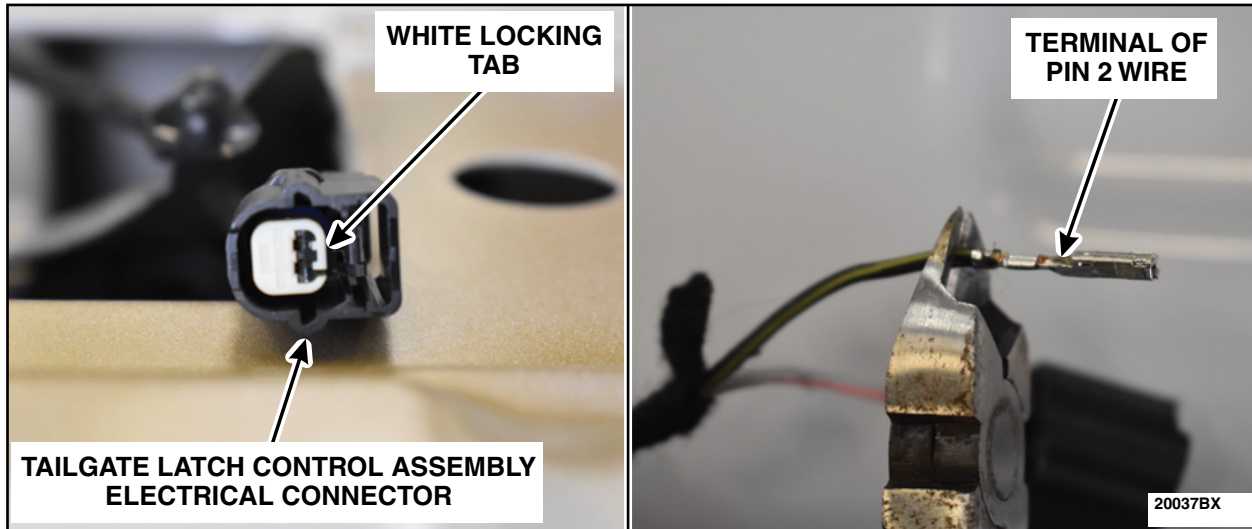
**FIGURE 46**

65. Remove the white locking tab and the pin 2 wire from the tailgate latch control assembly connector. Cut off the terminal of the pin 2 wire. See Figure 46.

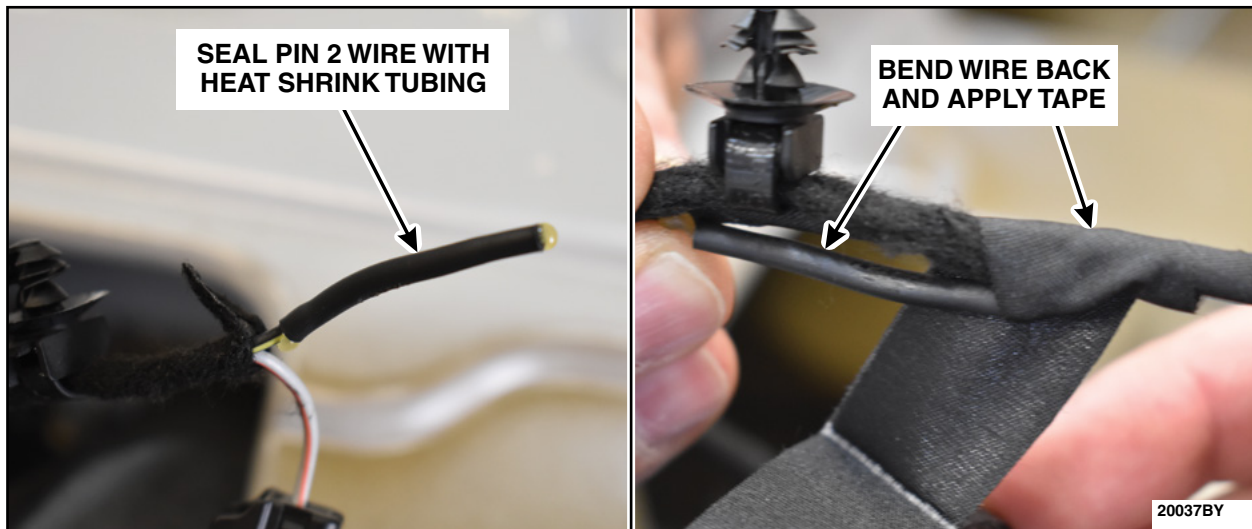
**FIGURE 47**

66. Seal the pin 2 wire using heat shrink tubing. Bend back the sealed wire and secure using Coroplast® 837 or Equivalent Electrical Wire Harness Tape. See Figure 47.

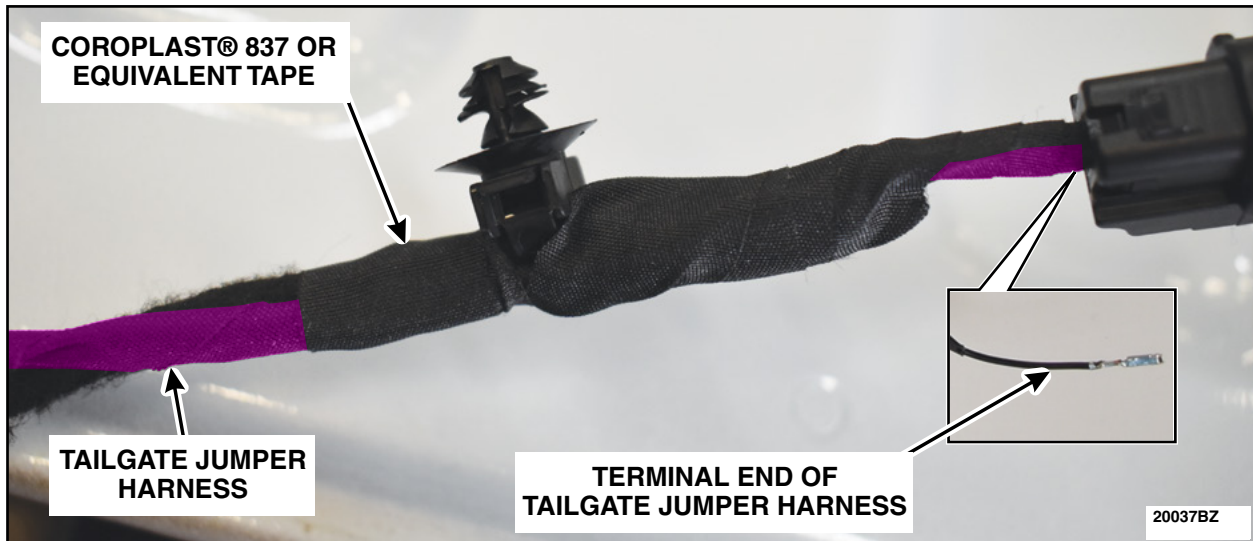
FIGURE 48

67. Install the terminal end of the Tailgate Jumper Harness into the open pin in the tailgate latch control assembly electrical connector. Secure using Coroplast® 837 or Equivalent Electrical Wire Harness Tape. Reinstall the white locking tab. See Figure 48.

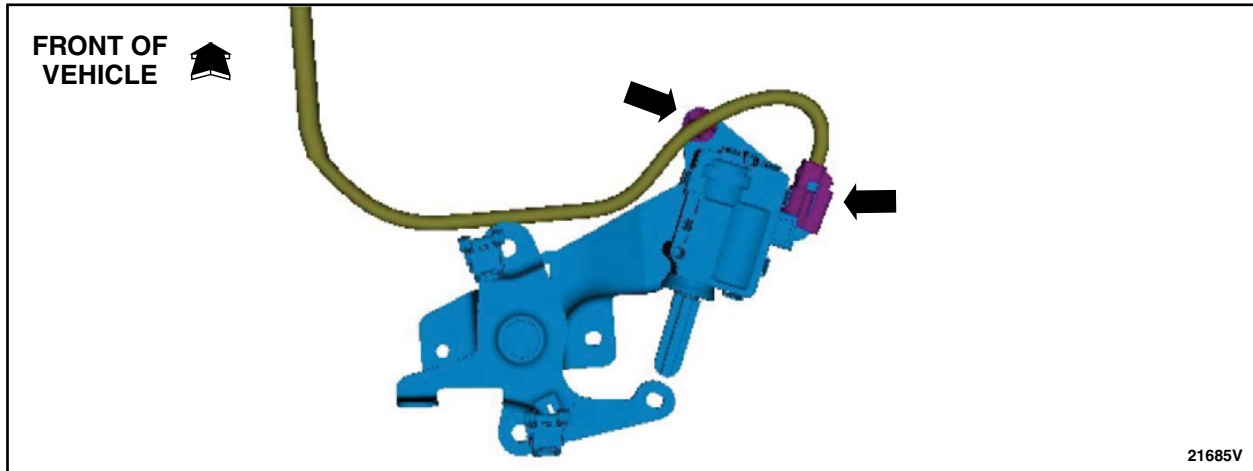
FIGURE 49

68. Reconnect the electrical connector and the push pin retainer. See Figure 49.

**NOTE:** Tailgate latch control assembly shown outside of the vehicle for clarity.

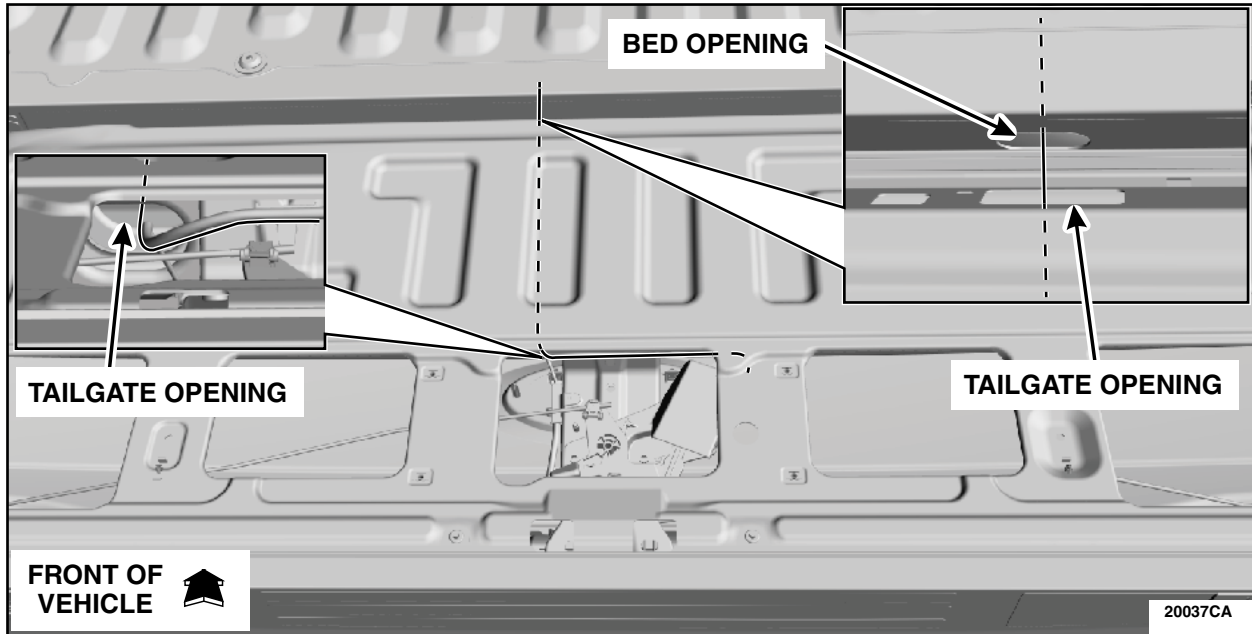
FIGURE 50

69. Using a straightened coat hanger, tape the end of the Tailgate Jumper Harness Wire without a terminal to one end of the coat hanger. Route the wire and coat hanger on the Left Hand (LH) side of the tailgate latch control assembly and through the opening in the center bottom of the tailgate. Continue to pass through the opening in the bed and down through the bottom of the vehicle. See Figure 50.

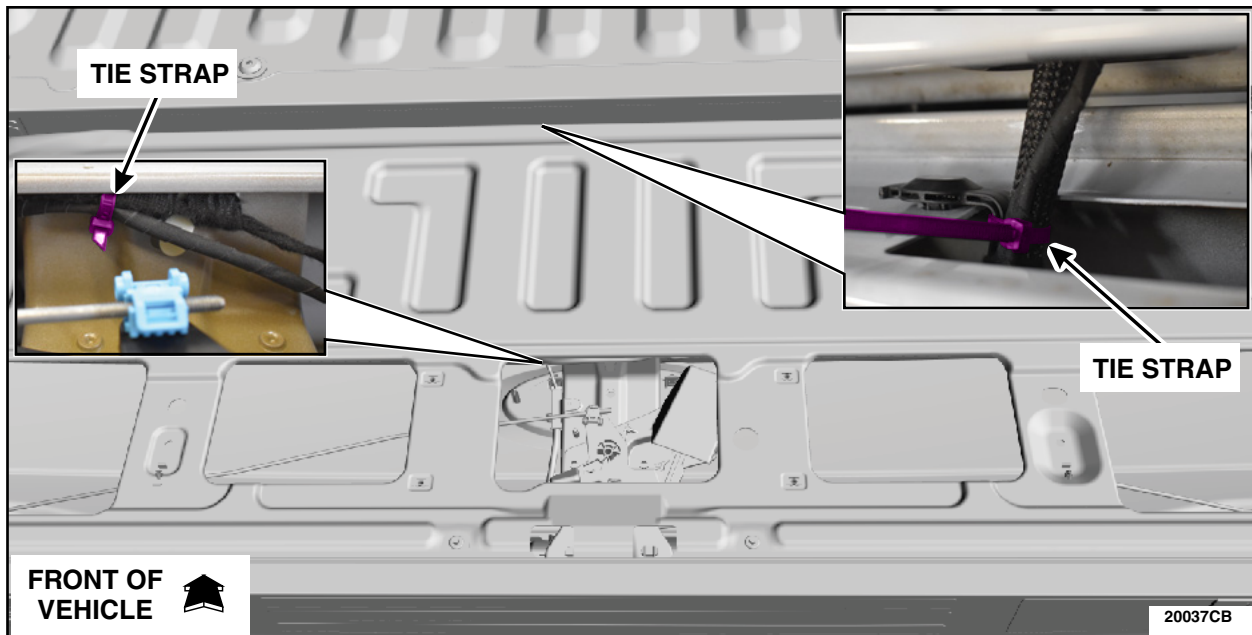
FIGURE 51

70. Secure the Tailgate Jumper Harness using tie straps and trim any excess length of tie strap. See Figure 51.

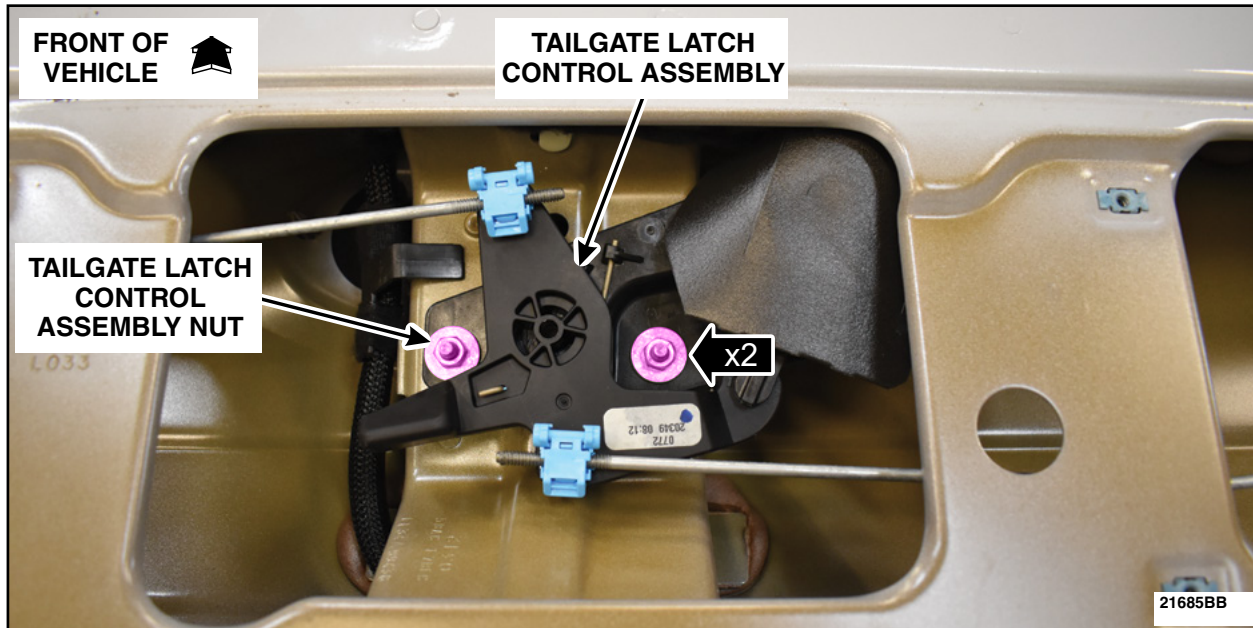
**FIGURE 52**

71. Position back the tailgate latch control assembly and install the nuts. See Figure 52.

- Torque: 80 lb.in (9 Nm)

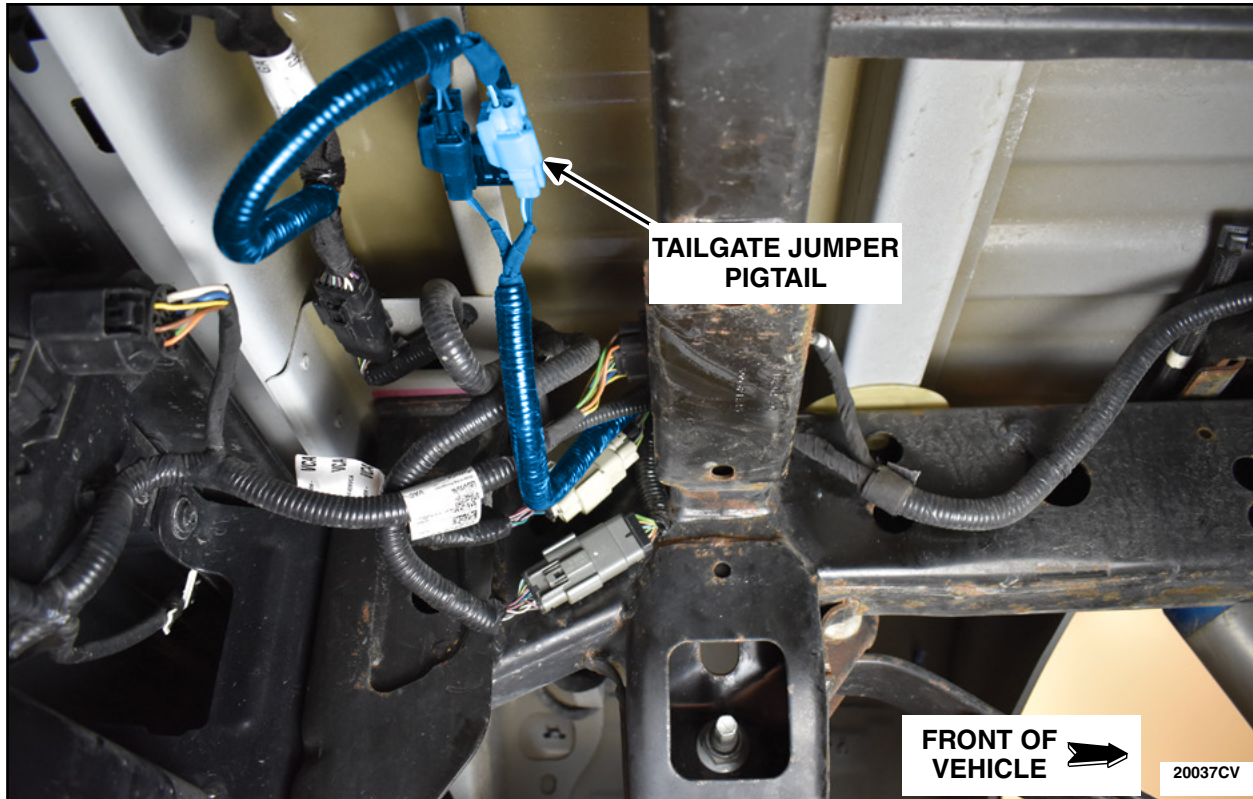
FIGURE 53

75. Inspect underneath the rear of the vehicle, on the bed support, and determine if a Tailgate Jumper Pigtail is present. See Figure 53.

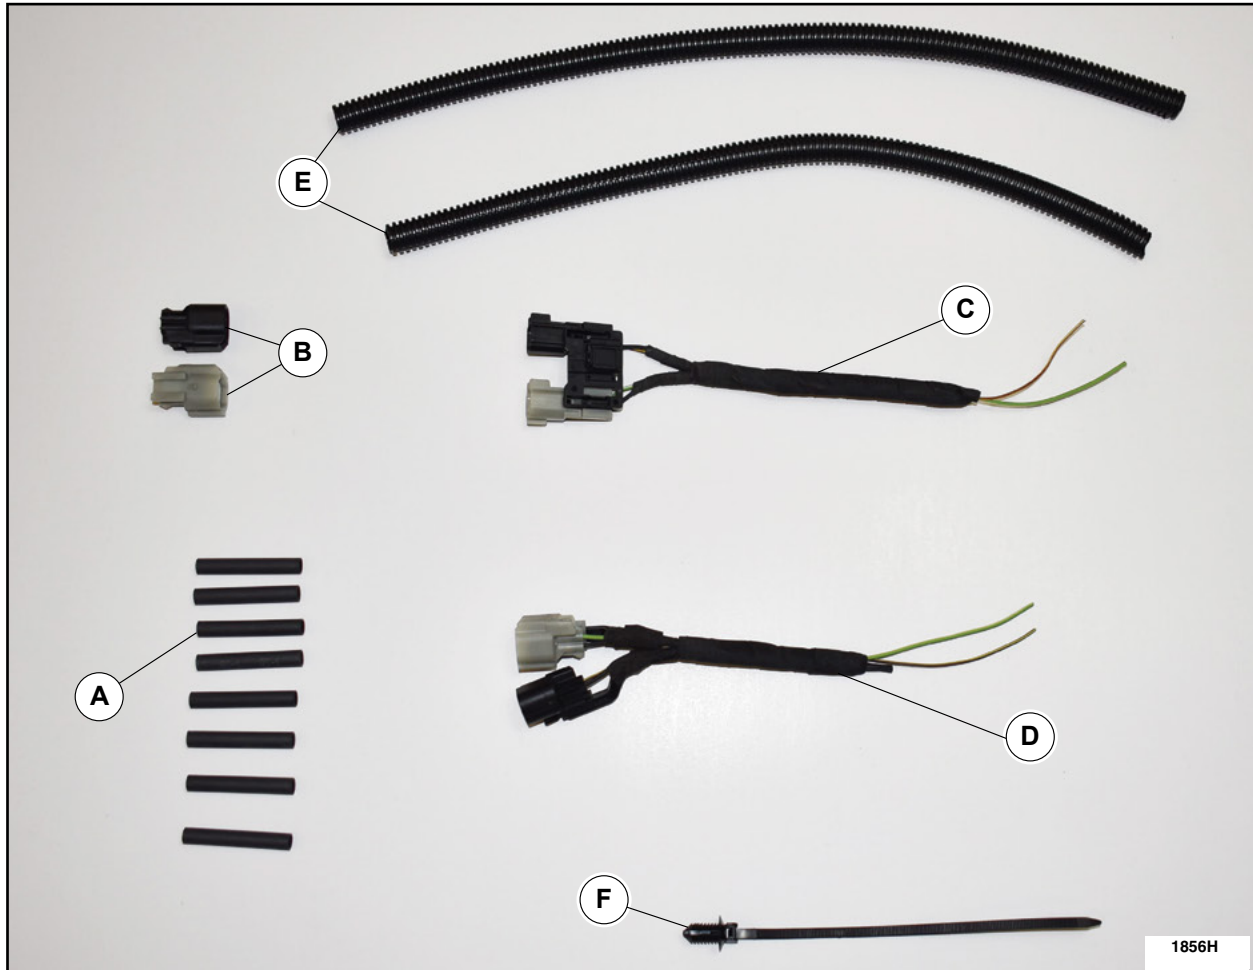
FIGURE 54

Complete Tailgate Jumper Pigtail Part Kit

ITEM	DESCRIPTION	QUANTITY
A	Dual Wall Heat Shrink Tubing	8
B	Delete Caps	2
C	Male end of <i>New Jumper Pigtail</i>	1
D	Female end of <i>New Jumper Pigtail</i>	1
E	Convolute	2
F	Push Pin Tie Strap	1

**NOTE:** The parts being installed in this procedure are not labeled. Refer to Figure 54 for component identification.

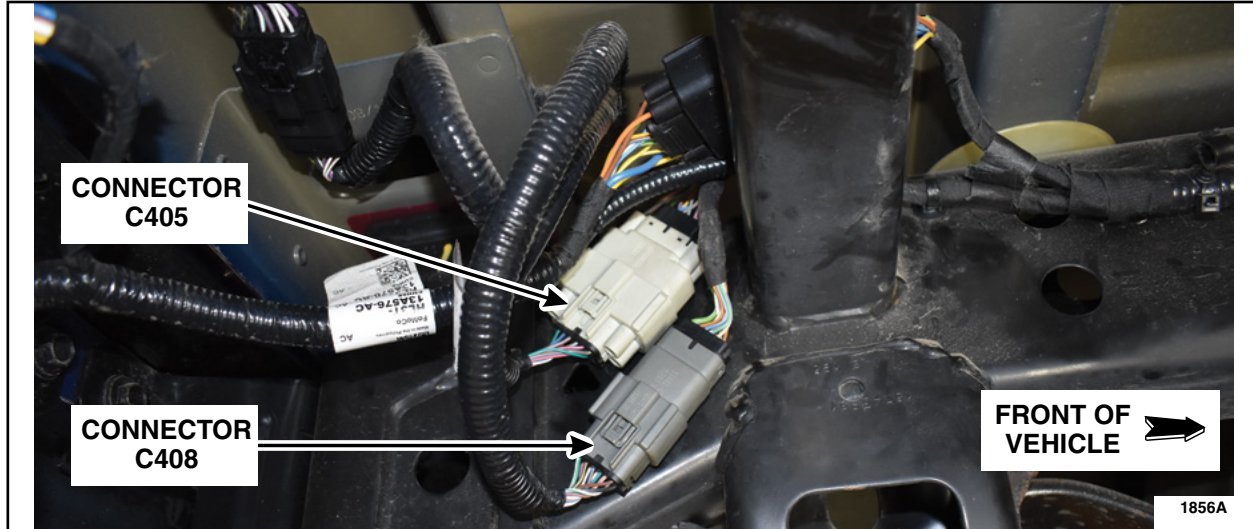
**FIGURE 55**

1. Disconnect inline connector C408 and C405 located on the left hand (LH) side of the frame at the rear of the vehicle. See Figure 55.

**NOTE:** If a service pigtail was installed it is possible that the wire colors will not match the figures below.

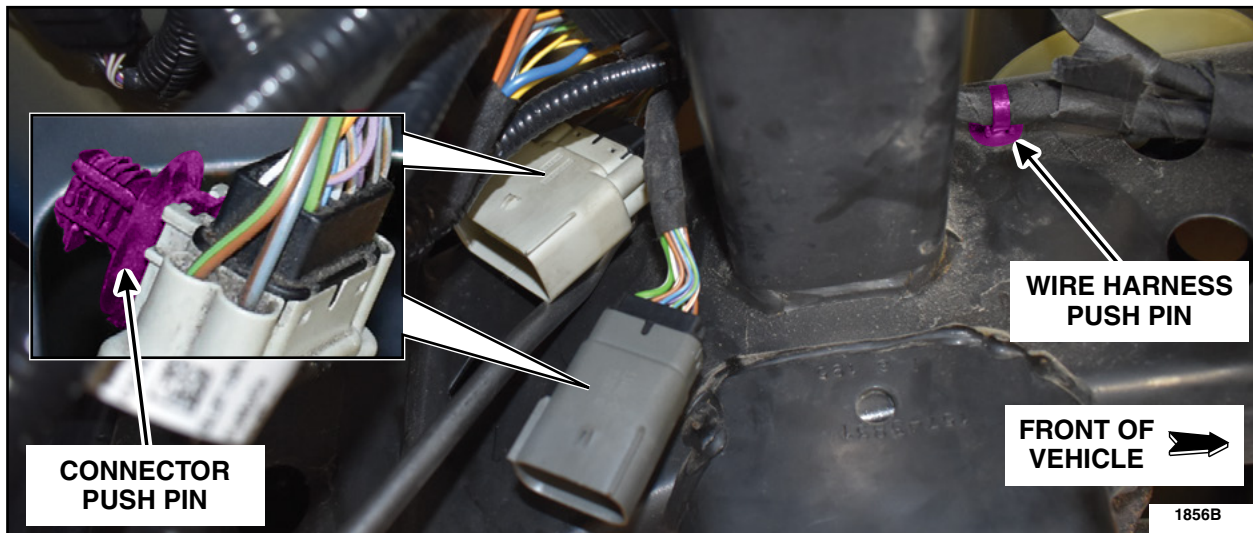
**FIGURE 56**

2. Blow dry both halves of C408 with compressed air.
3. Detach the two connectors and the wire harness push pin retainers. See Figure 56.

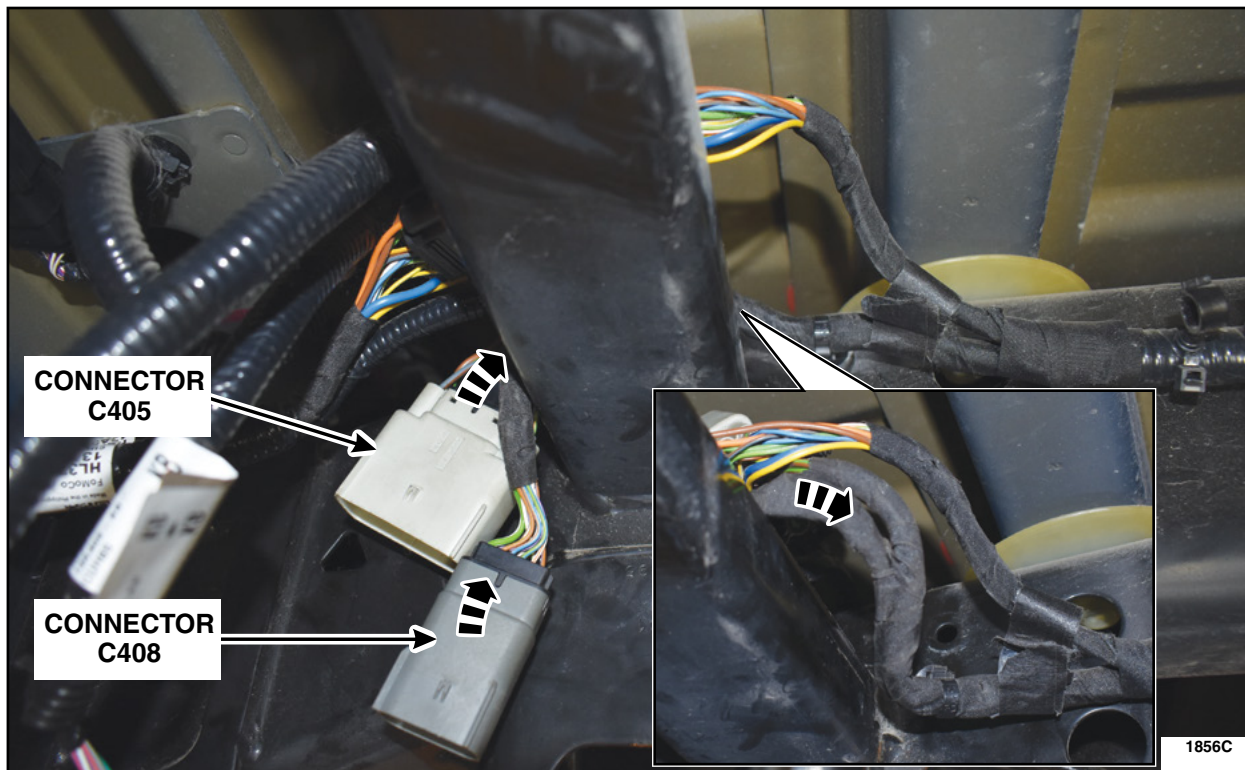
FIGURE 57

4. Route the C405 and C408 halves up over the frame and under the attached wire harness to allow for more slack. See Figure 57.

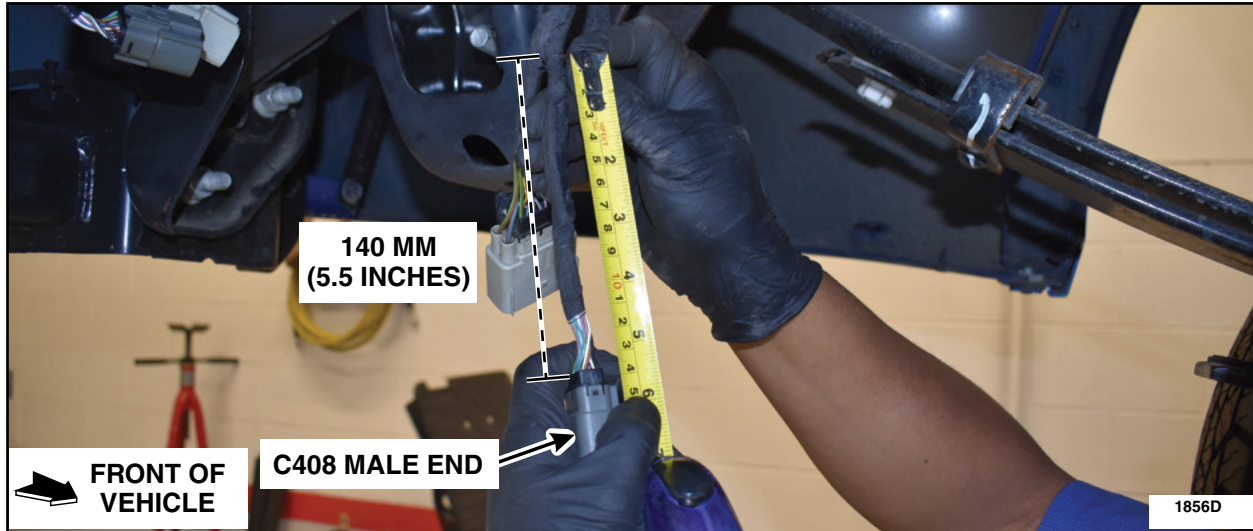
FIGURE 58

5. Measure 140 mm (5.5 in) from the back of the male end of C408. Remove 140 mm (5.5 in) of tape to expose the wires. See Figure 58.

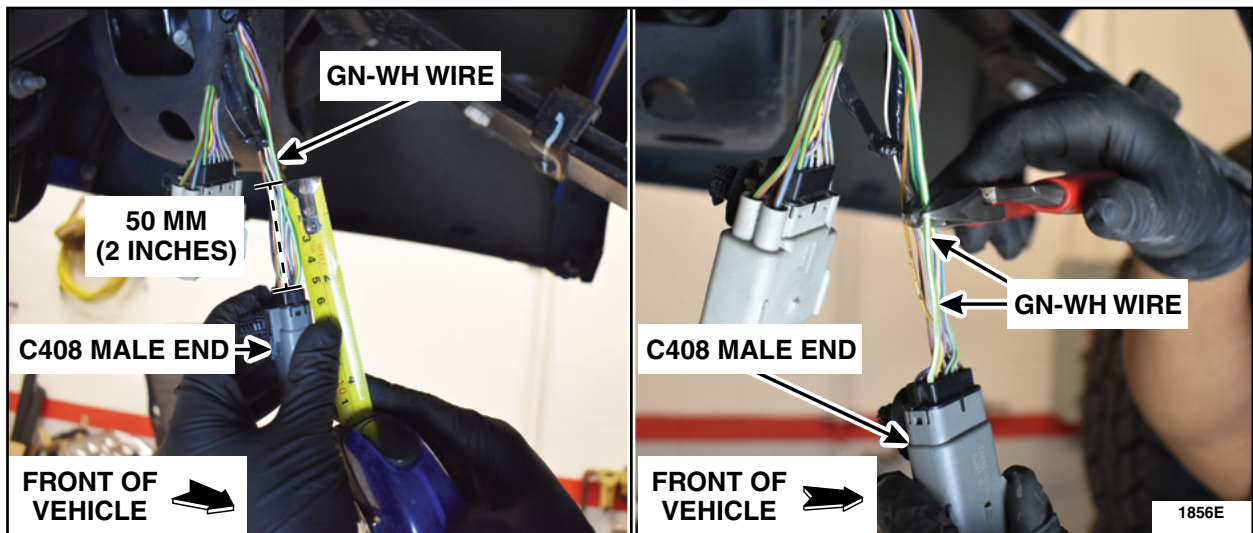
FIGURE 59

6. Measure 50 mm (2 in) from the back side of the male end of C408 and cut the Green-White (GN-WH) wire (cavity 1) at the 50 mm (2 in) measurement. See Figure 59.
