**SUBJECT:** **Customer Satisfaction Program 21M06 - Supplement #1**  
 Certain 2015-2020 Model Year F-150 Vehicles Equipped with a Power Release Tailgate - Unintended Tailgate Opening

**New! REASON FOR THIS SUPPLEMENT**

*Parts ordering information and full repair instructions are now available to support completion of this customer satisfaction program.*

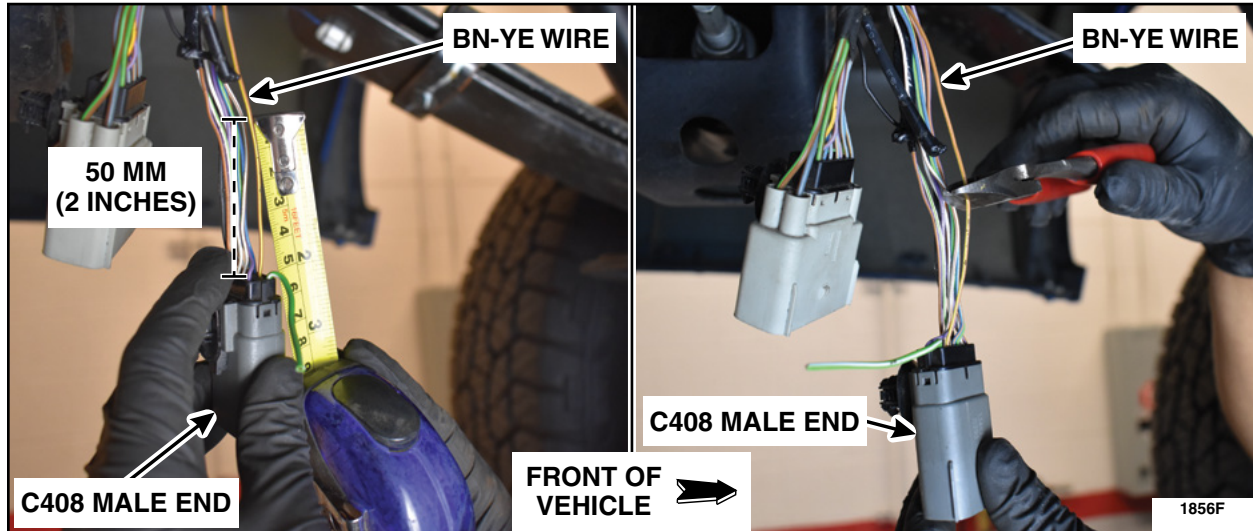
FIGURE 60

7. Measure 50 mm (2 in) from the back side of the male end of C408 and cut the Brown-Yellow (BN-YE) wire (cavity 2) at the 50 mm (2 in) measurement. See Figure 60.

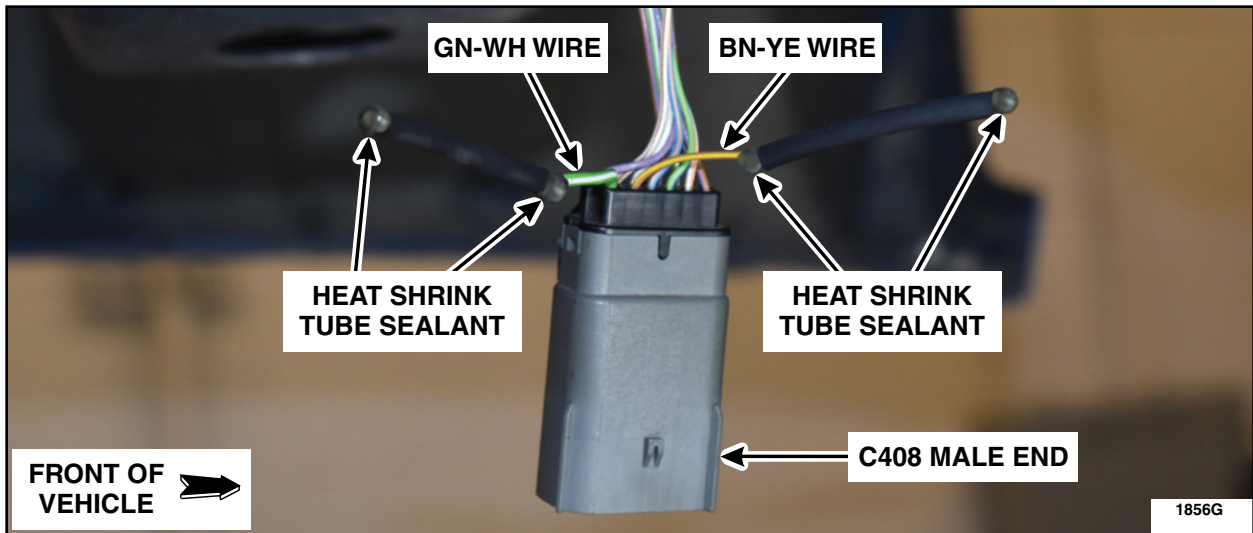
FIGURE 61

8. Install a piece of dual wall heat shrink tube on the GN-WH and BN-YE wires making sure the end of the wire is located in the middle of the tube. Evenly heat up the heat shrink tube until the heat shrink tube sealant bubbles out of both ends. See Figure 61.

**NOTE:** Make sure the heat shrink sealant is bubbled out of both ends or the circuit is not sealed.

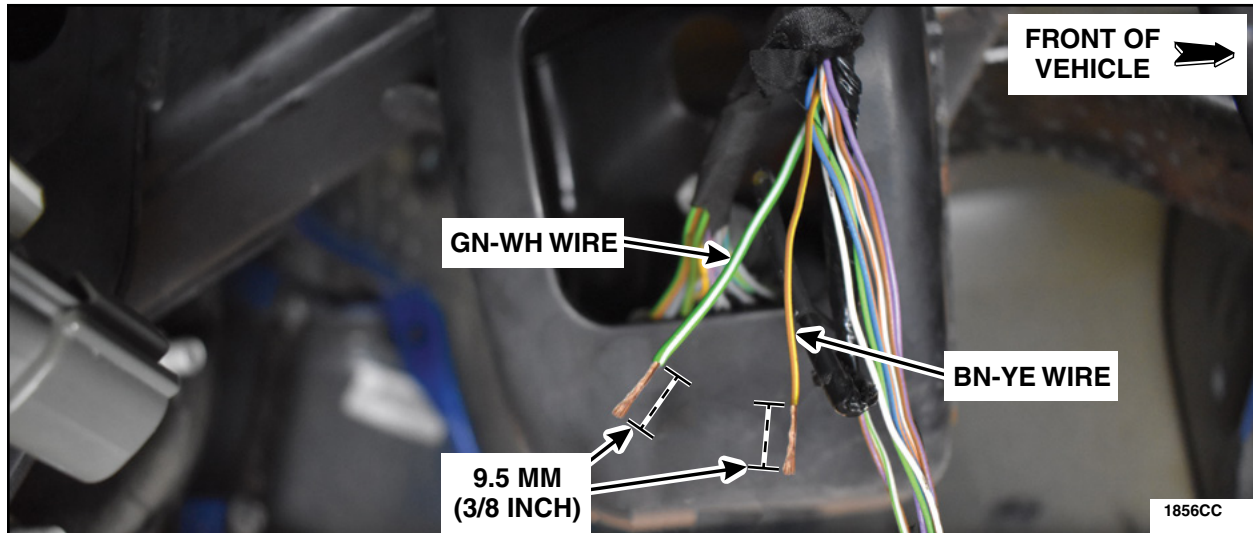
FIGURE 62

9. Strip 9.5 mm (3/8 in) of the GN-WH and BN-YE wire insulation on the male connector harness side.  
See Figure 62.

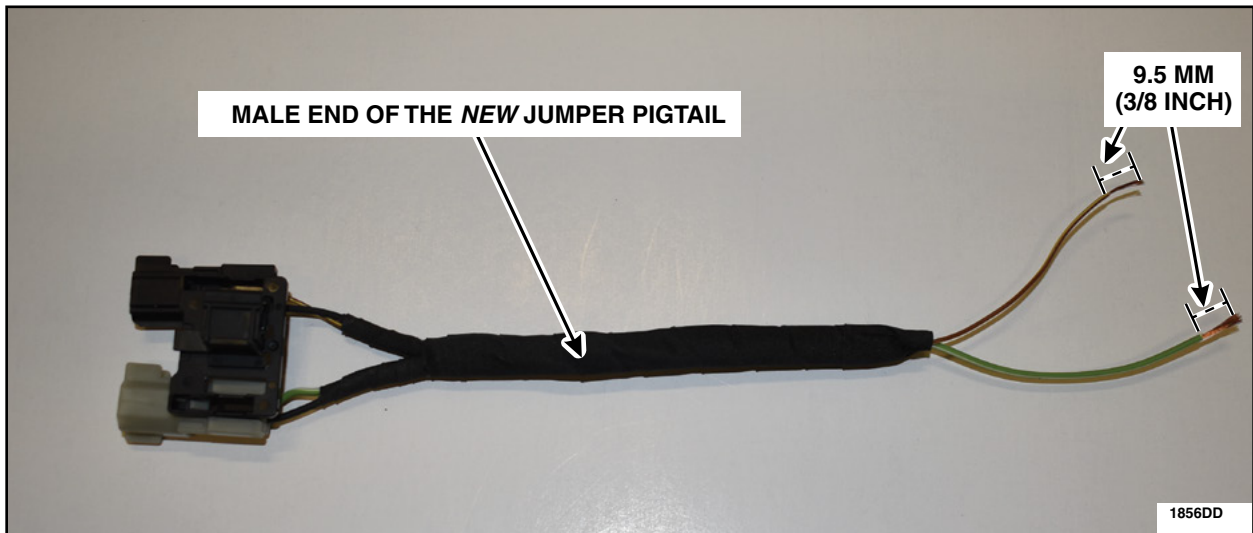
FIGURE 63

10. Strip 9.5 mm (3/8 in) of the wire insulation on the *new* jumper harness male connector end.  
See Figure 63.

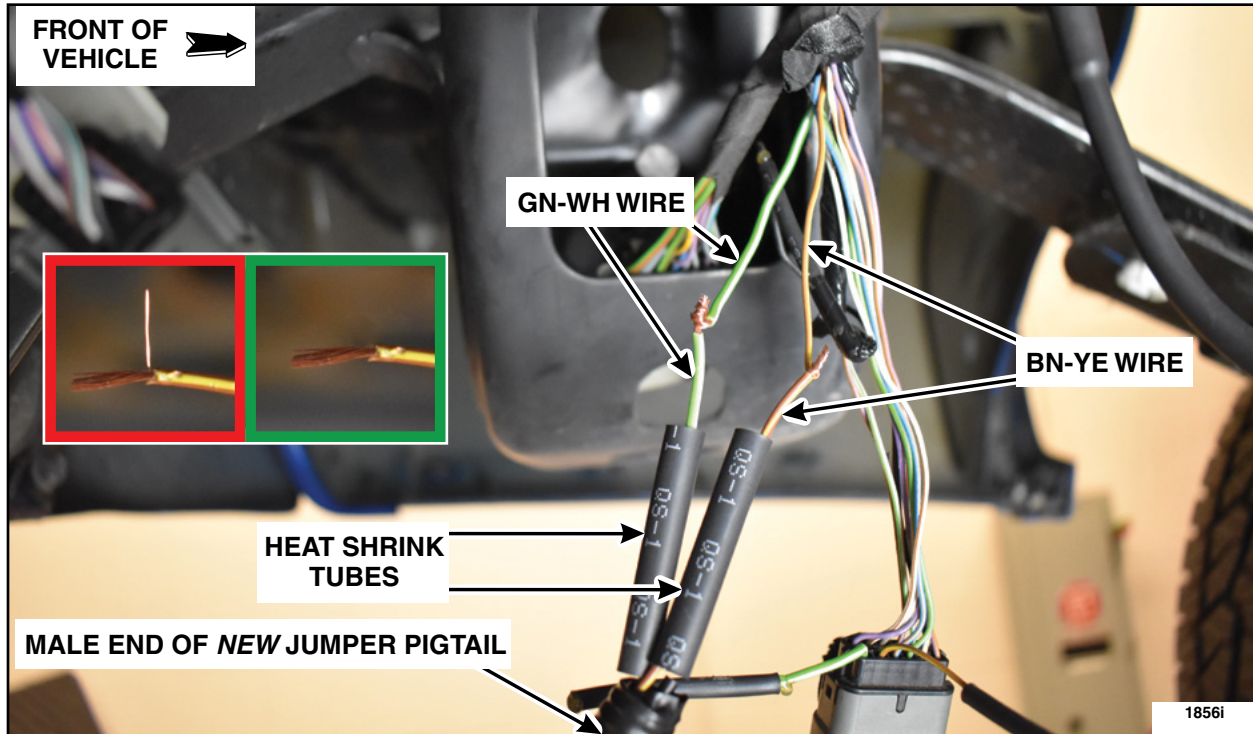
**FIGURE 64**

11. Place a heat shrink tube onto each GN-WH and BN-YE wires. Install the male end of the *new* jumper pigtail to the corresponding wire colors of the male end of the vehicle harness by twisting the exposed wires together. See Figure 64.

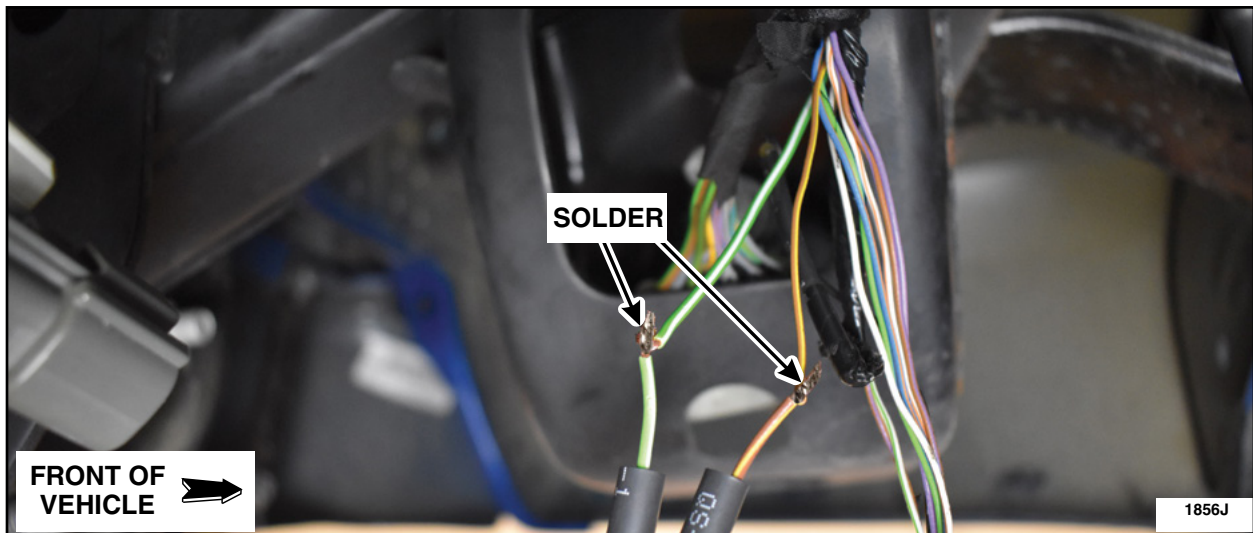
**FIGURE 65**

12. Solder the twisted wires of the male connector. See Figure 65.

**NOTE:** Keep the heat shrink tubes away from the soldering iron.

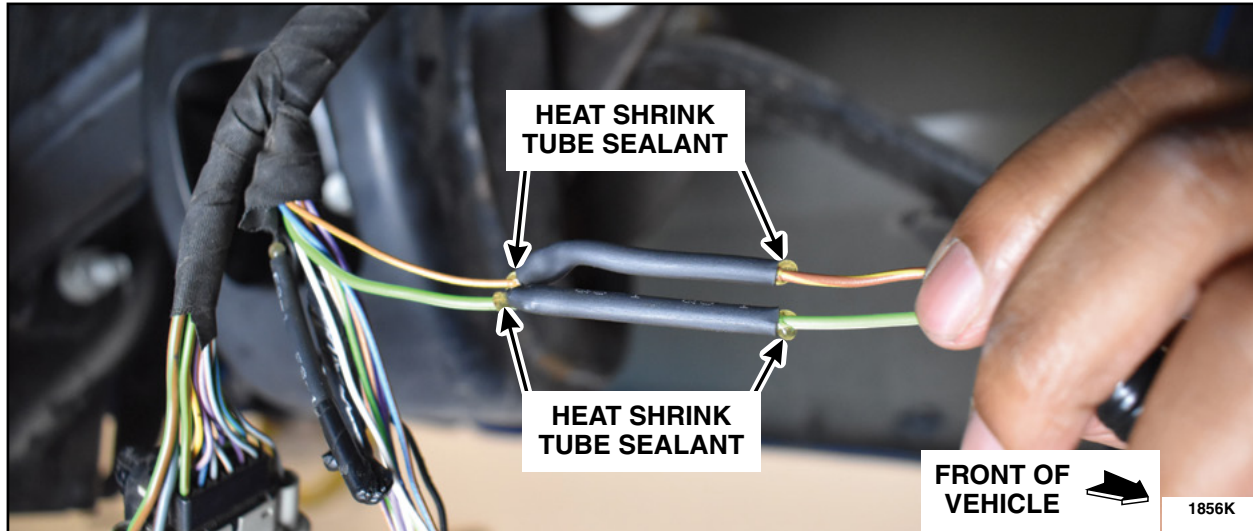
**FIGURE 66**

12. Position the dual wall heat shrink tubes over the solder joints making sure the joints are located in the middle of the tubes. Evenly heat up the heat shrink tubes until the heat shrink tube sealant bubbles out of both ends. See Figure 66.

**NOTE:** Make sure the heat shrink sealant is bubbled out of both ends or the circuit is not sealed.

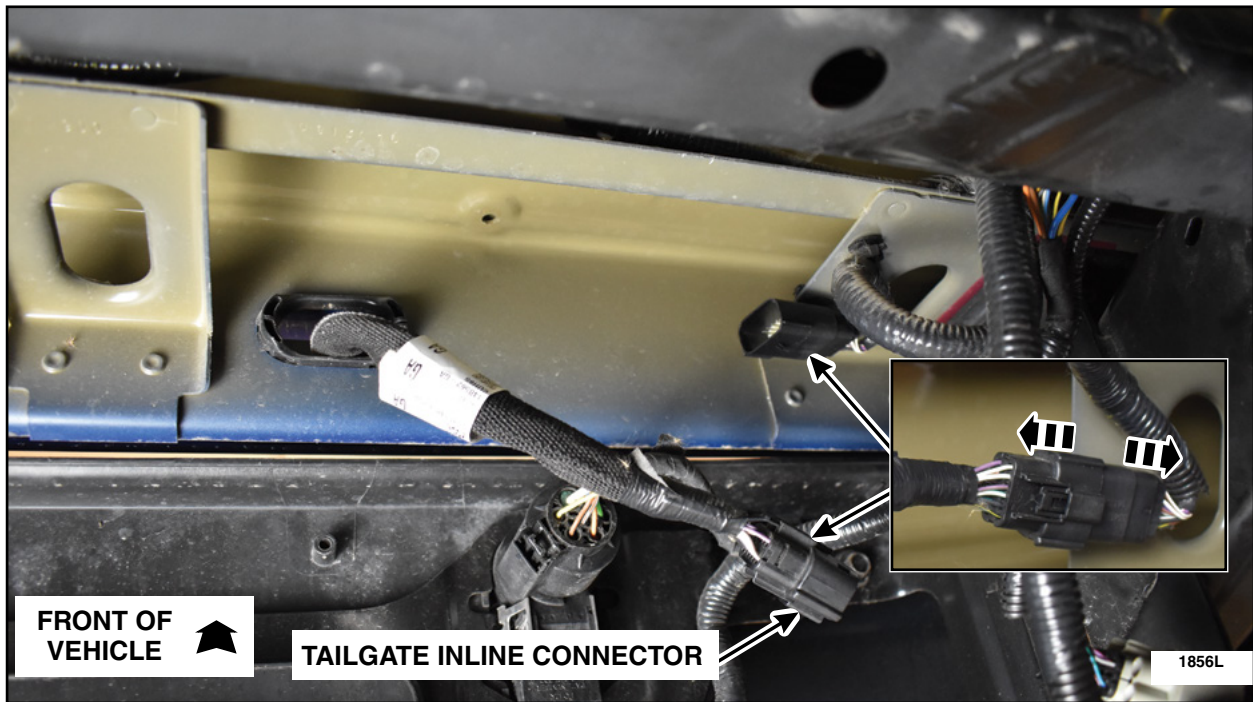
**FIGURE 67**

13. Disconnect the tailgate inline connector (12 pin or 16 pin). See Figure 67.

**NOTE:** C406 12 pin inline connector for 2017 model year shown, all other 12 pin and 16 pin inline connectors similar.

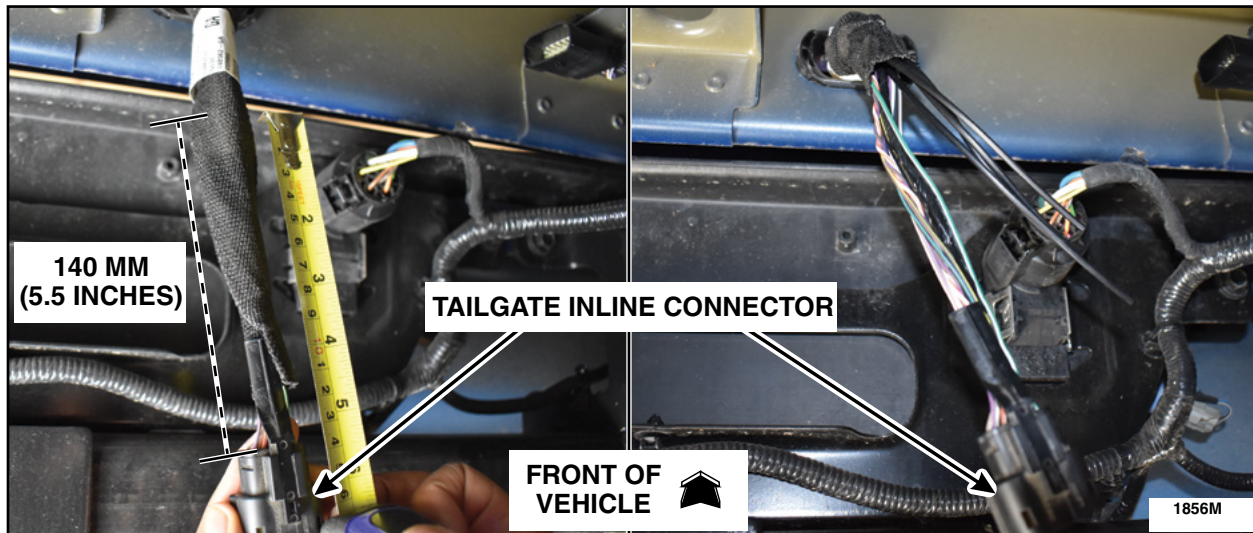
**FIGURE 68**

14. Remove the tape and slide back the mesh cover to expose 140 mm (5.5 in) of the wires on the female side of the tailgate inline connector. See Figure 68.

**NOTE:** C406 12 pin inline connector for 2017 model year shown, all other 12 pin and 16 pin inline connectors similar.

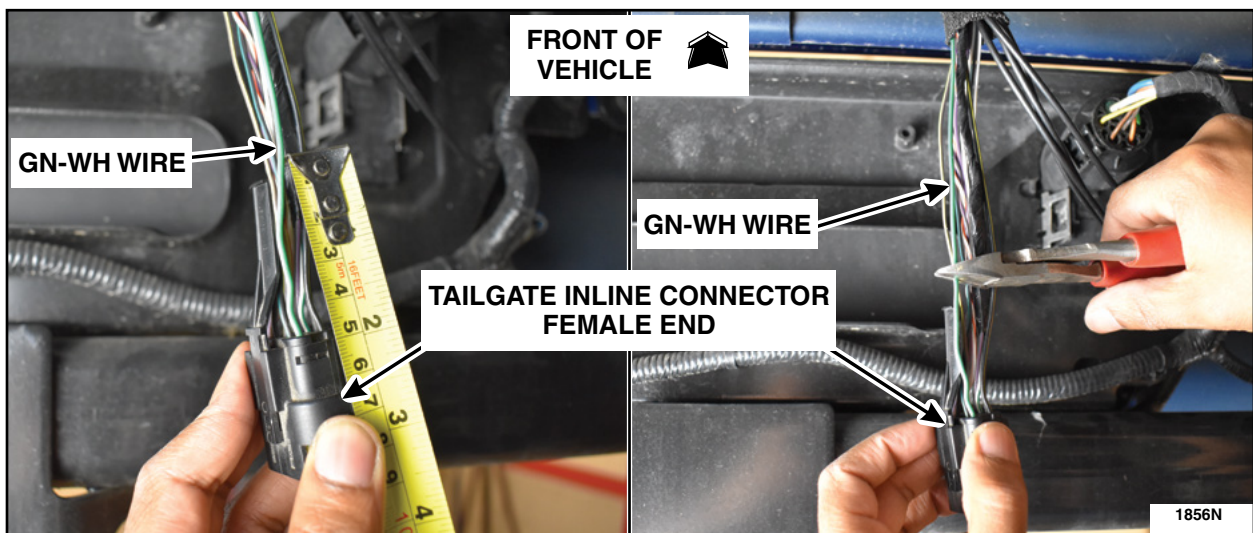
**FIGURE 69**

15. Measure 50 mm (2 in) from the back side of the tailgate inline connector female end and cut the GN-WH wire (16 pin connector: cavity 8 OR 12 pin connector: cavity 12). See Figure 69.

**NOTE:** C406 12 pin inline connector for 2017 model year shown, all other 12 pin and 16 pin inline connectors similar.

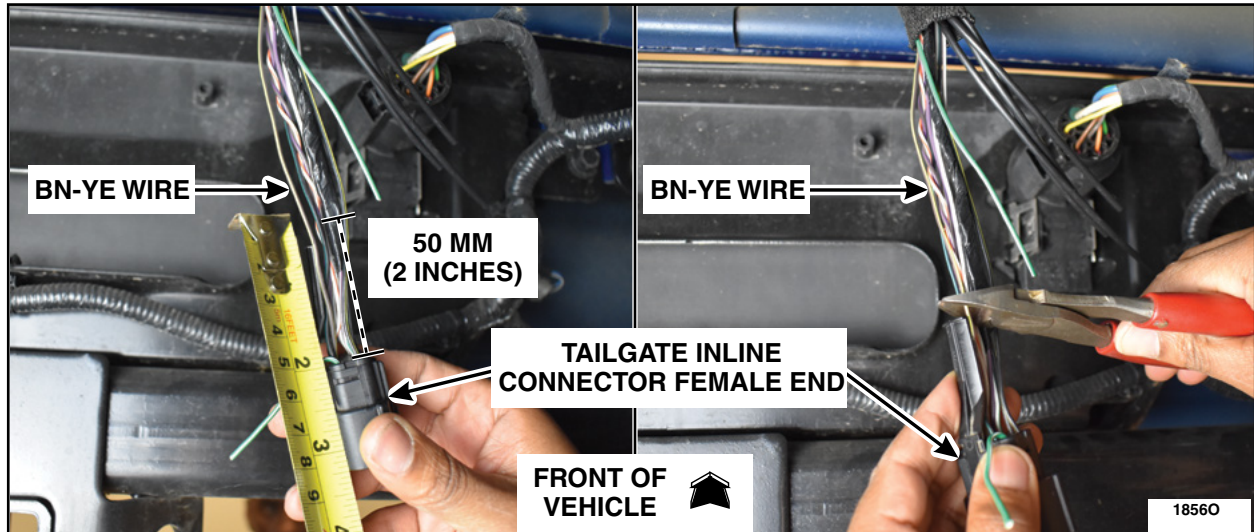
FIGURE 70

16. Measure 50 mm (2 in) from the back side of the tailgate inline connector female end and cut the BN-YE wire (16 pin connector: cavity 8 OR 12 pin connector: cavity 12). See Figure 70.

**NOTE:** C406 12 pin inline connector for 2017 model year shown, all other 12 pin and 16 pin inline connectors similar.

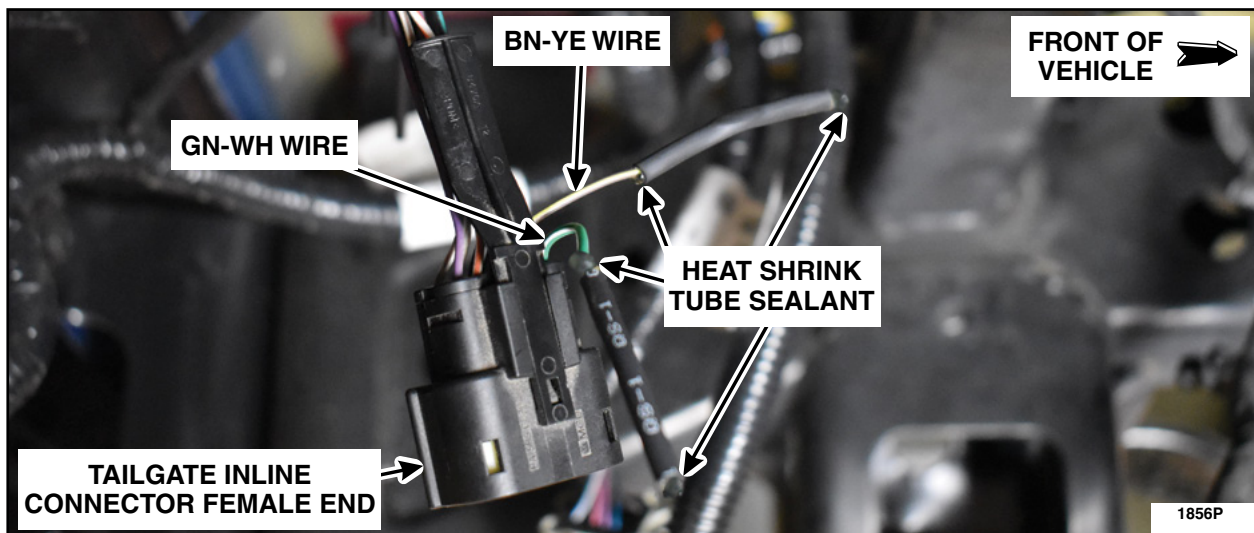
FIGURE 71

17. Install a piece of dual wall heat shrink tube on the GN-WH and BN-YE wires making sure the end of the wire is located in the middle of the tube. Evenly heat up the heat shrink tube until the heat shrink tube sealant bubbles out of both ends. See Figure 71.

**NOTE:** Make sure the heat shrink sealant is bubbled out of both ends or the circuit is not sealed.

**NOTE:** C406 12 pin inline connector for 2017 model year shown, all other 12 pin and 16 pin inline connectors similar.

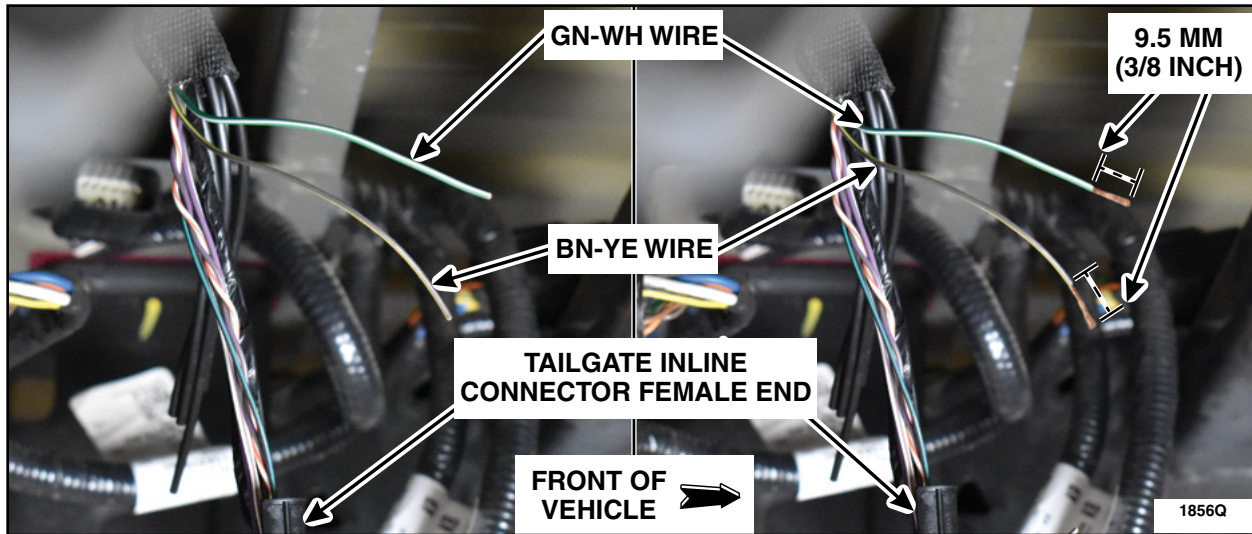
FIGURE 72

18. Strip 9.5 mm (3/8 in) of the GN-WH and BN-YE wire insulation on the female connector harness side. See Figure 72.

**NOTE:** C406 12 pin inline connector for 2017 model year shown, all other 12 pin and 16 pin inline connectors similar.

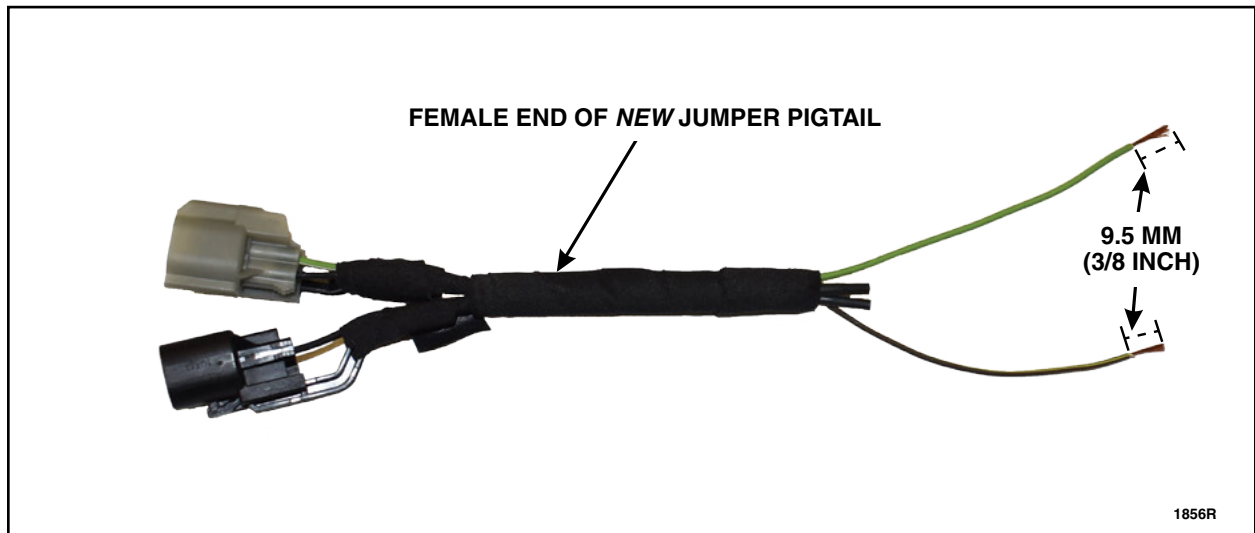
FIGURE 73

19. Strip 9.5 mm (3/8 in) of the wire insulation on the *new* jumper pigtail female connector end. See Figure 73.

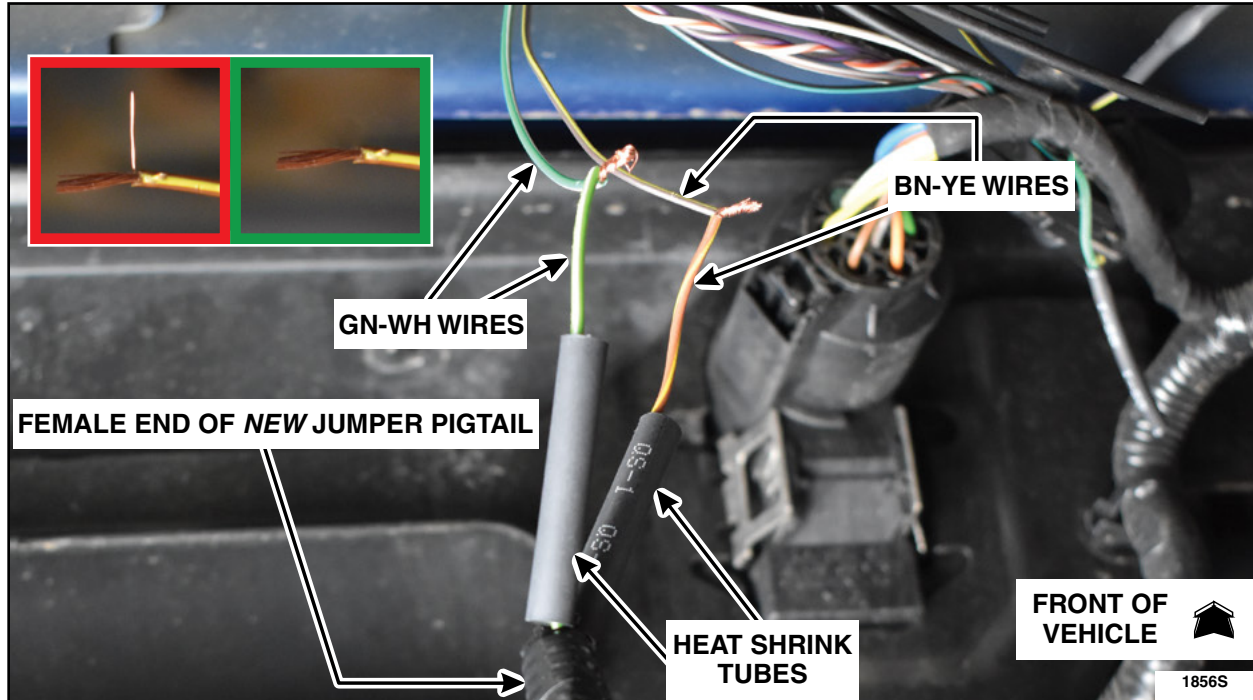
**FIGURE 74**

**NOTE:** Do not leave any stray strands of wire poking outwards as this may puncture the heat shrink tube when heated. See the red and green highlighted callouts below.

20. Place a piece of dual wall heat shrink tube onto each GN-WH and BN-YE wires. Install the female end of the *new* jumper pigtail to the corresponding wire colors of the female end of the vehicle harness by twisting the exposed wires together. See Figure 74.

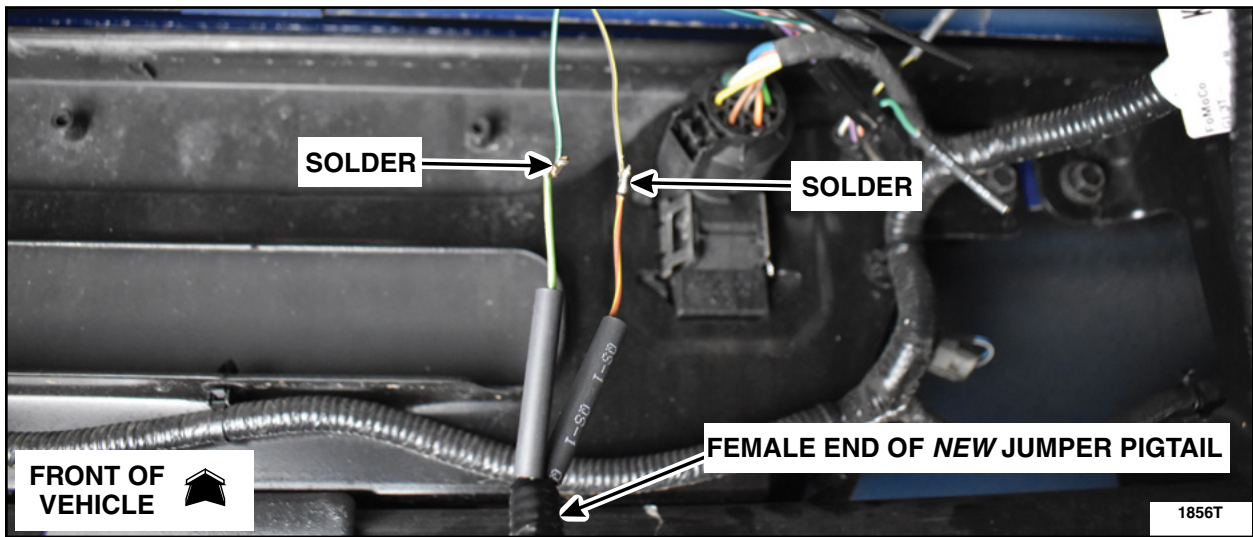
**FIGURE 75**

21. Solder the twisted wires of the female connector. See Figure 75.

**NOTE:** Keep the heat shrink tubes away from the soldering iron.

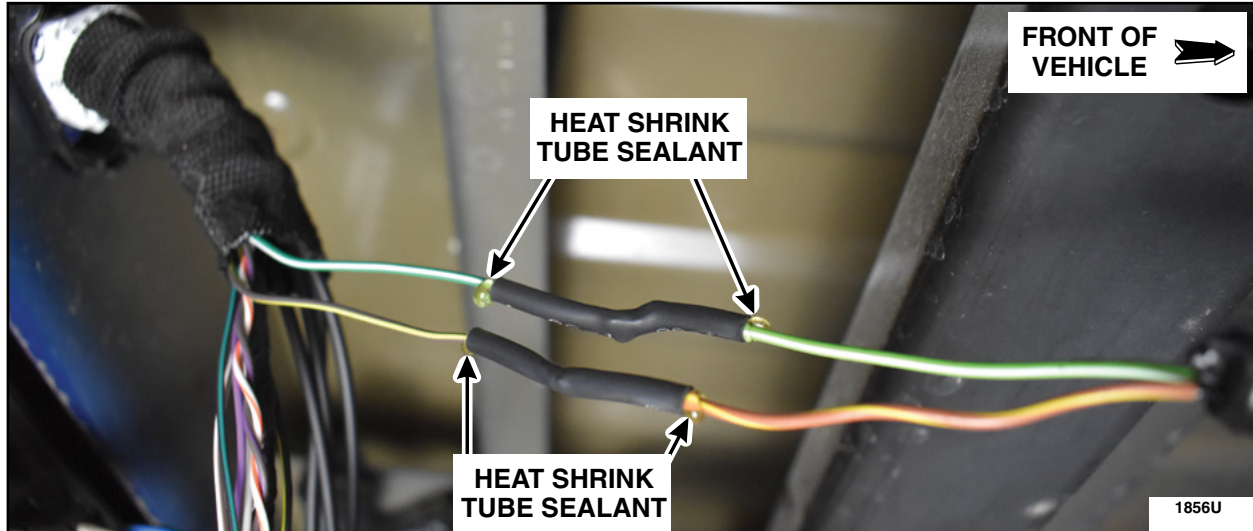
FIGURE 76

22. Position the dual wall heat shrink tubes over the solder joints making sure the joints are located in the middle of the tubes. Evenly heat up the heat shrink tubes until the heat shrink tube sealant bubbles out of both ends. See Figure 76.

**NOTE:** Make sure the heat shrink sealant is bubbled out of both ends or the circuit is not sealed.

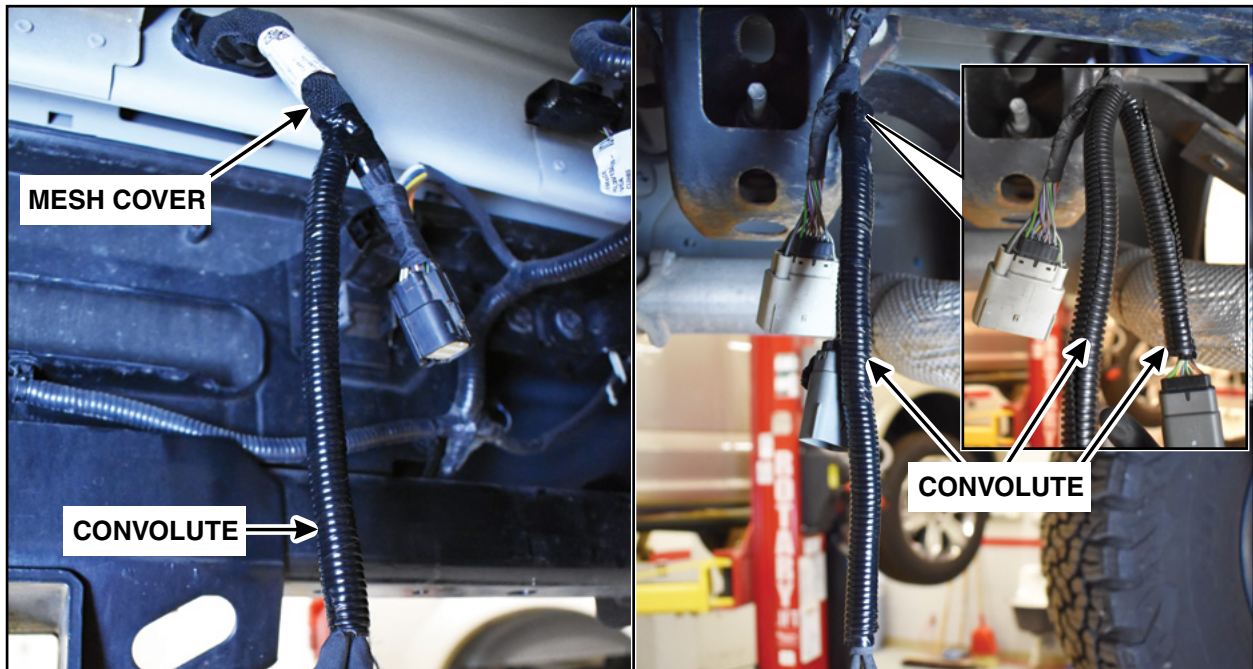
FIGURE 77

23. Position back the mesh cover. Cut to fit the *new* convolute and properly cover any exposed wiring then secure using electrical tape. See Figure 77.

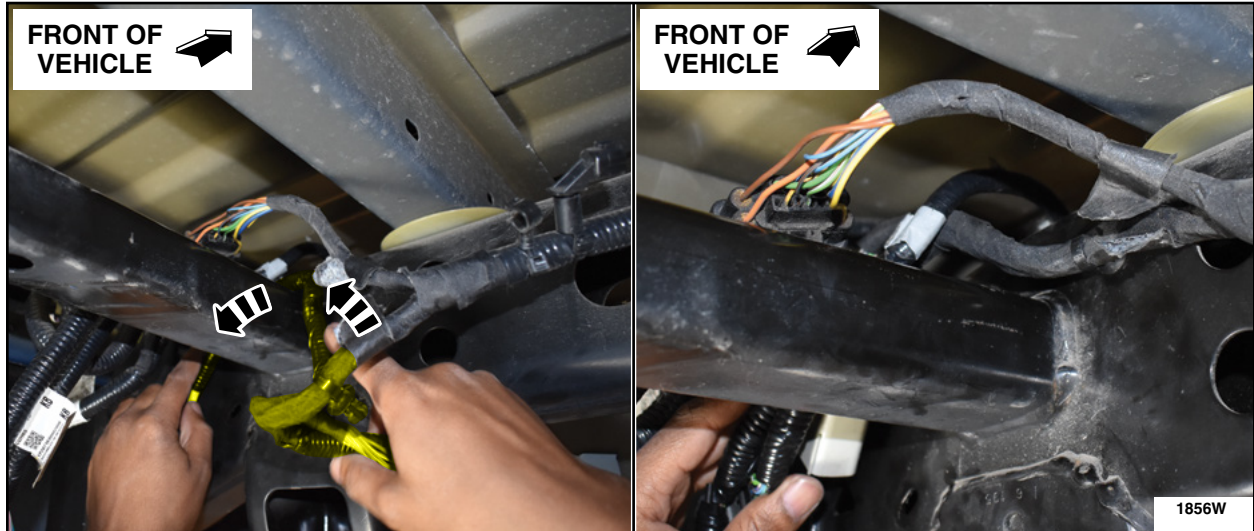
FIGURE 78

24. Route the male end of the *new* jumper pigtail, C405 and C408 halves under the attached wire harness and over the frame. See Figure 78.

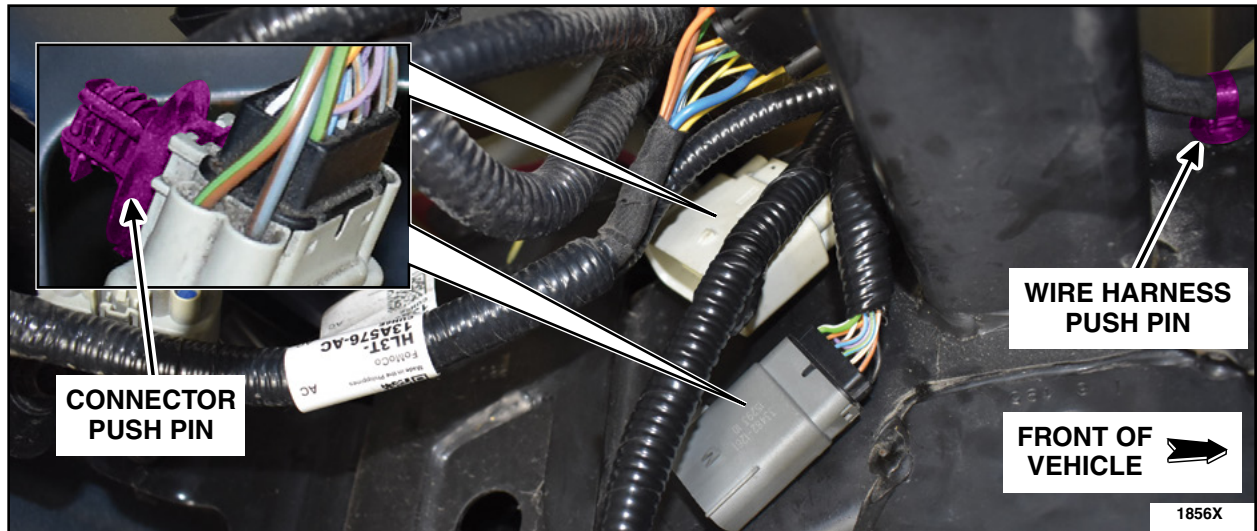
FIGURE 79

25. Attach the two connectors push pin and the wire harness push pin retainers. See Figure 79.

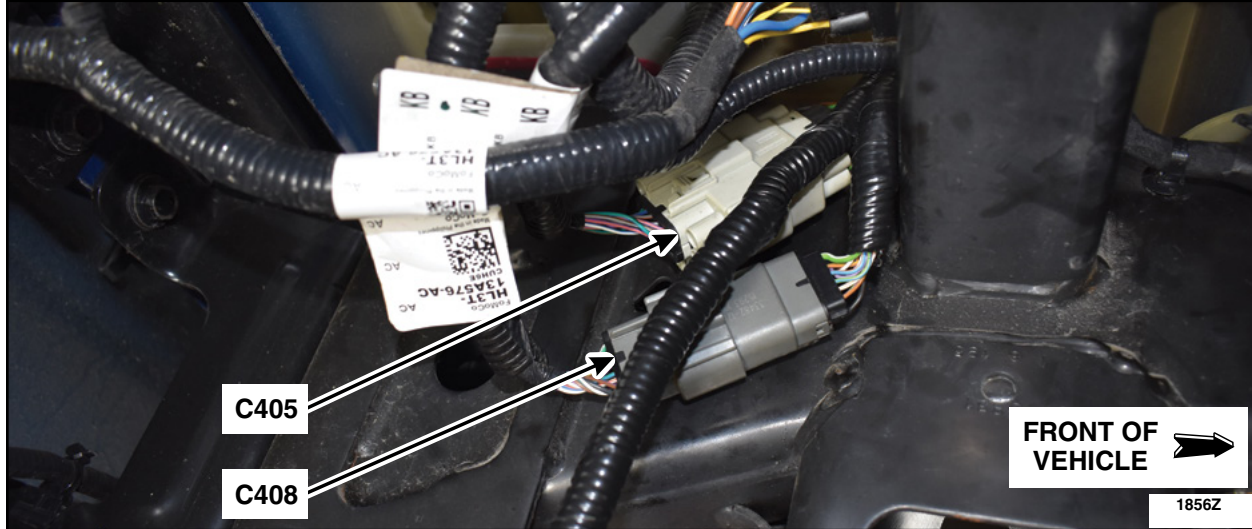
FIGURE 80

26. Apply some Motorcraft® electrical grease (XG-12) to the male side of C408. Inject the grease straight from the tube filling the connector cavity halfway being careful not to bend or damage any terminals.
27. Connect inline connector C405 and C408. See Figure 80.

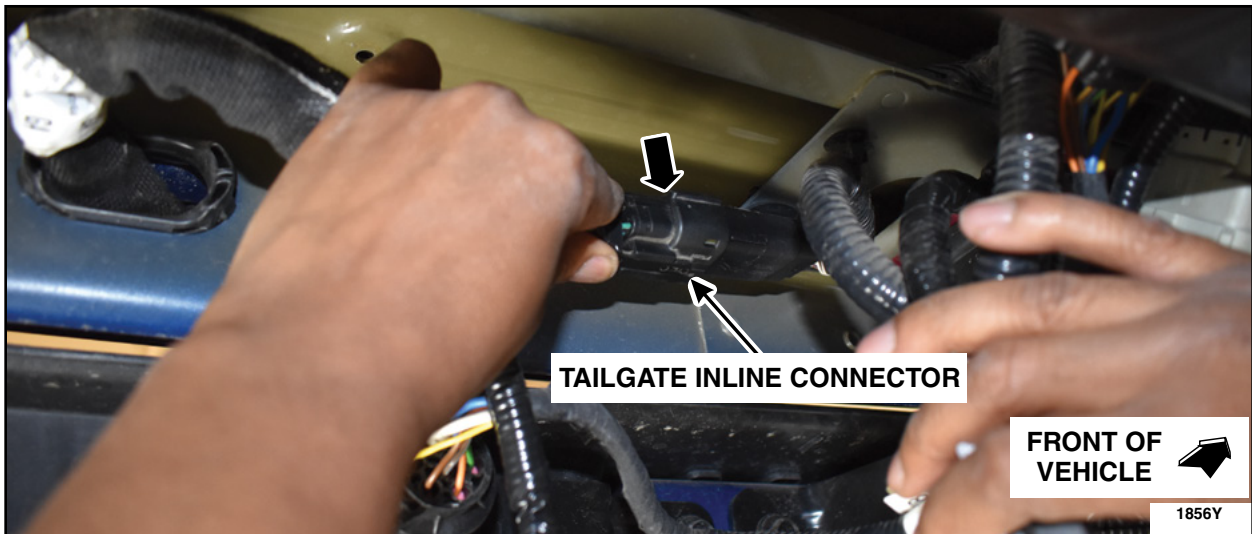
FIGURE 81

28. Apply some Motorcraft® electrical grease (XG-12) to the male side of tailgate inline connector. Inject the grease straight from the tube filling the connector cavity halfway being careful not to bend or damage any terminals.
29. Connect the tailgate inline connector. See Figure 81.

**NOTE:** C406 12 pin inline connector for 2017 model year shown, all other 12 pin and 16 pin inline connectors similar.

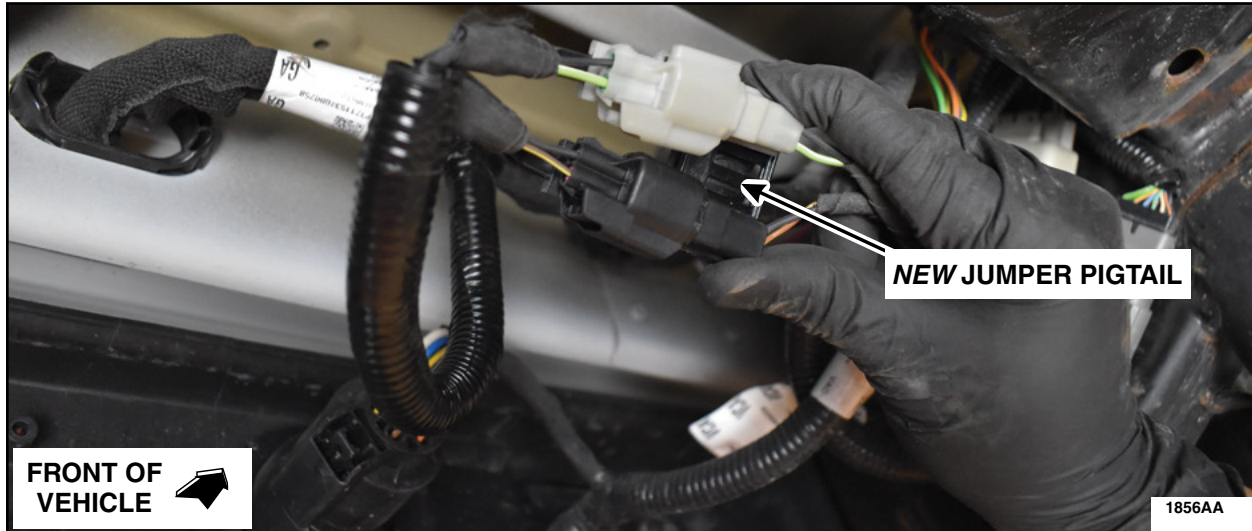
**FIGURE 82**

30. Connect the *new* jumper pigtail. See Figure 82.

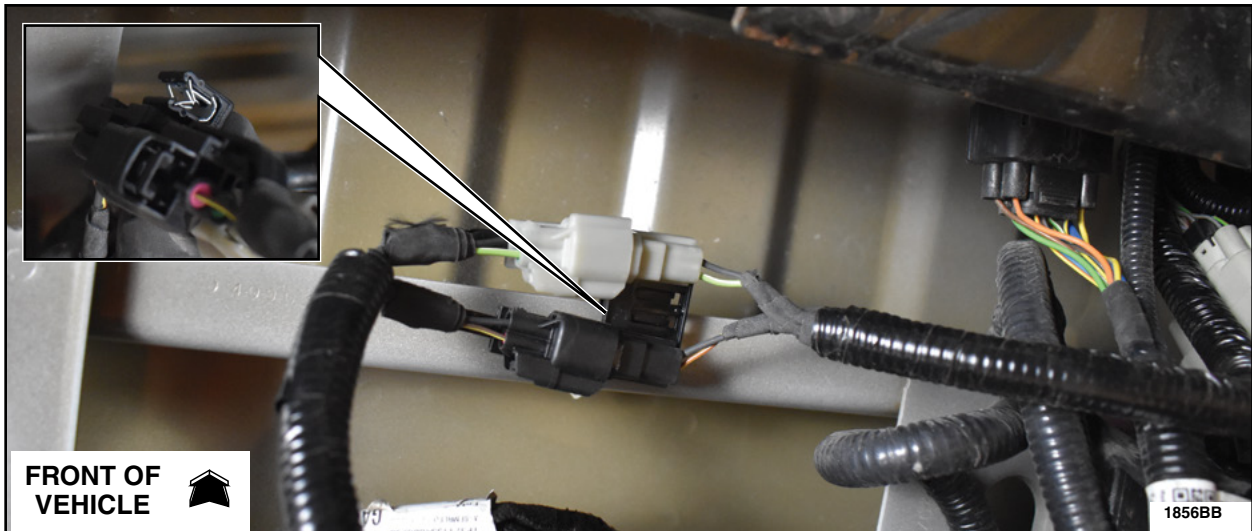
**FIGURE 83**

31. Attach the *new* jumper pigtail to the bed support. See Figure 83.

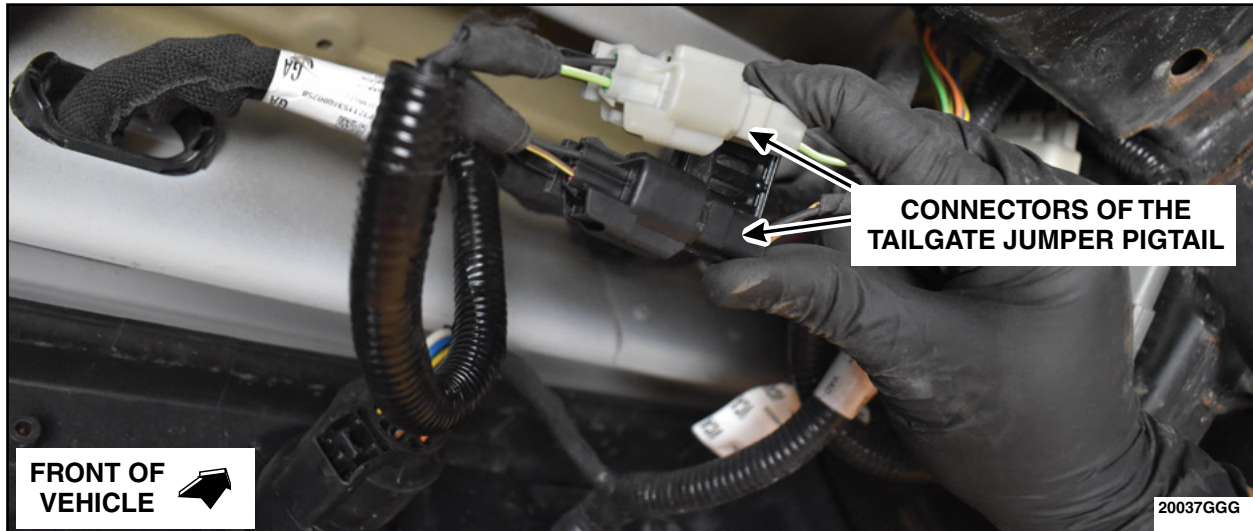
FIGURE 84

76. Disconnect the black and grey connectors of the Tailgate Jumper Pigtail. See Figure 84.

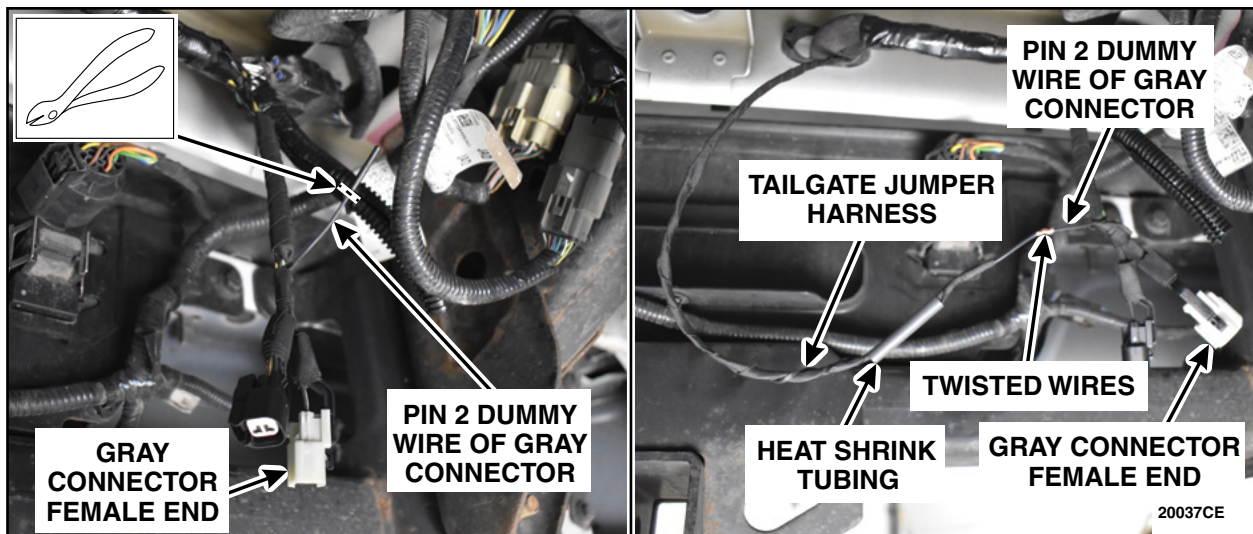
FIGURE 85

77. Remove any tape and/or convolute from the gray connector female end to expose the pin 2 dummy wire. Cut the pin 2 dummy wire just in front of the heat shrink tubing and discard the heat shrink end. Install a *new* piece of heat shrink tubing, twist the Tailgate Jumper Harness and the gray connector female end pin 2 dummy wire together. See Figure 85.

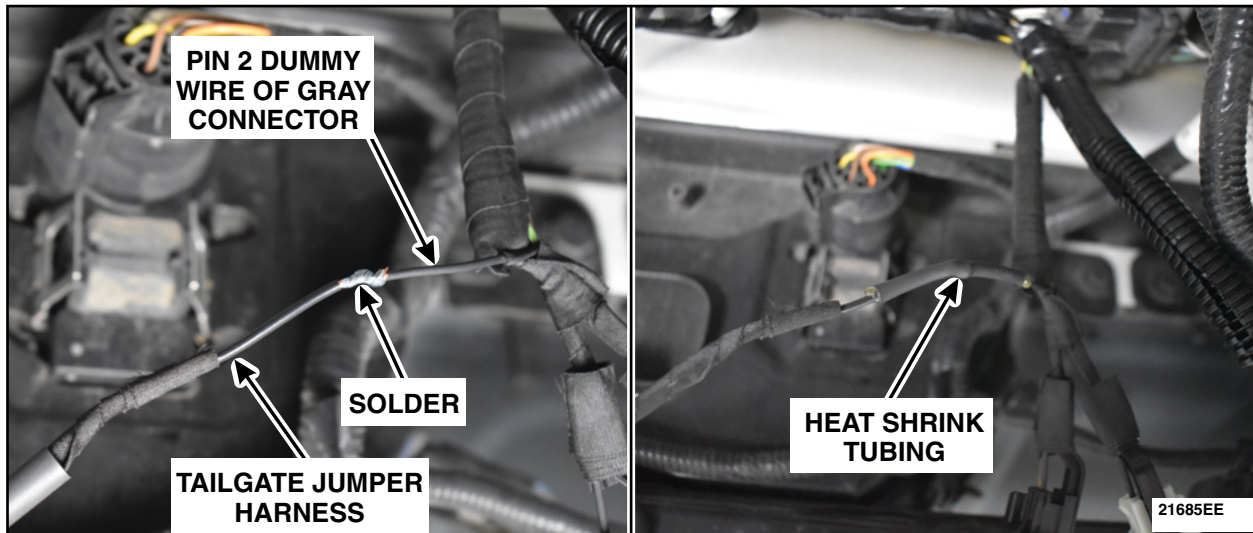
FIGURE 86

78. Solder the twisted wires and apply and seal the heat shrink tubing. See Figure 86. Reapply the convolute and/or black electrical tape.

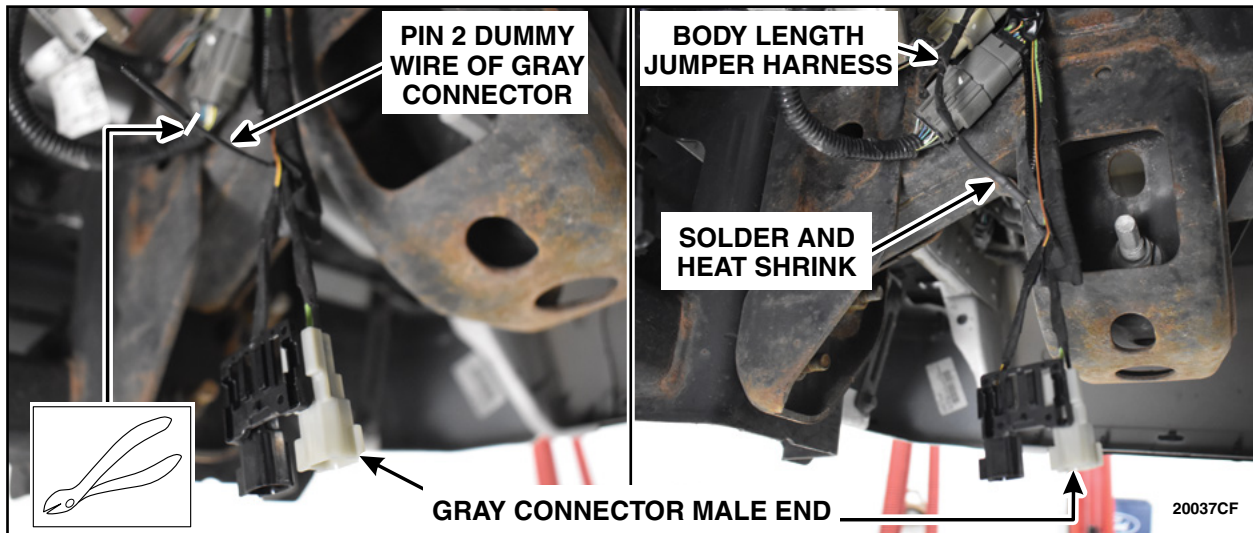
FIGURE 87

79. Remove any tape and/or convolute from the gray connector male end to expose the pin 2 dummy wire. Cut the pin 2 dummy wire just in front of the heat shrink tubing and discard the heat shrink end. Install a *new* piece of heat shrink tubing, twist the end of the Body Length Jumper Harness without a terminal and the connector male end pin 2 dummy wire together. Solder the twisted wires then apply and seal the heat shrink tubing. Reapply the convolute and/or black electrical tape. See Figure 87.

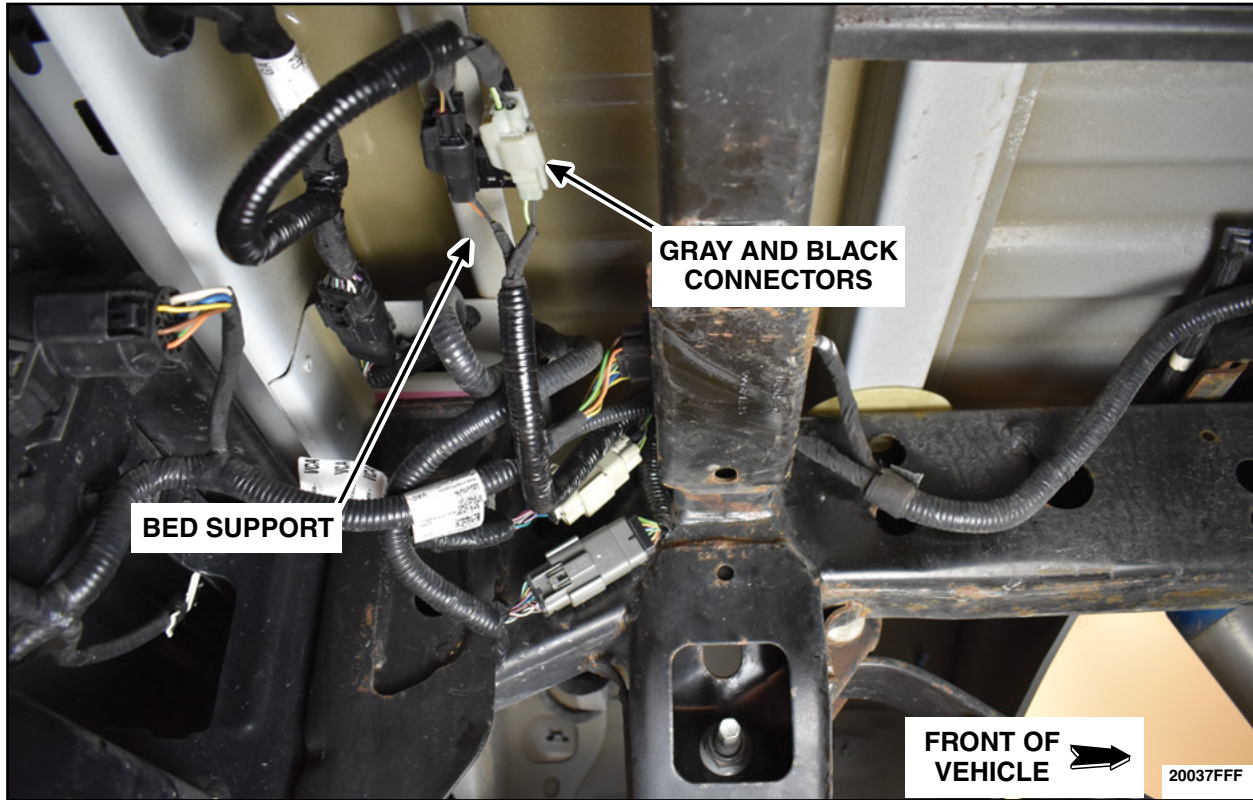
FIGURE 88

80. Reconnect the gray and black connectors and attach them back onto bed support. See Figure 88.
