**SUBJECT:** **Customer Satisfaction Program 21M06 - Supplement #1**  
 Certain 2015-2020 Model Year F-150 Vehicles Equipped with a Power Release Tailgate - Unintended Tailgate Opening

**New! REASON FOR THIS SUPPLEMENT**

*Parts ordering information and full repair instructions are now available to support completion of this customer satisfaction program.*

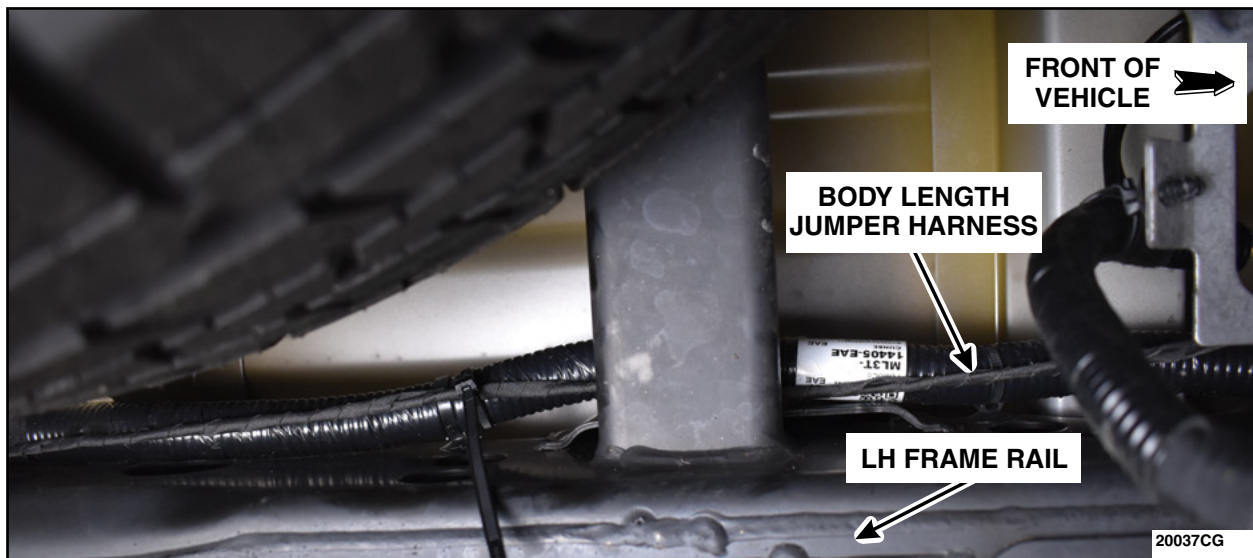
FIGURE 89

81. Route the Body Length Jumper Harness along the LH frame rail towards the front of the vehicle keeping the harness as close to the bed as possible. Secure using tie straps approximately every 12 in (305 mm). See Figure 89.

**NOTE:** The tie straps were left untrimmed for clarity. Trim any excess from the tie straps once installed.

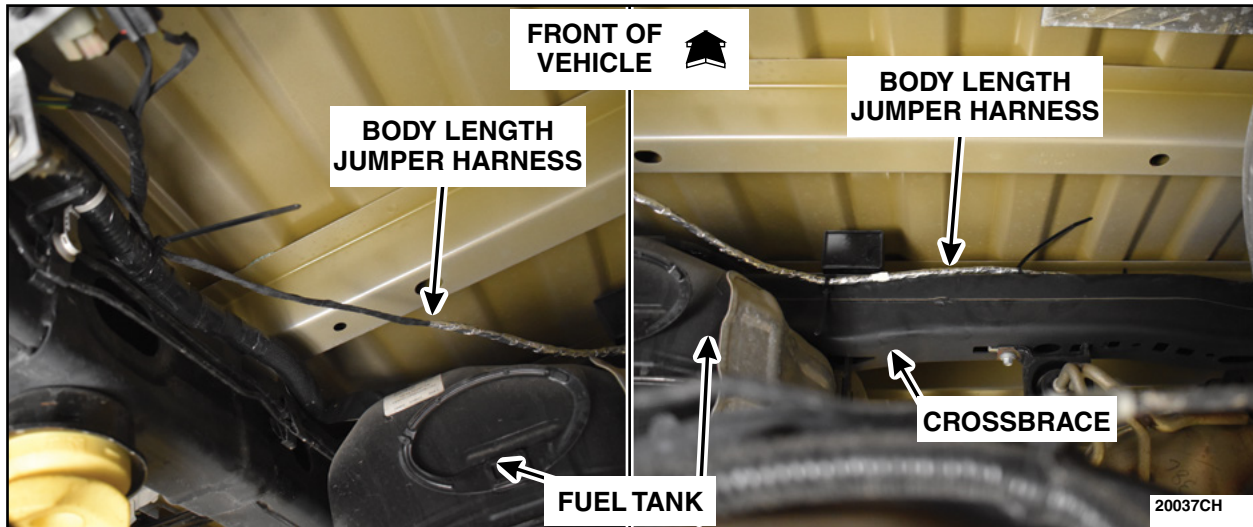
FIGURE 90

82. Continue to route the Body Length Jumper Harness along the LH frame rail. Once at the fuel tank, route the Body Length Jumper Harness across the crossbrace to the RH side of the frame rail on top of the fuel tank. Secure the Body Length Jumper Harness to the existing harness and to the holes within the crossbrace using the assorted supplied tie straps approximately every 12 in (305 mm). See Figures 90 and 91.

**NOTE:** The tie straps were left untrimmed for clarity. Trim any excess from the tie straps once installed.

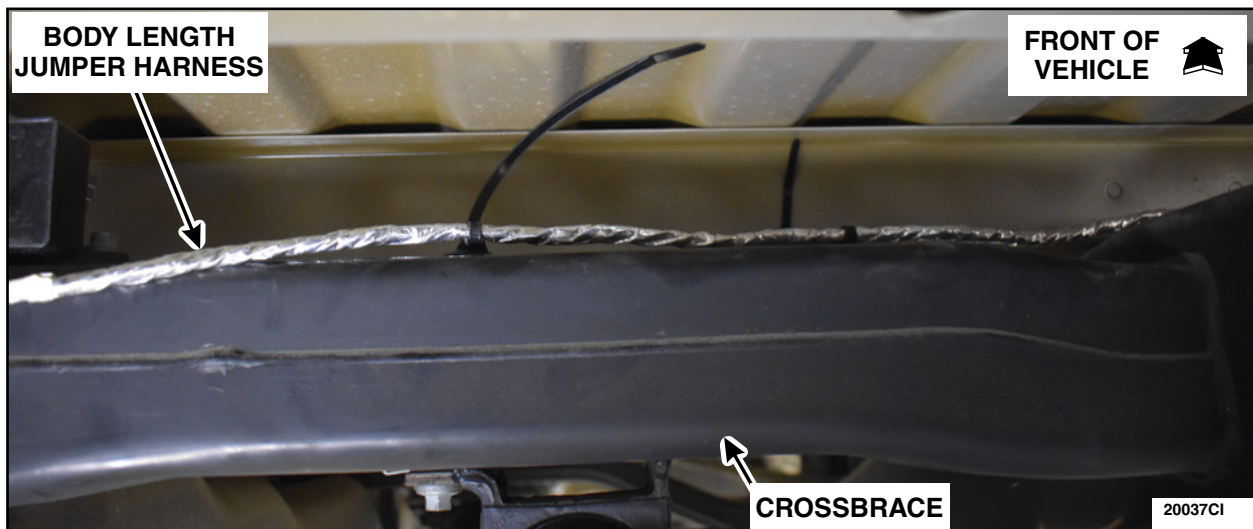
FIGURE 91

**NOTE:** The tie straps were left untrimmed for clarity. Trim any excess from the tie straps once installed.

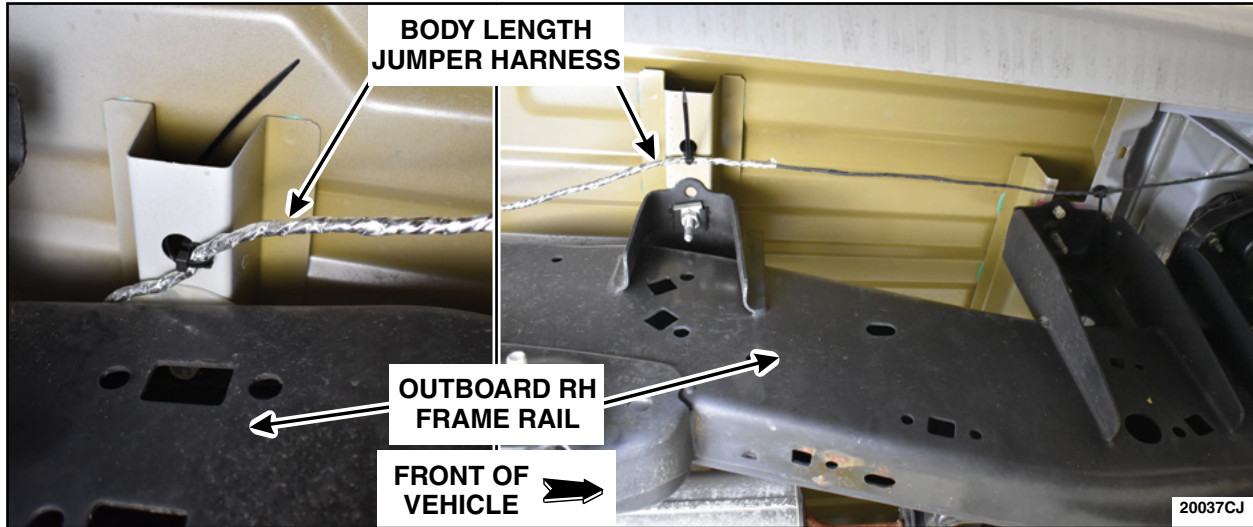
FIGURE 92

83. Route the Body Length Jumper Harness over the RH frame rail and continue on the outboard RH frame rail as close to the bed as possible. Secure the Body Length Jumper Harness to the holes within the underside of the bed and to the outboard RH frame using the assorted supplied tie straps approximately every 12 in (305 mm). See Figure 92.

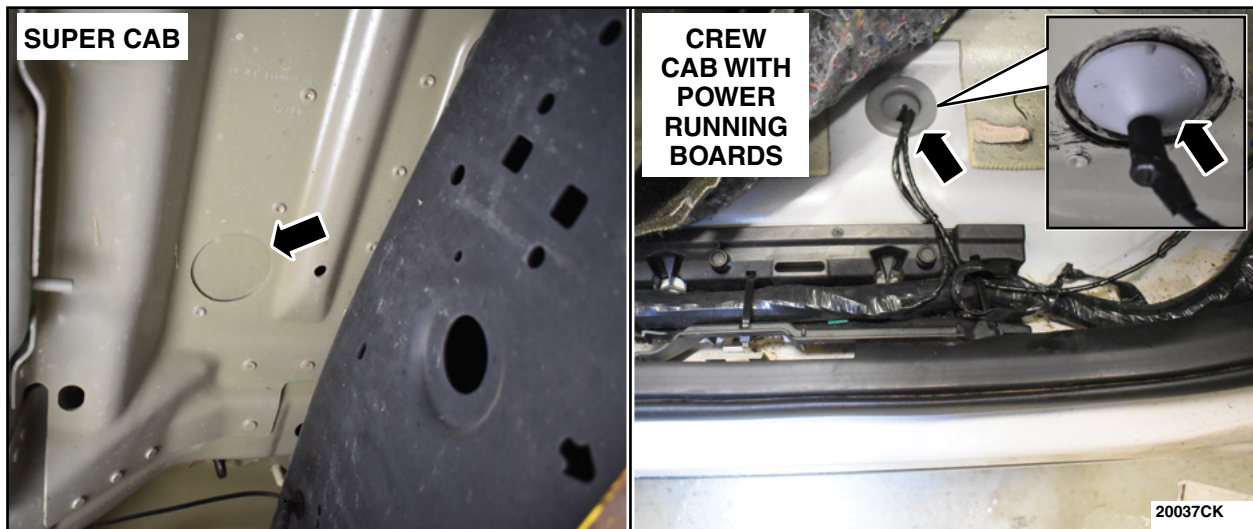
FIGURE 93

84. **Super Cab** vehicles have no hole present on the front passenger floorboard. **Crew cab** vehicles equipped WITH power running boards have a grommet located on the front passenger floorboard. **Crew Cab** vehicles WITHOUT power running boards have a plug on the front passenger floorboard. See Figure 93.

**NOTE:** Floorboard grommet shown, floorboard plug similar.

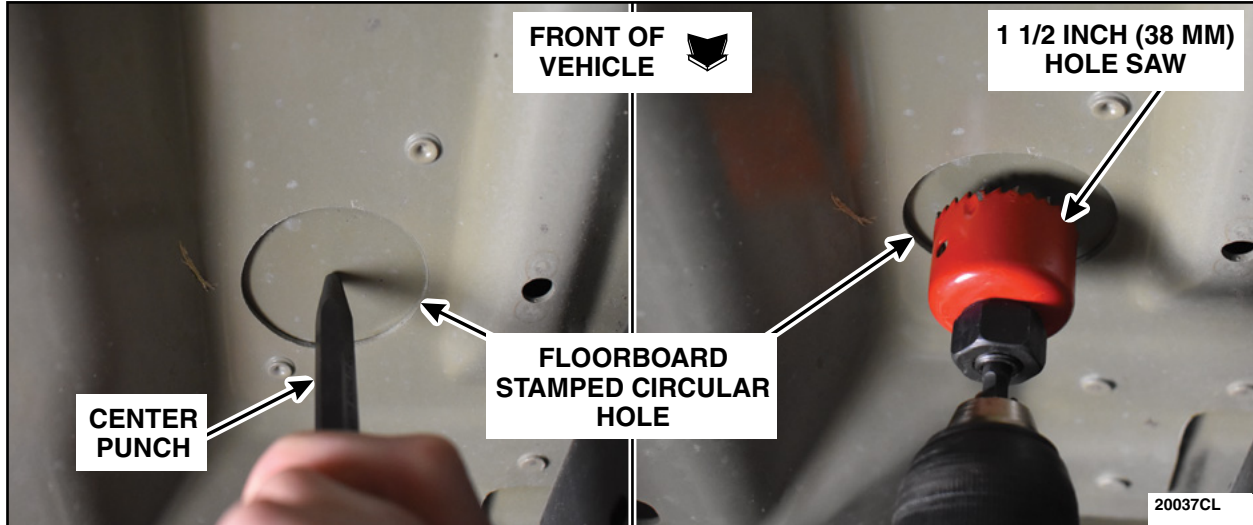
FIGURE 94

85. Locate the floorboard stamped circular hole on the under side of the front passenger floorboard. Using a Center Punch, mark the center of the circular hole. Using a 1-1/2 inch (38 mm) Bi-Metal Hole Saw with arbor and pilot bit, drill through the floorboard towards the inside of the vehicle. De-burr the hole. See Figure 94.

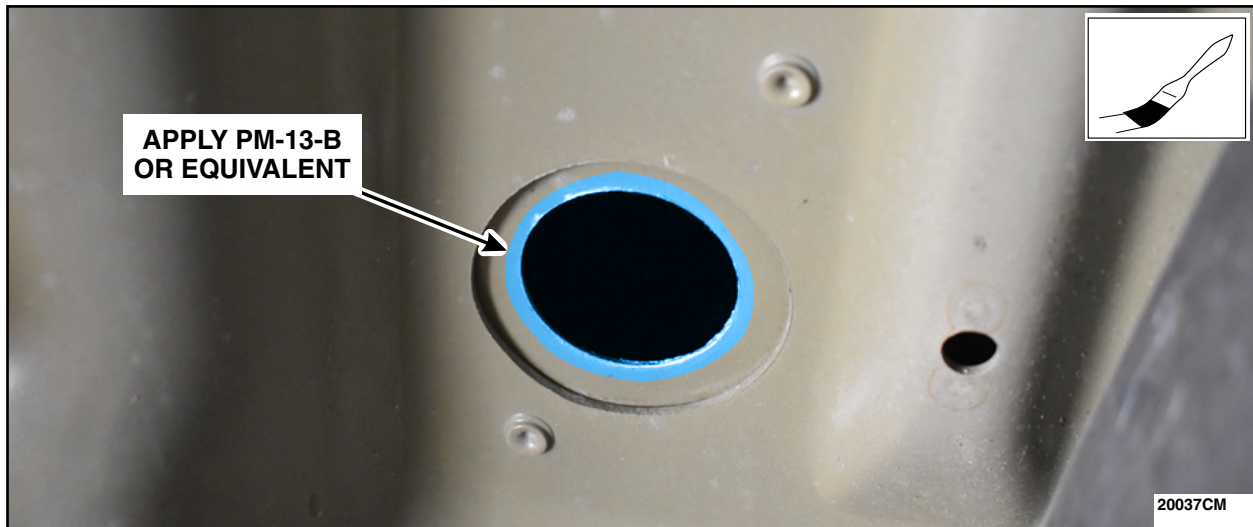
FIGURE 95

86. Following the directions on the can, liberally apply some PM-13-B Anti Corrosion Coating or equivalent to the edge and surface around the hole drilled into the floorboard. Allow to fully dry. See Figure 95.

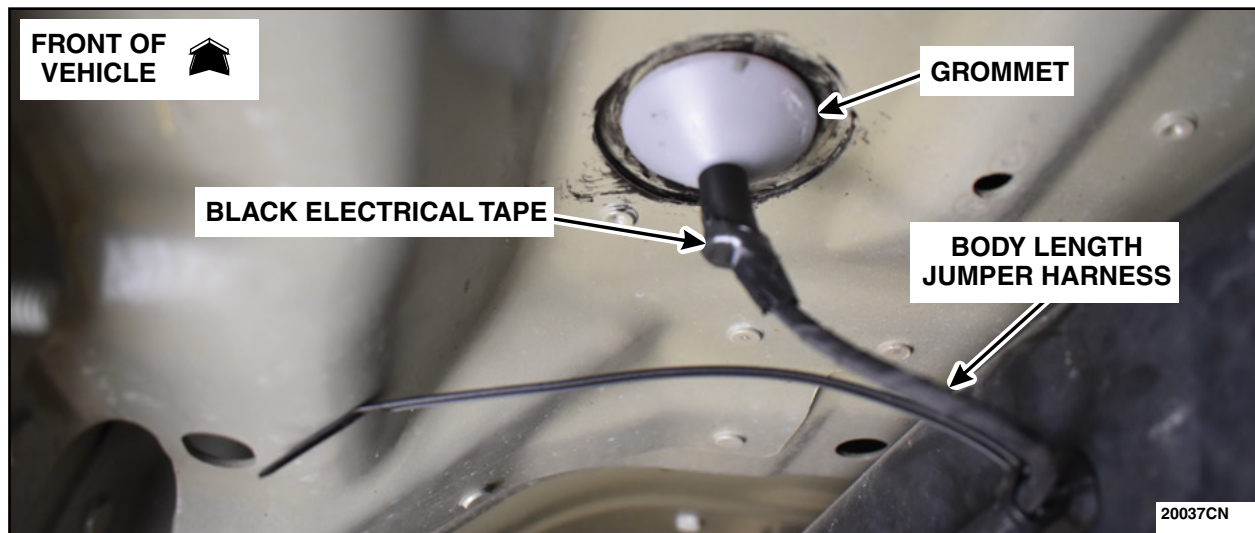
FIGURE 96

87. Install the grommet and route the Body Length Jumper Harness. See Figure 96.

- As needed, install the grommet included in the Tailgate Actuator Ground Wiring Part Kit into the hole drilled into the floorboard being sure that the grommet is fully seated.
  - a. **For Crew Cab vehicles equipped with power running boards**, remove the electrical tape off of the grommet that is already installed into the floorboard.
- Route the Body Length Jumper Harness through the center of the grommet.
  - b. **For Crew Cab vehicles equipped with power running boards**, route the Body Length Jumper Harness through the center of the existing grommet along side of the existing wire. See Figure 97.
- Apply black electrical tape over the end of the grommet and the Body Length Jumper Harness.

**NOTE:** Grommet on Crew Cab vehicle without power running boards shown, other similar.

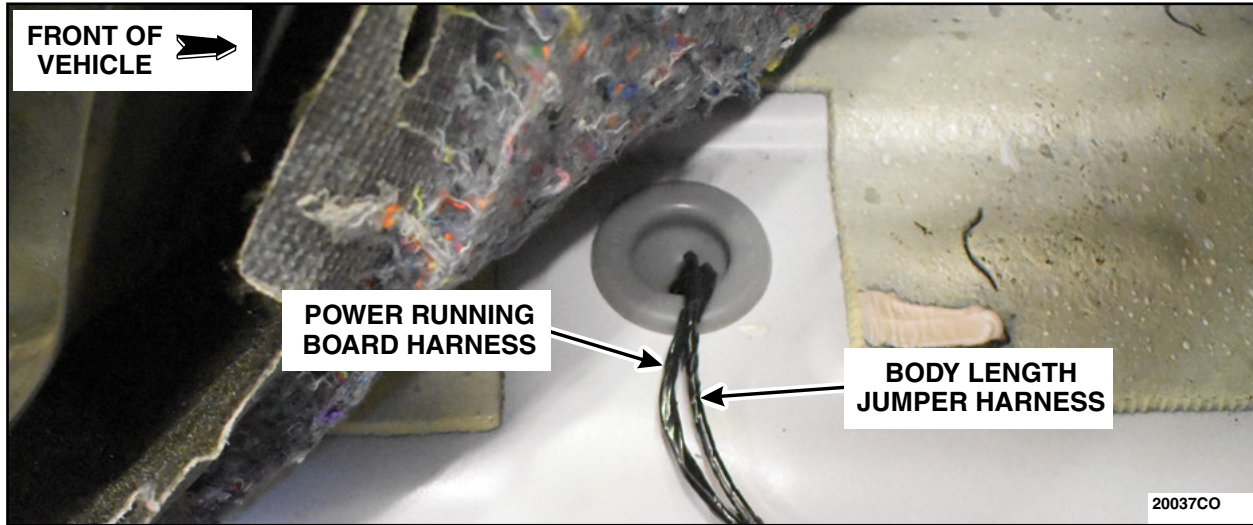
**FIGURE 97**

**NOTE:** Grommet on Crew Cab vehicle with power running boards shown, other similar.

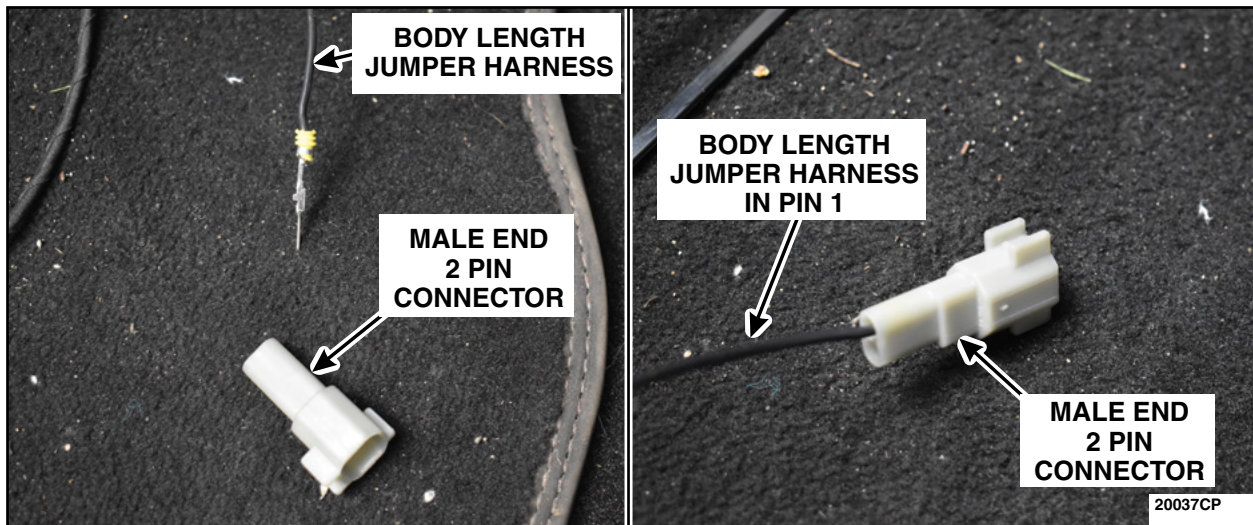
**FIGURE 98**

88. Install the terminal from the Body Length Jumper Harness into pin 1 of the male end 2 pin connector.  
See Figure 98.

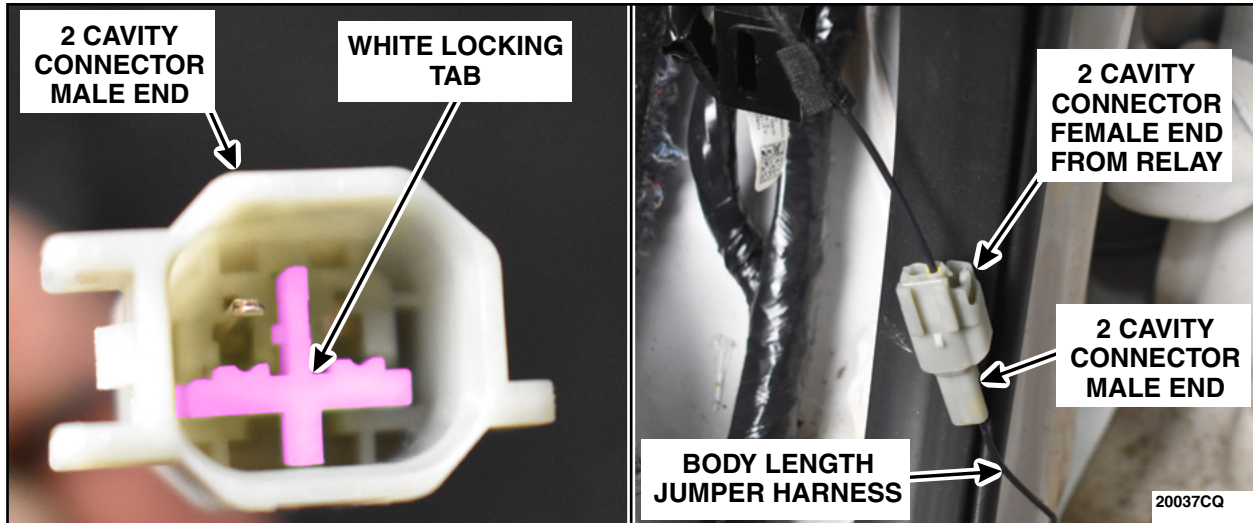
FIGURE 99

89. Engage the white locking tab. Connect the 2 cavity connector male end to the 2 cavity connector female end from the relay. See Figure 99.

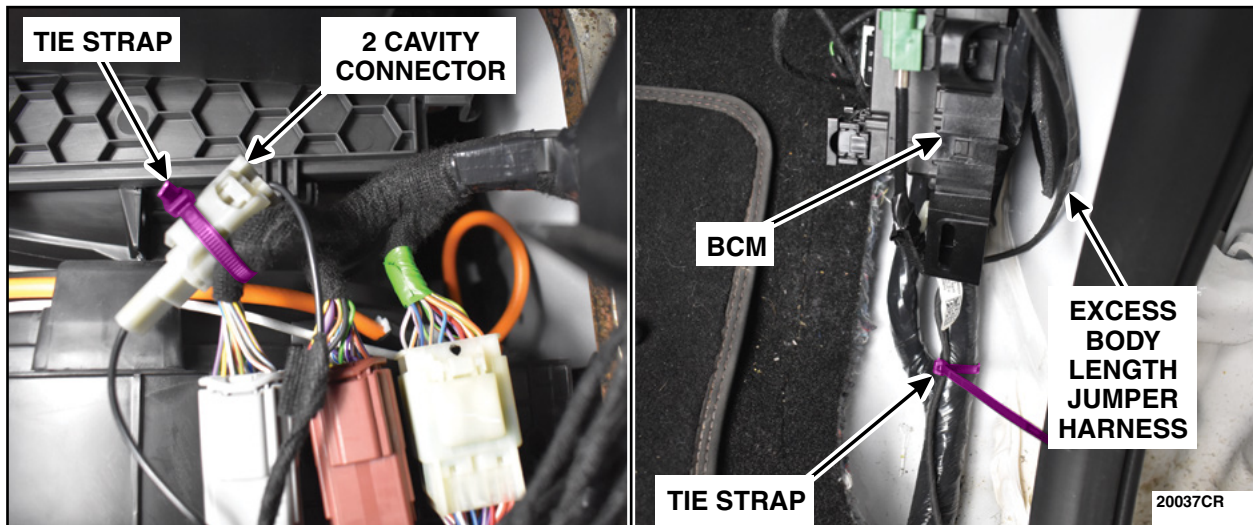
FIGURE 100

90. Secure the 2 cavity connector to a wiring harness near the 3 connectors in the glove compartment area. Secure the excess Body Length Jumper Harness to the wiring harness below the BCM using a tie strap. See Figure 100.

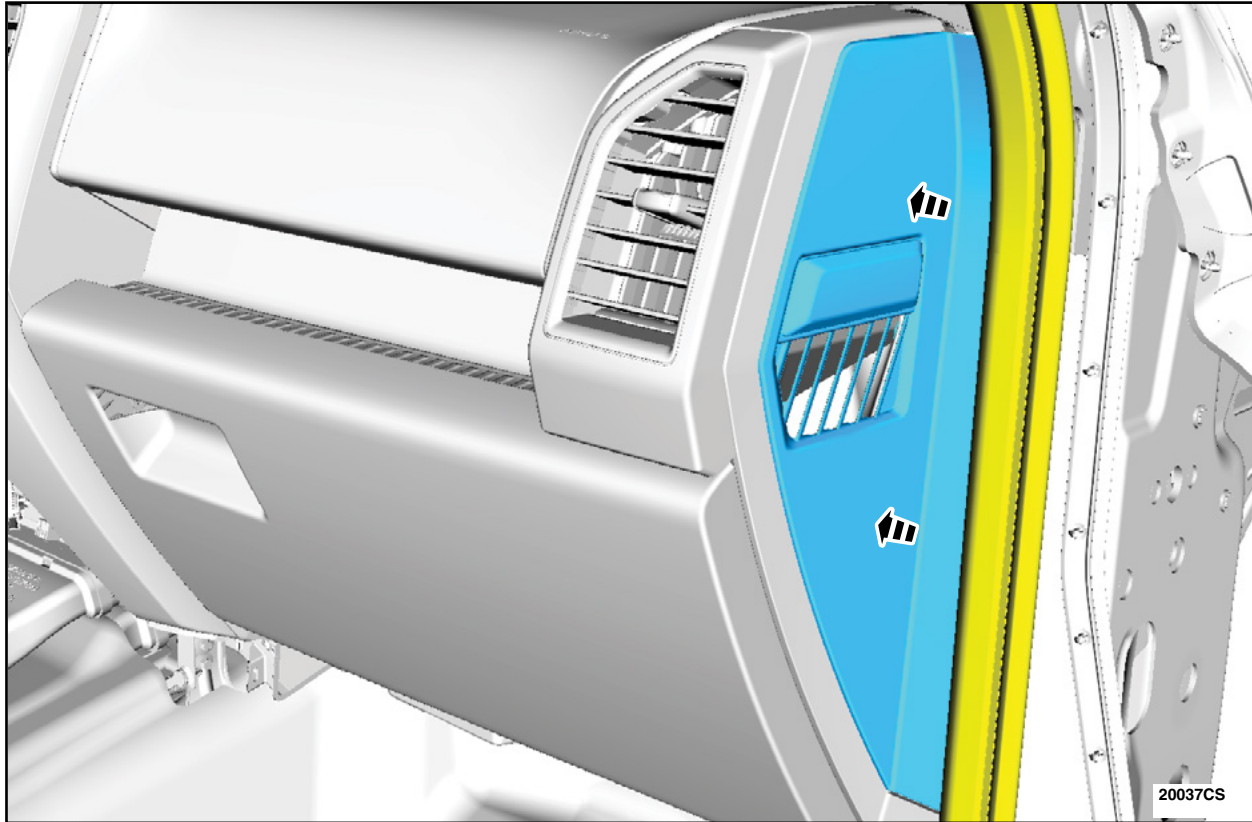
FIGURE 101

92. Install the RH Instrument Panel Finish Panel. Position back the weatherstrip. See Figure 101.

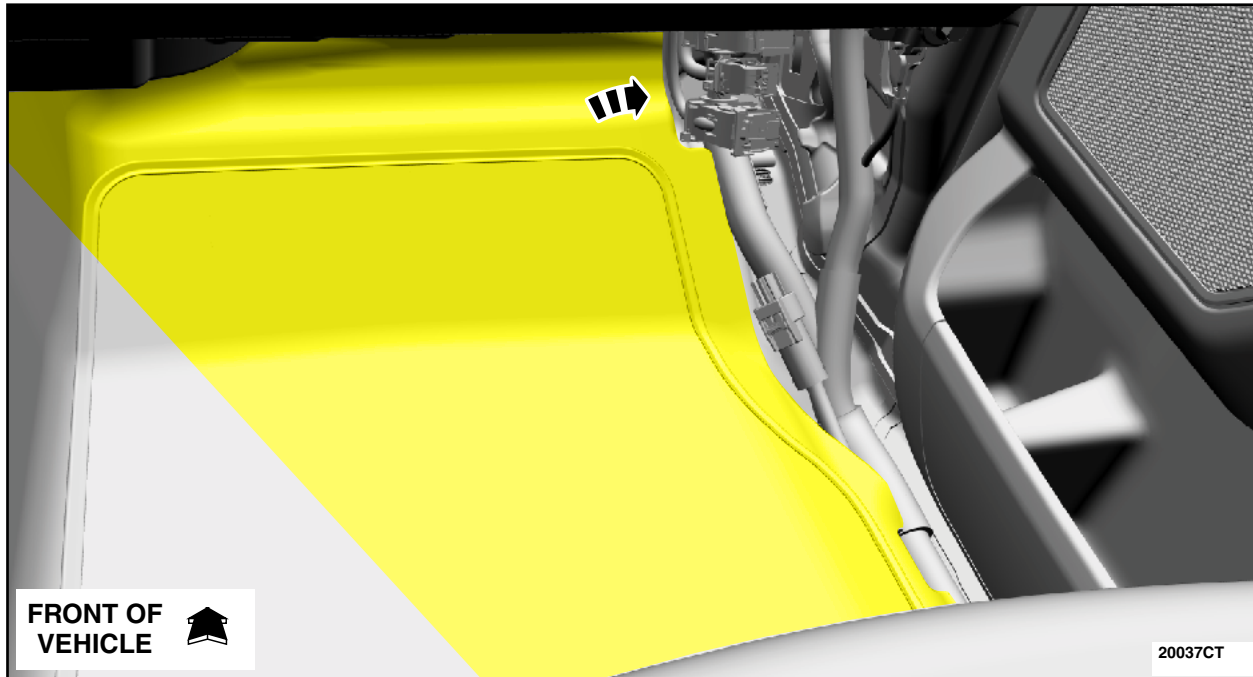
FIGURE 102

93. Position back the RH front carpet. See Figure 102.

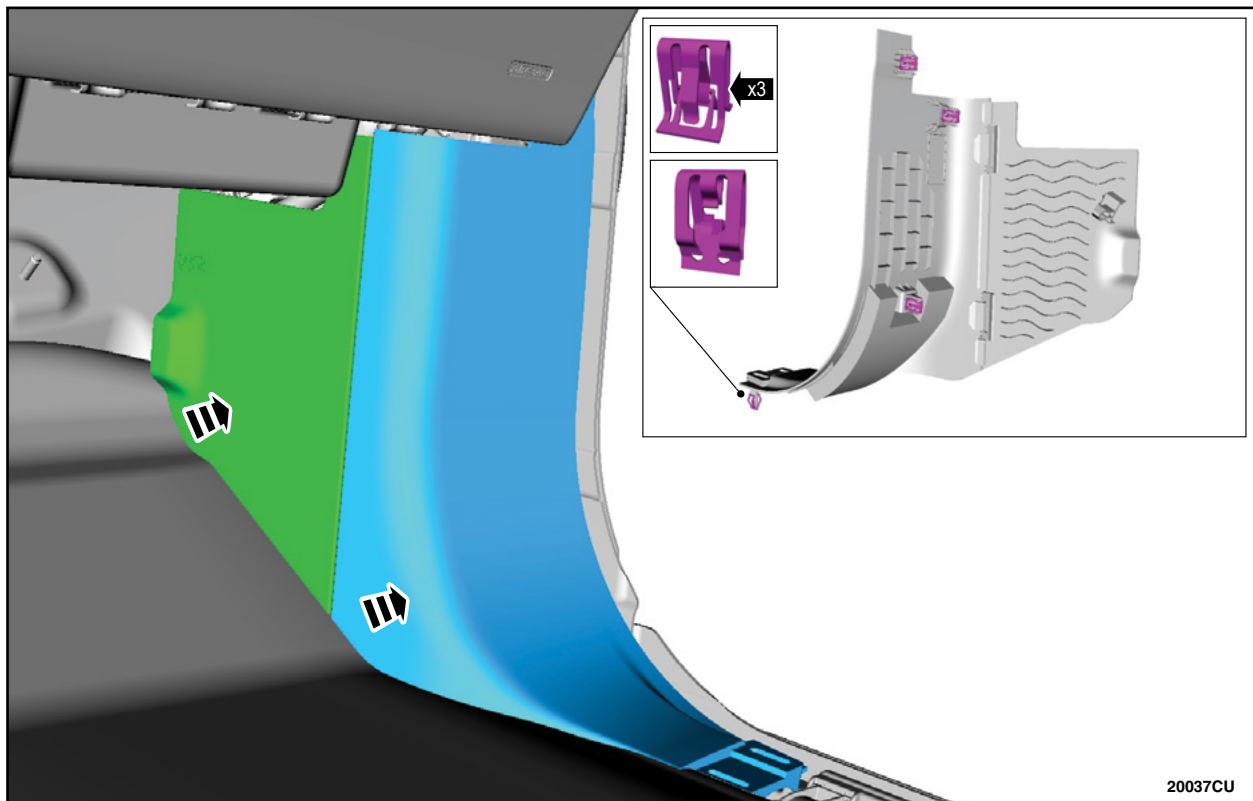
FIGURE 103

94. Install the RH Lower Cowl Trim Panel and the Fuse Panel Cover. See Figure 103.

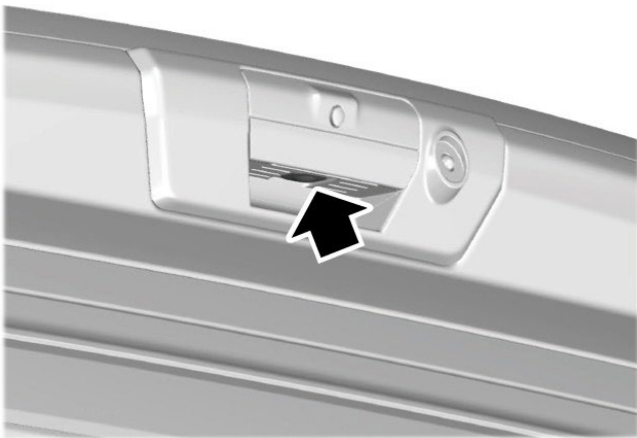
1. Unlock the vehicle with the remote control or power door unlock button.

**Note:** If an intelligent access transmitter is within 1 m (3 ft) of the tailgate, the tailgate unlocks when you press the tailgate release button.

2. Press the button in the top of the tailgate handle twice within three seconds.
