## **Safety Recall R03 / NHTSA 14V-373**

### **Wireless Ignition Node Module**

##### **2009 - 2010 (JC) Dodge Journey**

##### **2008 - 2010 (RT) Dodge Grand Caravan / Chrysler Town & Country**

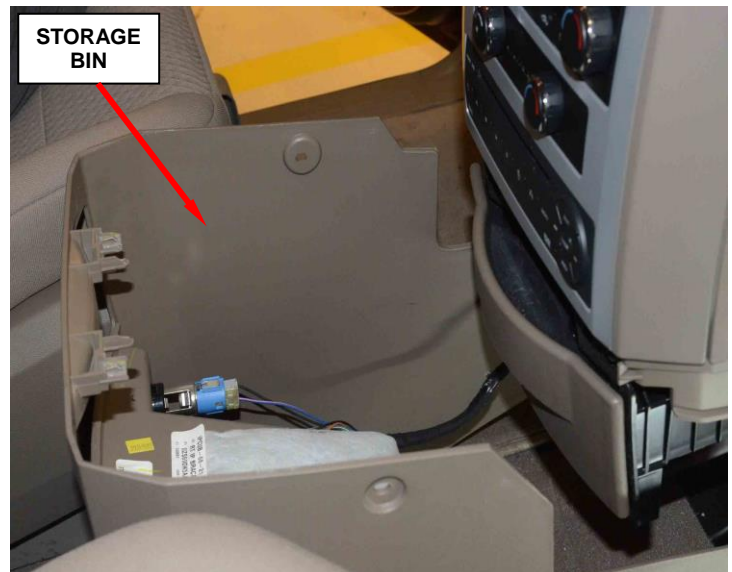
**Figure 3 - Center Stack Storage Bin**

7. Remove and save the lower center stack storage bin retaining screws.
8. Slide the lower center stack storage bin rearward, but do not remove it from the vehicle (Figure 3).
9. Remove and save the instrument panel center stack bezel (Figure 4).

24. Install the lower center stack storage bin and retaining screws (Figure 3).
25. Install the center stack bezel hood (Figure 2).
26. Install the gear shift knob and tighten the set screw.

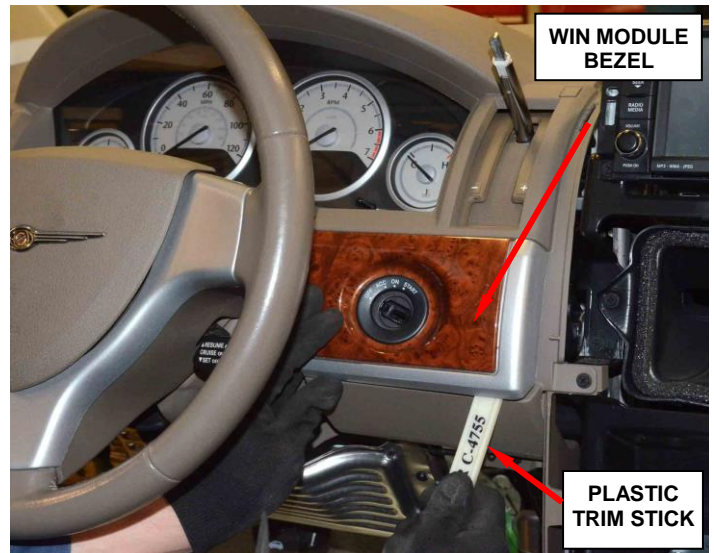
**Figure 5 – WIN Module Bezel**

10. Using a plastic trim stick, carefully remove and save the WIN module bezel (Figure 5).

21. Install the headlight switch bezel (Figure 6).
22. Install the WIN module bezel (Figure 5).
23. Install the instrument panel center stack bezel (Figure 4).

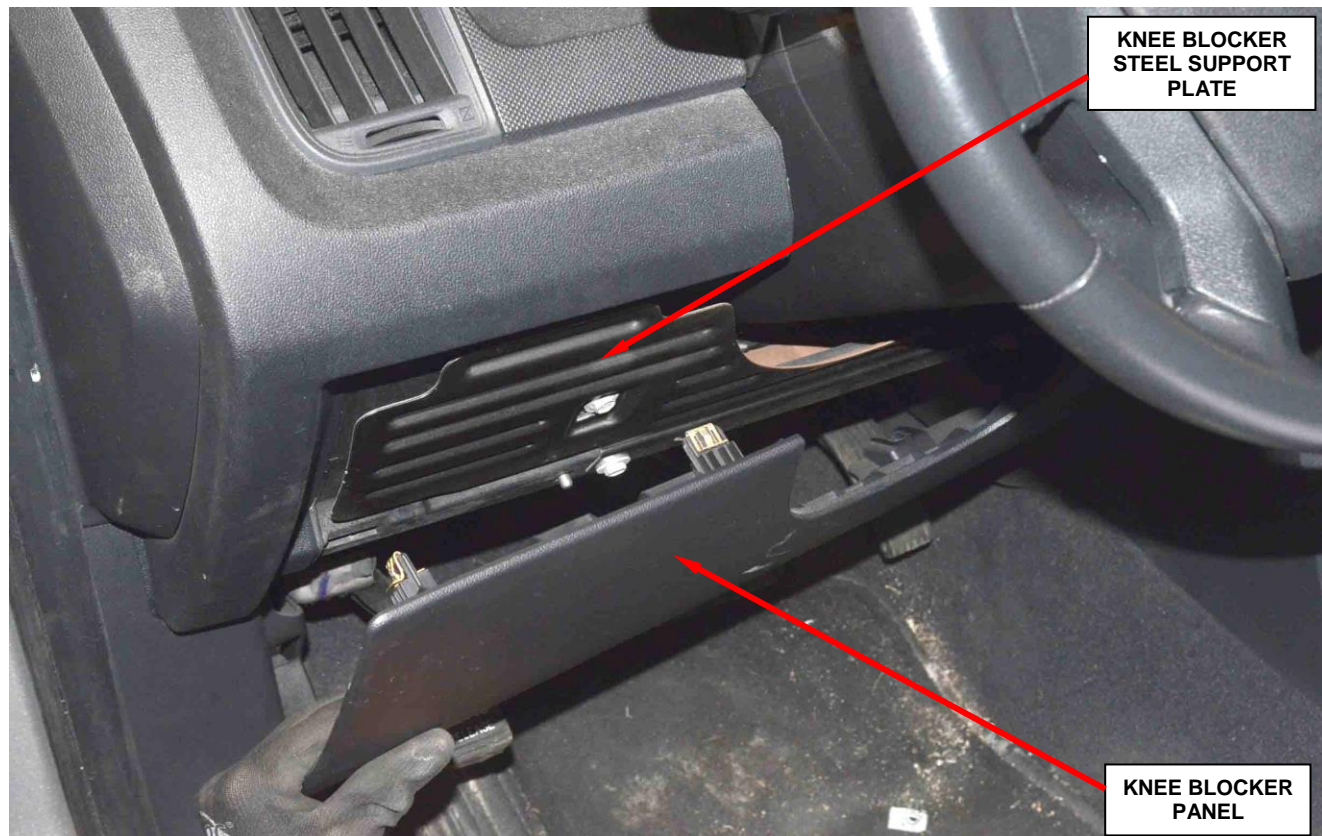
**Figure 9 – Knee Blocker Panel and Knee Blocker Steel Support Plate**

2. Remove and save the instrument panel knee blocker panel (Figure 9).
3. Remove and save the knee blocker steel support plate (Figure 9).

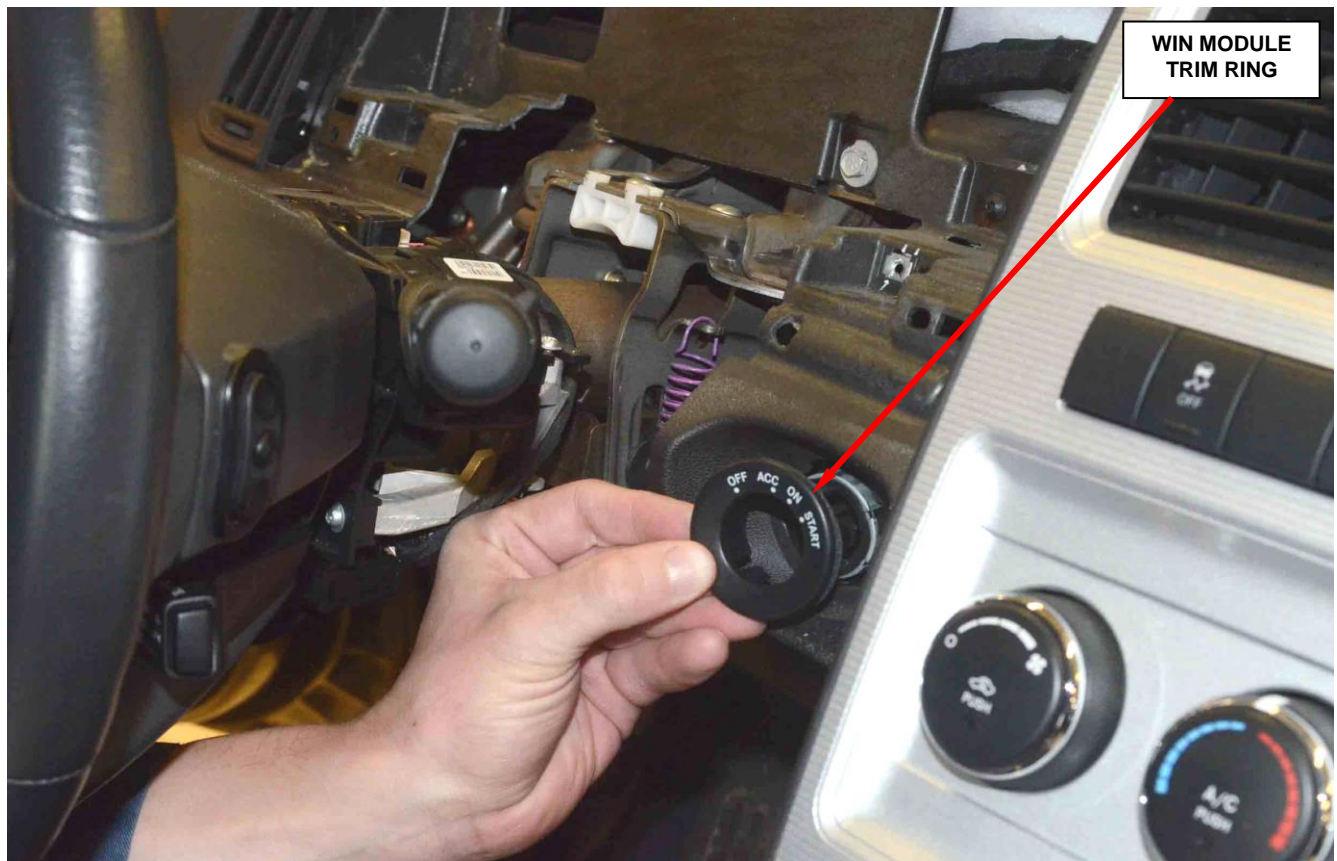
**Figure 12 – WIN Module Trim Ring**

6. Utilize a trim stick, or equivalent, gently pry WIN module trim ring away from the instrument panel (Figure 12).
7. Remove the lower WIN module attaching screw.
8. Remove the lower WIN module bracket attaching screw.
9. Rotate the WIN module and bracket to assist in removal from the instrument panel.
10. Remove and save the remaining WIN module mounting screws.

15. Install the remaining WIN module mounting screws.
16. **If equipped**, connect the coaxial electrical cable connector to new WIN module.
17. Install the WIN module trim ring (Figure 12).
18. Install the WIN module bracket attaching screw.
19. Install the instrument cluster into the instrument panel (Figure 11).
20. Install the instrument cluster bezel (Figure 10).
21. Install the upper and lower steering column shroud.
22. Install the knee blocker steel support plate (Figure 9).
23. Install the instrument panel knee blocker panel (Figure 9).
24. Connect the negative battery cable and tighten the negative cable nut to 45 in. lbs. (5 N·m).
25. Transfer the valet keys from the original FOBIK's to the new FOBIK's.
26. Continue with **Section D. WIN Module Programming (All models)**.

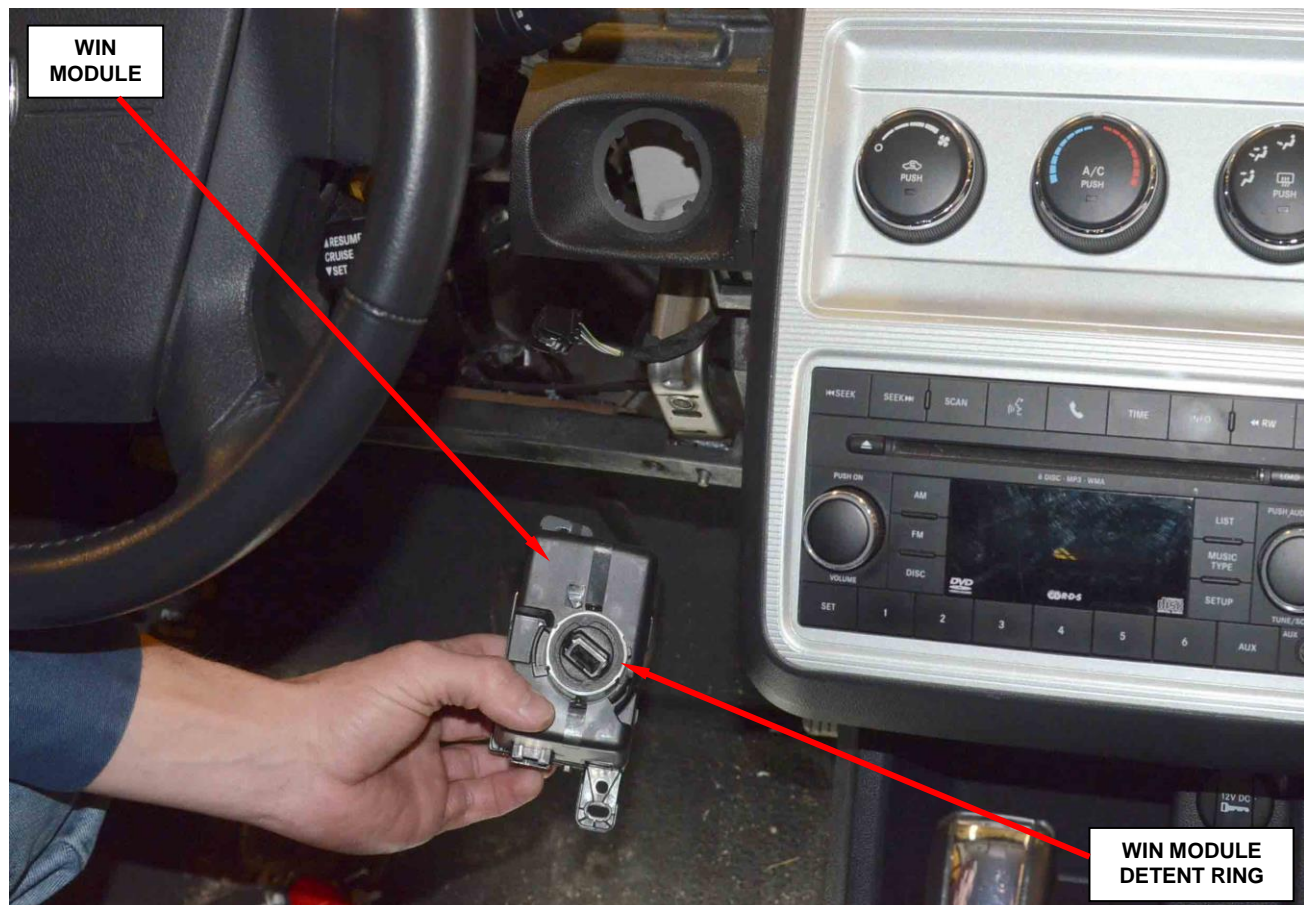
**Figure 13 – WIN Module**

11. Remove and discard the original WIN module and detent ring (Figure 13).
