# **Safety Recall T73 / NHTSA 17V-732**

## **Passenger Airbag Module**

**2018 (MP) Jeep® Compass**

**Service Procedure****A. Remove Passenger Airbag Module**

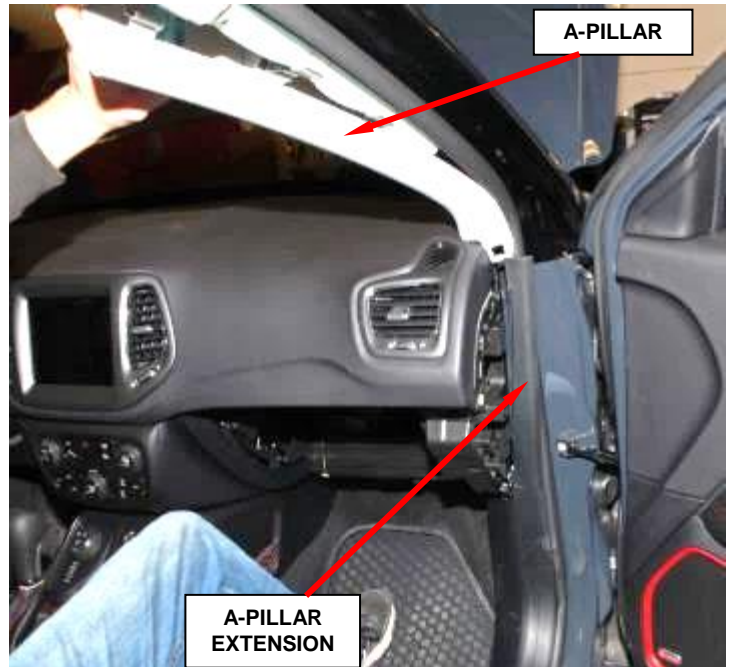
**Figure 2 – Right Side A-Pillar**

- Using a trim stick, remove the right-side A-pillar and A-pillar extension panel (Figure 2).

**NOTE: Right side shown, left side similar.**

46. Using a trim stick, remove the left-side A-pillar and A-pillar extension panel. Refer to Figure 2.

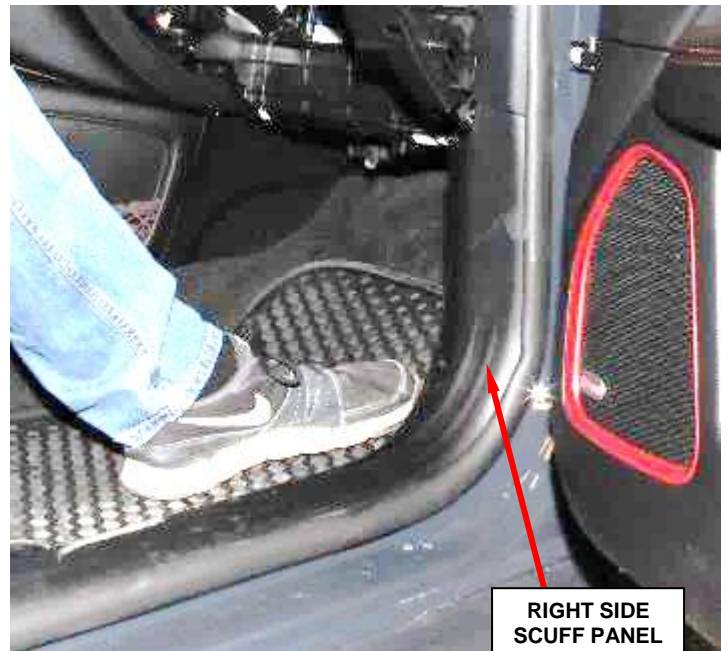
**Figure 3 – Scuff Panel**

- Lift the right side scuff panel at the rear, then pull rearward and remove (Figure 3).

47. Lift the left-side cowl side trim at the rear, then pull rearward and remove. Refer to Figure 3.

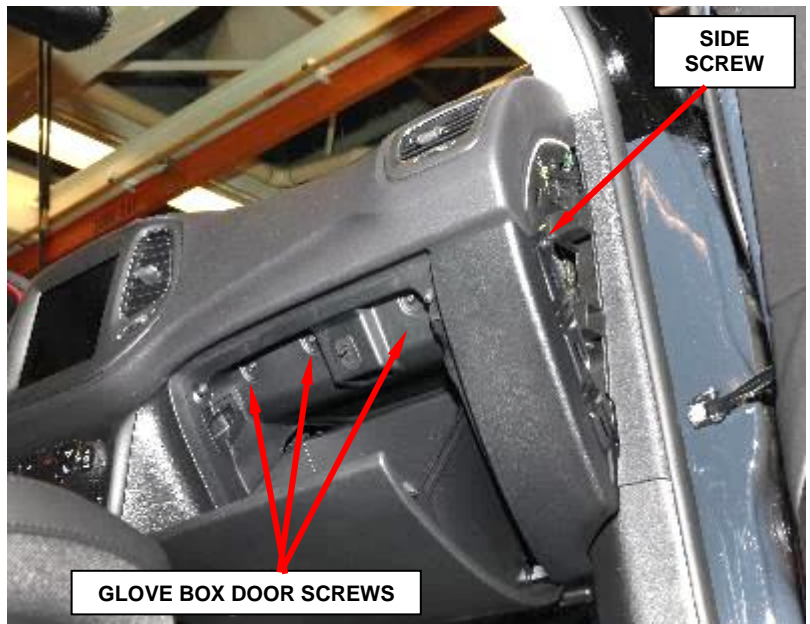
**Figure 4 – Glove Box**

6. Remove both instrument panel end caps, and remove the right side screw (Figure 4).
7. Open the glove box door and remove the three screws (Figure 4).
8. Pull rearward to release the retaining clips and remove the glove box assembly.
9. Disconnect the wire harness connector and remove the glove box.

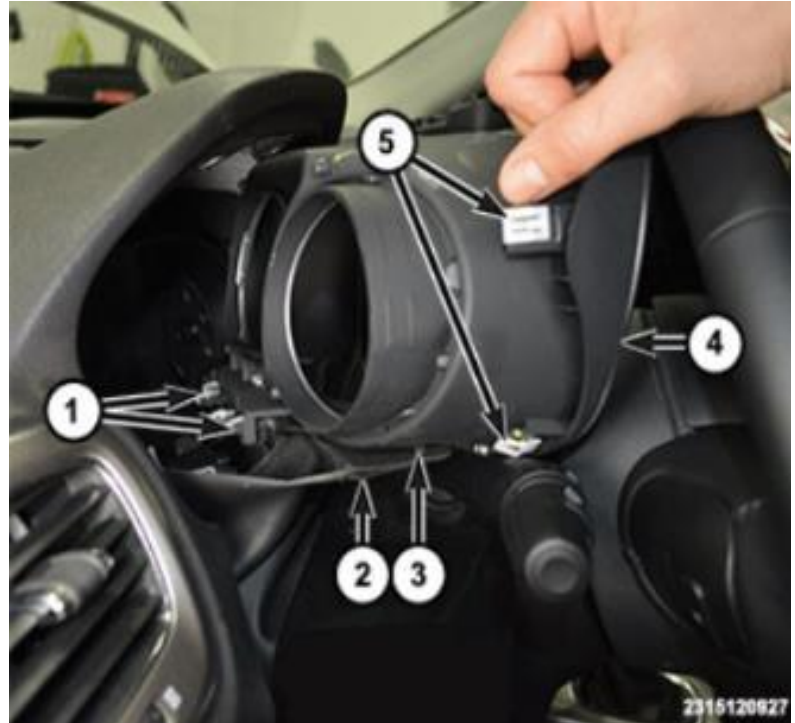
**Figure 7 – Instrument Cluster Bezel**

14. With a trim stick or equivalent, using extreme care not to damage the bezel, release the clips (5) on both sides and bottom of the instrument cluster bezel (4) and pull the outboard side rearward to access the gap hider (Figure 7).

15. Remove the gap hider flap (2) from the retainers (3), on both sides of the instrument cluster bezel (Figure 7).

16. Using a trim stick or equivalent, release the two clips (1) and separate the gap hider from the instrument cluster bezel. Remove the instrument cluster bezel (Figure 7).

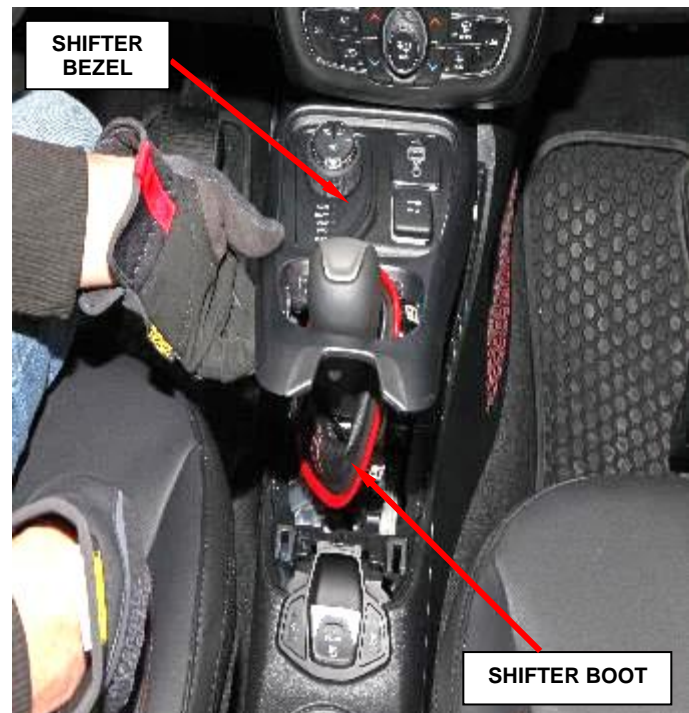
Figure 9 – Shifter Bezel

21. Using a trim stick, release the shifter boot from the shifter bezel and lift slightly (Figure 9).

22. Using a trim stick, loosen the shifter bezel. Disconnect the wire harness connectors and remove (Figure 9).

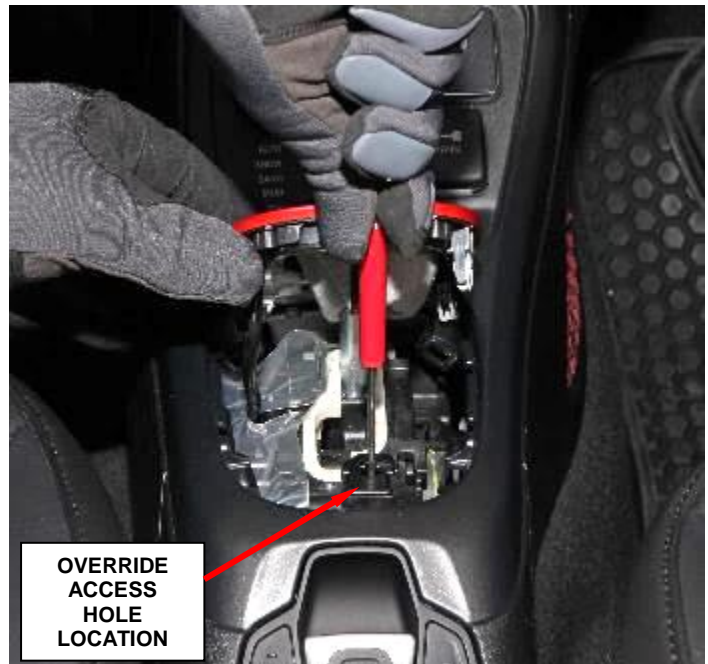
**Figure 10 – Override Release Lever**

- 24. Insert a small screwdriver or similar tool down into the shift lever override access hole and push and hold the override release lever down and place the shifter in the drive (D) position (Figure 10)

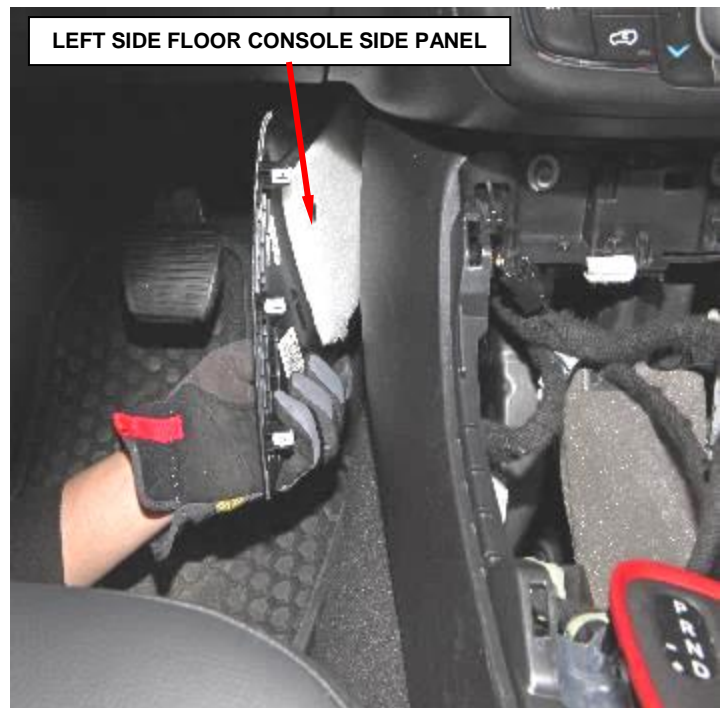
**Figure 11 – Floor Console Side Panels**

- 25. Using a trim stick, remove both floor console side panels (Figure 11).

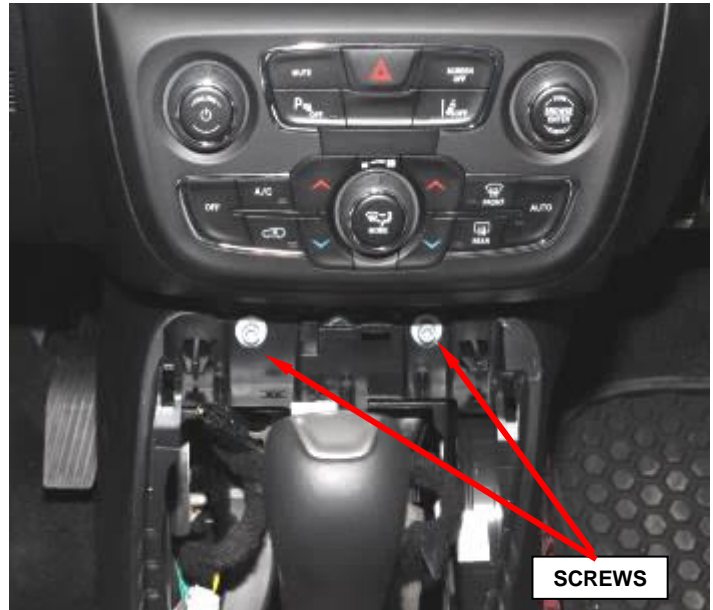
Figure 12 – Center Console Mounting Screws

26. Remove the two screws from the center console (Figure 12).

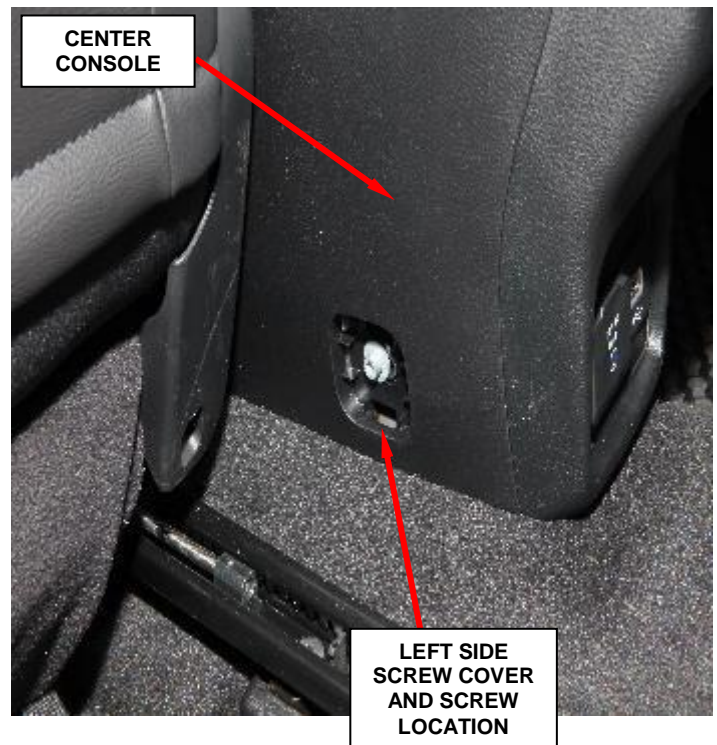
Figure 13 – Floor Console Mounting Screws

28. Remove the screw covers and the screws on both sides of the floor console (Figure 13).

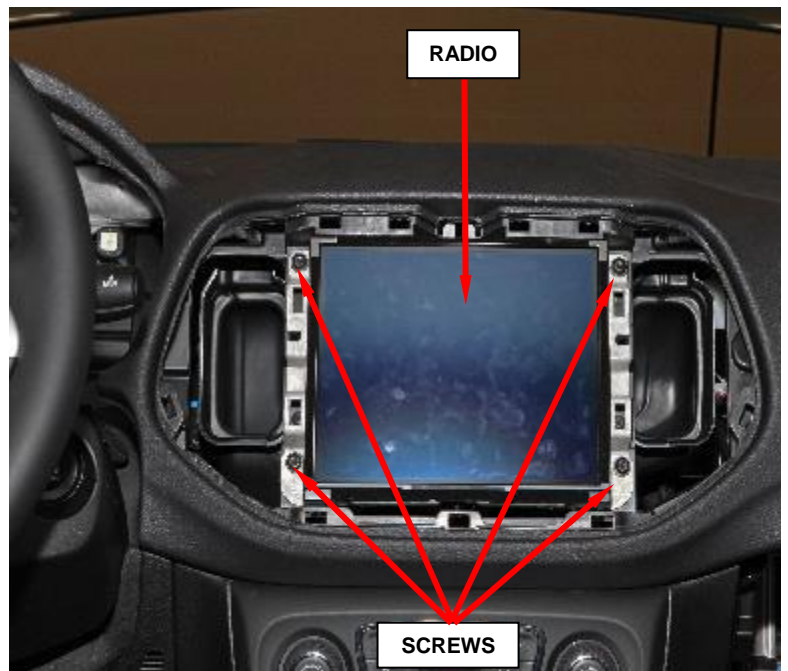
**Figure 15 – Radio**

34. Remove the four screws securing the radio to the instrument panel (Figure 15).
35. Pull the radio out far enough to access the back of the radio.
36. Disconnect the antenna cables, and radio wire harness connector.
37. If equipped, disconnect the USB connector.
38. Remove the radio from the instrument panel.
39. Using a trim stick C-4755 or equivalent, remove the Vehicle Feature Controls Center Stack (VFCCS) from the instrument panel (Figure 16).
40. Disconnect the VFCCS wire harness connector from the VFCCS.
41. Remove the VFCCS from the vehicle.

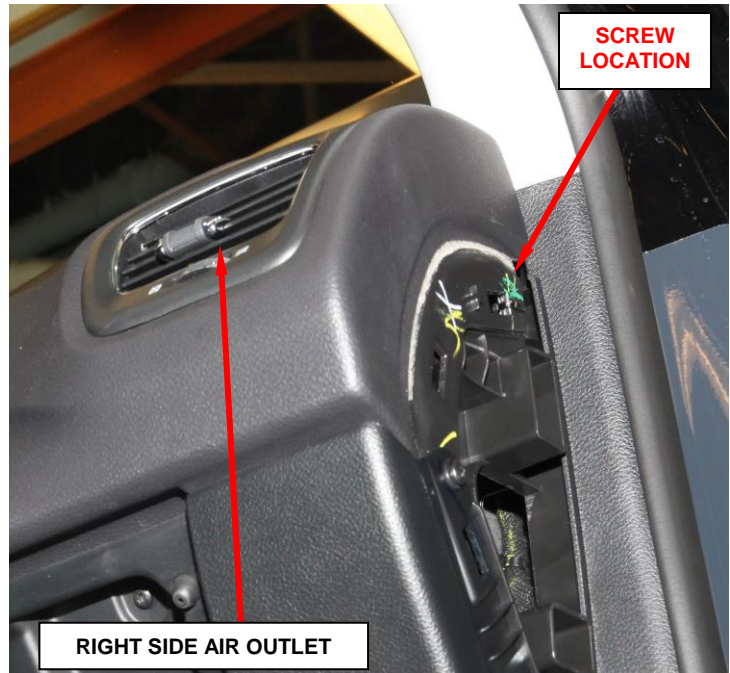
Figure 17 – Right Side Air Outlet Shown

42. Remove the air outlets (Figure 17).

**NOTE:** Some right-side air outlets are secured with an attachment screw located behind the instrument panel end cap (Figure 17).

- a. If equipped, remove the attachment screw from the right air outlet (Figure 17).
- b. Using a trim stick, remove the left and right air outlets

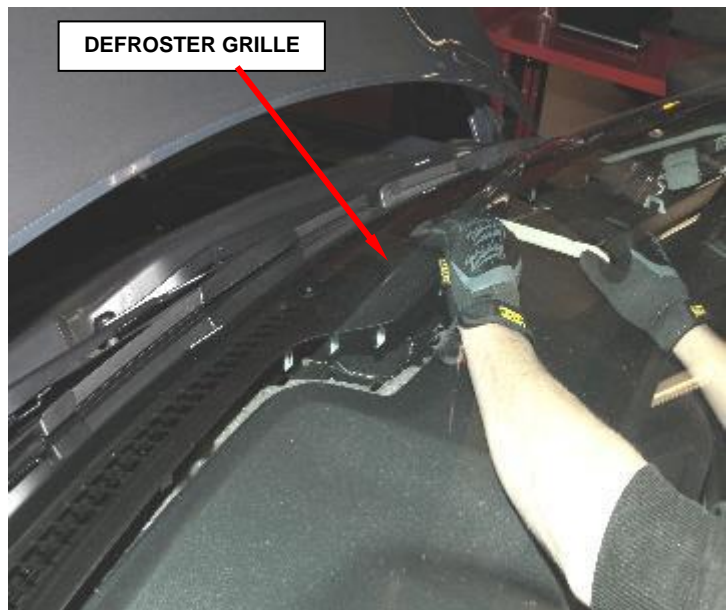
**Figure 21 – Defroster Grille**

- 52. Using a trim stick or equivalent, lift the rear of the defroster grille to release the retaining clip (Figure 21).
- 53. Lift the defroster grille and disconnect the sun sensor, then remove.

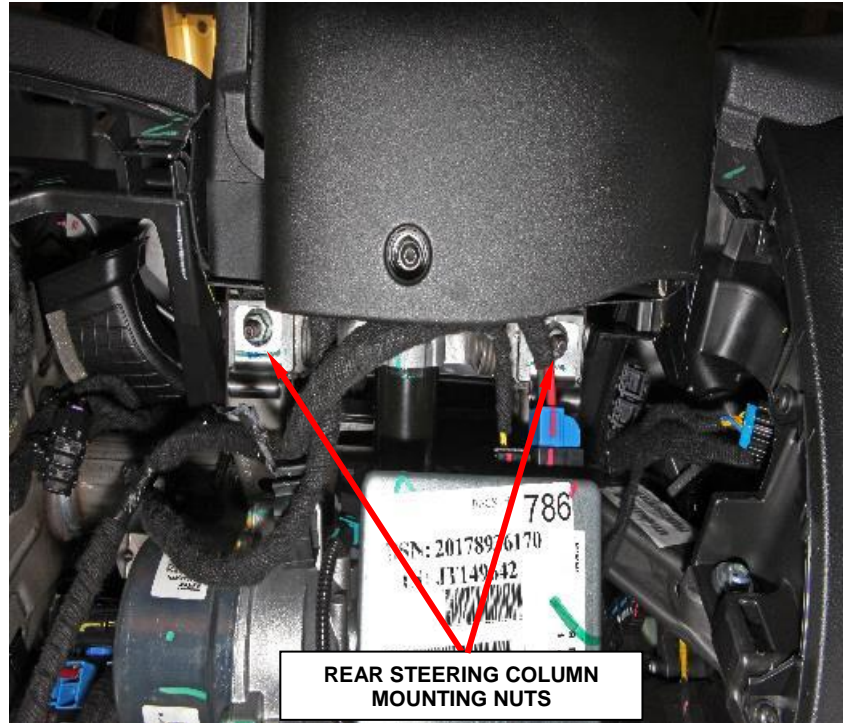
Figure 23 – Steering Column Mounting Bolts

60. Remove and save the two rear steering column nuts, and lower the steering column in the vehicle (Figure 23).

**CAUTION:** Position the steering column on the floor to avoid excessive tension on the connected wiring harness pigtails.
