**PRODUCT CAMPAIGN BULLETIN**

**NUMBER:** WQS-54  
**DATE:** June 30, 2015  
**NHTSA ID:** 15V-366

**SUBJECT:** WQS-54 Driver Assist System (EyeSight) Delay in Warning Indicator

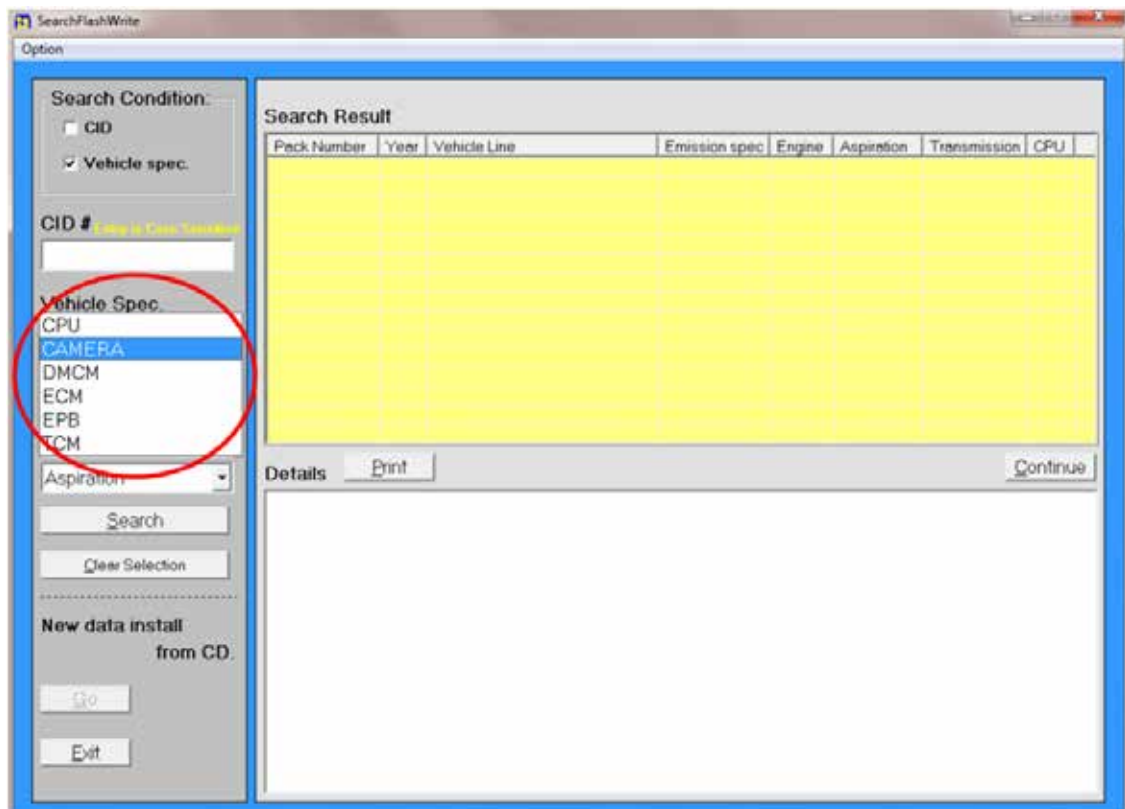
Click on the drop down box for CPU and Select CAMERA
